Rear of 80-81 Bailgate, Lincoln.

Archaeological Watching Brief

**NGR: SK 97659 71922
Site Code: LBTR 04
LCNCC Museum Accn Code: 2004.68
Planning ref.: 2003/0950/F and 2003/0952/LBC**

LAS Report No. 740

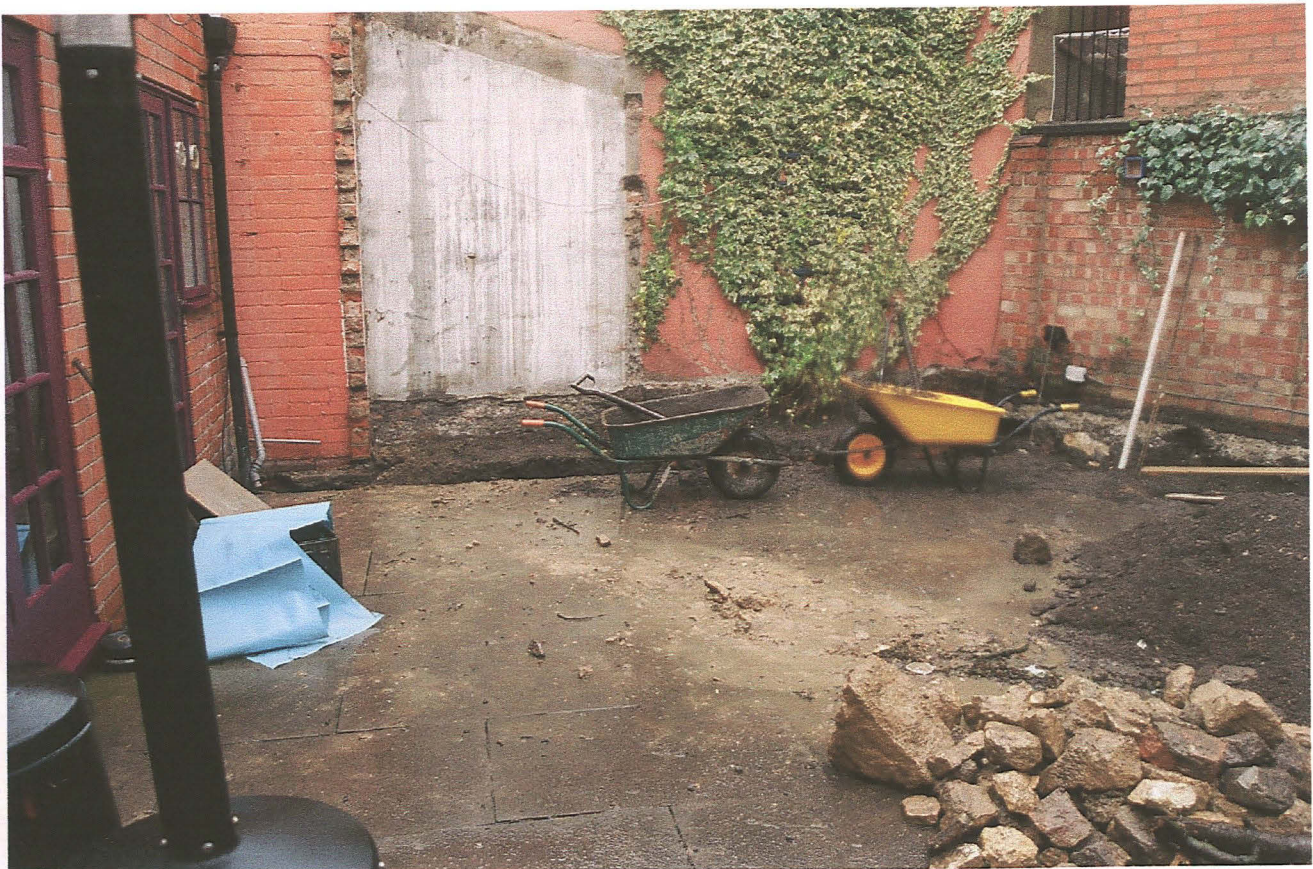
Pl. 2 Rear of 80-81 Bailgate looking north towards the wall of the Lion and Snake Public House.

The small area of the development hindered the photographic record; general shots of the foundations could not be taken and an overall view of the foundations is limited to **PI. 2**. Excavation undertaken by the workmen in the north western corner of the site removed masonry prior to the arrival of the monitoring archaeologist but the walls were recorded in section and elevation. The restricted access to the site, through a narrow passageway, may have impeded the accuracy of the levels.

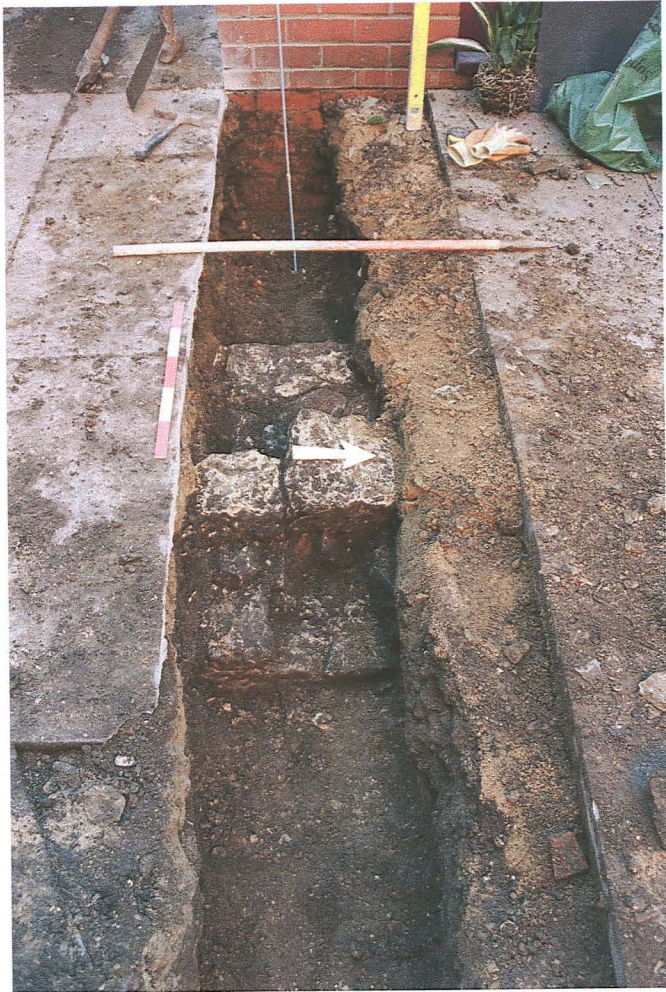
Pl. 3 Wall 1, looking west. Scales 1m and 0.5m.

Garden soil **2** sealed three walls. Wall **1** exposed in the southern foundation trench consisted of roughly finished limestone blocks bonded with soil (**Fig. 3 & PI. 3-4**). It was 0.7m wide with an off-set foundation on its east side giving a total width of 1m. The removal of the wall produced a roman brick and mid 14th to 16th century tile.

The shallow depth of the excavations (c. 0.50m) prevented an estimation of the preserved height of wall 7. The area of wall 1 which was exposed probably represents a foundation due to the off-set to the east of the wall. Wall 6 may also represent a foundation construction due to the soil bonding.

The finds retrieved from the centre of the wall 1 suggest a construction date after the mid 14th to 16th century. The two north-south walls 1 and 6, are probably not the same wall because they are not exactly aligned and they are bonded with different material.

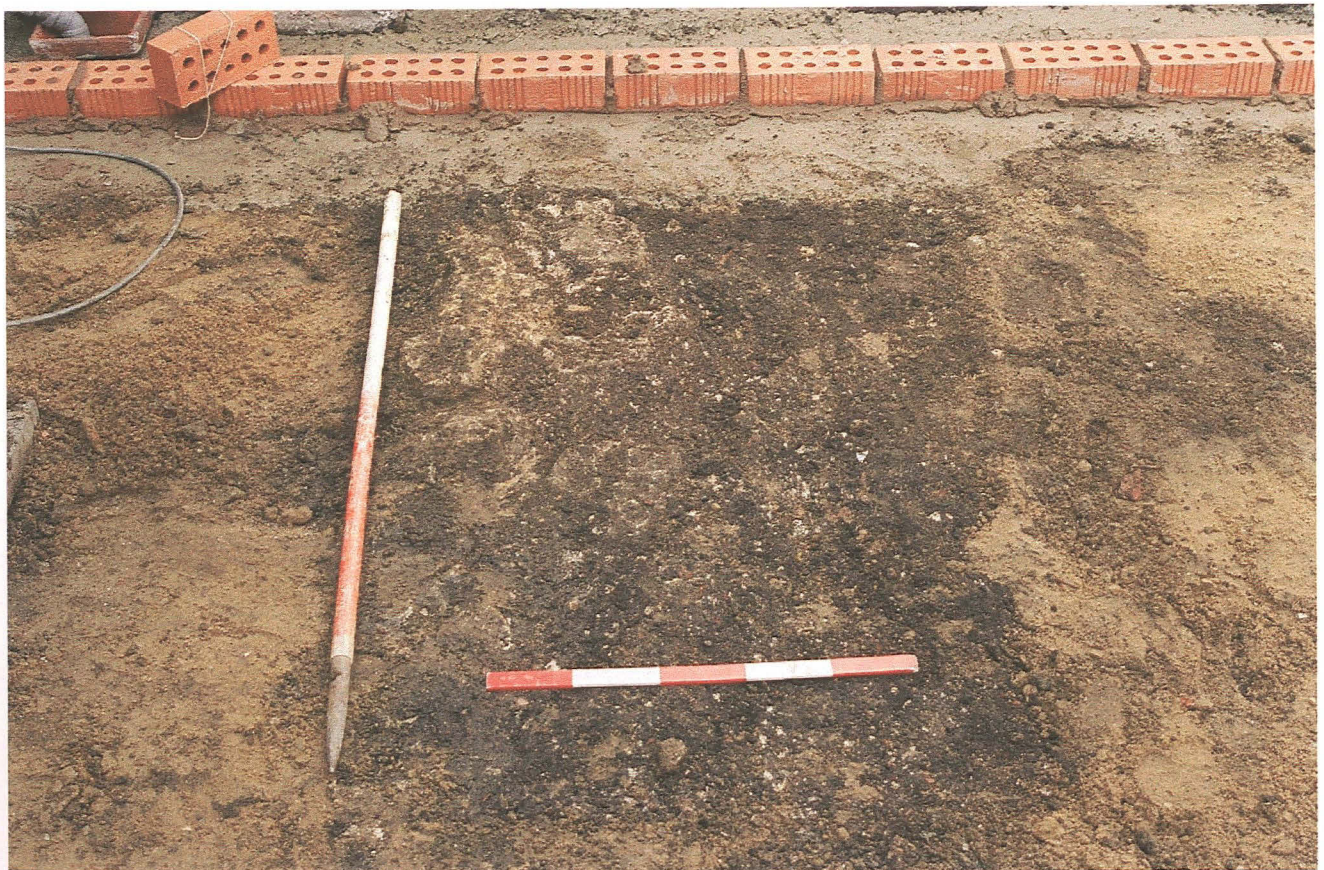
Pl. 8 Wall 3 exposed after the removal of the concrete paving (4) covered by sand bedding (5), looking north. Scales 1m and 0.5m.

The removal of the concrete paving (4) after the filling of the foundation trenches with concrete revealed the continuation of 6 running south (PI. 8). The internal flooring area of the development was not excavated beneath the top of the sand layer 5.
