**REAR OF THE OLD HOUSE, OLD LINCOLN ROAD,
CAYTHORPE, LINCOLNSHIRE**

**ARCHAEOLOGICAL WATCHING BRIEF
REPORT**

Site code	OHC 04
NGR:	SK 94030 48363
LCCM Acc No:	2004.61

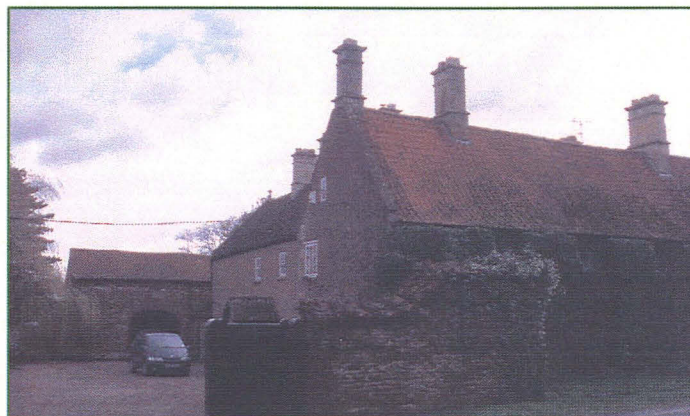
Plate 1 (right): The Old House, looking SE from the Old Lincoln Road, showing the barn (rear left) which backs on to the development site.

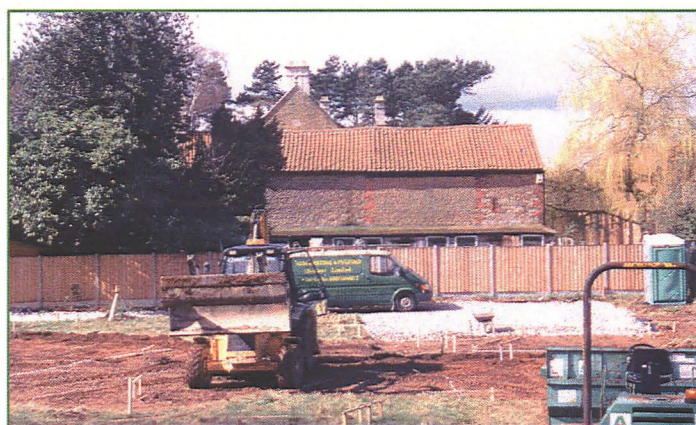
Plate 2 (left): General shot of the house footprint after excavation, looking SE, showing the barn to the rear of the Old House behind the boundary fence.

In the NW corner of the stripped area, layer 004 was seen under topsoil 001. This layer was 0.05m to 0.10m deep, and consisted of limestone fragments in a matrix of brown silty sand; it contained occasional fragments of brick or tile. The similarity to natural stony layer 005 indicates that this deposit may be redeposited natural, possibly utilised as a yard surface or hard-standing area associated with the farm buildings to the rear of the Old House, adjacent to this corner of the site (plate 2).

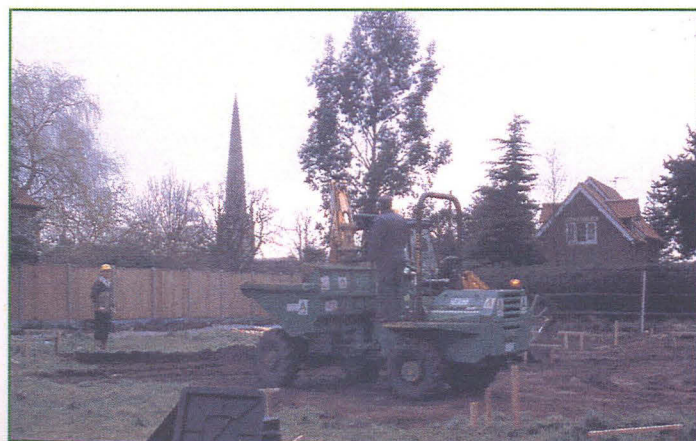
Plate 5 (right): Wall foundation [003] exposed in the access road strip, looking SE.

Excavation at the beginning of the access route exposed the foundation of a limestone wall, 003, which had been demolished for access to the field at an earlier date. This portion of the boundary wall could be seen to post-date the standing wall to the north, and modern material was found among the demolition rubble.

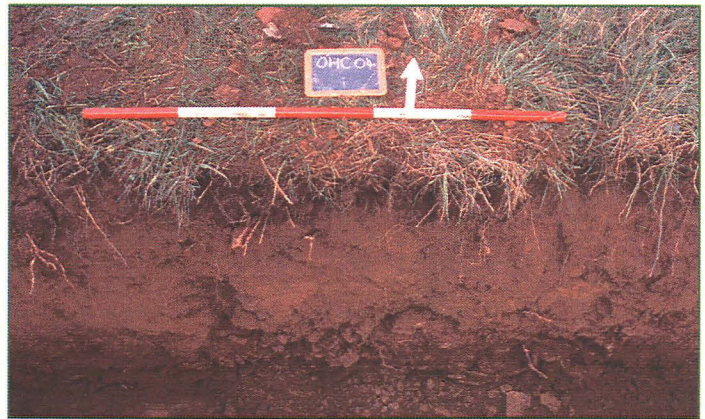
Plate 8 (left): Sample section 3, on the W edge of the house plot, showing the modern ashy material in topsoil 001, looking WNW.

The site was sealed to a depth of 0.25m-0.30m by topsoil 001, a mid brownish-grey sandy loam, which contained large patches of recent ash and burning debris in the house footprint area. Below this was subsoil 002, a layer of light brown sandy silt, generally 0.50m-0.65m in depth, and containing no dating evidence. Where excavations were deep enough to expose it, natural 005 underlay 002: it consisted of irregular, platy limestone and ironstone fragments in a matrix of mid-brown clayey coarse sand.
