**ARCHAEOLOGICAL
WATCHING BRIEF.
SAINT THOMAS'S CHURCH
MARKET RASEN, LINCOLNSHIRE**

NGR: ~~SK~~^{TF} 1065 8922.
SITE CODE: STMR03
LCNCC ACC. NO: 2004.98

Report prepared for
West Lindsey District Council
by William Munford
April 2004

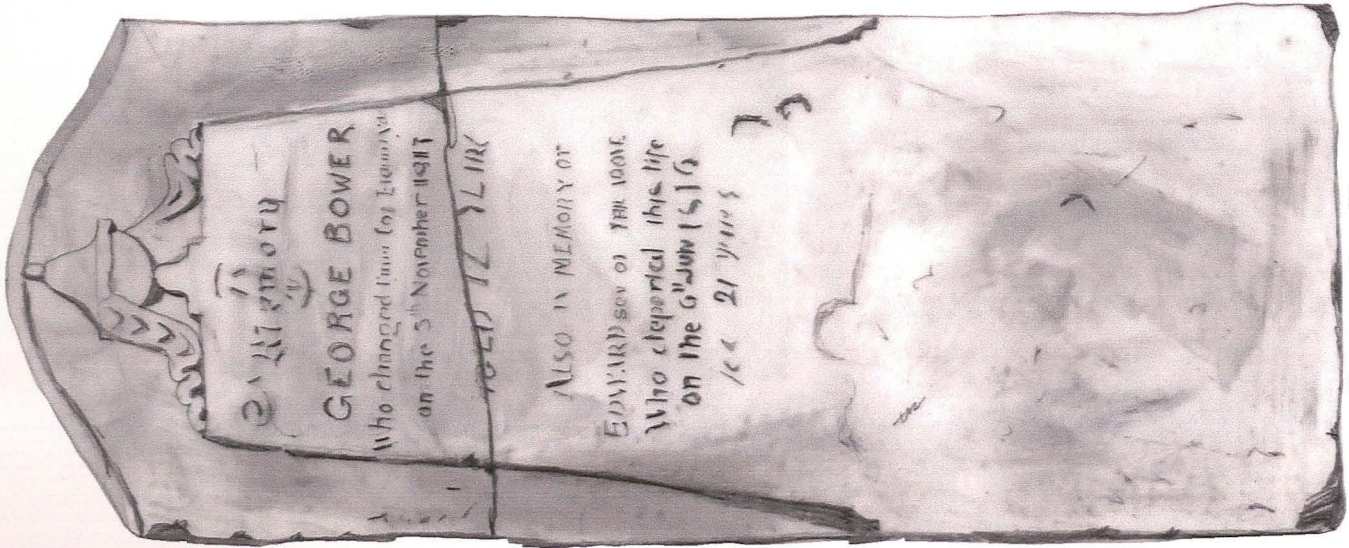
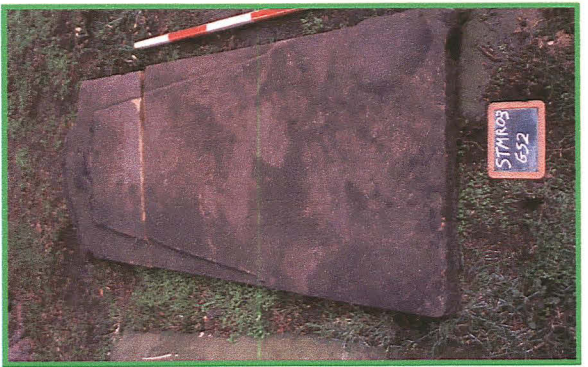
Grave marker #2 also consisted of a sub-rectangular slab of limestone, in this case measuring 1730mm long by 704mm wide by 75mm thick. Like grave marker #1, it had a shouldered top edge and showed signs of having been finely sawn. It featured an inscription platform surmounted by a relief carving of a cloaked urn. Its inscription read:

In
Memory of
George Bower
Who changed life for eternity
On the 5th November 185..
Aged 77

Also in memory of
Edward son of the above
Who departed this life
On the 6th June 1816
Aged 21 years

It is worth noting that there may be some un-readable family relationship between the recipients of Grave marker #1 and grave marker #2. They display the names "George Bo..." and "George Bower" respectively. This could indicate that a family group was inhumed in this corner of the churchyard and that the stones were not simply disposed of here. The facts could probably be established by studying the local parish records.

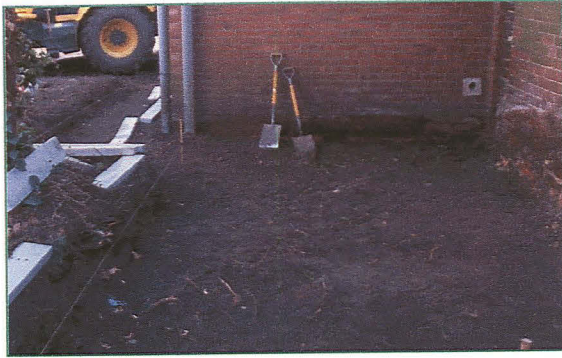
Pl. 1. Part of the completed groundworks in the south west corner of the church yard, looking east.

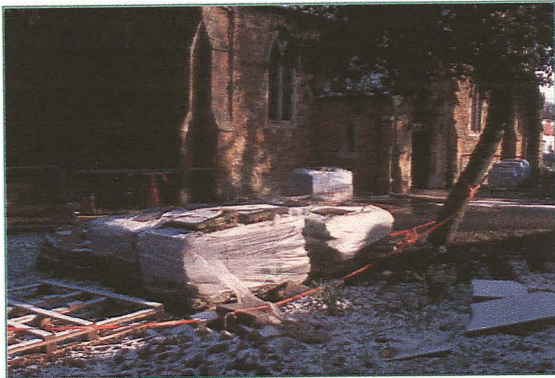
Pl. 2. The churchyard during the enhancement works, looking east.

Pl. 2. The churchyard during the enhancement works, looking east.

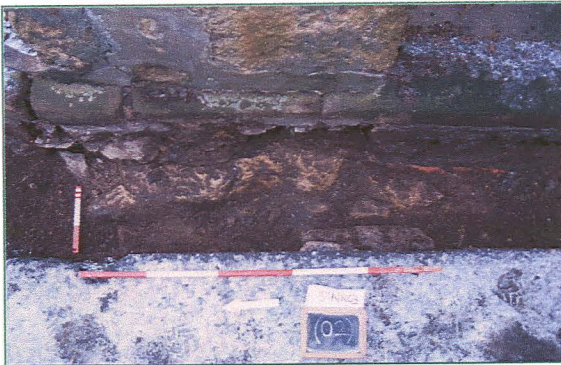
Pl.3. Stone foundation blocks, (002) at the base of the tower buttress, looking east.

The works also included the excavation of 400mm deep by 400mm wide trenches either side of the existing pavement in the majority of the churchyard. As this work was carried out at the base of the north westernmost buttress of the church tower, it revealed a number of substantial stone blocks, (002), in the base of the trench. In plan these appeared to commence in line with the northernmost edge of the buttress and end approximately 300mm to the south of its southernmost edge. A single human long bone was discovered amongst the stone blocks and removed.

The discovery of the large stone block foundations, (002), within the trench at the base of one of the buttresses of the church tower was anticipated. We know that the style of the buttresses themselves is typical of the 15th century. Throughout the Middle Ages the depth of buttresses increased in relation to their width as understanding of their structural properties developed, (Jones, 1969), and those at St Thomas's display appropriate dimensions for the probable 1405 construction date. Interestingly the single human bone found amongst the foundation stones indicates that the early 15th century works for the tower may have truncated previous graves or that the process of forgotten graves being disturbed within the churchyard, had already begun at this early date.

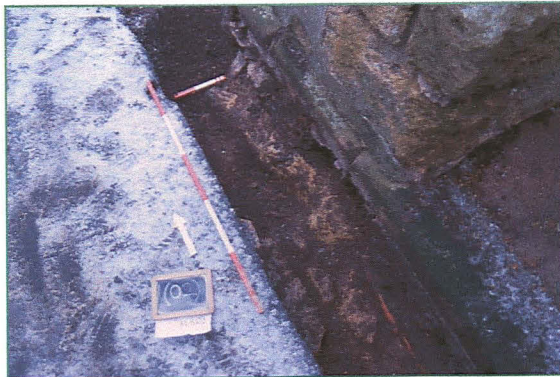
Pl.4. Stone foundation blocks, (002) at the base of the tower buttress, looking north east.
