**Grantham Street, Lincoln  
Archaeological Watching Brief**

**Site Code: LGS 03**

**LAS Report No: 727**

**April 2004**

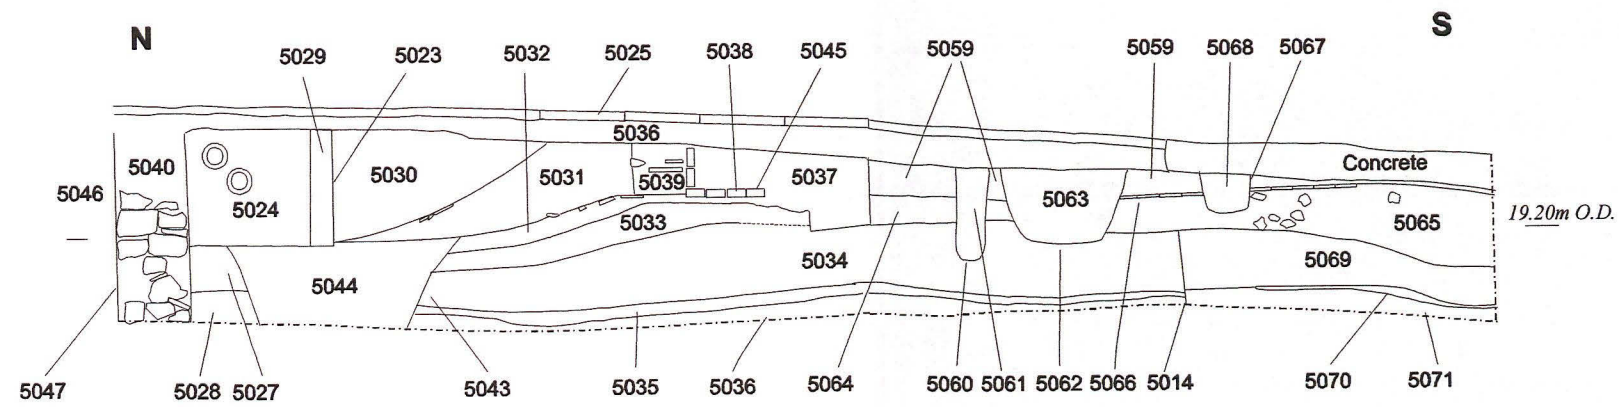
Fig. 3 A) Main south facing section B) Main west facing section

Below the modern car park surface of 0.06m thick tarmac, **5025**, and concrete/paving blocks, **5103**, was a layer of concrete and crushed limestone bedding, **5001/5026**, up to 0.20m deep. Beneath **5001/5026** were modern levelling deposits, **5030**, **5031**, **5059**, **5064**, **5065** and **5087/5104**, varying from brown sand silt to rubble, which was up to 1.10m thick, infilling robbed out walls. A posthole, **5092**, seen only in the south facing main section, was below **5087**, filled by rubble **5091**.

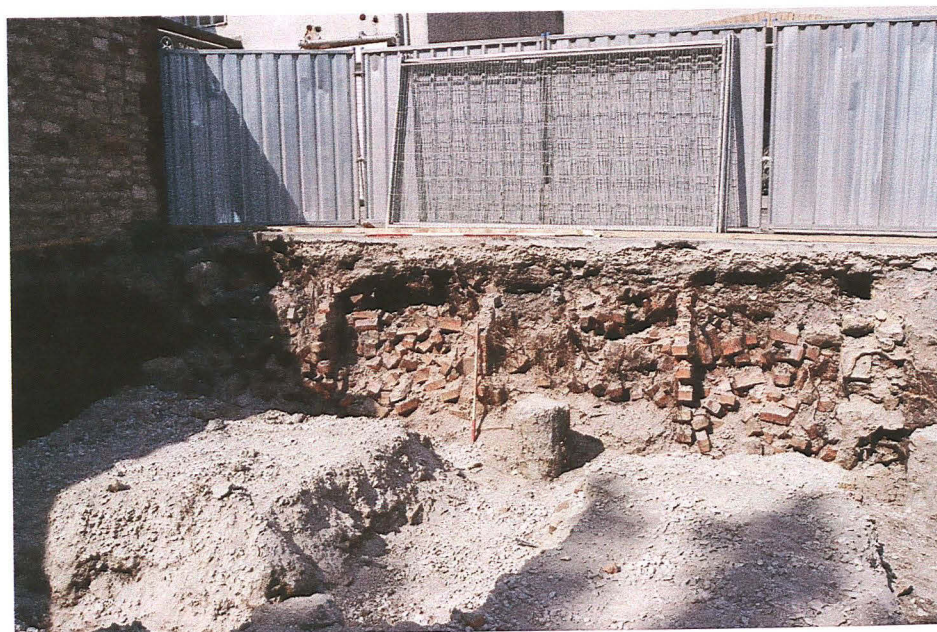
Pl.2 South facing main section, west end. Horizontal scale 2m, vertical scale 1m

A larger stone-lined cellar, **5098**, c.6.40m long and a minimum of 3.5m wide, was recorded close to the north-west corner of the site (Pl. 2). It was subdivided by brick wall partitions, **5095**, and filled with bricks, **5096**. To the south of **5047** and **5098** were cellars, **5009** and **5111** (Pl.13). **5009**, c.6.5m long and 3m wide, had been robbed of all its stone and was filled with brown silt sand containing brick, mortar and limestone fragments, **5010**. **5111** to its east was 5.50m long and 3.50m wide, and retained its stone walls, **5000**. The cellars cut into the top of an earlier pit **5062** which was filled with a dark brown grey sand silt, **5063**, and postholes **5067** and **5060** (Fig. 3B). The fill of **5067**, was the same as found in the pit **5062**. Posthole **5060** contained brick and concrete, **5061**.

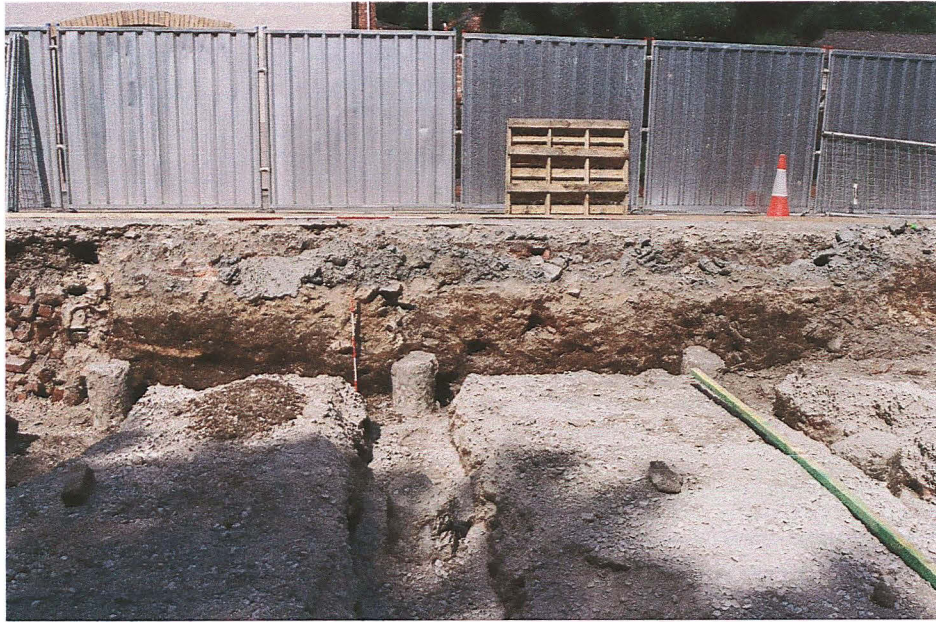
P1.3 South facing main section, central area. Horizontal scale 2m, vertical scale 1m.

To the west of robber trench **5089** was surface, **5107** (Pl. 3), constructed on top of a 0.03m thick charcoal rich deposit, **5101**. A second surface 5100 was separated from **5107** by topsoil layer, 0.60m deep, **5099** (Pl. 3). These deposits may be additional rooms west of the robber trench **5089** or might be associated with a new property, whose western limit would have been destroyed by cellar **5098** to the west. The north-west corner of the site had the same sequence of deposits, surfaces **5113** and **5114** separated by topsoil **5075** (Pl. 2). The later floors, **5081**, **5107** and **5114**, were all sealed by a further former topsoil recorded variously in the different trenches as **5074/5080/5112**.

**5006** (Pl. 4), another possible robber trench, was filled by **5007**, yellow and red clay mixed with light brown silt clay, and **5008**, limestone fragments. The robbing may have turned north, becoming 3m wide, flat based feature **5106** (Pl. 3), to the west (filled by **5105** which was similar to **5007**), and **5094** to the east (Pl. 4), over 1m deep and 0.80m wide, which had a single dark brown black sand silt, **5093**. The level for the base of these features is the same, 18.84m O.D.. If these features are part of the same robber trench this means that a possible c.5m wide structure was present on the site after the earlier medieval building. **5081** is the remains of a new floor surface, covered over by an accumulation of trample, **5080** (Pl. 4), 0.17m deep, which in turn was covered by another floor **5078** (Pl. 4).

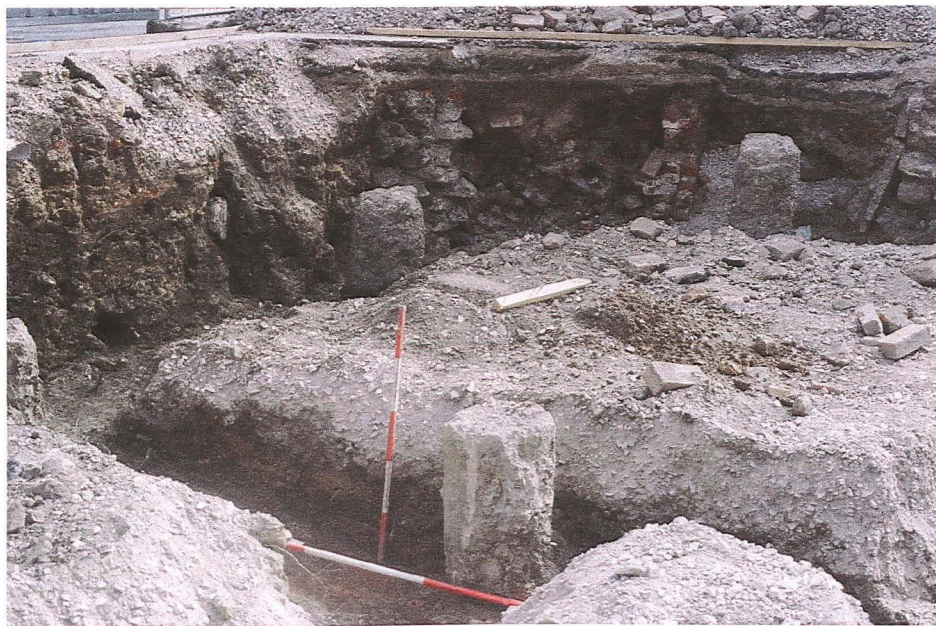
P1.4 South facing main section, east end. Horizontal scale 2m, vertical scale 1m.

In the north-east corner of the site was a stone-lined cellar, **5047** (Pl. 4), over 4m long and 2m wide, which extended beyond the northern and eastern limits of the site. Its west and south walls (**5040**) were two blocks of stone thick, and eight courses, over 1.26m in height, were exposed. The stonework was bonded with brown silt, except for the upper courses which were mortared. Cellar **5047** was filled by brick rubble, **5046**.

Floor layer **5084** was sealed by a 0.40m thick build up of soil, **5082** (Pl. 4), suggesting the building had been derelict for a while before the walls were robbed away. The two walls were robbed on different occasions as the robber trench **5088** was sealed by surface **5080** whereas robber trench to the west **5089** cut through it (Pl. 4).

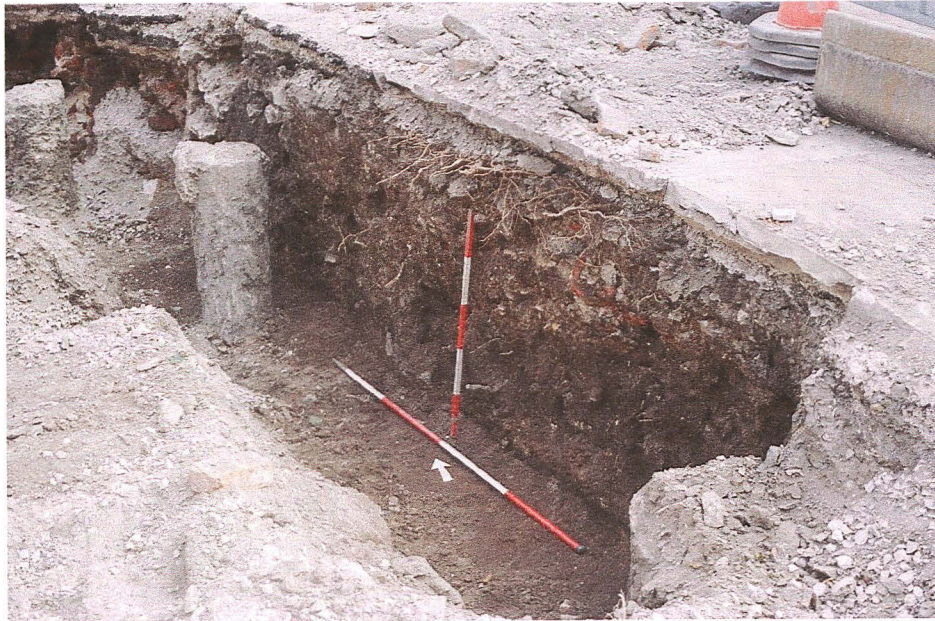
Pl.5 West facing main section, north end. Horizontal scale 2m, vertical scale 1m.

A stone-lined inspection chamber, **5023**, 1m wide and 0.78m deep and containing two ceramic pipes, was noted in the west facing section of the trench (Pl. 6). Its wall, **5029**, was constructed from limestone blocks up to 0.16m in size and it was filled with black sand silt, **5024**. A brick lined drain, **5045**, lay c.2m to the south (Pl.5). The bricks, **5038**, were 0.13m wide and 0.06m deep, and were below light brown silt sand, **5037**. Immediately to the north of **5045** was wall **5039** (Pl.5), 0.36m wide, comprising tiles set in cement.

Between **5002** and **5021/5041/5043** was brown sand silt surface **5035** (Pls. 5 and 6). **5035** appeared to butt up to **5043** to the north and **5014** to the south. Its relationship with robber trench **5019/5012** is unknown as this feature did not appear in the west facing main section. Below was former topsoil **5005/5016/5028/5036/5057** (Pls. 5 and 6) which produced 5 sherds of pottery of mid to late 12<sup>th</sup> century date and a piece of Roman tile.

Surfaces **5066** and **5033** (Pls. 5 and 6) were recorded to the south of **5021/5041/5043**. **5066** comprised horizontally placed tiles 0.13m in width, whilst **5033** was made from mortar. They were separated by **5032**, a topsoil layer. These layers may stratigraphically correspond with the later phase of floors within the building.

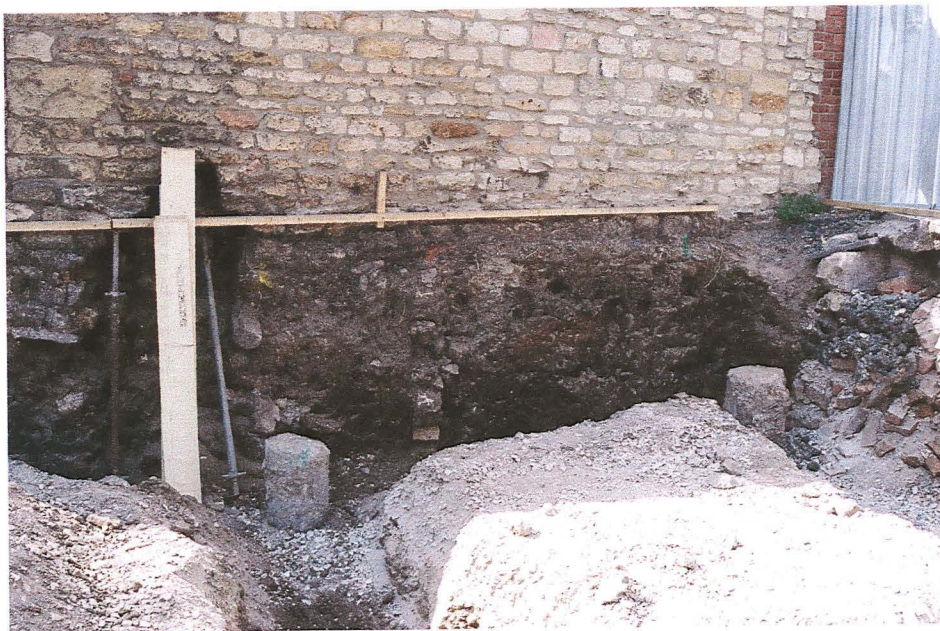
Pl.8 East facing main section, north end.

c.1.50m to the south of **5002** was another robber trench recorded in the various ground beam trenches which crossed it as **5021/5041/5043** (Pls. 4, 10 and 11). It was aligned east/west and ran the full length of the development site and was also noted in the east facing main section (Pl.8). Between the building(s) and the boundary wall was **5027**, a deposit not dissimilar to topsoil **5082**, which probably accumulated at the same time.

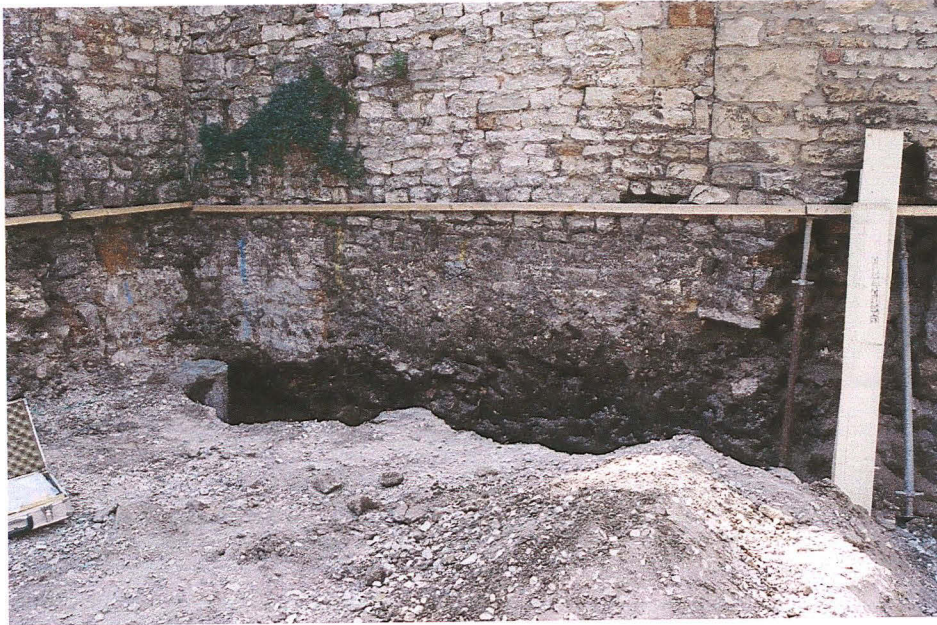
Pl.9 East facing main section, south end.

The possible position of a terrace, **5014/5017** (Pls.9 and 14), was noted c.9m to the south of the northern limit of the site. The terrace was on an east/west alignment until c.12m from the eastern edge of the site where it turned north-west/south-east. All soil layers south of this cut (**5015**, **5018**, **5050**, **5051**, **5052**, **5053**, **5054**, **5055**, **5056**, **5058**, **5069**, **5070**, **5071** and **5073**) are presumed to be over the lower terrace. No structures were observed in this part of the site which is where the two evaluation trenches (dug in 2000) were located.

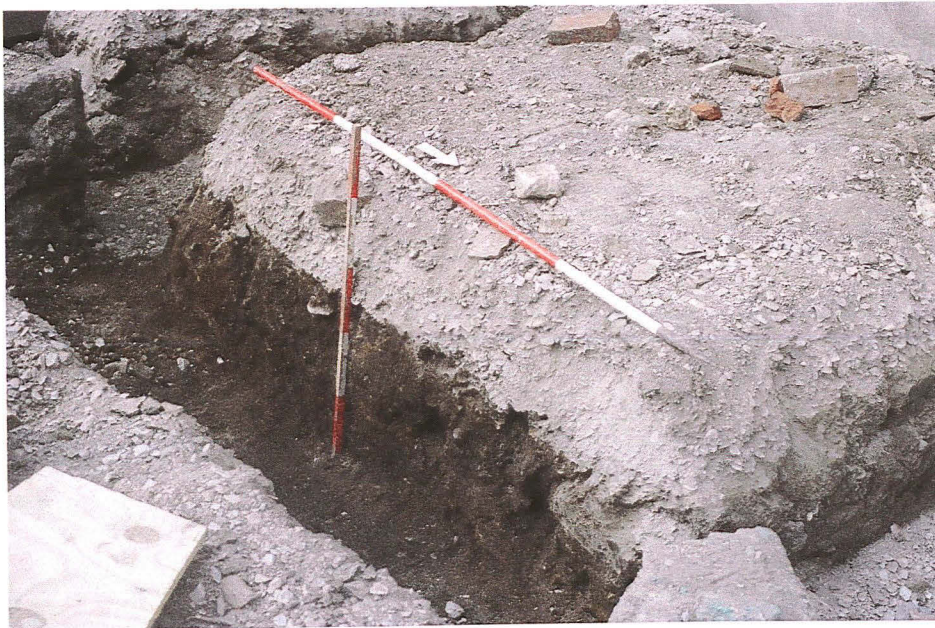
Pl.10 West facing section of 5019 and 5021. Horizontal scale 2m, vertical scale 1m.

Robber trench, **5019/5012** (Pls.10 and 12) was on a similar orientation to, and c.1m to the south of **5021/5041/5043**. It was noted in the east facing main section, but was cut through by later cellars **5009** and **5000** and was not seen in the west facing section to the east of **5000**. It was filled by **5013**, a dark grey brown sand silt to the west and a cream mortar to the east, **5020**. A single sherd of 11<sup>th</sup> to 12<sup>th</sup> century pottery was recovered from this deposit.

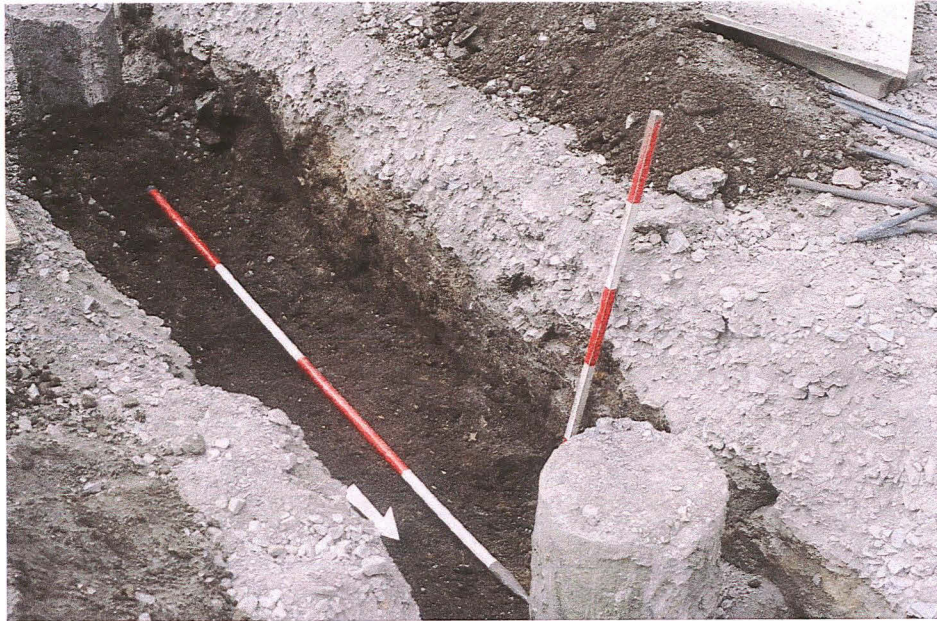
Pl.11 West facing section, showing 5041. Horizontal scale 2m, vertical scale 1m.

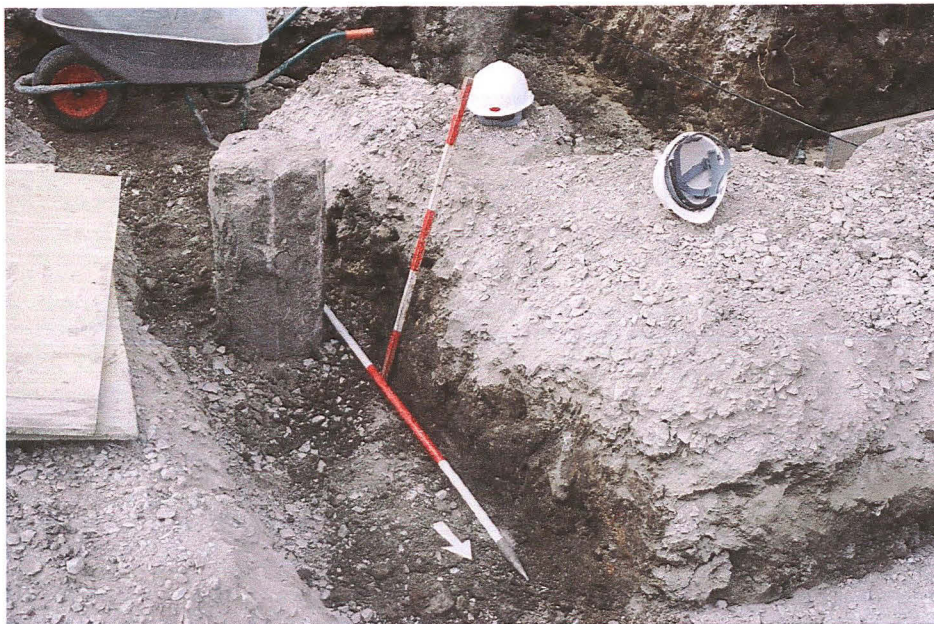
Pl.12 West facing main section of 5012. Horizontal scale 2m, vertical scale 1m.

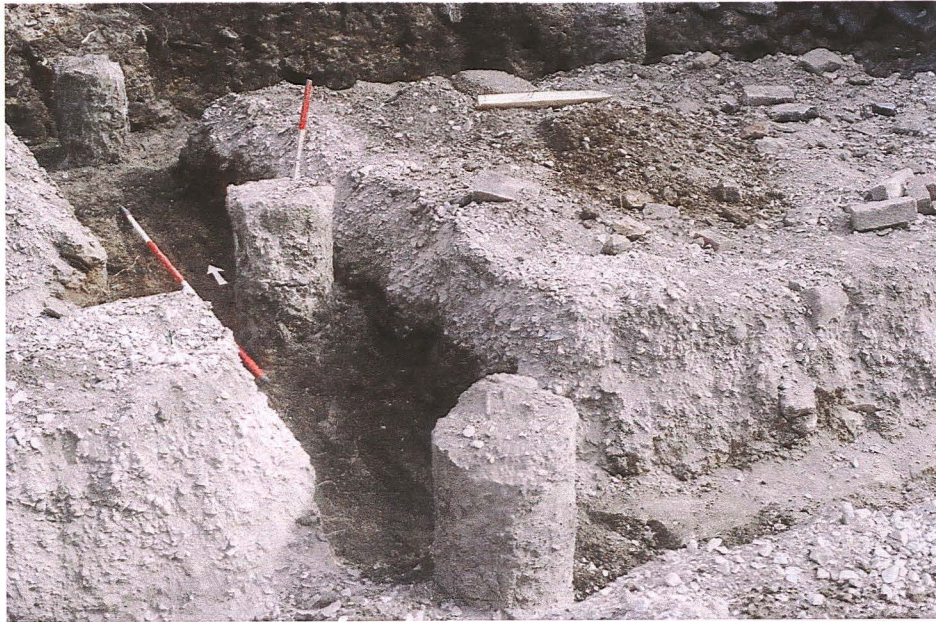
Pl.13 Robber trench 5002 and cellar 5009 (foreground). Horizontal scale 2m, vertical scale 1m.

been constructed in limestone and the robber trenches were c.2m wide running beneath the modern street to the north, and extending c.2.50m into the trench. A robber trench, **5002** (Pl. 13) aligned west-east was also noted cutting into soil layer **5076/5086/5102** and may have connected **5088** and **5089**. Red and yellow clay mixed with dark brown sand silt filled the robber trench **5002** and contained late 12<sup>th</sup> to early/mid 13th century pottery with some residual Roman tile.

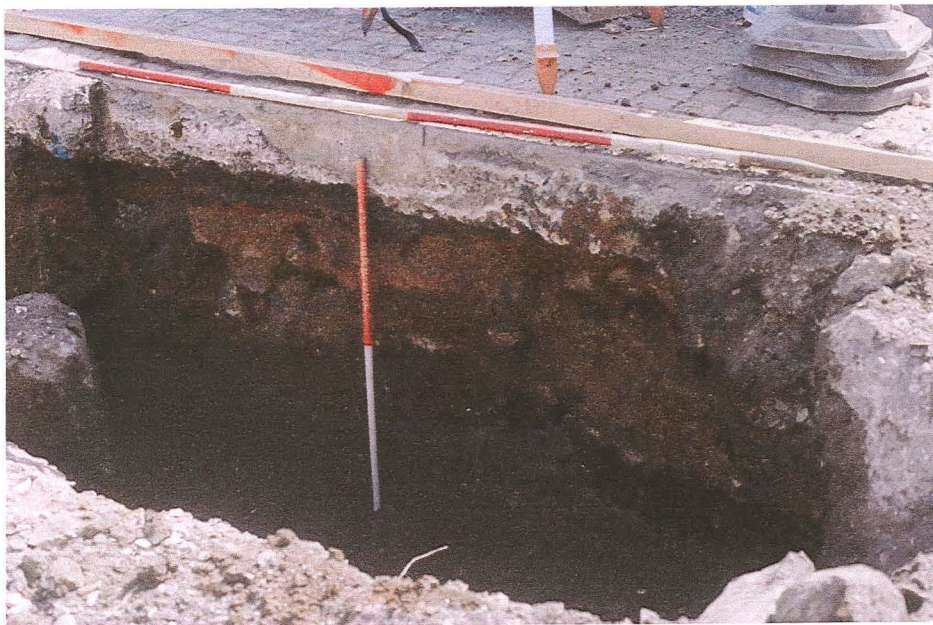
Pl.14 West facing main section, slumping into terrace 1517. Horizontal scale 2m, vertical scale 1m.
