## Church Farm, High Street, Fillingham, Lincs.

## Archaeological Watching Brief

Report for  
Lindum Homes

LAS Report No. 741

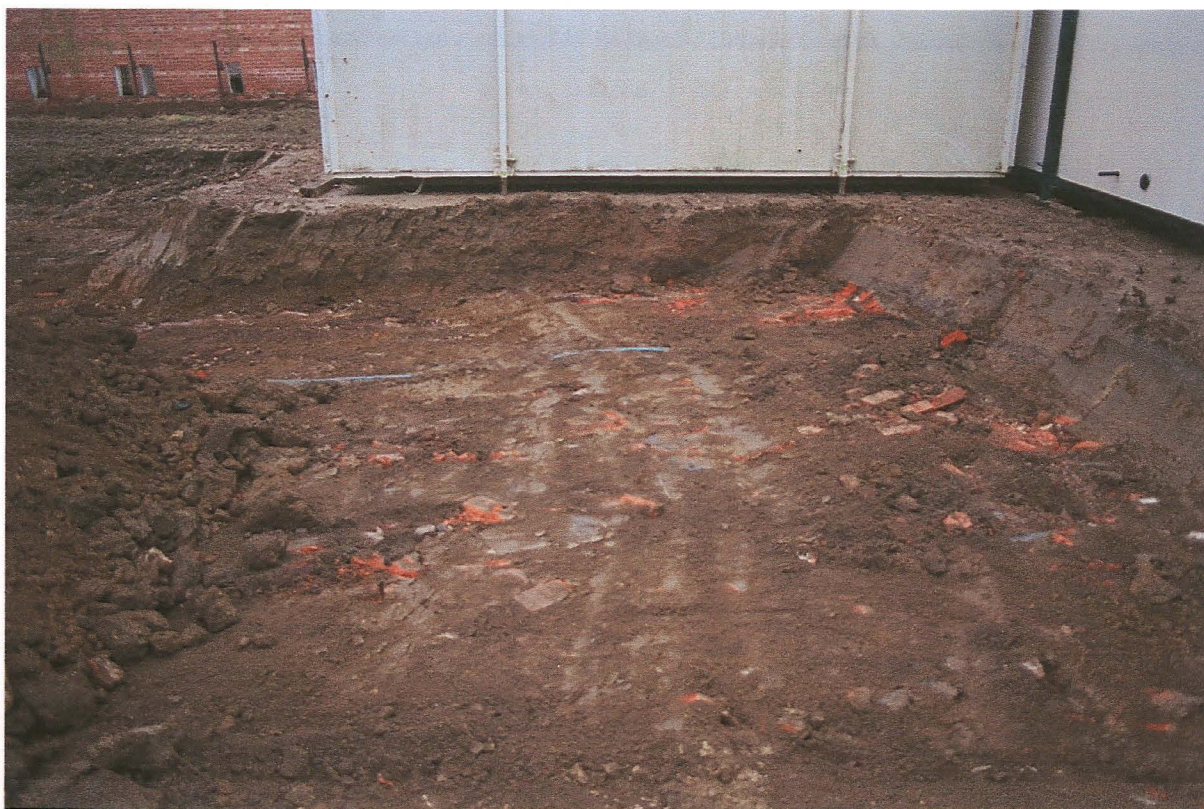
The first area to be monitored was the stripping of the site entrance and towards the south-east corner of the site. From approximately 30m south of High Street inside the development the area had been recently stripped to the limestone natural and a layer of imported topsoil 0.35 – 0.40m deep was seen to be covering this area of the site (Pl. 3). This topsoil extended across the site towards plots 11 and 25 before thinning to nothing. This is thought to have been a part of the landscaping immediately after the demolition of some of the farm buildings, and certainly within the last 10 – 20 yrs.

Pl. 2 Stripped road area showing redeposited topsoil with brick demolition beneath. (Looking westwards)

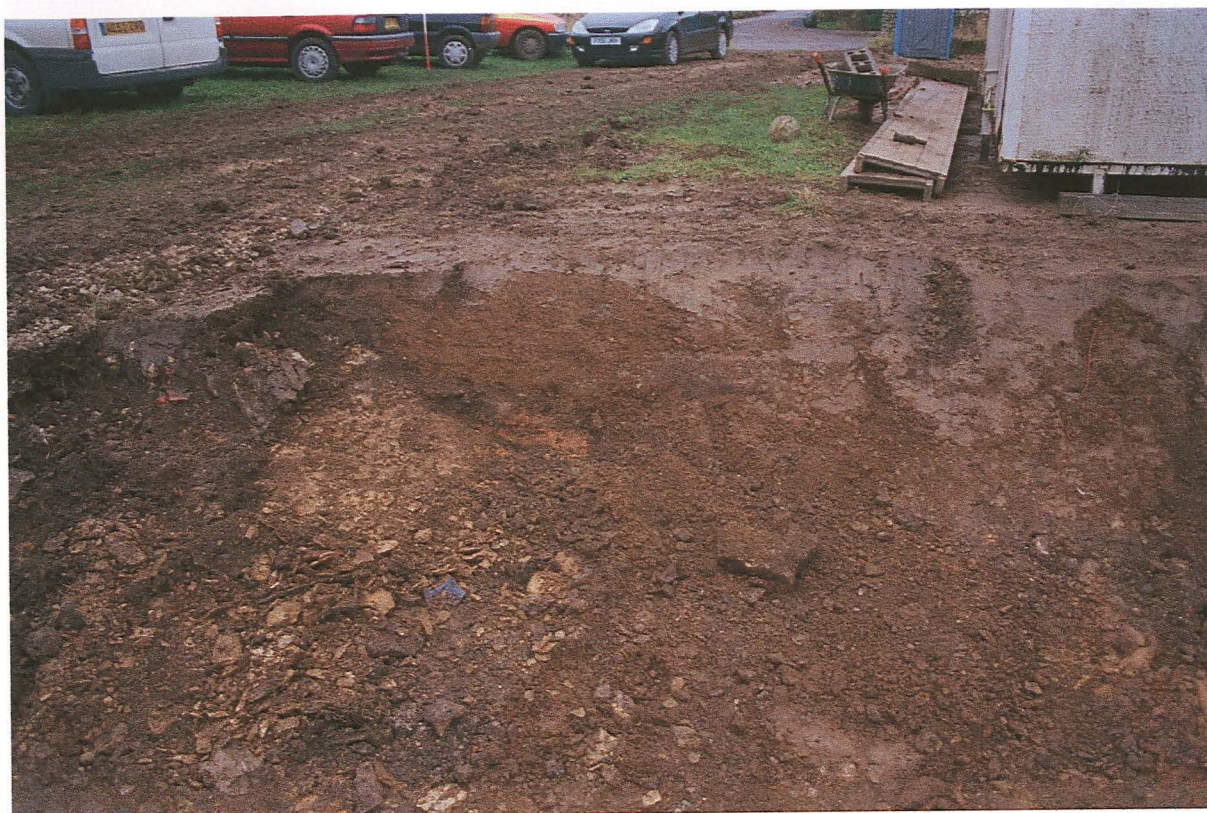
Pl. 3 Imported topsoil on the limestone brash inside the site entrance.

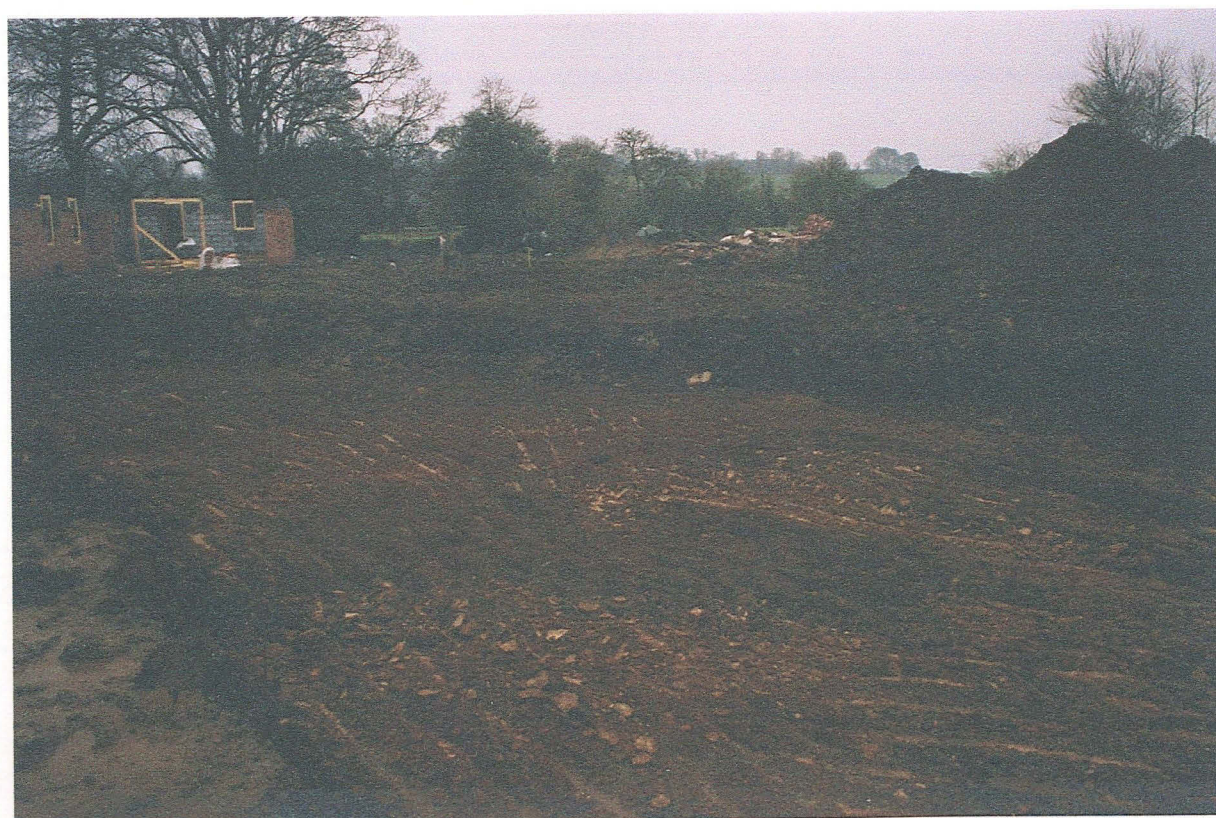
The stripping of the road for the remainder of the site began on 12/2/03 and was monitored by D. Marshall. The area was stripped to 0.7m deep using a JCB excavator with a 1.8m-toothed bucket. This revealed a limestone brash natural with two large intercutting pits (2) and (3) containing fills (1) and (4), and each approximately 1.5m in diameter (Pl. 4). Three sherds of pottery were collected, two were 18<sup>th</sup> century and a single sherd of glazed pottery dated late 14<sup>th</sup> - 15<sup>th</sup> century. (Appendix 2, Post-Roman pottery archive, J. Young.)

Pl. 4 Pits (2) and (3) cut into the access road. (Looking westwards).

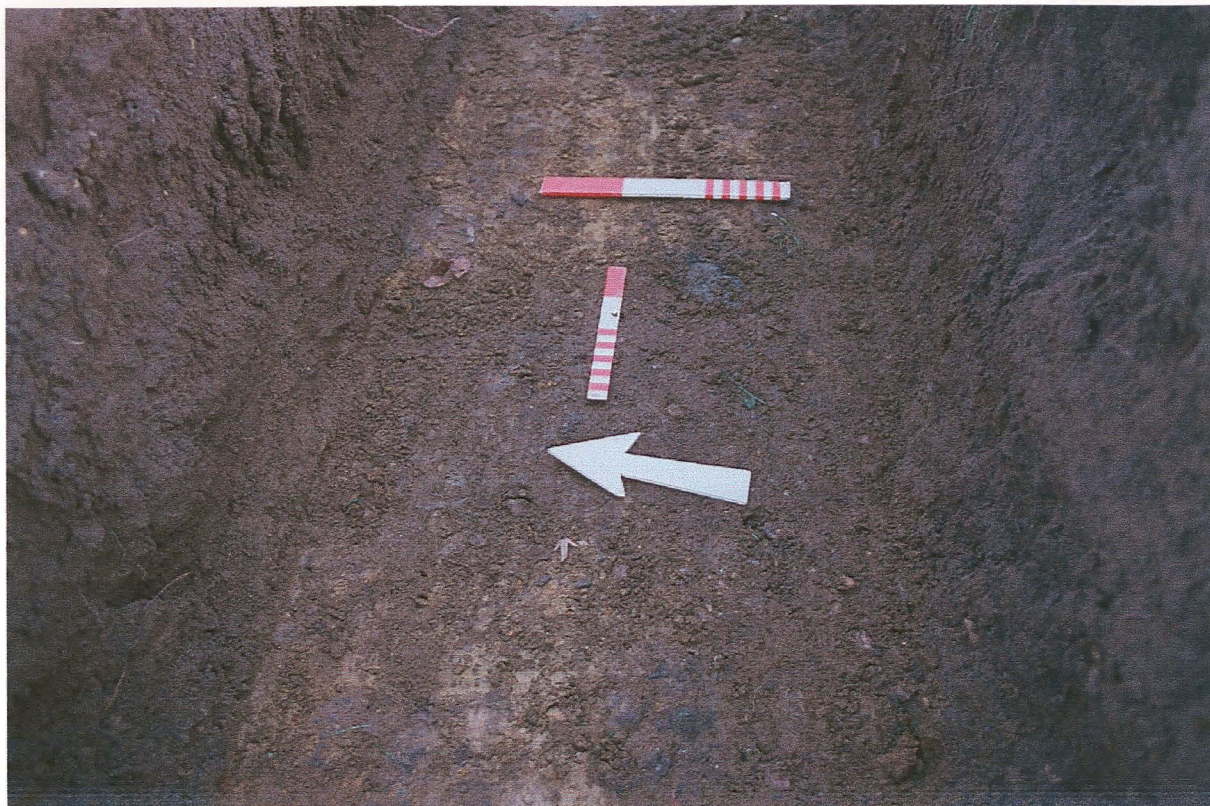
(1103) (Pl. 5) proved to be a shallow ditch / gully of 0.4m wide and 0.25m in depth. (Fig. 4). A small section of the fill (1104) was excavated but with no finds, Pl. 6. Small posthole (1105) produced no finds. (1107) was a narrow shallow gully 0.5m wide and 0.25m deep. Its fill (1108), produced two small animal bone fragments and a single piece of Anglo Saxon pottery.

Pl. 5 Gully (1103). (Looking eastwards). Scales 0.3m and 0.2m.

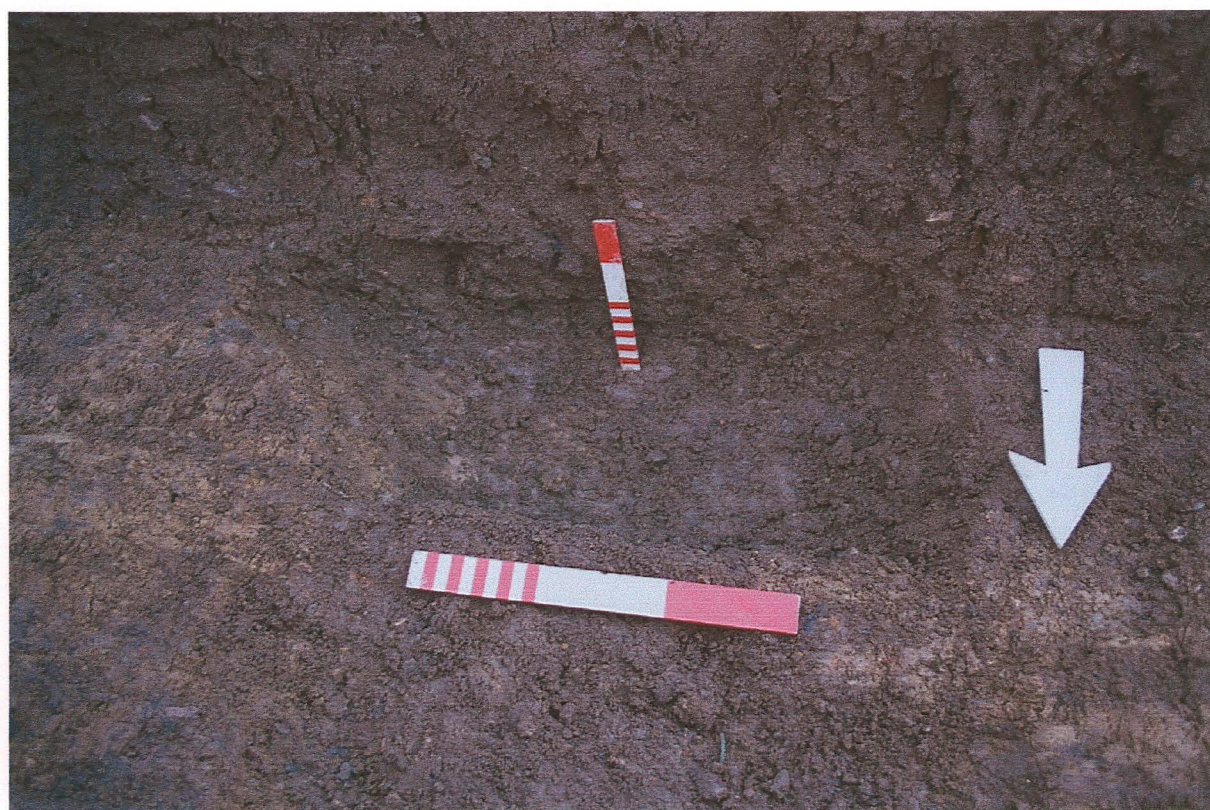
Pl. 6 Excavated section of (1103). Looking southwards. Scales 0.3m and 0.2m.

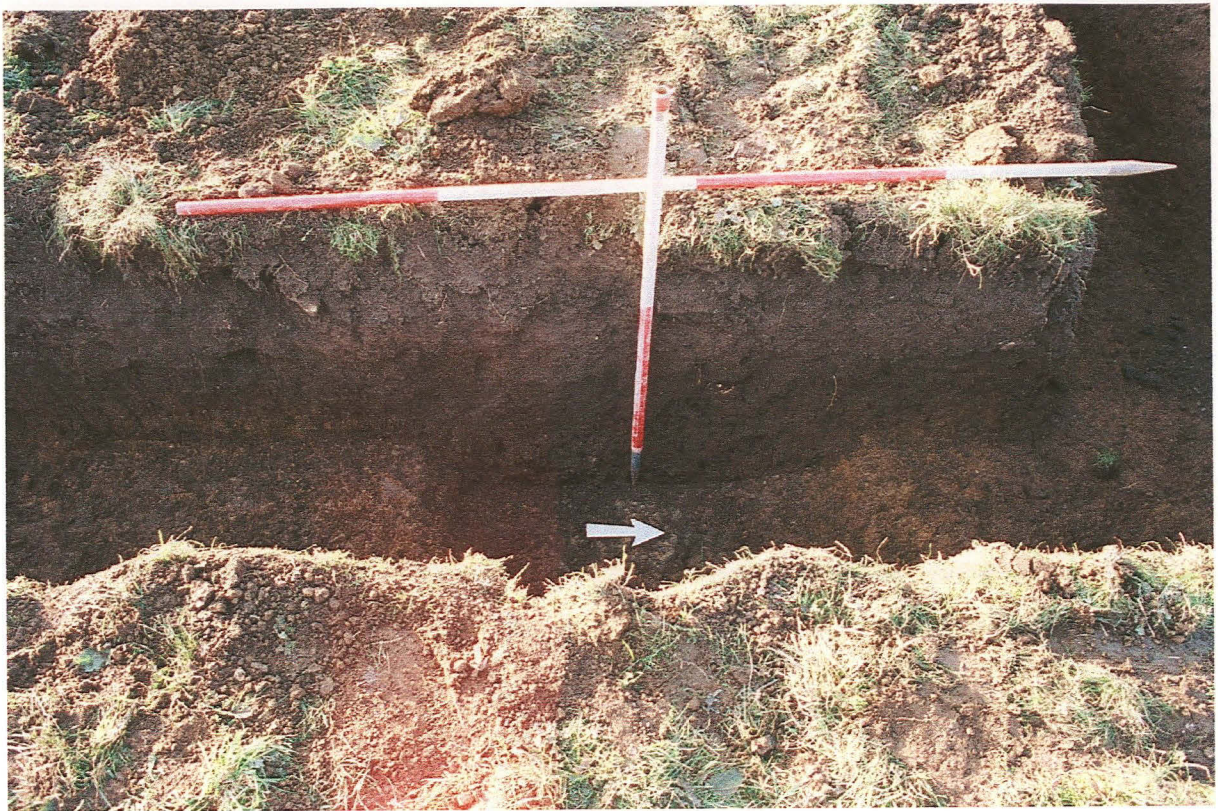
The trenches for Plot 11 were excavated using a 0.6m toothless bucket. The topsoil and subsoil layers (1100, 1101) were removed to reveal a series of soilmarks cutting into the mixed clay natural (1102). (1109), contained fill (1110), a dark brown loose sandy clay, to a depth of 0.35m, (Pl. 7). It's fill contained two sherds of Anglo-Saxon pottery, and nine small animal bone fragments. A pit/soakaway, (1131), had a very grey/brown sandy clay fill (1132), containing brick and tile fragments associated with the early modern farm buildings. This was removed with the aid of the JCB excavator to a depth of 1.2 m.

Pl. 7 Excavated section of (1109). (Looking westwards.) Scales 1m and 2m.

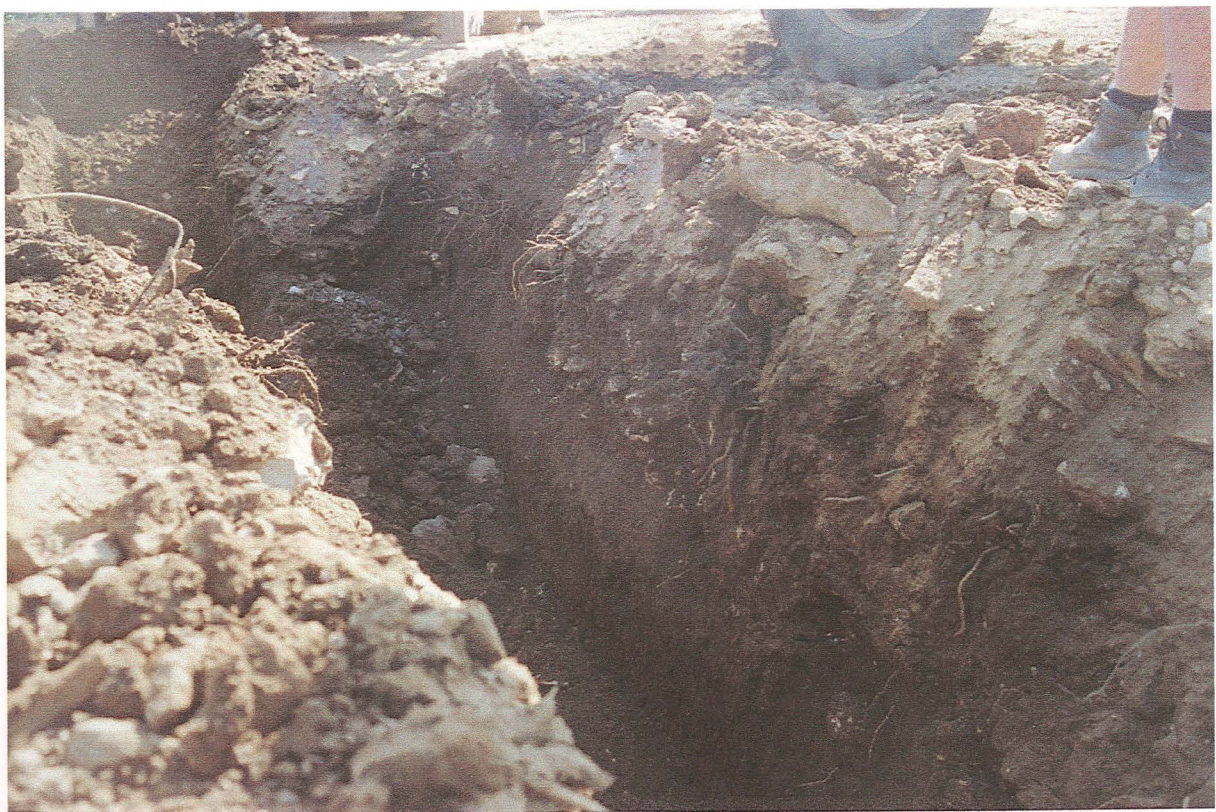
Apart from a recent ceramic land drain, and a 3.2m wide, 2m deep trench backfilled with twentieth century demolition material, only one archaeological feature was revealed in the trench faces. Close to the SW corner of the house site, a 0.25m thick band of stone rubble (1202) was observed, apparently within the subsoil layer (Pl. 8). It was seen across a 4m length of trench face, but was only exposed

across a width of about 0.75m. It may have been the foundation of a stone wall, but could equally have represented a path or track.

Pl. 8 Limestone rubble layer (plot 12). (Looking northwards). Scales 1m and 2m.

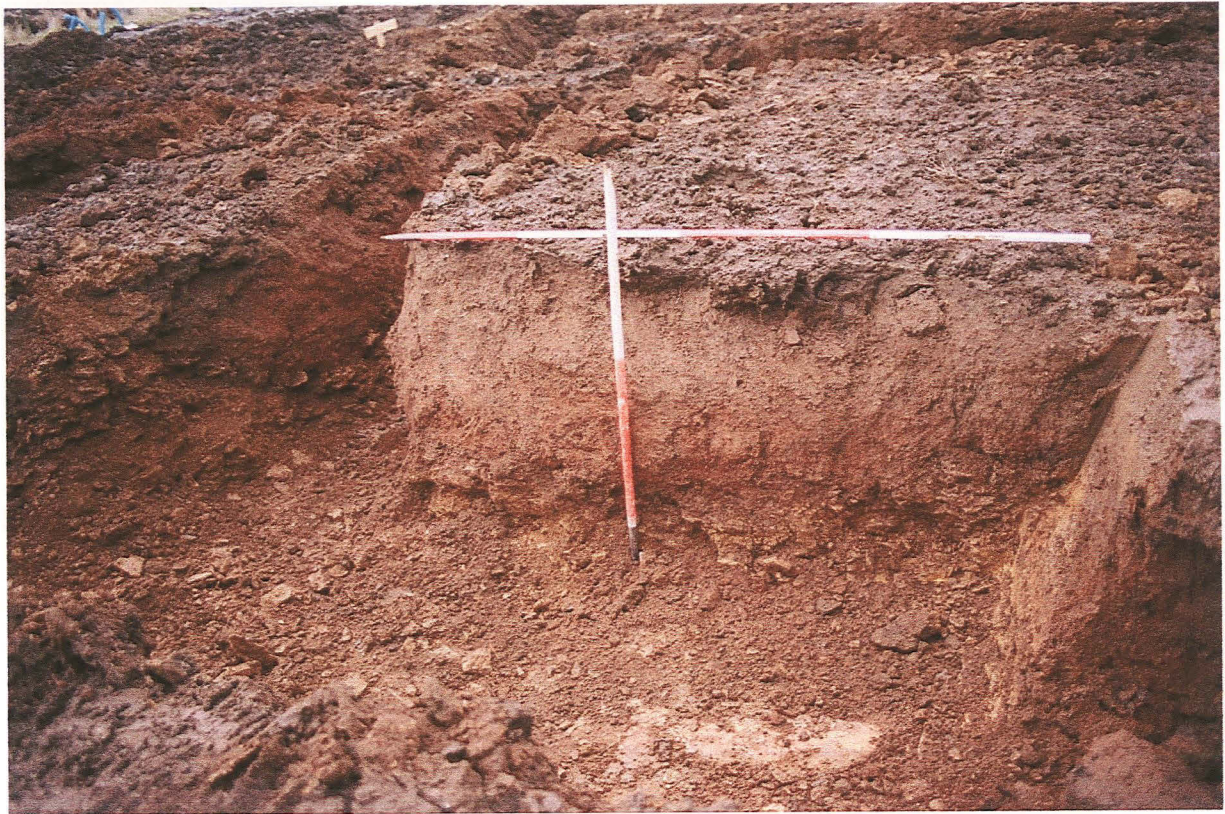
Pl. 9 Typical section (plot 25). (Looking northwards). Scales 1m and 2m.

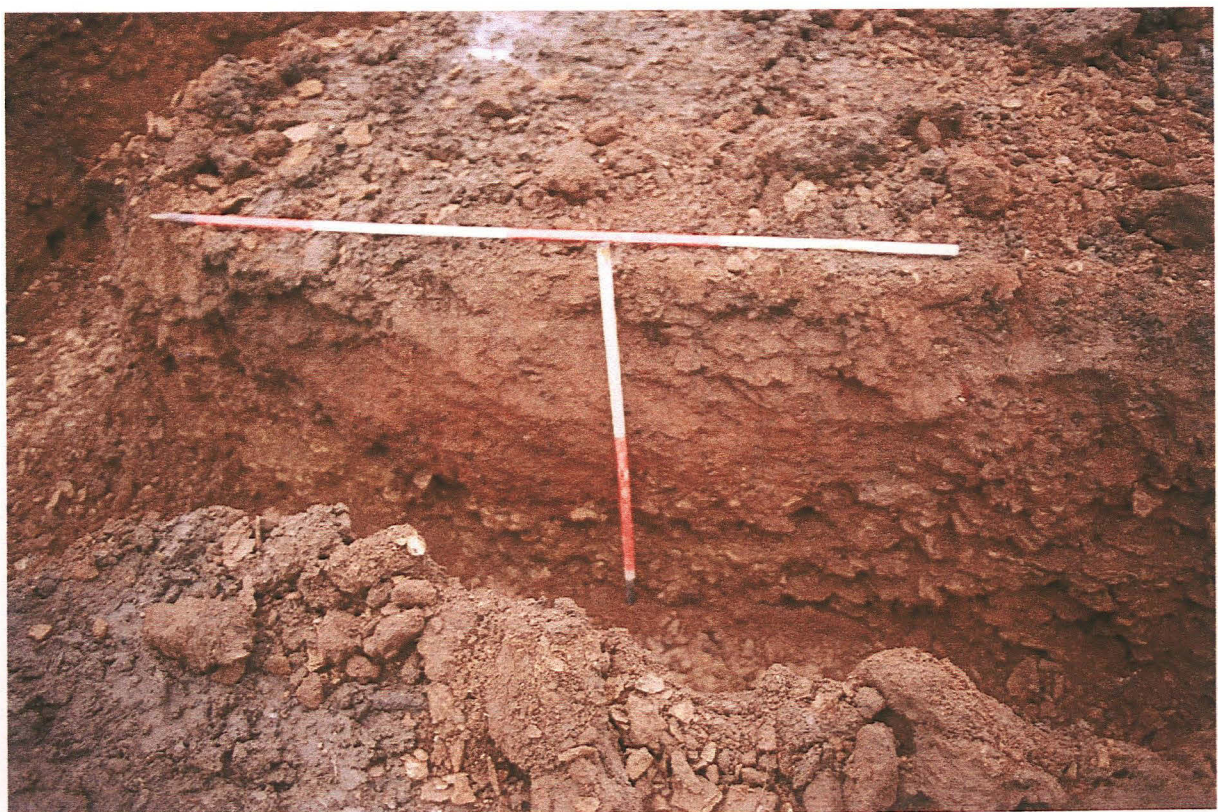
Pl. 10 west facing section (2505). Scales 1m and 2m.
