**Plots 1 and 2, Chestnut Ave, Bucknall, Lincs.  
Archaeological Watching Brief**

**Site Code: BUCA 04  
NGR: TF 1700 6920  
LCNCC Accn N°. :2004.47  
Planning Application: S/022/00985/03**

**LAS Report No. 749**

**April 2004**

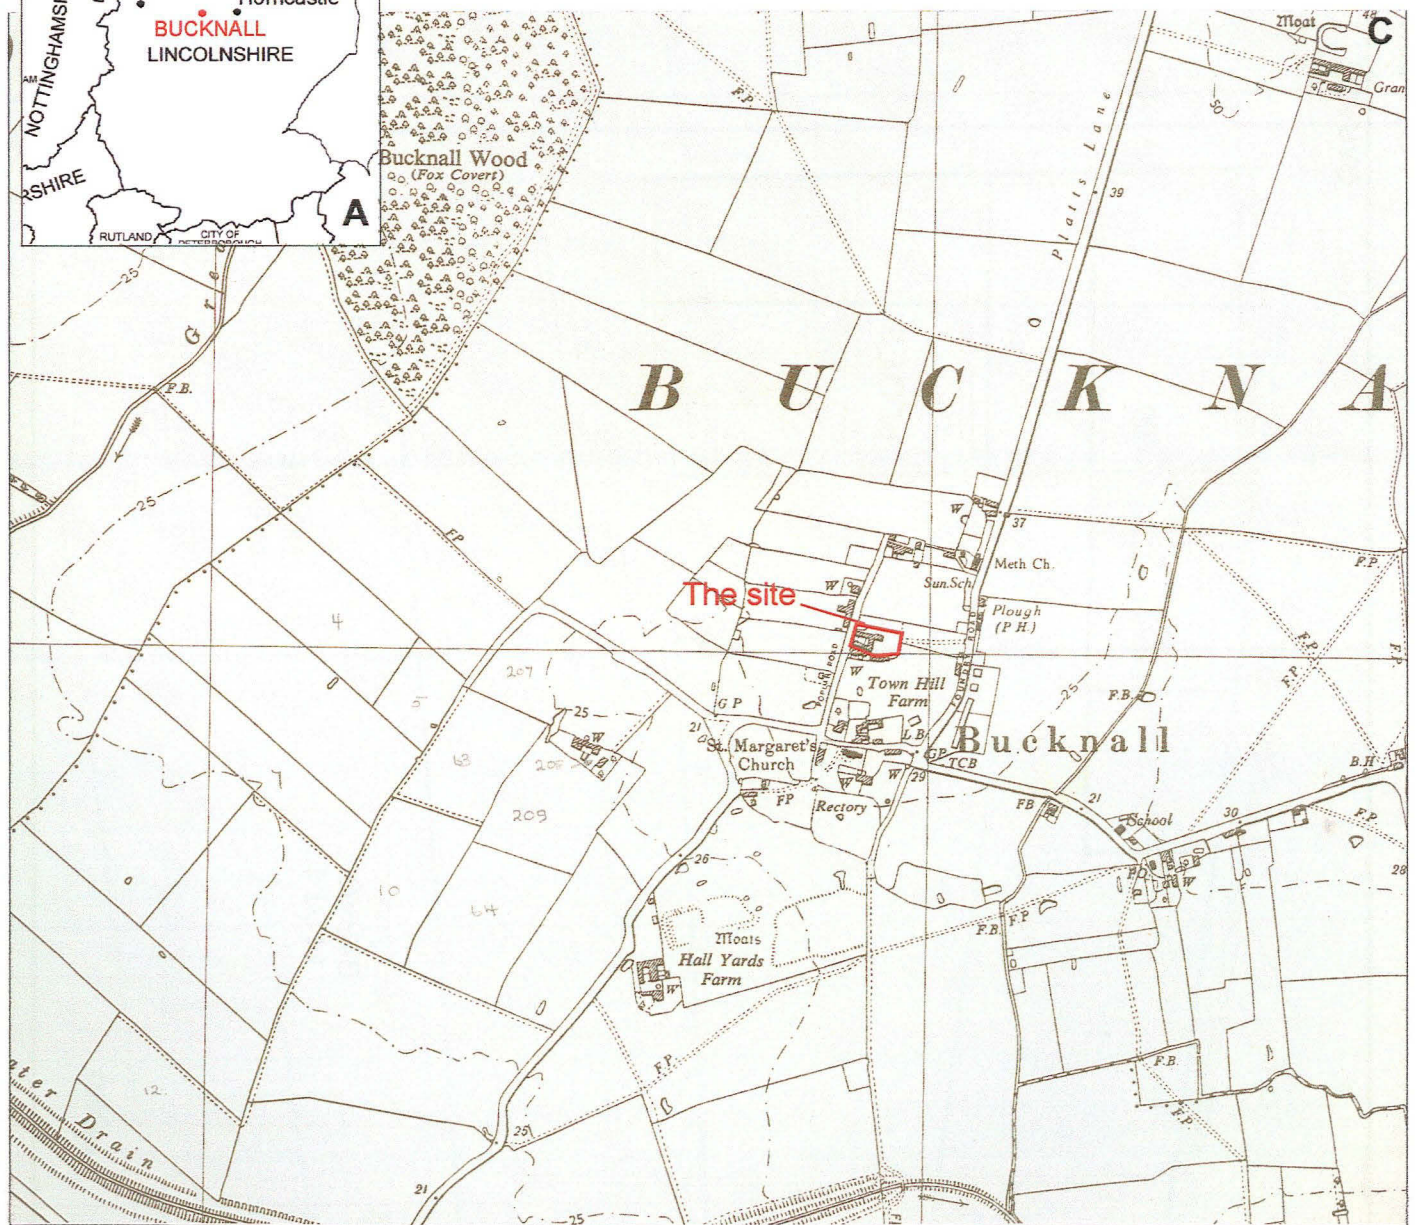
Fig. 1 Location of the development site within Bucknall (C based on the Ordnance Survey 1957 1:10,560 sheet; © Crown copyright, reproduced with the permission of the Controller of HMSO. LAS Licence No. AL 100002165).

The Parish of Bucknall lies 24km east of Lincoln and 10km west of Horncastle (**Fig. 1**). The development site is situated at the north end of the village and comprised an area of scrubland on the site of a former farmyard.

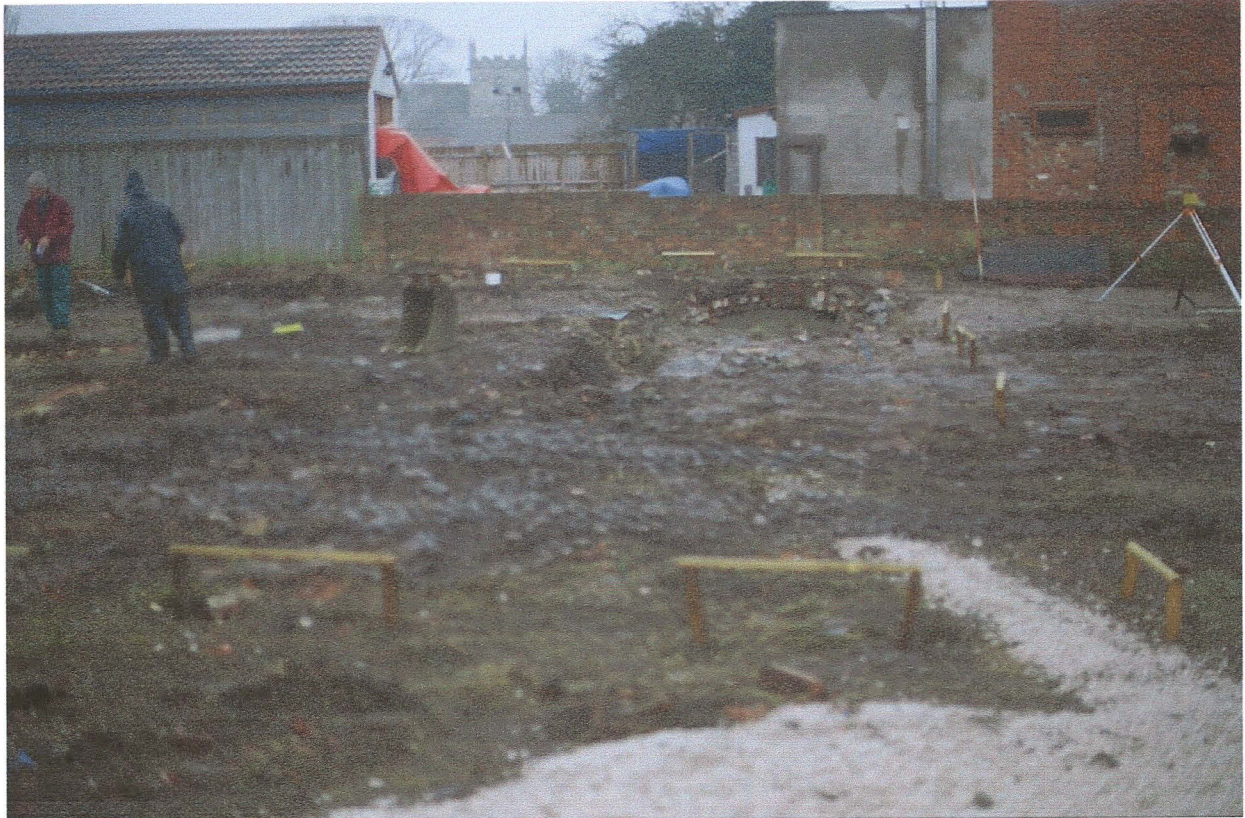
Pl. 1 Plot 2 looking south towards St. Margaret's Church showing the boundary wall.

The excavation of the foundation for the building disturbed the remains of a building along a similar axis as the new structure (**Fig. 2**). Underlying **102** were the remains of the walls of the farm buildings. The surviving remains of the farmstead consisted of a shallow foundation, **104**, of 0.30- 0.40m deep containing **105**, a wall foundation consisting of four to five courses of red bricks bonded by a grey cream mortar. The foundations, **104**, were cut into the natural **103** a blue green clay, with bands of an orange sandy gravel (**PI. 3-5**). Recognition of the full extent of the former farmstead was impeded by **102** still covering the remains although walls were traceable in the area of the new development (**Fig. 2; PI. 1-2 & 7**).

A wing of the building running parallel to the existing southern boundary wall of the site to the west edge of the property at the same width as the 'study area' of the new building with two partition walls visible in the area cleared for material storage (**PI. 7**). Another wing was evident to the north west of plot 2 (**PI. 1**)

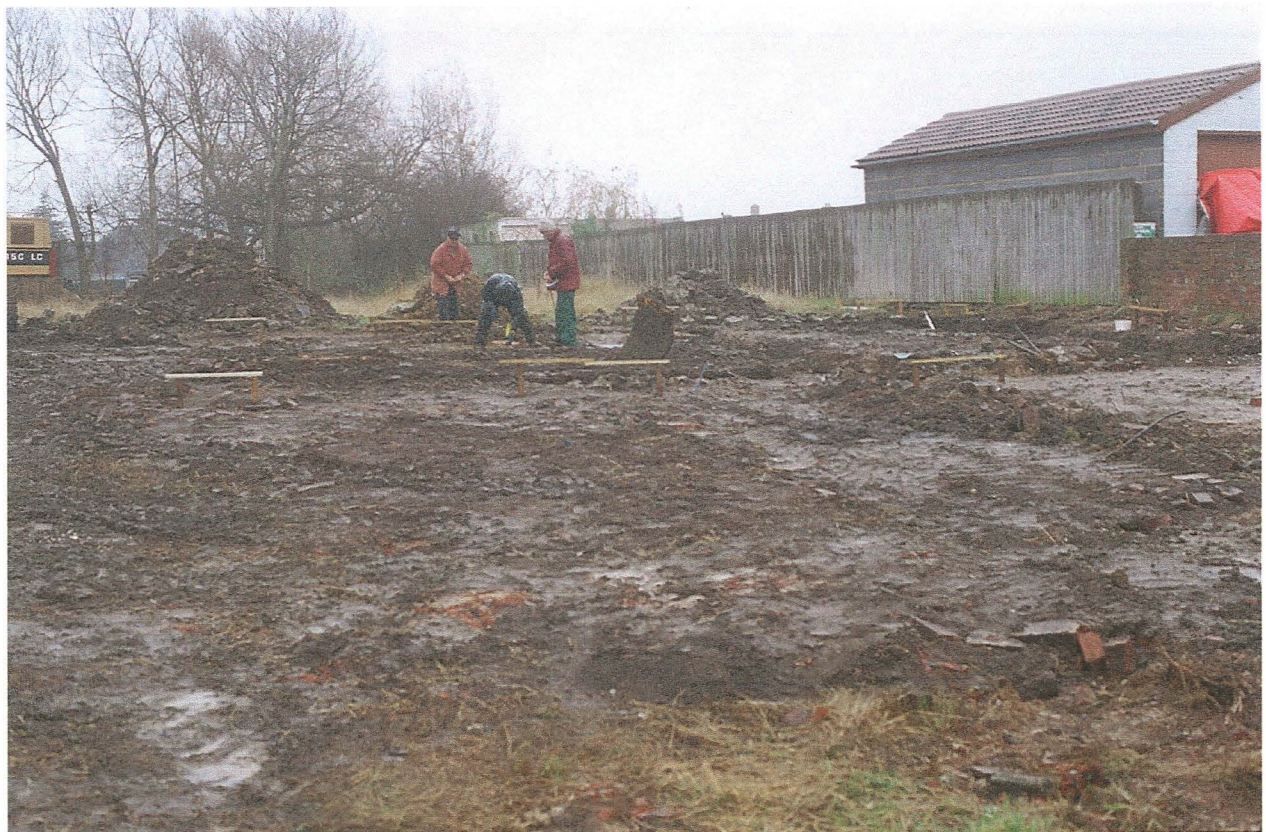
Pl. 2 Plot 2 during excavations with remnants of the brick farm buildings, 105, in the foreground, looking SW.

Remnants of the pond which appears on the 1951 map may be encountered during the excavation of garage foundations for plot 1. The excavation of foundations for the house on plot 1 will encounter further farmhouse remains (**Fig. 2; Pl. 2**).

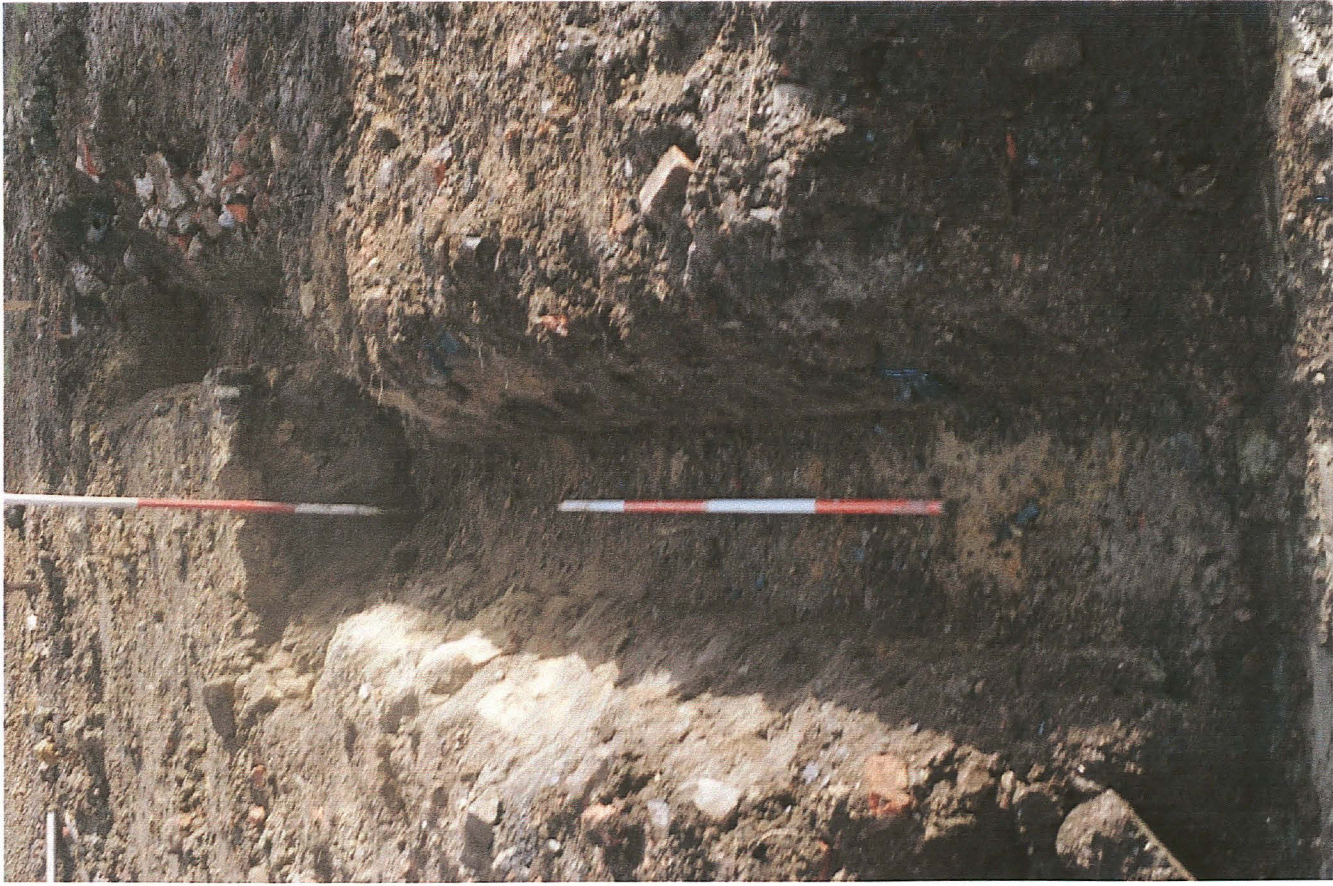
Pl. 3 Central internal foundation trench, showing 105, looking east. Red and white scales 0.5m increments.

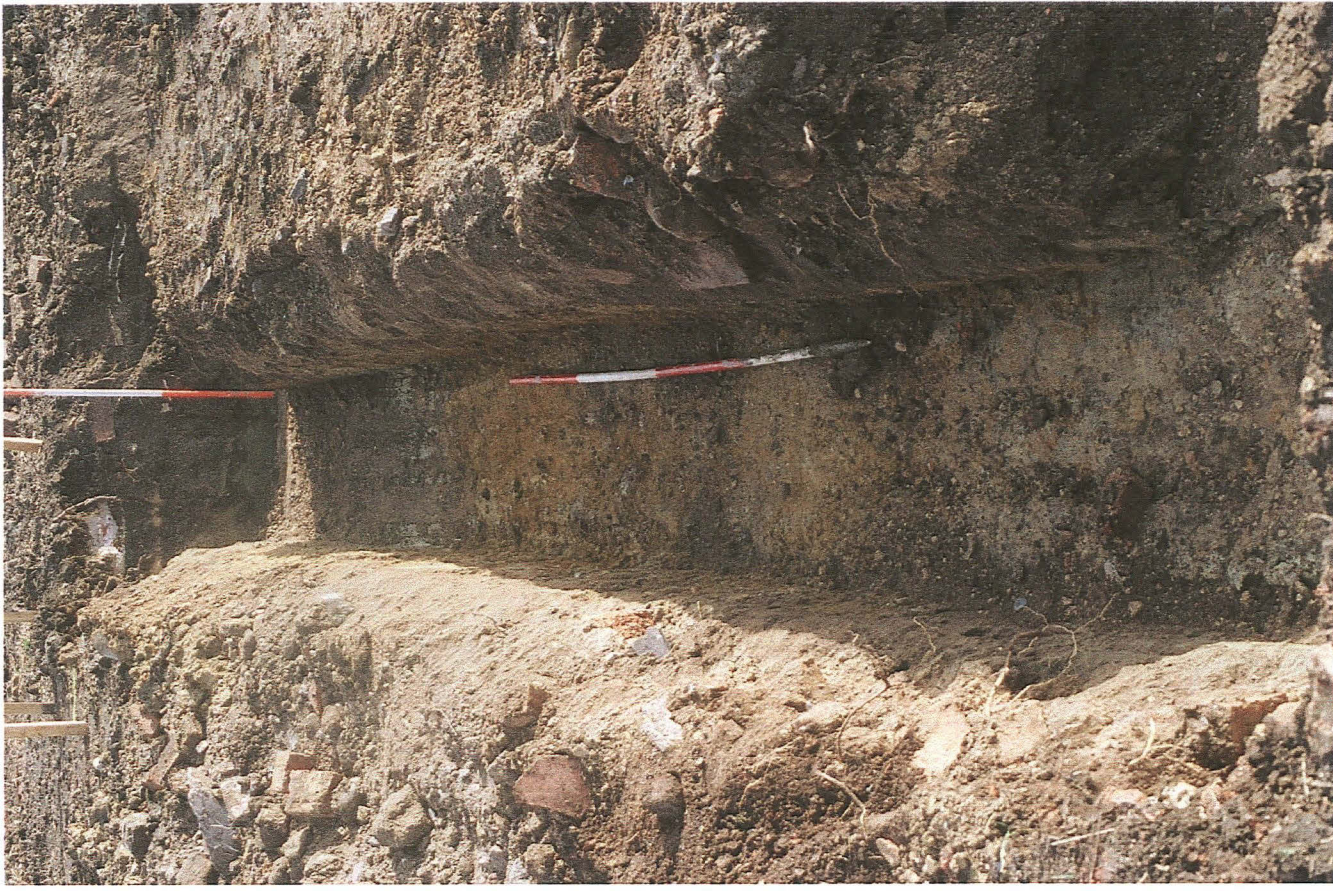
Pl. 4 Plot 2 northern external foundation trench, looking east. Red and white scales 0.5m increments.

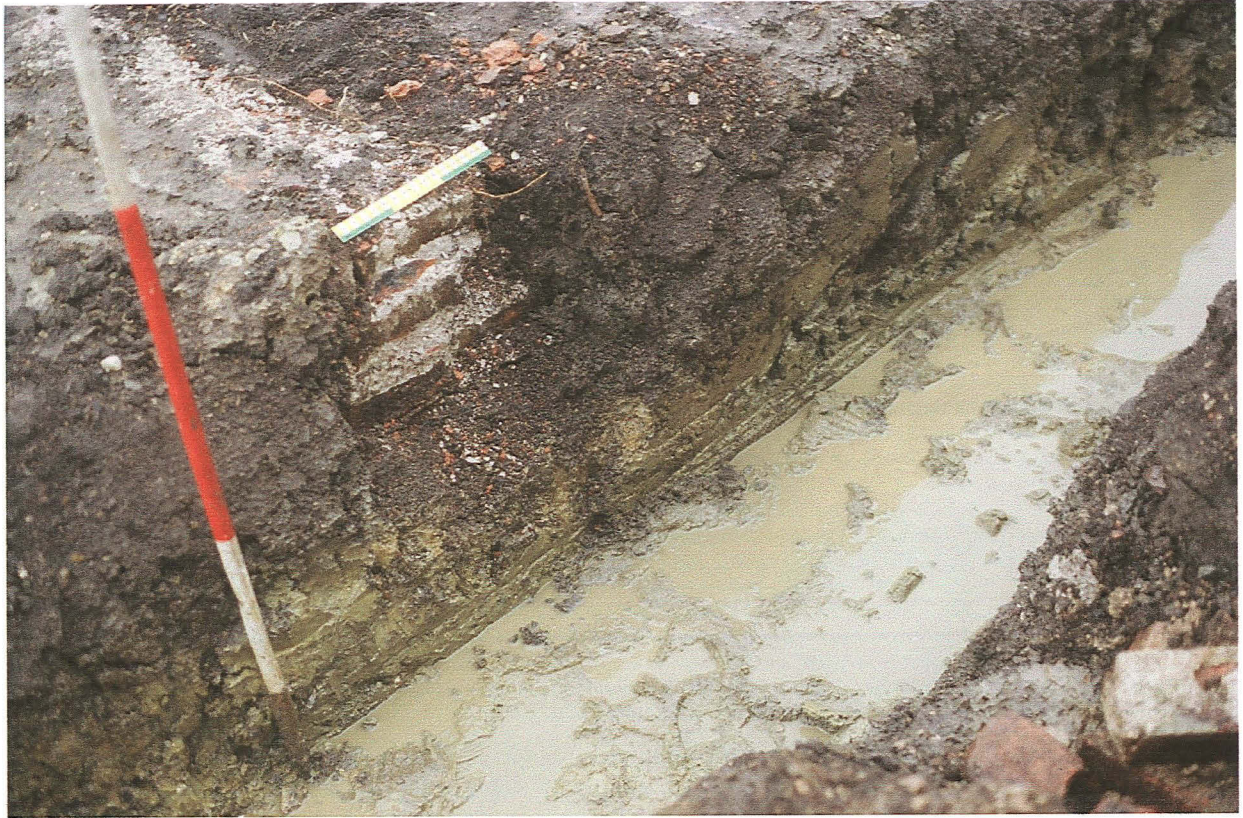
PI. 5 Wall 105 shown in section in the centre of the southern external foundation of plot 2, looking north. Small scale 0.3m red and white scale 0.5m increments

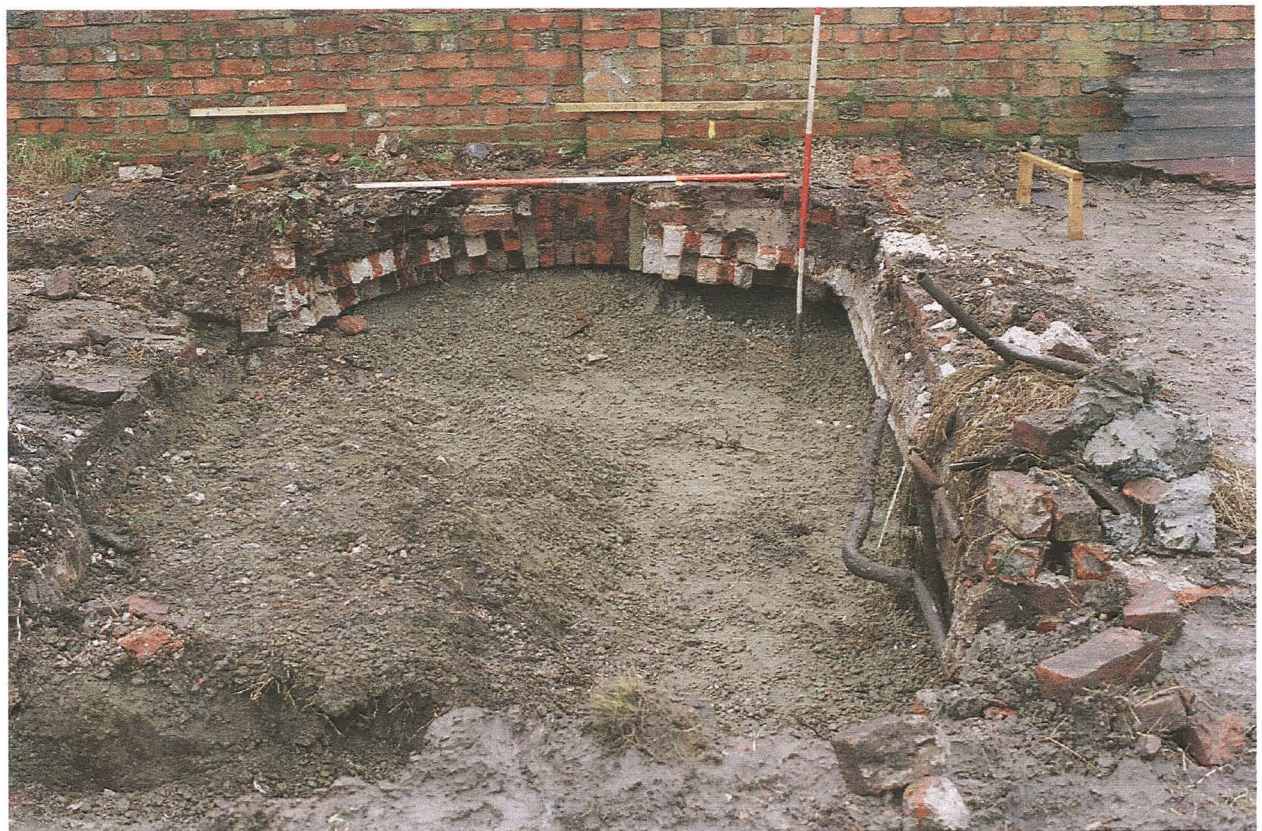
PI. 6 Vaulted cellaring, 107, looking south. Red and white scale increments 0.5m.

The cellar was vaulted by an arch visible to the south of the excavated area beneath, **108**, a layer of rich organic silty material was visible in section beneath exposed to a depth of 0.30m (**Fig. 2; PI. 6-7**). Although an area of 4m by 3.25m of the pit was exposed only the eastern and northern edges of the structure could be confirmed due to the limit of excavation.

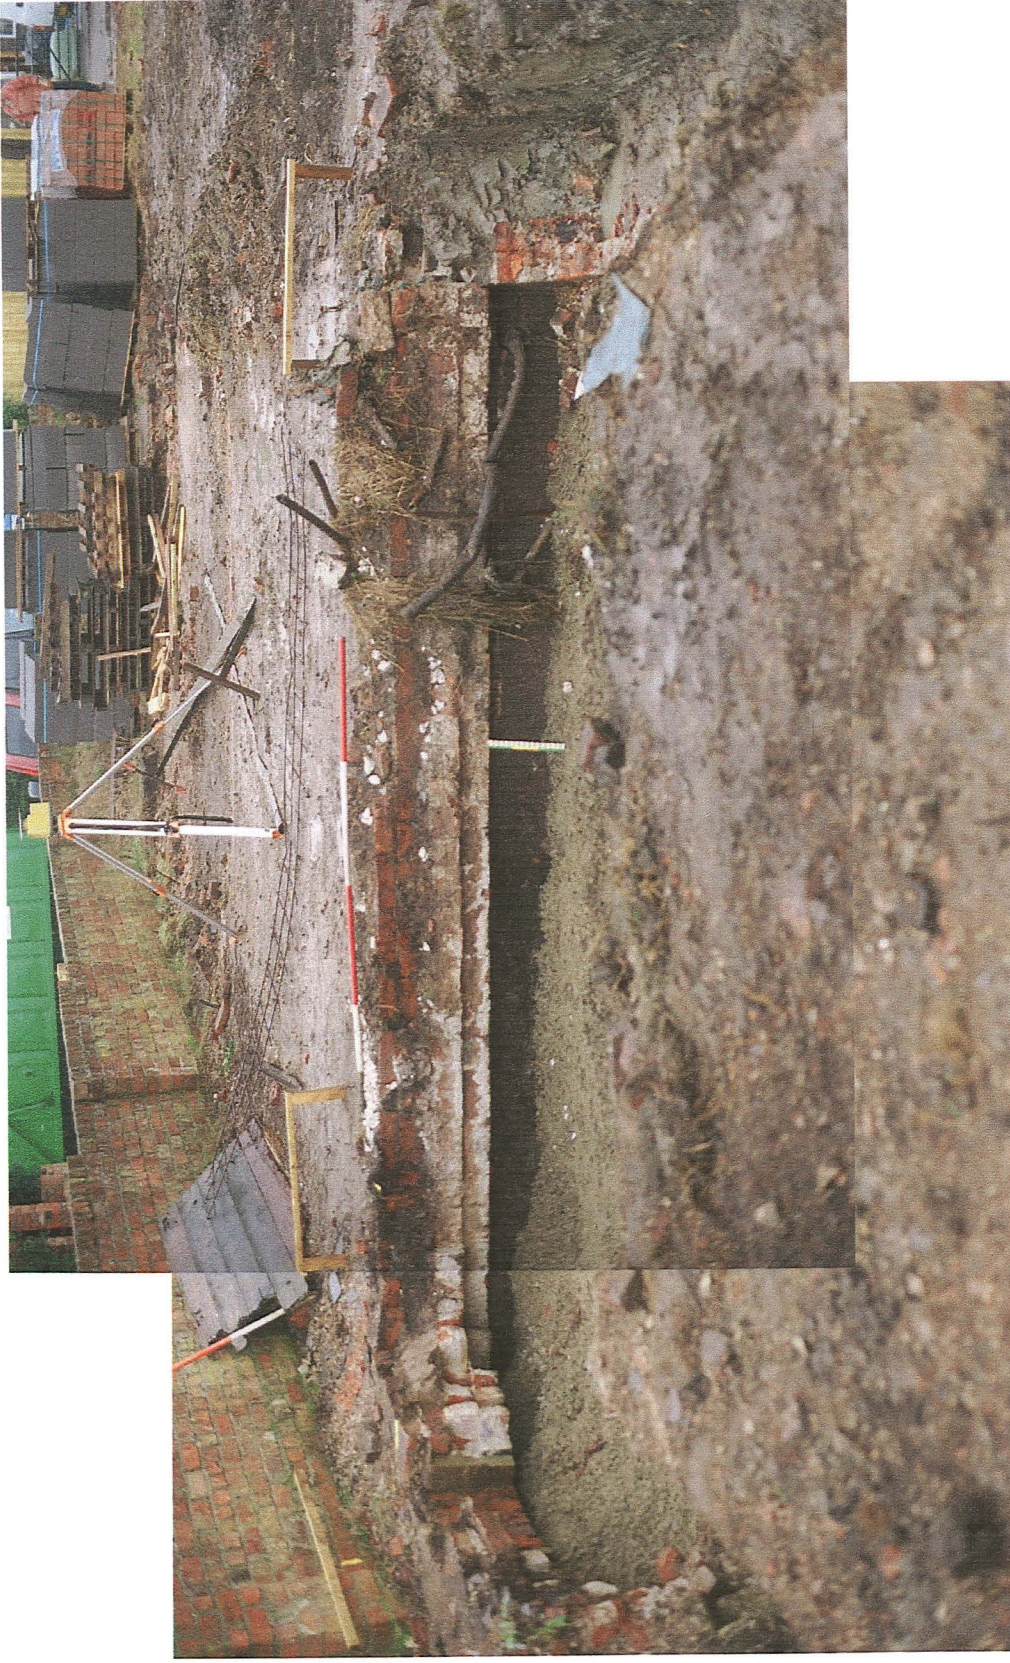
Pl. 7 Area of cellaring exposed during the excavation showing slurry fill 107 in section between brick vaulting 108 and concrete laid for the foundations of plot 2. The continuation of the foundations of the farmhouse are visible beyond the slurry pit, looking west. Scales 2m and 0.3m.

A neighbour had told the developers that the cellar structure had been used to store slurry from the barns until the accumulated waste was pumped out for manuring. Fill **107** is the result of the final load of manure being left in situ when the farm was demolished. The high organic content of **107** would support this theory.
