# ARCHAEOLOGICAL INVESTIGATIONS AT ALL SAINTS CHURCH, THEDDLETHORPE, LINCOLNSHIRE (ASCT 03)

Work Undertaken For
Peter McFarlane
On behalf of the
Churches Conservation Trust

April 2004

A.P.S. Report No: 61/04

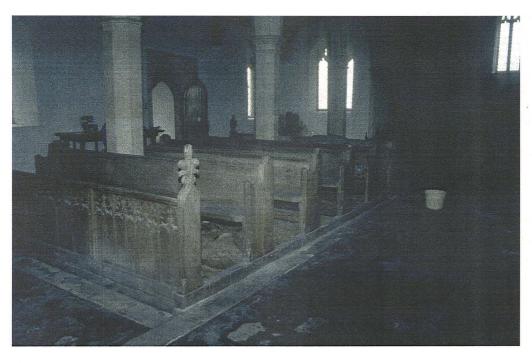
Plate 2 - Interior of the church showing the  $16^{\text{th}}$  century pews, looking southwest

The work undertaken involved removing the wooden seating platform, leaving the pews intact (Plate 2). This revealed the underlying timber support beams which rested upon a single course and width of brick plinths (Plate 3). Between the plinths was a very compacted stone rubble deposit which was not affected by the rebuilding works.

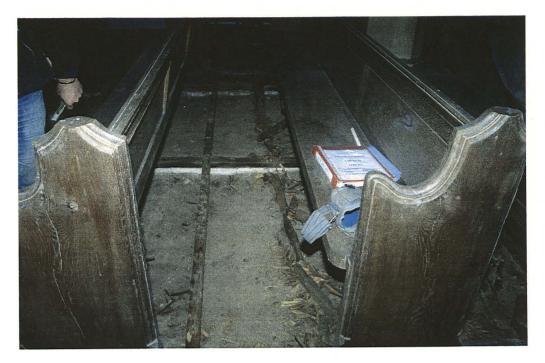
Plate 3 - View showing the exposed timber floor joists and compacted rubble deposit

However, removal of a wooden seating platform revealed wooden floor joists, supported upon bricks, with a compacted rubble deposit. No archaeological features were identified and the works did not affect the fabric of the building.

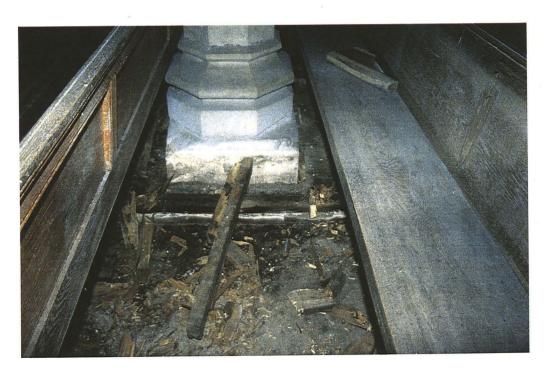
Plate 4 - View showing the exposed base of the nave/south aisle column
