**LAND AT MANOR FARM,
BARDNEY, LINCOLNSHIRE**

**ARCHAEOLOGICAL
WATCHING BRIEF REPORT**

Site code	BARD 04
NGR:	TF 1207 6921
LCCM Acc No:	2004.89

July 2004

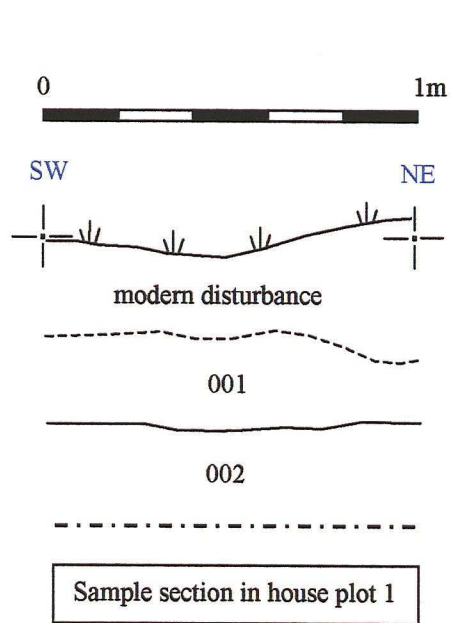
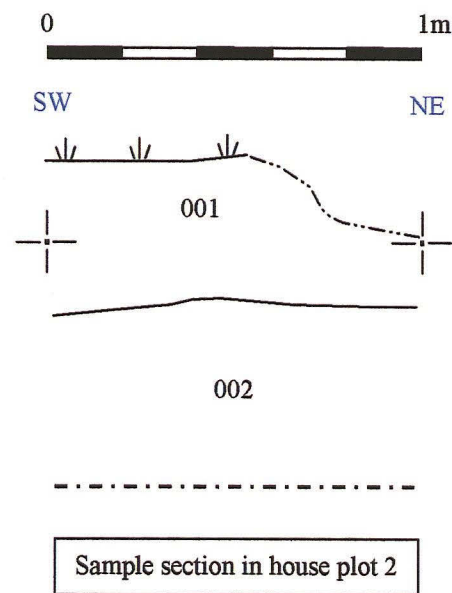
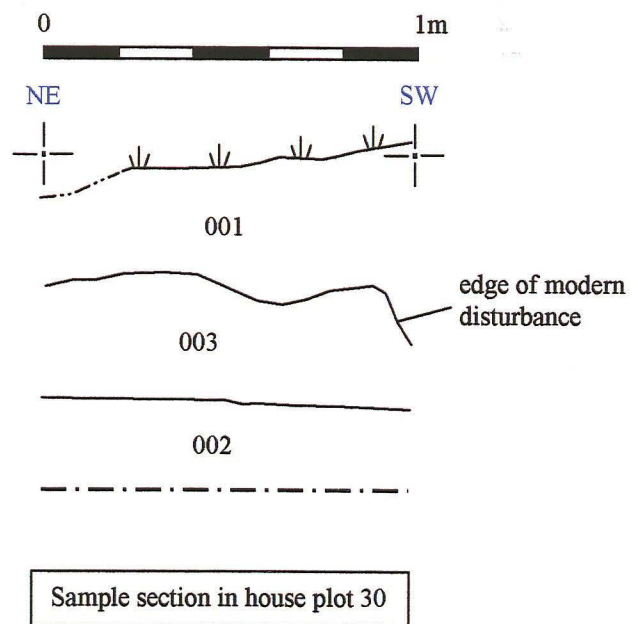
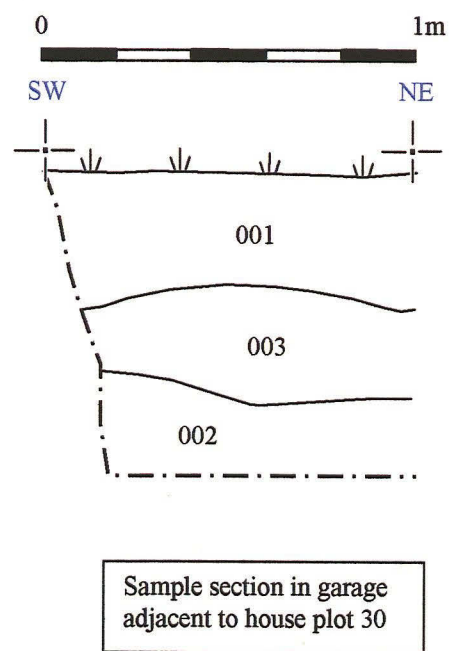
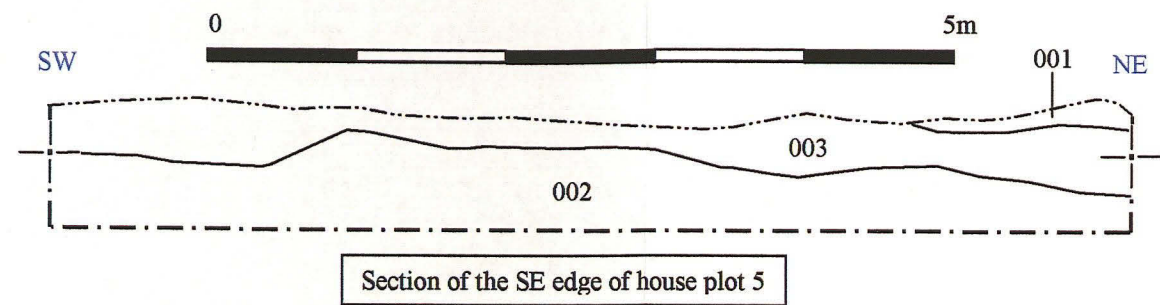
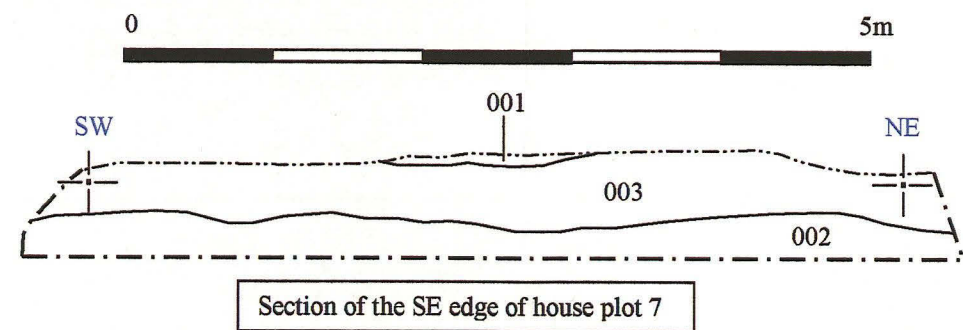
Fig. 4: Sample sections in house plot foundation trenches at scale 1:20, with sections in house plots 4/5 and 6/7 at scale 1:50 to show up the presence or absence of ridge-and-furrow.

The site was sealed by dark brownish-grey sandy ploughsoil 001, up to 0.45m deep at the edge of the field. Along the NW side of the development area (house plots 1, 2 and 3 and sewer trench F3A), the upper layers were extremely disturbed, with patches of rubble and modern deposits, probably a result of building works for the surgery and its access road: no subsoil could be seen in this area, even after it had been identified elsewhere. Over the rest of the development area, 001 sealed mid brownish-grey sand subsoil 003. This layer varied in depth from 0.26m to 0.45m. On the principle that this variation might represent buried ridge-and-furrow earthworks, two sections the full width of the house plots 5 and 7 were drawn, but the results were inconclusive.

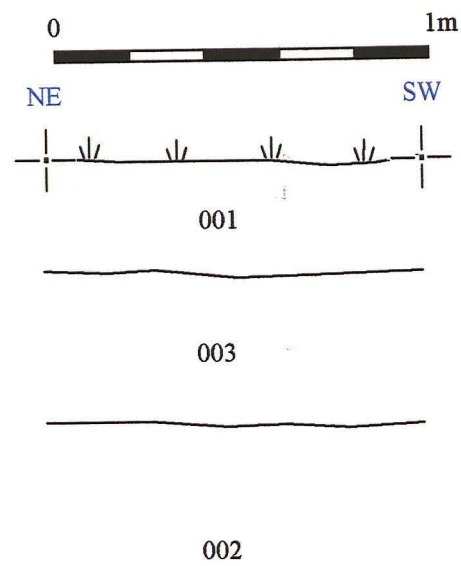
Sample section in sewer trench, NE of pit F7

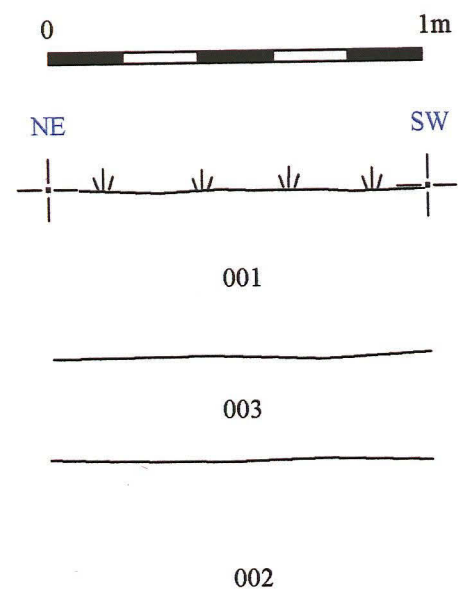
shoring inserted at this depth

Sample section in spur trench F5A

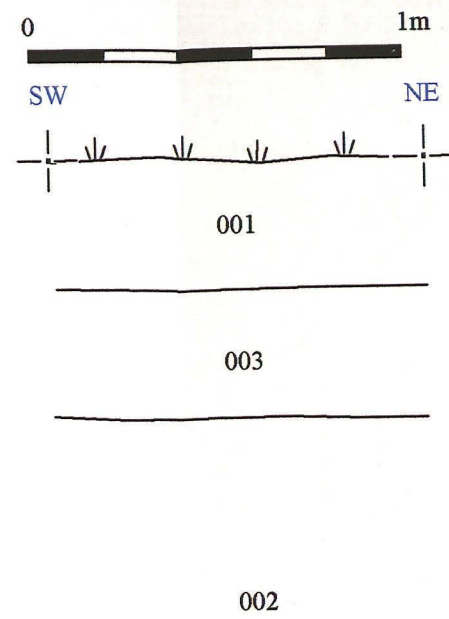
Sample section in pit F7

Below the topsoil and subsoil was varicoloured sand natural 002, which in manhole pit F7 and part of the trench running NE from it overlay dark bluish-grey clay 004 at a depth of 1.6m. This layer was not seen in any other part of the groundworks, and probably represents a change in the drift geology.

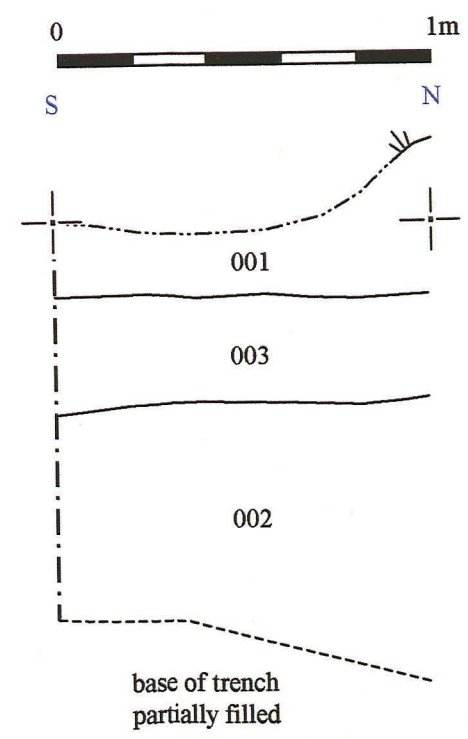
Sample section at S end of sewer trench FB 03

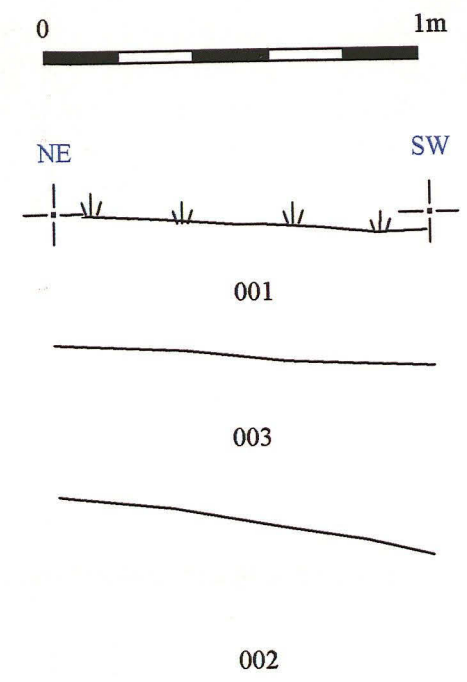
pit not yet at full depth (danger of collapse)

Sample section in pit F4

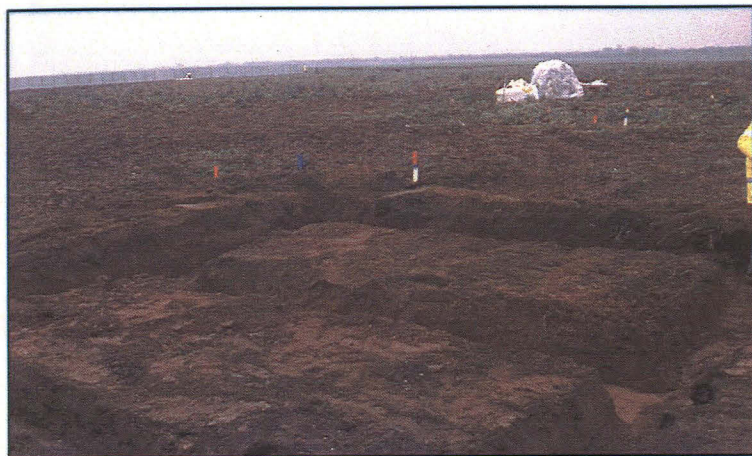
Plate 1 (top left): General shot of the development site, looking south from the north corner, with the completed foundation trench of the garage attached to house plot 1 in the foreground.

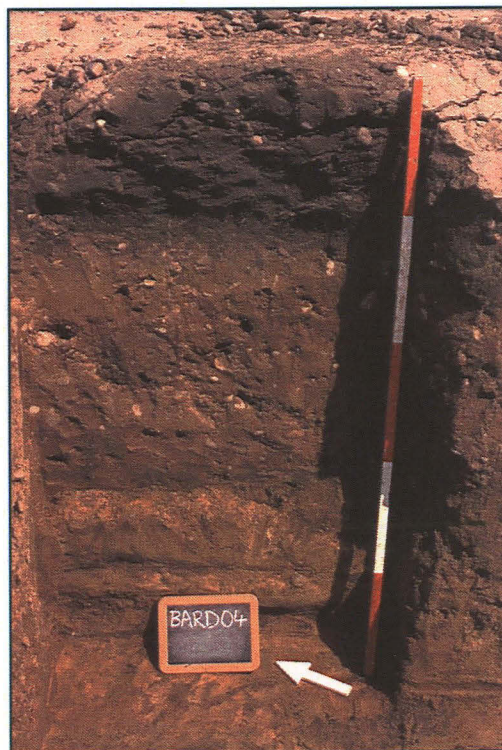
Plate 4 (top right): Sample section in the foundation trench of the garage attached to house plot 3, showing the maximum depth of subsoil 003, looking NE.

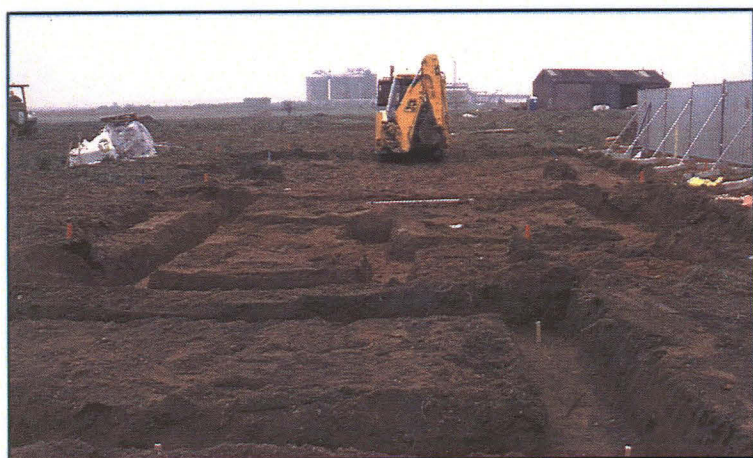
Plate 3 (bottom left): Sample section in the foundation trench of house plot 30, looking SE.

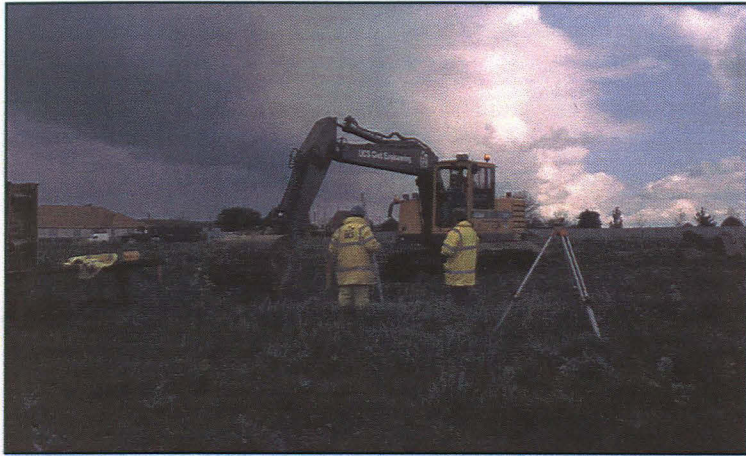
Plate 5 (top left): General shot at the start of machining for the drainage run, looking north from the south corner of the field.

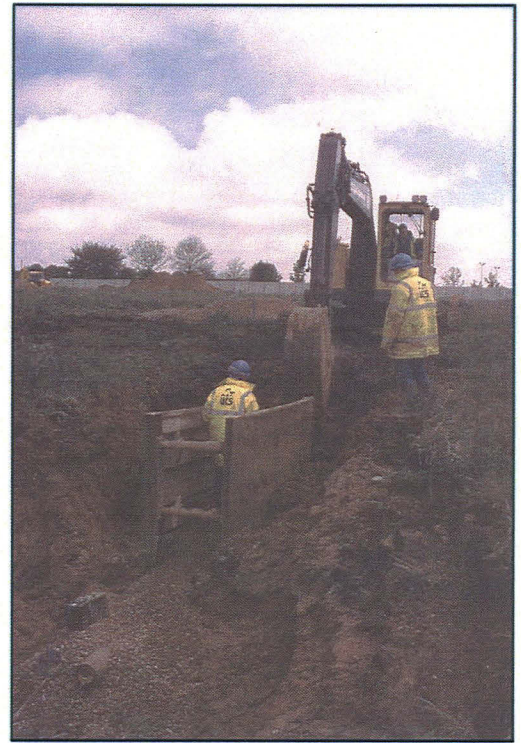
Plate 6 (above): Working shot: machining in progress on the drainage run section F7, looking NE, showing the extremely unstable condition of the trench.

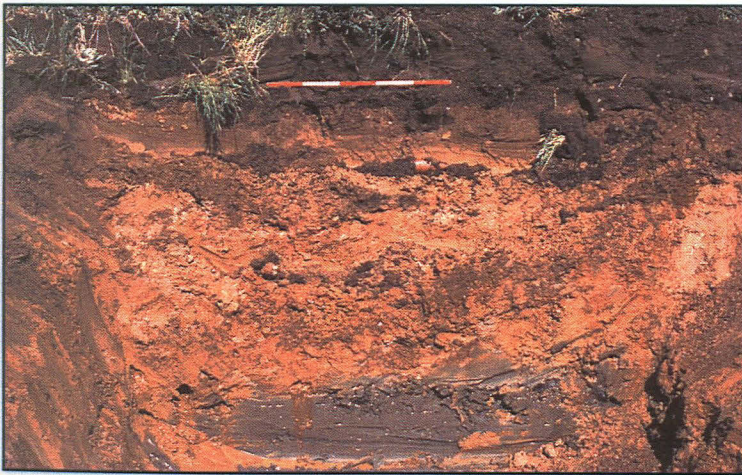
Plate 7 (above left): The section of manhole pit F7 directly after machining, looking NW, showing running sand above clay layer 004.

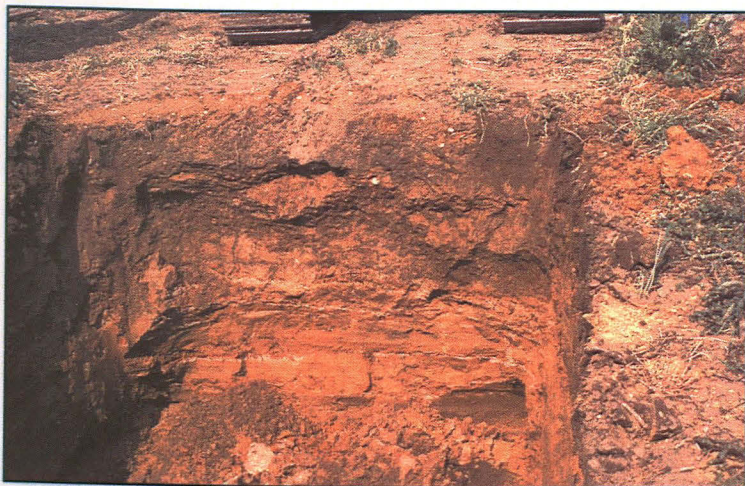
Plate 8 (left): Manhole pit F4, after collapse of the side during machining left a fresh section. The pit was too unstable to approach, so the machine tracks have been included for scale.
