**ARCHAEOLOGICAL WATCHING BRIEF,
LAND OFF ST. MARK'S STREET/BRAYFORD WHARF,
(THE JUNXION), LINCOLN**

NGR: SK 97292 70887
SITE CODE: JUNX03
ACC. NO.: 2004.72

Report prepared for North Midlands Construction plc,

July 2004

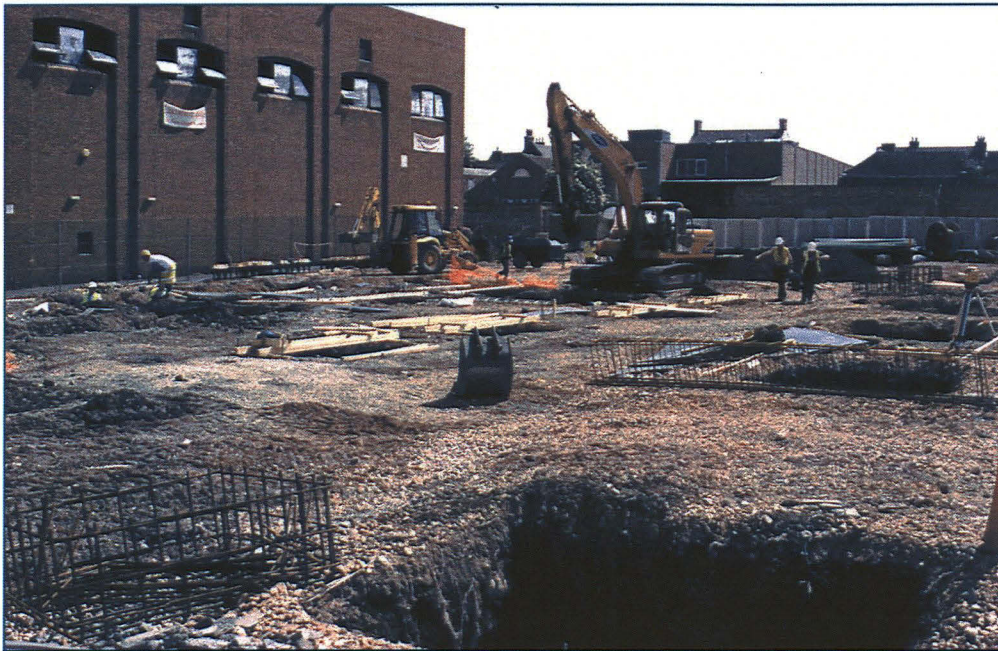
Pl. 1: General view of the development area, showing the foundation pits partially backfilled with concrete. Looking north-east

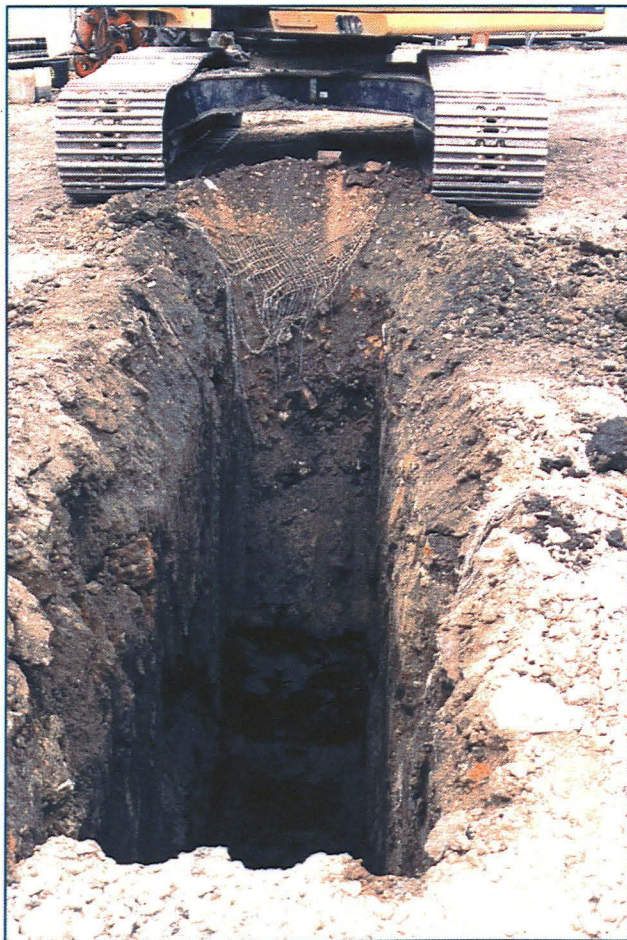
Pl. 2: View of the pit excavated to assess diesel contamination. Looking south-west
