Thorngate House, Broadgate, Lincoln Archaeological Observation and Recording

NGR: SK 97761 71181 SK 97770 71180 Site Code: LBTH 04

LAS Report No. 766 August 2004

Summary

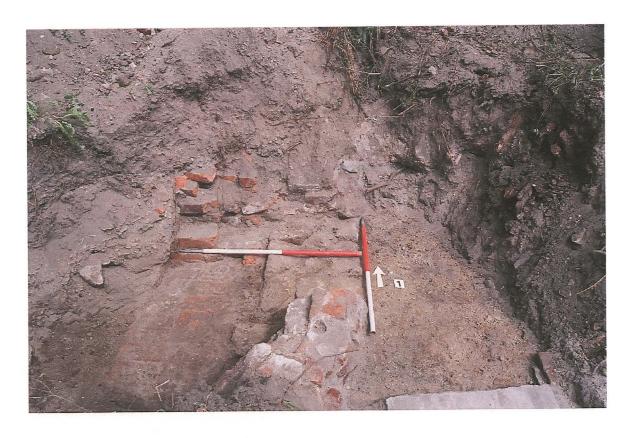
Pl. 2 Trench 1 showing stone wall 104 under brick wall 101. Deposit 105 is to the east. Scales 1m. Looking North.

This L-shaped trench had 0.60m deep topsoil, **100**, which sealed 0.50m thick levelling deposits **102** and **103**, composed of light grey and light brown sand silts often mortar rich. Below was a 1.40m wide north/south aligned modern brick wall, **101**, over 4 courses deep, over 0.40m in depth, whose eastern side utilised an earlier wall, **104**. Wall **104** was built of limestone blocks up to 0.30m in size, was on the same alignment as **101** and appeared to mark the western extent of deposit **105**, light brown, friable silt sand, possibly a floor surface, which produced 3 fragments of medieval flat roof tile, $12^{th} - 16^{th}$ century in date.

The stone wall, **104**, recorded in Trench 1, which was also present in Trenches 2 (**203**) and 3 (**308**) appears to be the same stone wall recorded during the 2002 evaluation as **125** which was dated by material from its foundation trench **128/129** to the 13th –14thcenturies. The orange brown sand **304**, which sealed wall **308** may equate to the demolition layer **109** and **126**, recorded in the evaluation trench as sealing wall **125**. Possible demolition layer **105** in Trench 1 may also be part of the same deposit. This material was below the 15th- 16th century pits suggesting that a 15th century date is possible for the wall. Such a late date would rule out **125** as been the town wall.

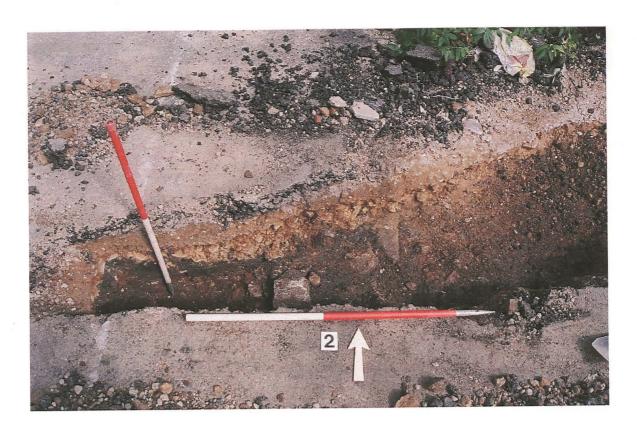
Pl. 3 Trench 2. Stone wall 203, looking north. Scales 1m.

After removing tarmac, 200, and underlying concrete, 201, a limestone hardcore layer, 210, was exposed, giving the modern deposits a depth of 0.28m. Beneath was a dark grey silt clay, 211, 0.14m deep. The post-medieval levelling deposit noted in the 2002 evaluation trench. 0.50m wide limestone wall 203 was the continuation of the stone wall noted in Trench 1. Within Trench 2 the wall was 1 course deep. 0.14m, was within a construction trench, 205, over 0.75m in width, whose eastern side was only visible due to its fill (204) being identical to 211. The wall cut a 0.24m deep grey brown sand silt layer, 202, which sealed a light grey clay floor. This floor was to the east of a 1.86m wide robber trench, 206, filled by brown grey silt clay, 207, with mortar and limestone inclusions. The earliest deposit was brown silt clay, 208.

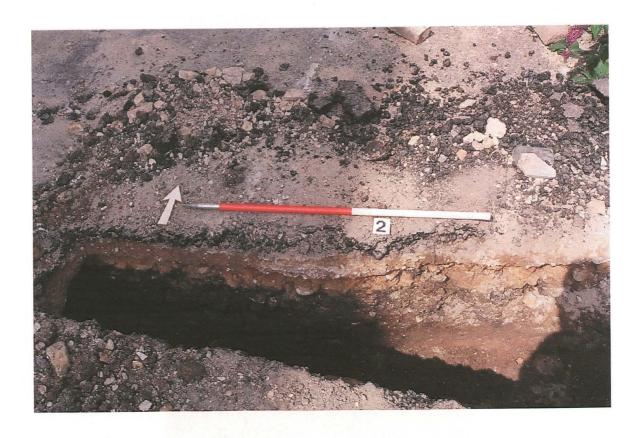
Pl. 4 Trench 2. Robber trench 206, looking north. Scale 1m.

The robbed-our earlier wall, recorded as 156 in the 2002 evaluation trench, was noted in Trench 2 as robber trench 206. The width of the robber trenches suggests that this wall would originally have been c.2m wide. In the evaluation report (Field 2002) it was suggested that 156 might be the remains of the medieval town defences. Wall 156 appears to have been incorporated into a later building, which straddled the wall. In Trench 2 floor surfaces 111 and 209 to the west and east of the robbed wall, respectively, may be contemporary with wall 206, although floor layer 209, to the east, did not have a direct relationship to the robber trench. A robber trench, 309, in Trench 3 was on the same alignment but was only 1.40m wide suggesting it may not be a continuation of the same wall. The layer below floor, 209, brown grey clay 208, may be the same deposit as 307 and 314 in Trench 3, the change in soil consistency being due to 307's closer proximity to the water course to the south. The levels of these deposits also suggest a slope to the south.

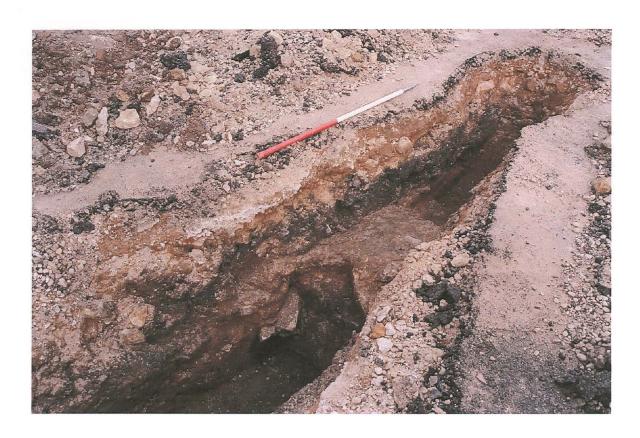
Pl. 5 Trench 3. Wall 308 sealed by demolition layer 304. Looking east-north-east. Scale 1m.

Identical post-medieval and modern deposits were recorded in this trench as in Trench 2 (300 tarmac, 301, concrete, 302, sand bedding and 303 was the continuation of 211 but was 0.40m thick). Limestone wall 308 was the continuation of wall 203 in Trench 2. It too was 1 course deep (0.14m). It was sealed by brown mortar rich sand, 304. Below 304 was grey brown silt, 305, only 0.04m deep, which in turn covered 0.05m deep brown sand, 306, not dissimilar to 304.

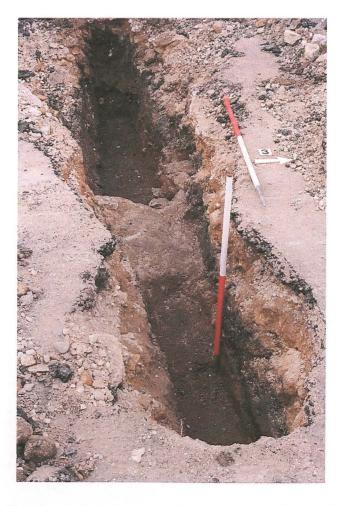
Pl. 6 Trench 3. Eastern deposits, looking west. Scales 1m.
