**EXTRACTION OF EXISTING PETROL TANKS,
FORMER 'SAVE' PETROL STATION,
216-232 MONKS ROAD, LINCOLN**

**ARCHAEOLOGICAL
WATCHING BRIEF REPORT**

Site code	PSMR 04
LCCM Acc No	2004.224
NGR (centre)	SK 99280 71425
Planning ref.	2003/0838/F

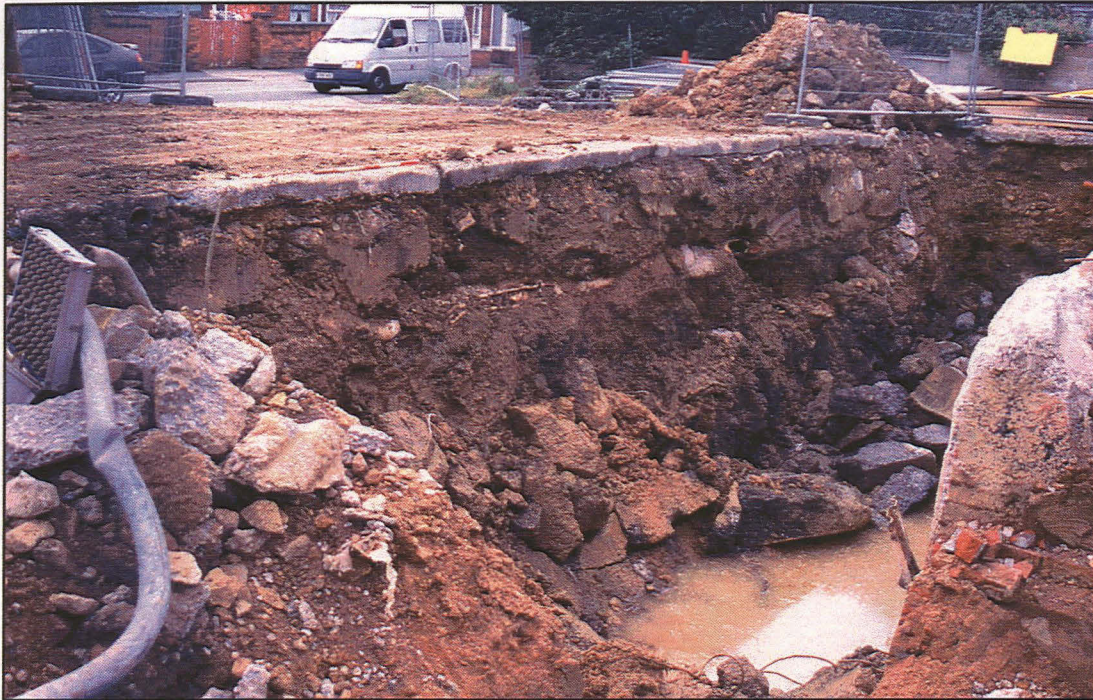
Plate 1 (above): General view of the development site with petrol tanks removed, looking south-west.

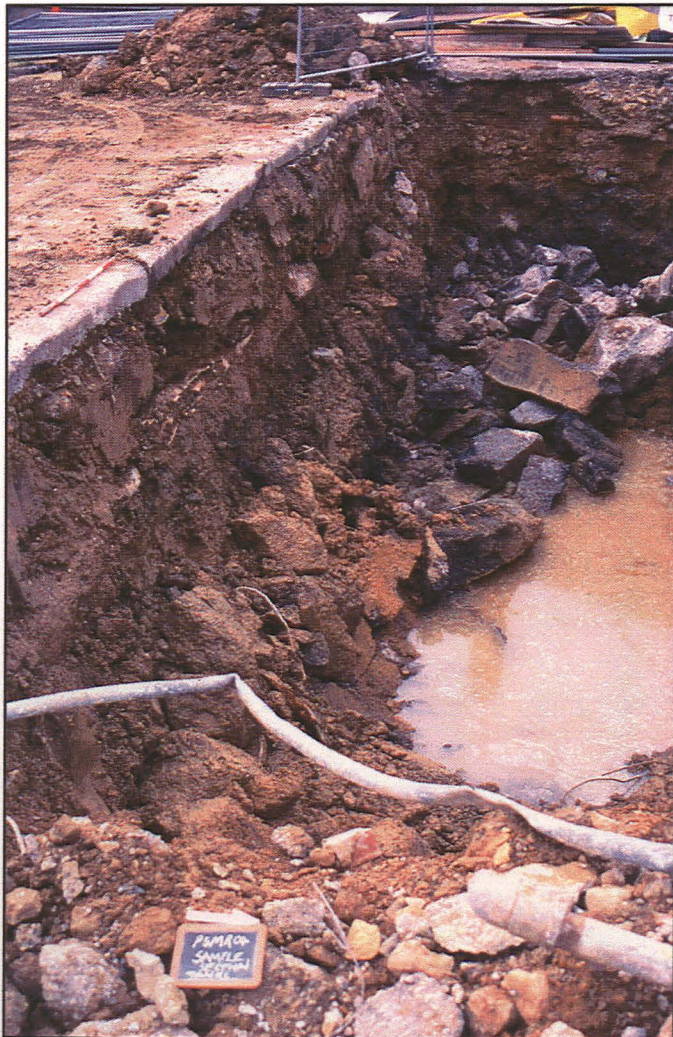
Plate 2(right): View of the development site, showing the pit excavated to remove the petrol tanks, looking west.
