LINDSEY ARCHAEOLOGICAL SERVICES

**The Punch Bowl Public House
37 New Road, Spalding, Lincs.
Archaeological Watching Brief**

LAS Report No. 774

October 2004

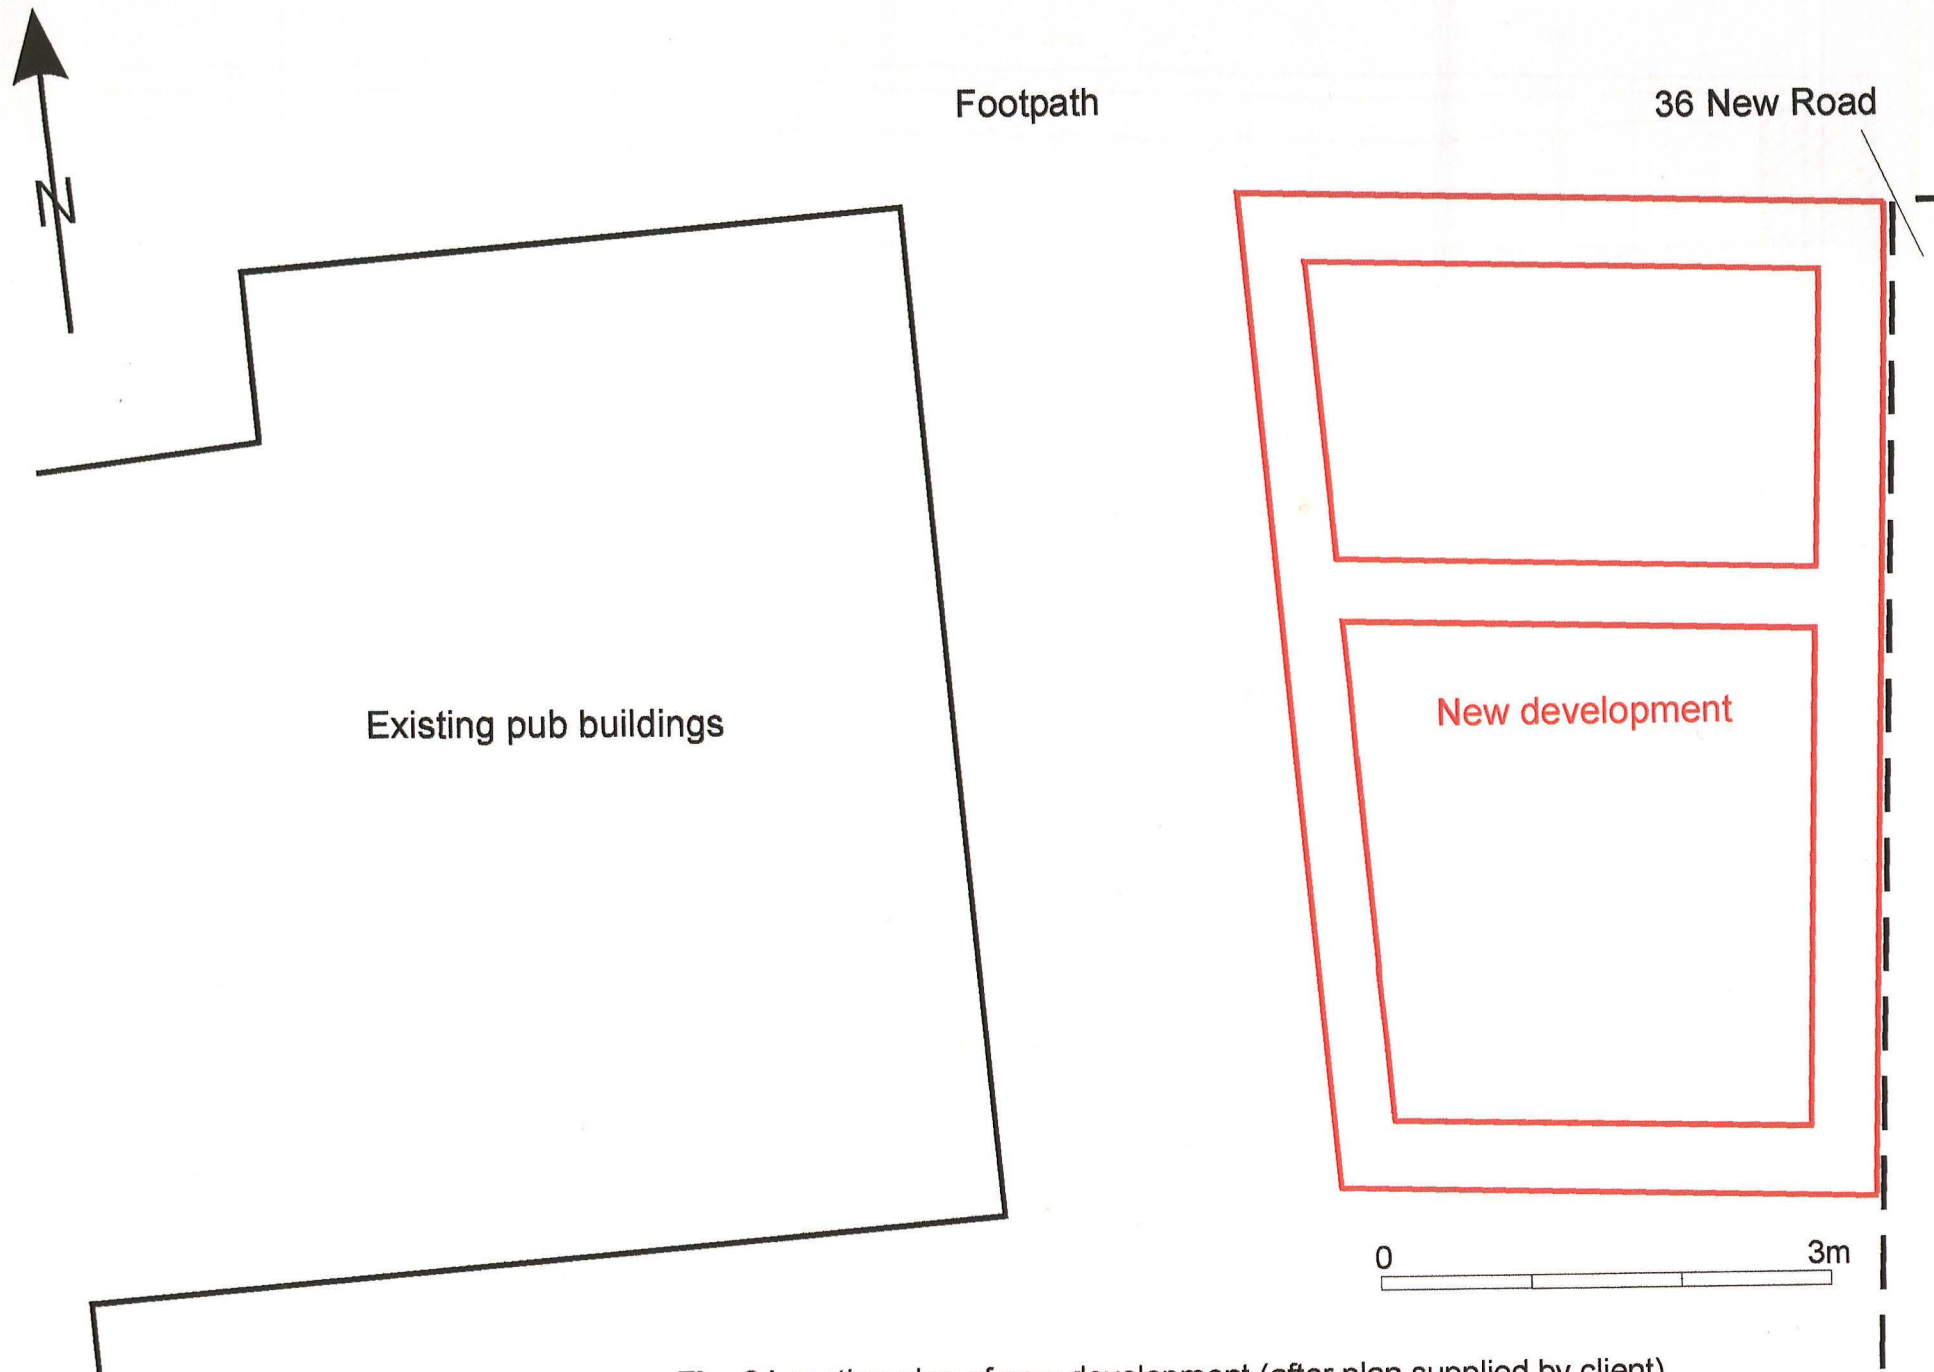
Fig. 2 Location plan of new development (after plan supplied by client).

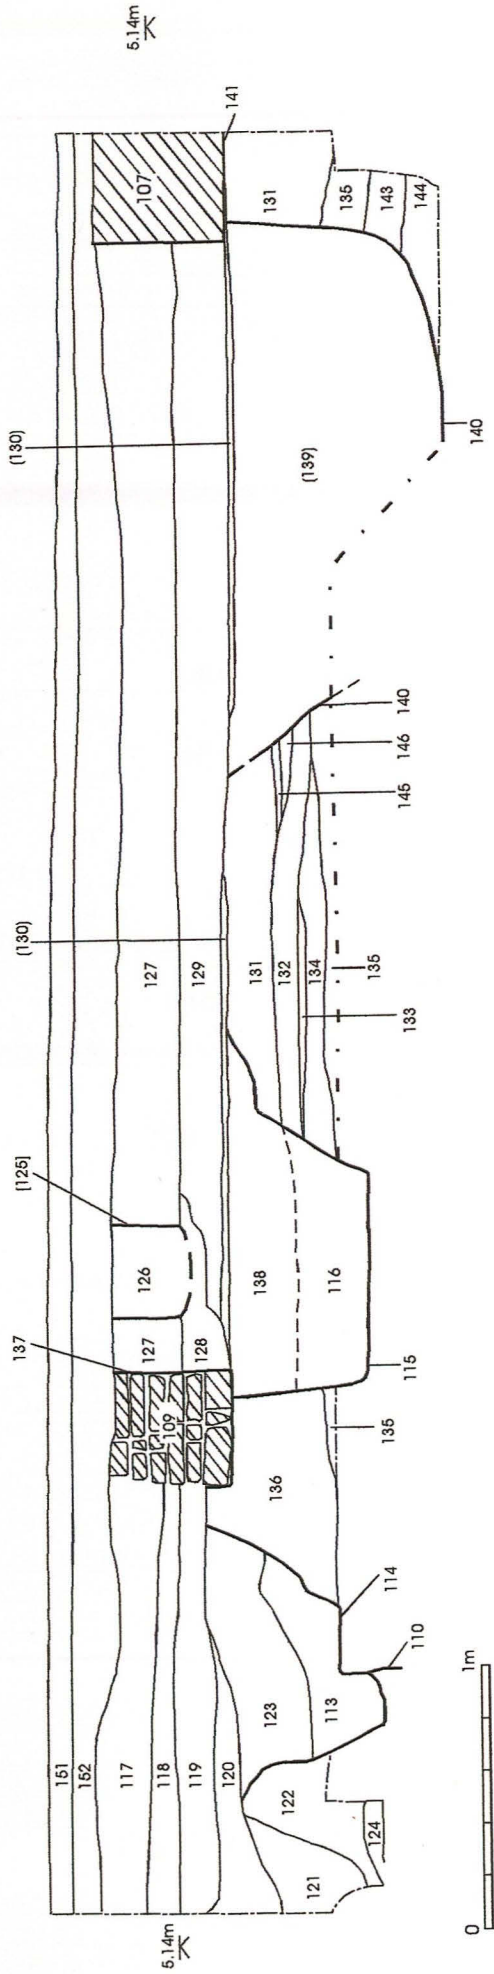
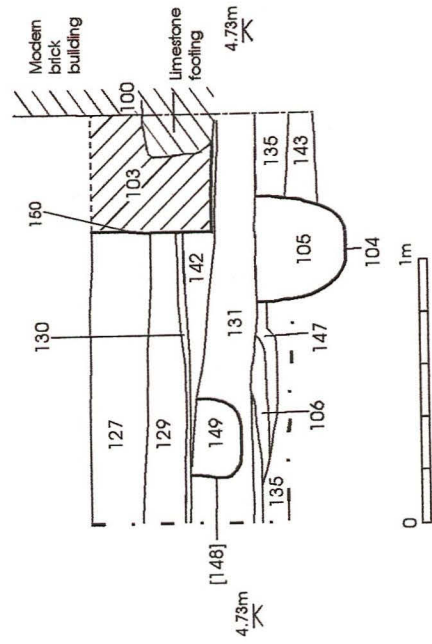
Fig. 3 The sections.

The excavation of the southern foundation trench (Pl. 5) through **152** revealed a number of levelling layers which comprised **117**, a mixed deposit of pale grey yellow very fine clay silt with occasional brick rubble (0.22m), **118**, a dirty pale orange very fine silt with frequent charcoal flecks and occasional brick fragments (0.14m) and **120**, a dark grey fine clay silt with frequent charcoal and ceramic building material and small fragments (>0.20m) (Fig. 3.1; Pls 5 & 6).

Beneath **152** to the north of the west foundation flood deposits were evident; the upper silting horizon, **127**, consisted of 0.24m layer of clean homogenous pale yellow very fine silt mottled with light brown clay silt. Beneath **127** a sloping a mixed deposit of grey-midbrown very fine silt with flecks of charcoal and ceramic building materials (**128**) which may have formed part of a feature but truncation prevented any confident interpretation. Below **128** lay 0.15m of grey yellow-brown very fine silt (**129**); the clarity of edge between **127** and **129** decreased to the north of the trench due to similarity of material (Fig. 3.1; Pls 5 & 6).

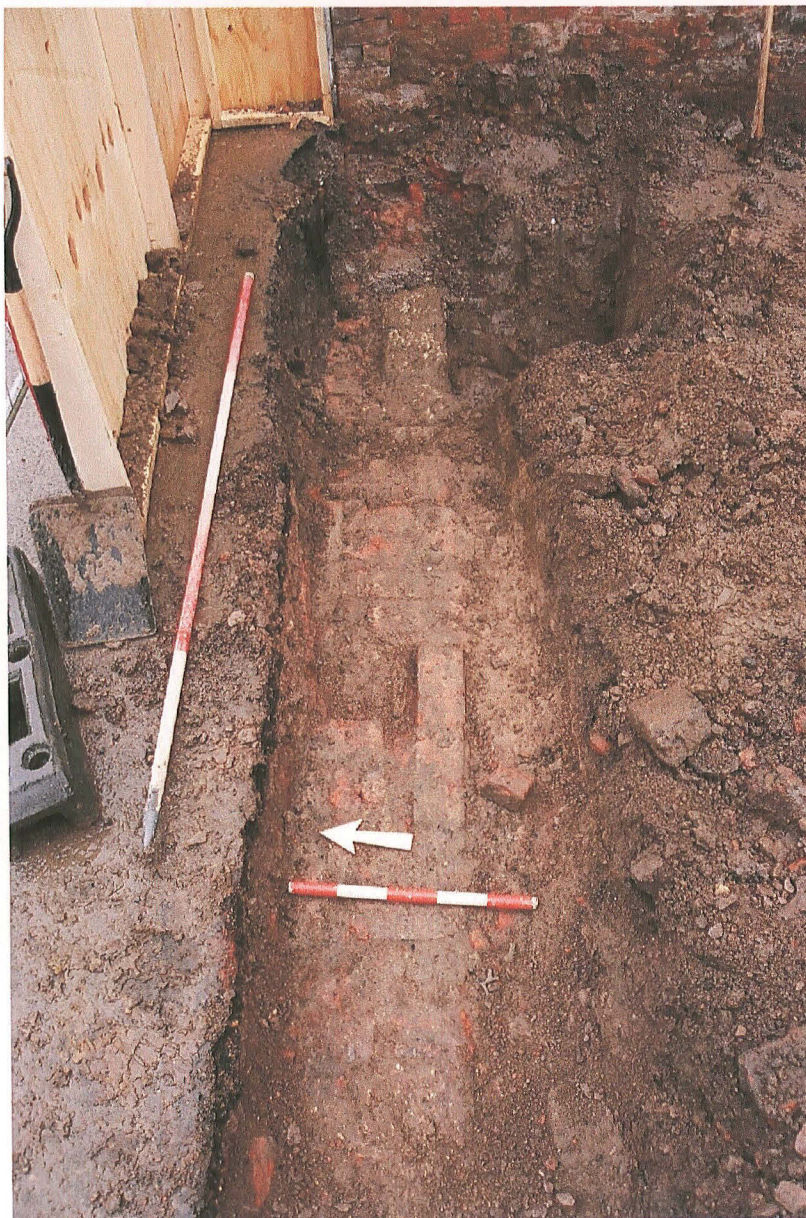
Pl. 3 Wall 107 showing reused limestone blocks within the foundations (looking east).

The foundations of wall **100** were also exposed in the trench for the internal wall (Pl. 3). This foundation differed from the other section as the on-end course was mortared to a foundation roughly built from limestone blocks and mortared together with a light grey mortar. It is clear that foundation cut [**153**] for wall **100** was cut into **127**, **129**, **130** and **142** but this has been obscured by the construction of wall **103**. Evidence for **102** was not encountered in this trench and it is unclear if this is due to the wall being robbed out or whether the course of **102** did not continue further north.

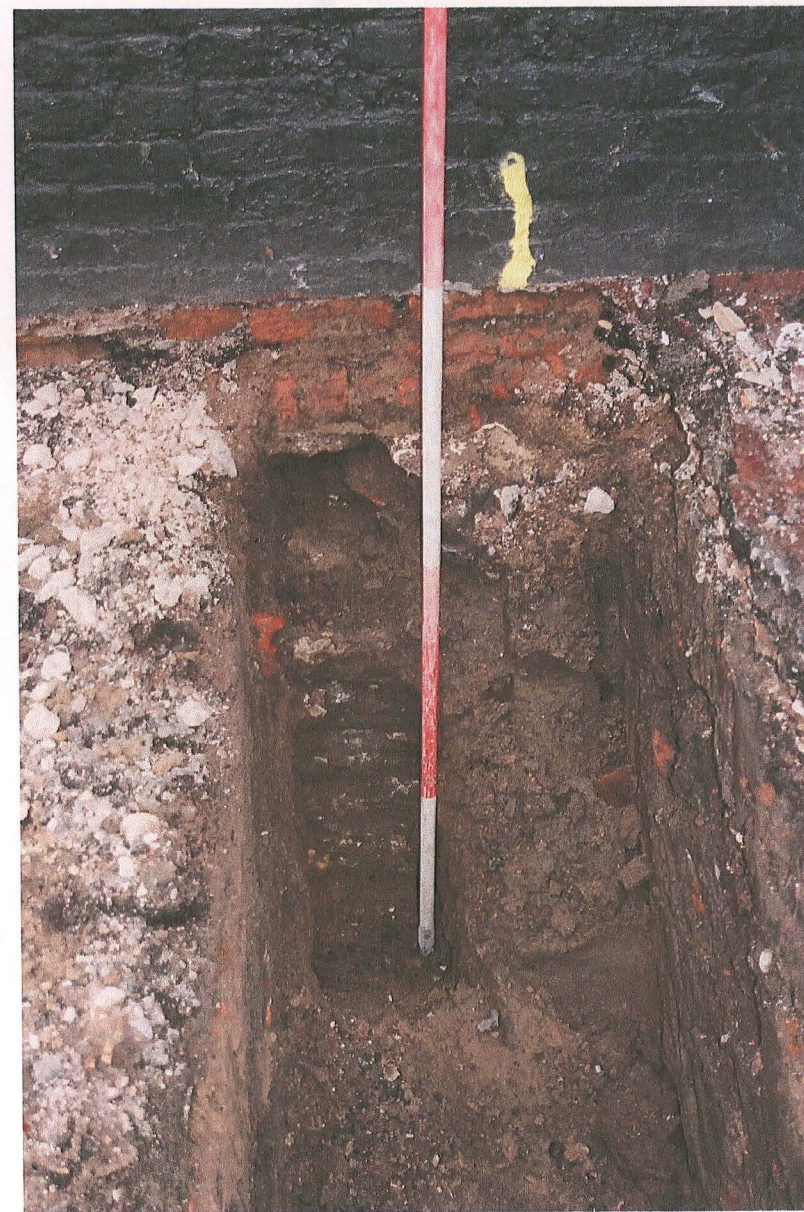
Pl. 4 Georgian town house (100) and limestone wall (102), looking east (scale 2m)

on-end course set on a 0.08m mortar bed. The area of wall **100** exposed in the southern foundation trench (Pl. 4) was cleaned up by the builders with a shovel revealing the shallow foundations resting on **101**, 0.40m of dirty yellow brown silt with occasional fragments of ceramic building materials. Beneath **101** a section of limestone wall consisting of five regular courses of fair-faced limestone blocks (<0.30m x 0.13m x ?) mortar joints (**102**) was encountered when the builders excavated a test *sondage* by hand. Investigation by the builders showed that there were no courses beneath those already exposed (Pl. 4). As visibility was limited and further investigation not advisable it appeared that the foundation cut for **100** [**153**] cut layers **117**, **118** and **119** as it was exposed in this area. The limited area of **102** and the manner in which it was exposed made it difficult to discern which alluvial layers the foundation cut (**154**) and which layers were butting the wall. It therefore it was only possible to demonstrate that **102** pre-dated **101** and **100**.

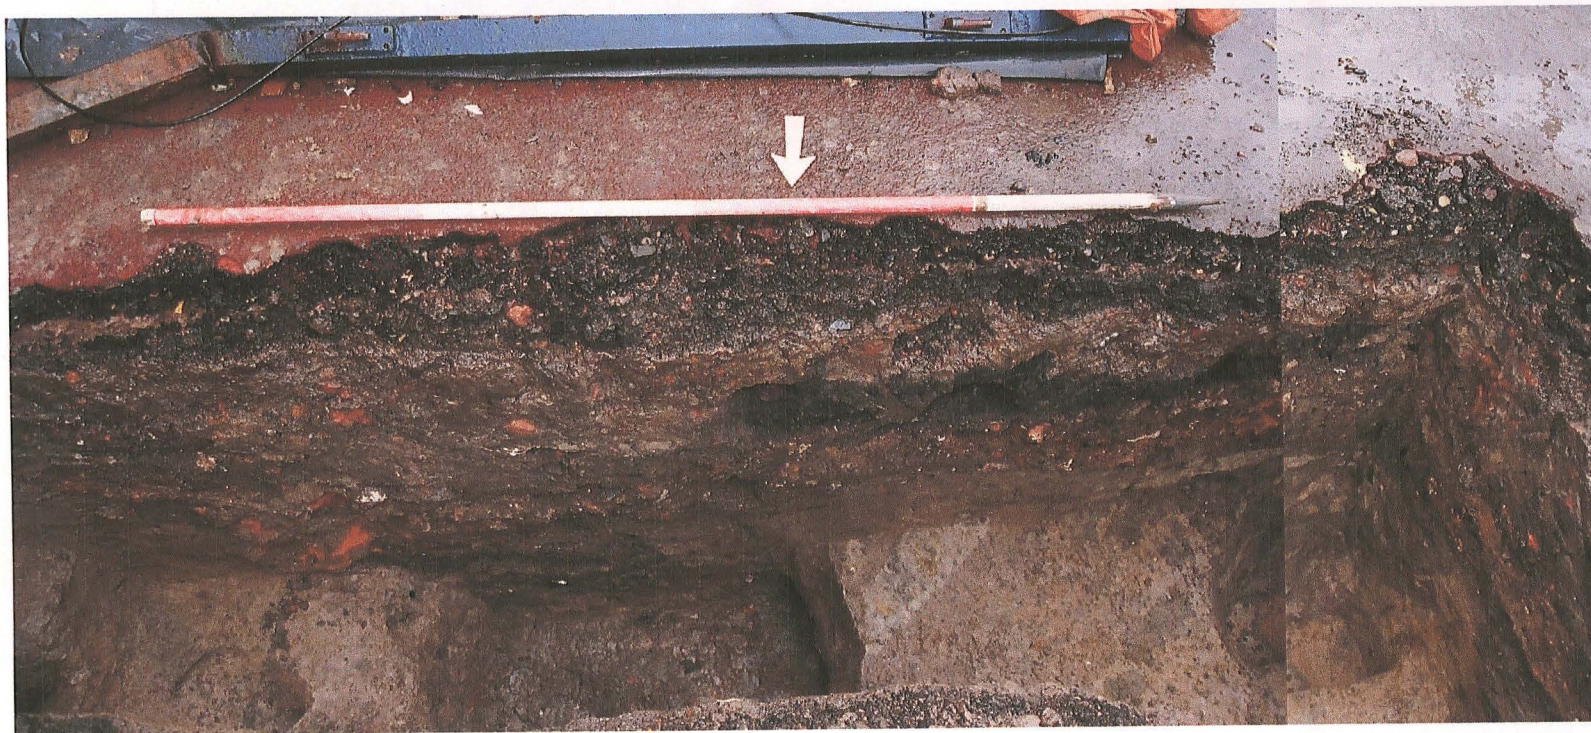
PI. 5 Large pit [110] with sampled dark fill (108) exposed in southern foundation trench, looking south. Scale 2m.

Excavating the southern foundation a large pit, **110**, was encountered (Figs 3. 1 & 4; Pl. 5). The fills consisted of dark fills mixed with re deposited natural. Dark fill **108**, was hand excavated to investigate a fill which appeared to have straight sides but upon excavation the irregular edges confirmed it was back fill of the large pit.

The large pit **110** may be as the result of a pond cut as part of a system to alleviate flooding from the now culverted West Lode channel. The backfilling deposits of **110** suggest that the feature was rapidly backfilled with both silty materials from flood deposits and dark fills rich in charcoal. The fill which was investigated contained pottery dating it to the mid 17th- 18th century (Appendices 2-4) and contained a

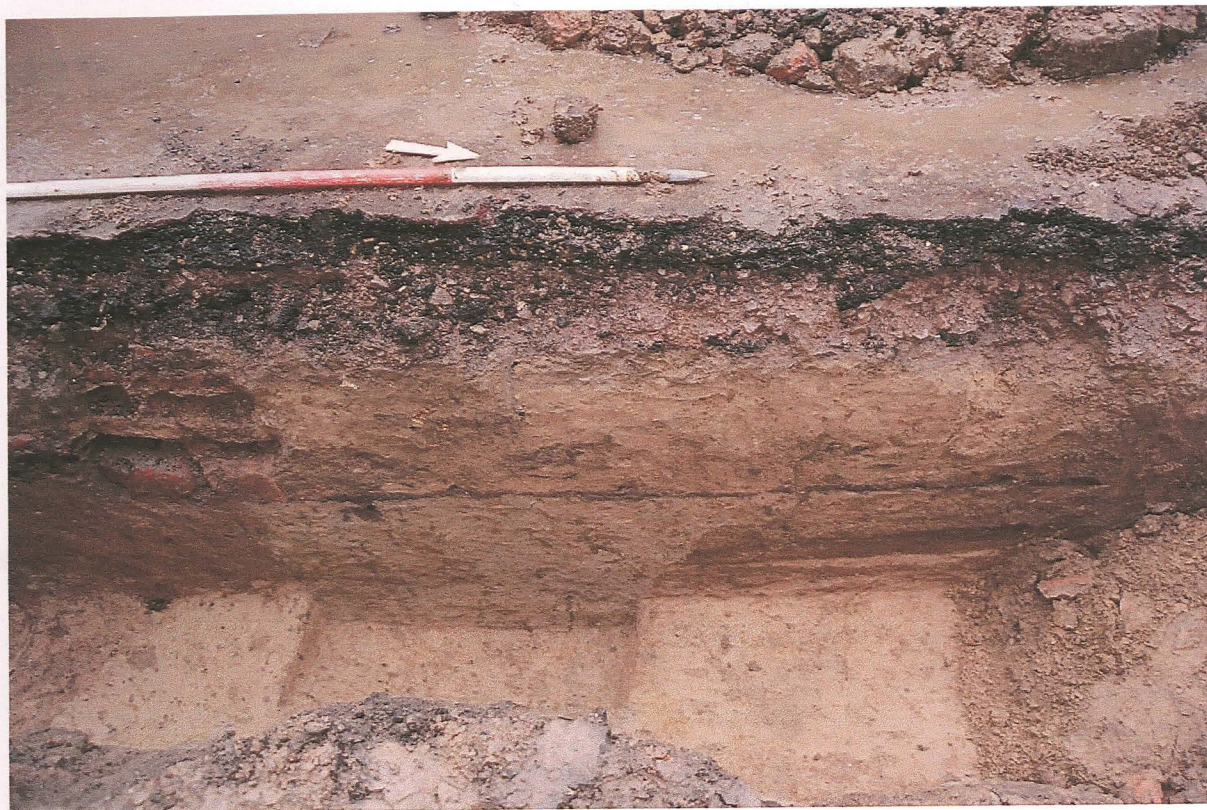
Pl. 6 Western foundation showing brick wall 109, ditch 115 and occupation layer 130, looking west. Scale 2m.

Beneath silting layer **129** was an occupation layer which consisted of a shallow band of charcoal rich dark grey fine silt, **130**. The occupation layer sealed a number of thin flood silt deposits which between 0.5 and 0.20m thick (**142**, **131**, **132**, **133**, **134**, **135**, **143** and **144**) with one area up to 0.5m where no laminations were apparent (**136**) (Figs 3.1& 3.2; Pl. 6, 7, 8 & 9).

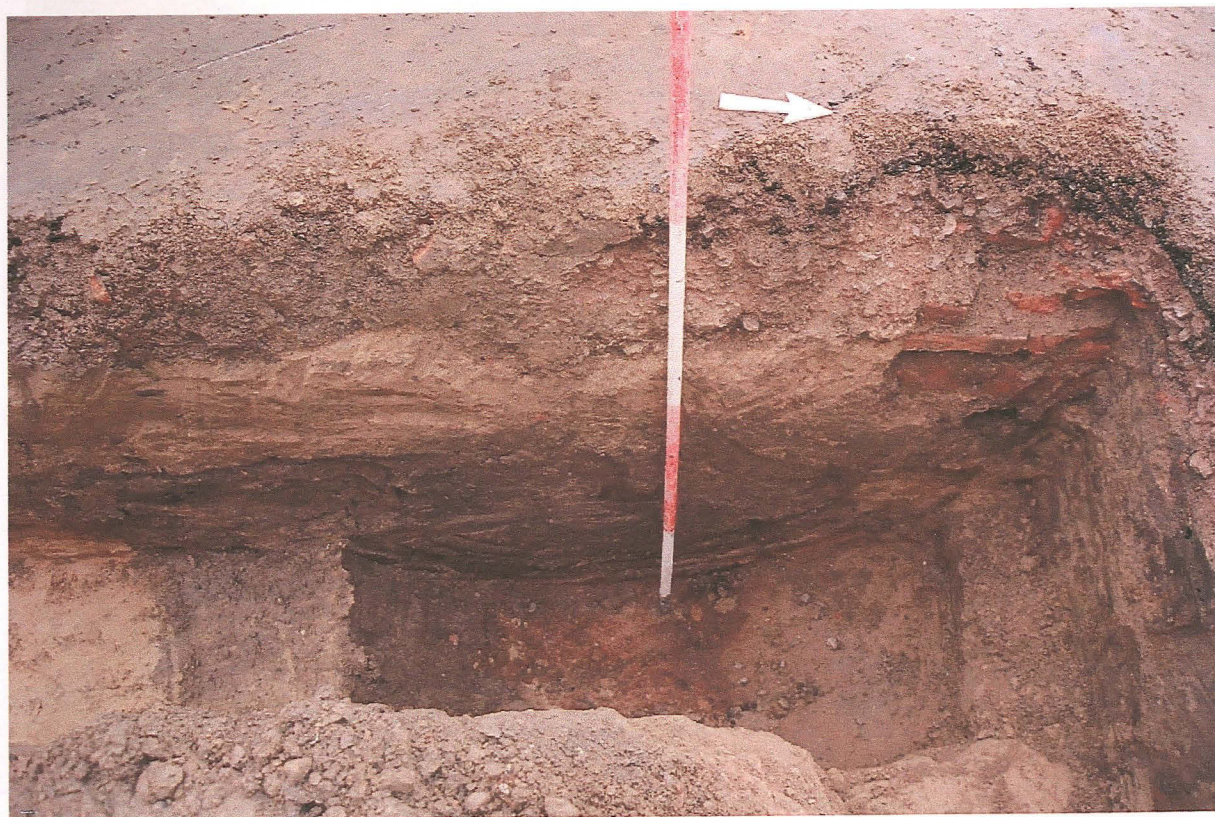
Pl. 7 Western foundation showing brick wall 107 and pit 140. Scale 2m.

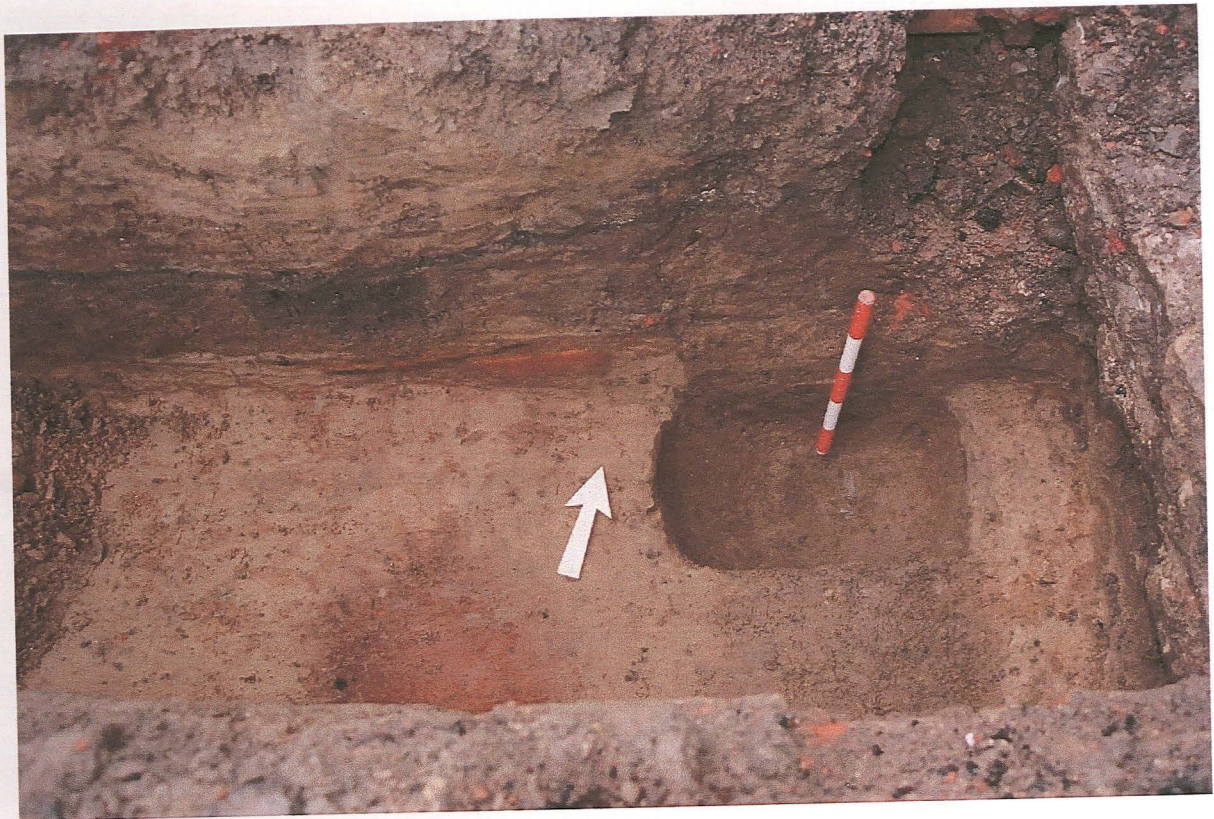
Pl. 8 (above) Gully 148, ditch 104 and hearth 106, looking north. Scale 0.5m.

Two hearths were present. One hearth was visible in section above alluvial layer **132** (**145/146**) consisting of heat affected silt (Fig. 3.1). Another hearth above **135** (**106/147**) (Fig. 3.2; Pls 8 & 10) contained a decorated tile (Appendix 5, Pl. 10). A small ditch [**104**] running north- south also cutting alluvial layer **135** 0.4m wide, 0.34m deep and in excess of 3m (visible in central and northern foundation) contained a light brown fine clay sand (**105**).

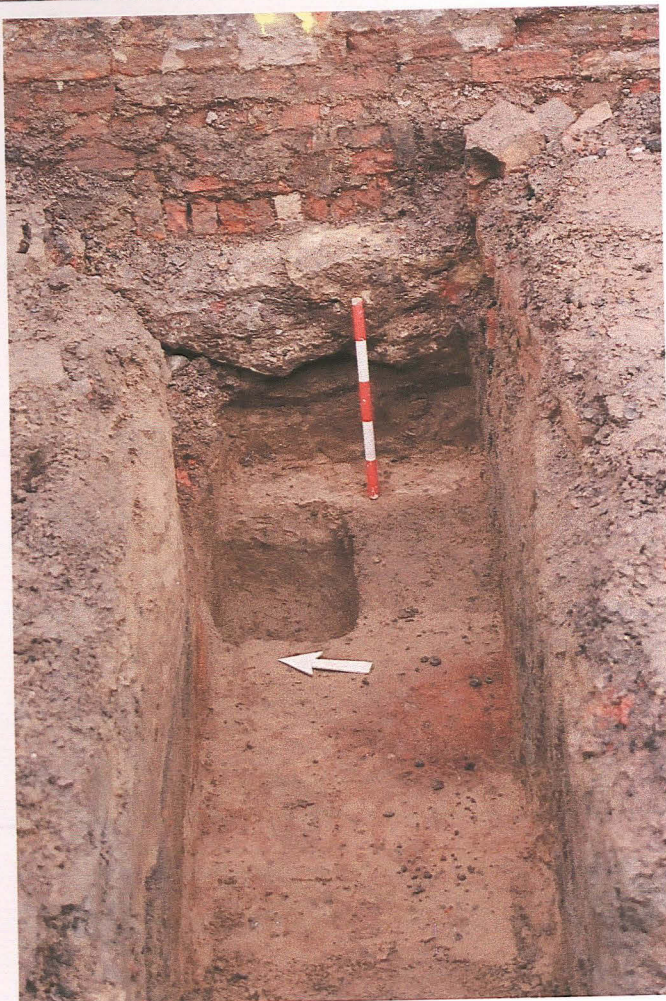
Pl. 9 Central foundation trench showing wall 100, ditch 105 and hearth 106, looking east. Scale 0.5m.

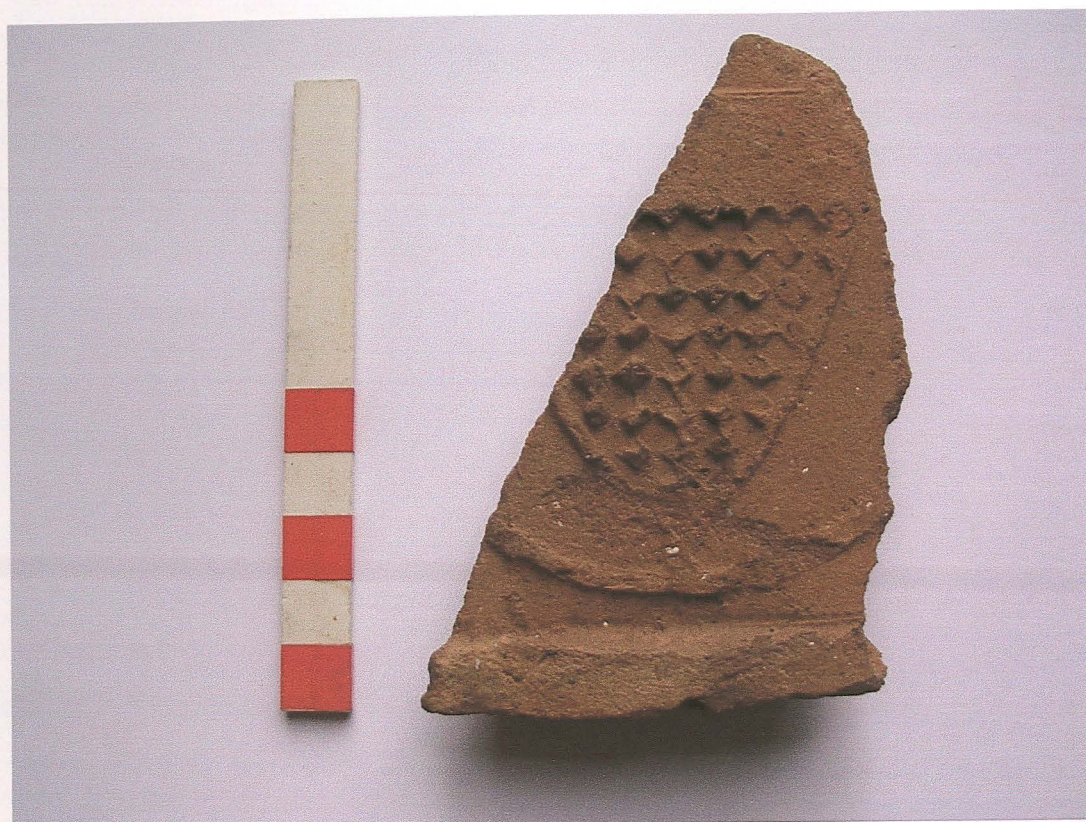
Pl. 10 Decorated tile from hearth 106 (see Appendix 5). Scale 0.10m.

Salt processing in Spalding is known (Tann 2004) and the areas of heating **145** and **106** may relate to such an activity. Hearth **106** contained a very fresh decorated tile with no evidence for wear or setting in a wall or floor. The tile was probably a waster as it has not been glazed and is probably the product of a Bawsey tiler of the late 13th to 14th century (Appendix 5, Pl. 10).

The tile comes from context 106, a hearth, and is the only retained find. It is an unglazed fragment from a square tile, in the order of 158 mm square and 19 mm thick. The decoration consists of a relief stamp with a central heraldic shield enclosed in a raised circular band. There is no sign of wear on the very sharp surfaces of the tile and neither is there any evidence for the tile having been set in a floor or wall.

The condition of the fragment suggests strongly that it was never used and the absence of glaze suggests it may be waste. The sand temper is indicative of a sand derived from lower and Cretaceous strata whilst the clean matrix is only matched locally by Jurassic clays such as the Oxford Clay. The lack of quartz and mica silt certainly discounts a fenland silt origin for the clay. It is likely that the parent clay is a boulder clay composed of material derived from the Oxford Clay, Spilsby Sandstone and Chalk but a source in the Vale of Ancholme is also possible. It is also possible that the tile originated to the south of the fens and relief tiles of this type were produced at Bawsey, Norfolk, in the late 13th and 14th centuries. If the tile is indeed waste then it implies the existence at Spalding of suitable boulder clay and would indicate contact between Spalding and tilers from Norfolk. The die cutting is well-executed and it is very unlikely that such a die would have been cut except by a skilled tiler, for the production of a larger order of tiles. It is therefore likely that even if the tile is indeed locally-made that the die was obtained from the Bawsey tiler.
