**ARCHAEOLOGICAL WATCHING BRIEF
OF SERVICE TRENCHES AT
ST. JOHN THE BAPTIST'S CHURCH,
STAMFORD,
LINCOLNSHIRE
(SSJ 04)**

**Work Undertaken For
Tim Ratcliffe Associates**

October 2004

APS Report No. 138/04

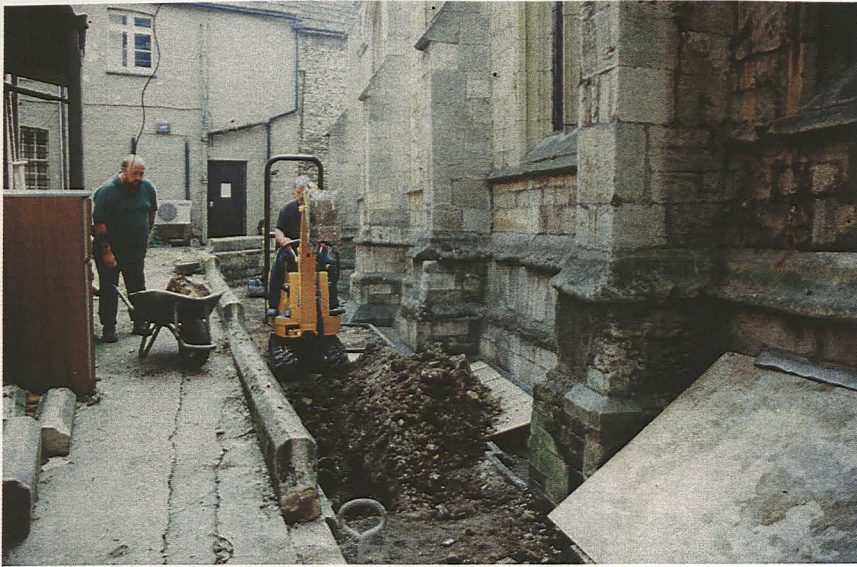
Above the 19th century dumped deposit and evident within the trench north of the church and above the steps on the south side was a layer of built up ground. This comprised a 0.6m thick deposit of brownish grey clayey silt (002).

Plate 1 - General view of the drainage trench on the north side of the church, looking west

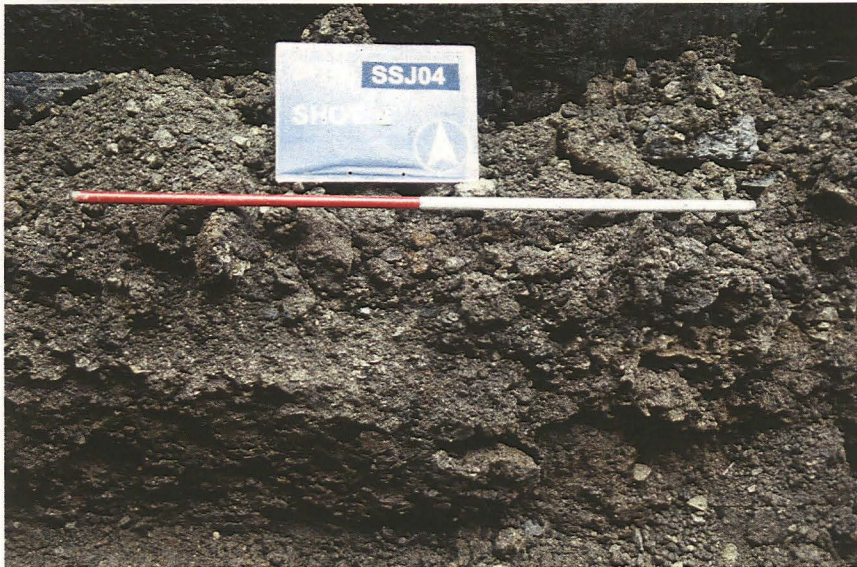
Plate 2 - Section 1, looking north

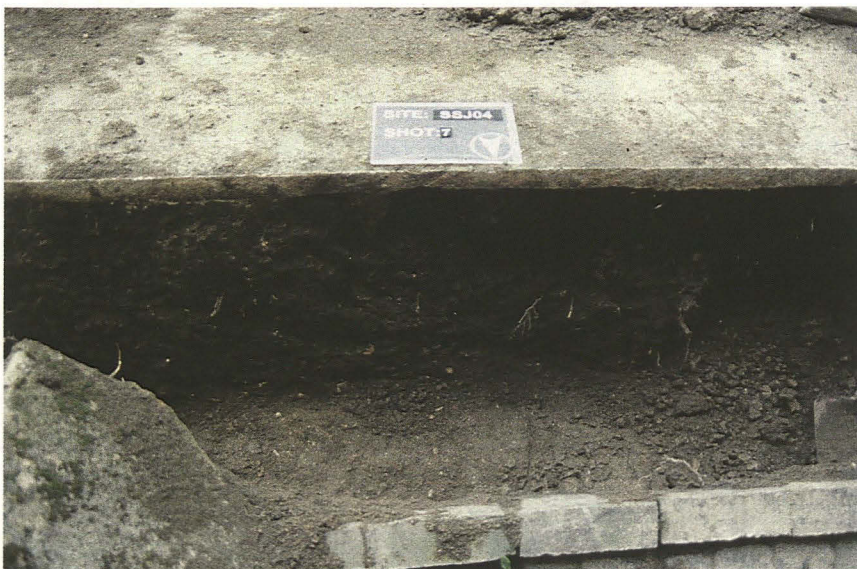
Plate 3 - Section 3, looking south

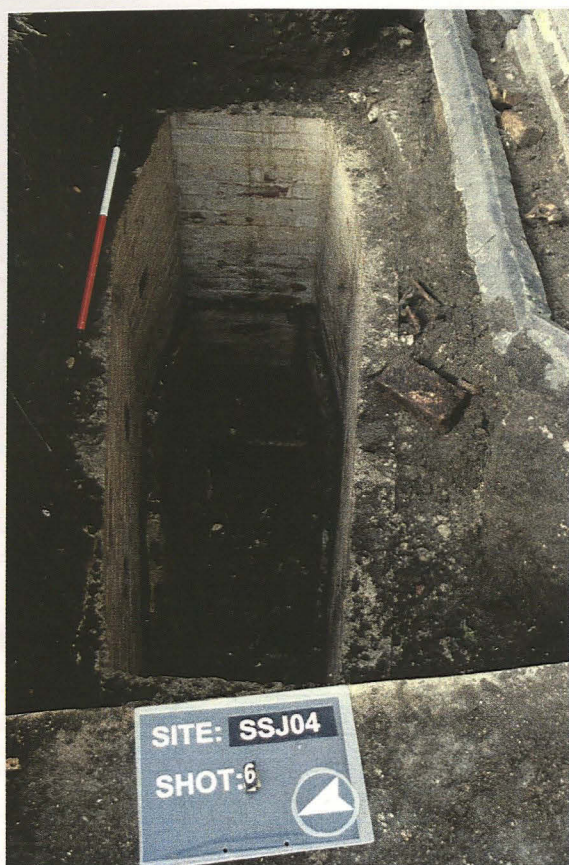
Located 4m southwest of the undated steps was a brick built tomb (007). This was 2.4m long by 0.75m wide and deeper than 1.75m (Fig. 4, Section 4). Backfilled around this tomb was a deposit of grey clayey silt (006) which contained human bone, limestone rubble as well as 19th century pottery, brick, glass and a nail.

Plate 4 - View showing the brick built tomb (007), looking east

Deposits of 19th century date (Phase 2) comprise a brick built tomb, extensive graveyard soils and a dumped deposit.

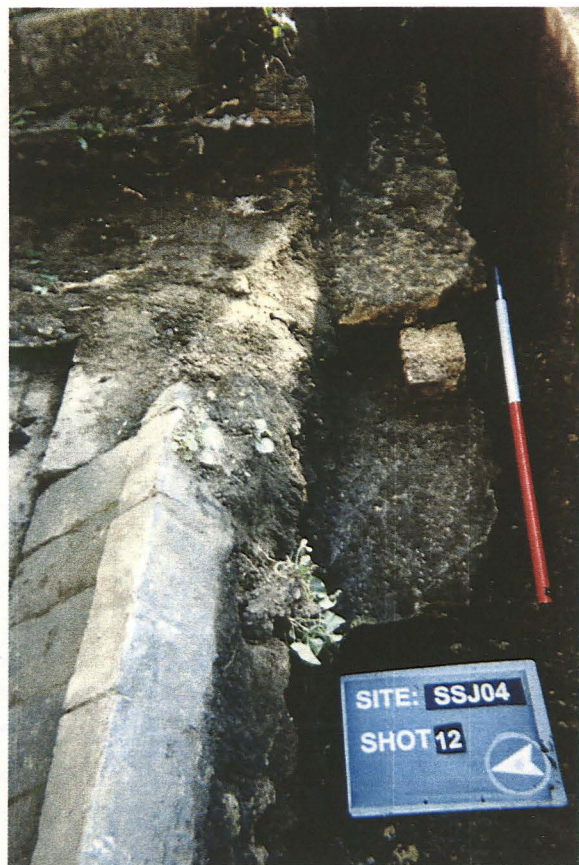
Located within the southern trench, adjacent to the South Chapel was a deposit of brown mortar (009) identified as a bedding layer (Fig. 4, Section 5). Upon this were sandstone slabs with brick risers (008) forming steps.

Plate 5 - View showing the sandstone steps (008), looking east

A set of steps with mortar bedding (Phase 1) was the earliest feature identified but is undated due to a lack of artefactual material. A view of St. John the Baptist's church of the early 18th century (Peck 1979, Plate 15) does not depict any steps and it is possible they pre-date this.
