**95, NETTLEHAM ROAD,
LINCOLN**

**ARCHAEOLOGICAL
EVALUATION REPORT**

Site code	NERD 05
NGR:	SK 98409 72885
LCCM Acc No:	2005.16

R. D. Gardner

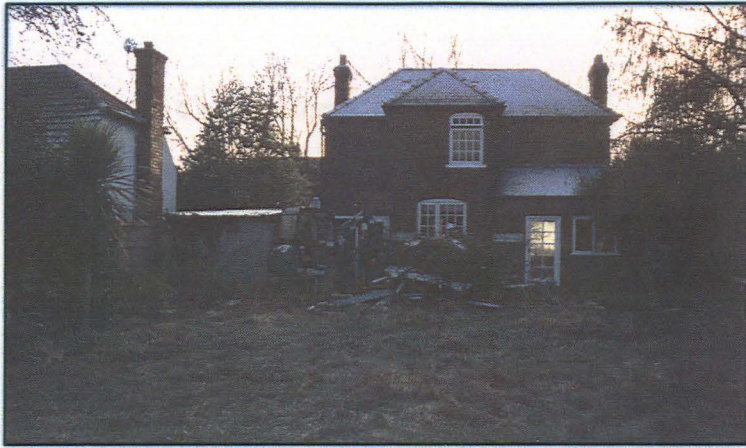
Plate 1 (left): General shot of the development area during machining, looking SE towards the rear of the current house.

Plate 2 (right): Machining the evaluation trench, looking NW from the rear of the house.

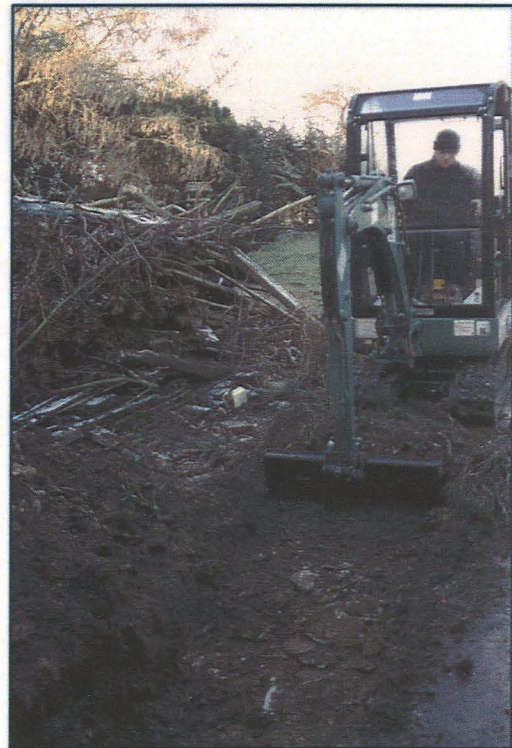
Plate 3 (bottom left): The completed evaluation trench, looking SE. The disturbed area containing modern services is visible as darker material at the far end of the trench.

Plate 4 (bottom right): The completed evaluation trench, looking NW. The modern water pipe is visible at the near end of the trench, directly above the number board and north arrow; the area of larger stones in the foreground is naturally bedded limestone.
