ARCHAEOLOGICAL WATCHING BRIEF AND SURVEY REPORT

3 NEW STREET, BOSTON
LINCOLNSHIRE

Site Code: BNS 94
CCM Accession Number 108.94

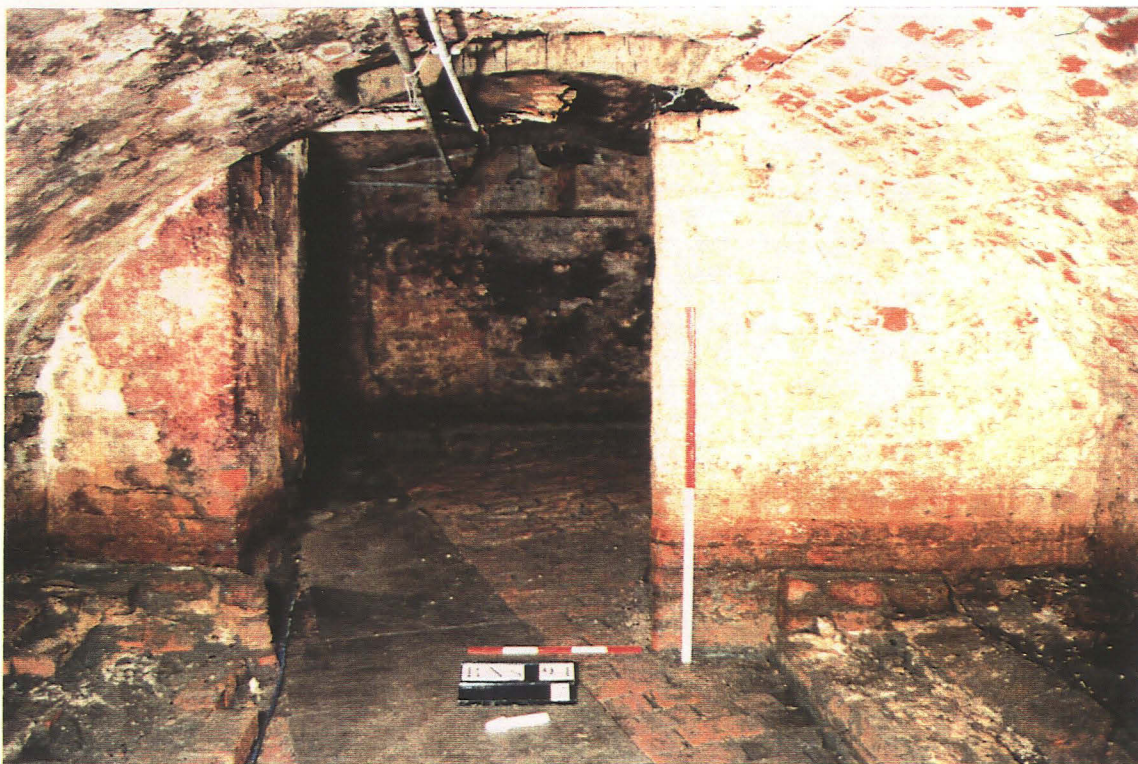
Photo. 1 Looking east from west bay, with cross-wall [7] in foreground

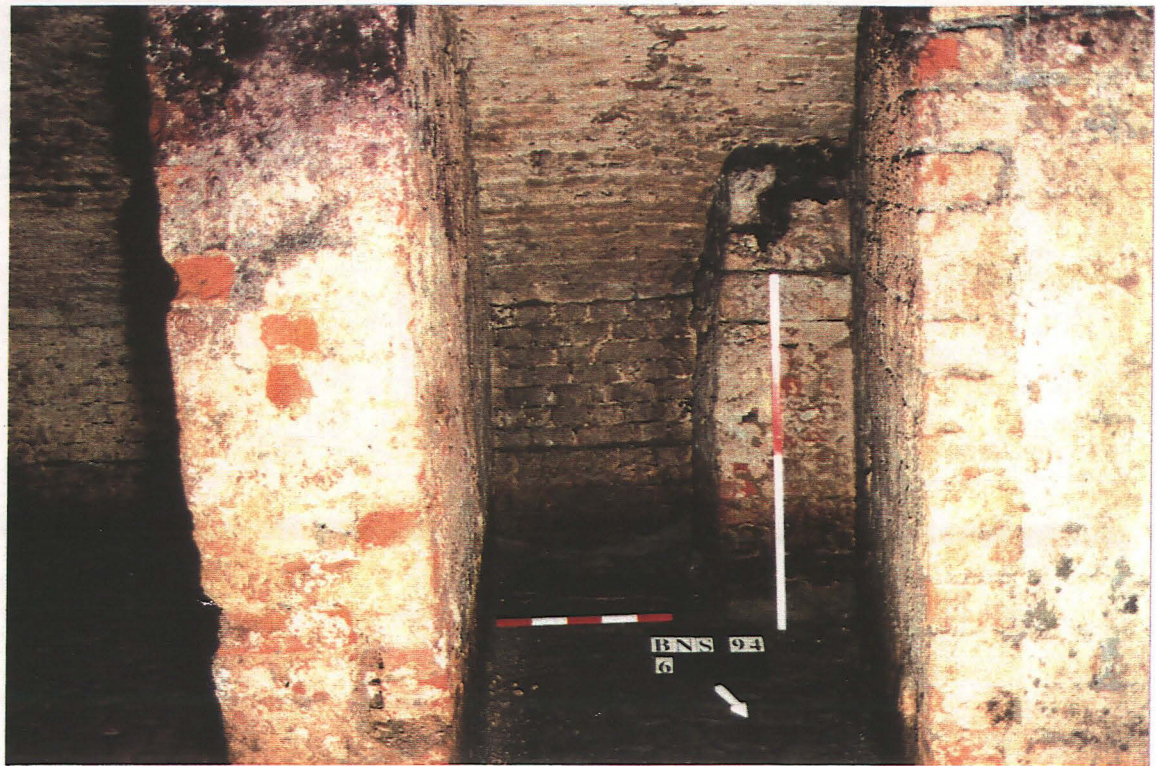
On the south-west side of the east bay, a half-wall, [5] had been inserted against (perpendicular to) the south wall [4], creating an area bound by walls [4], [5] and [7]. Separating walls [4] and [7] was an irregular buttress-type feature, [6] (photo. 3). It appeared to be of the same build as [7], though was secondary to the principal wall [4]. Its purpose was not determined.

Photo. 3 Looking south-west into small bay demarcated by cross-walls [5] and [7]. Buttress-type feature [6] in right hand corner

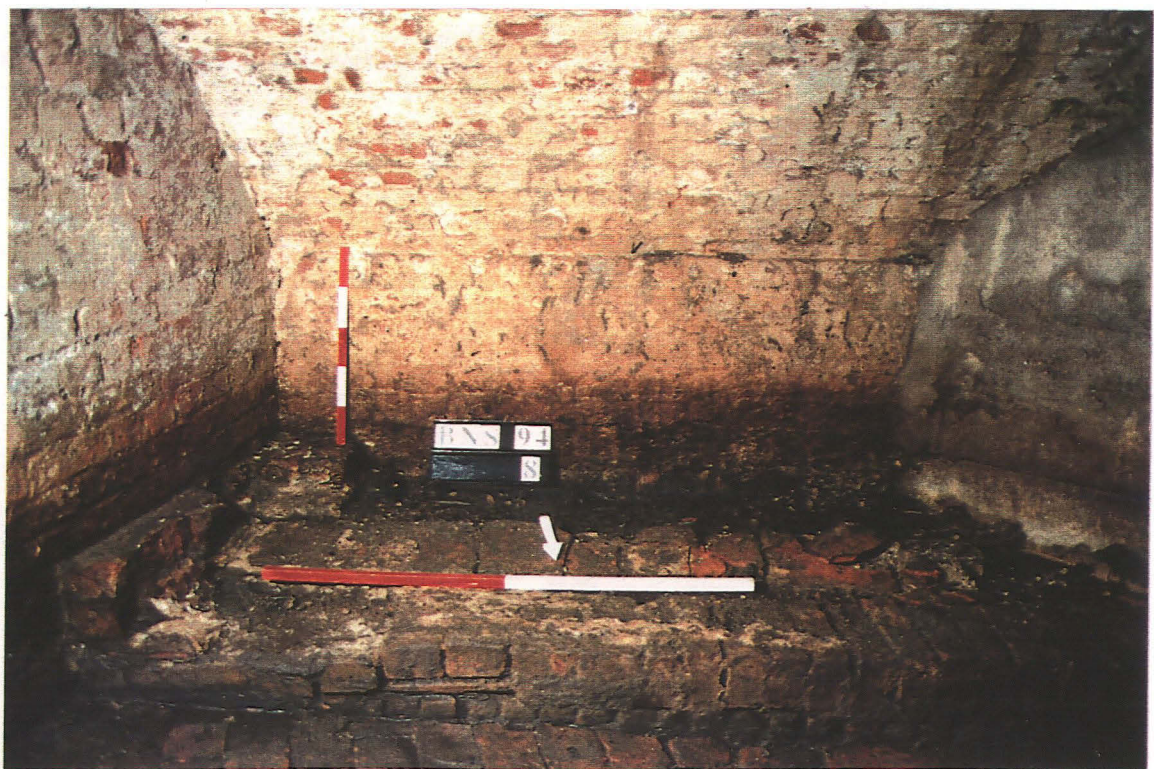
Photo. 4 Looking south at wall elevation [8], with raised brick/tile feature [9] in foreground

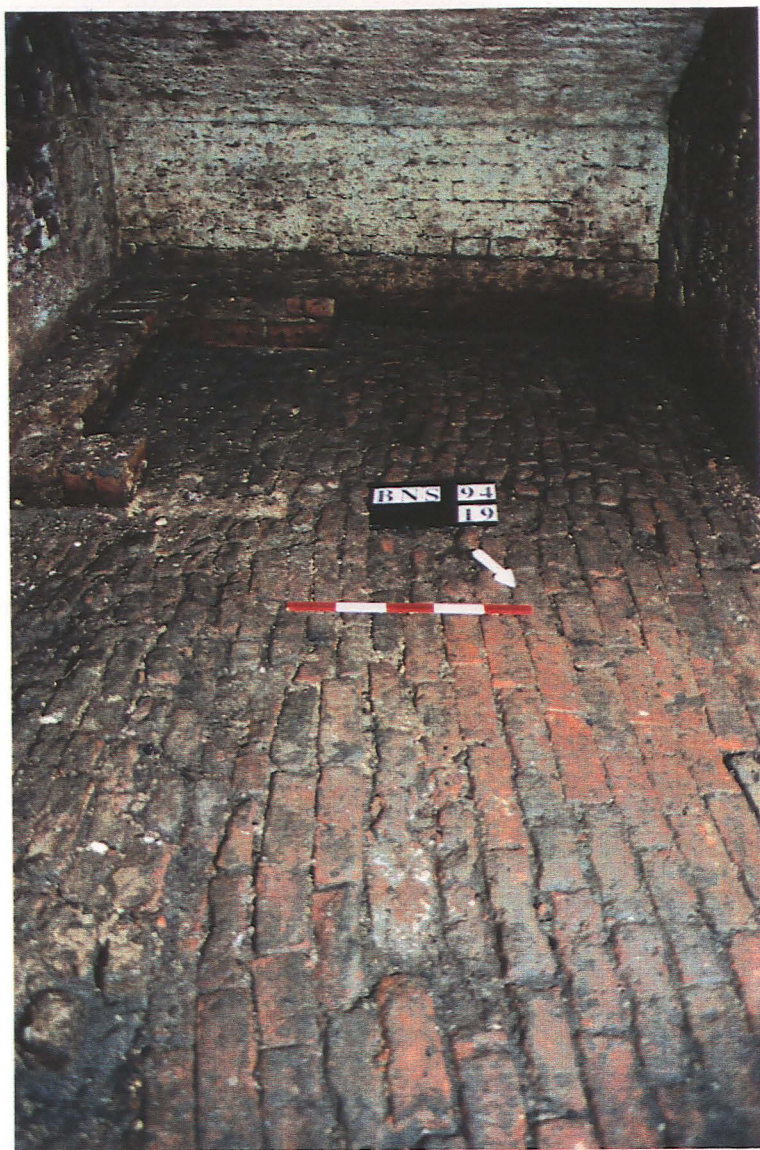
Photo. 7 Looking south-west at brick floor [19] (foreground) and wall elevation [4] (background)

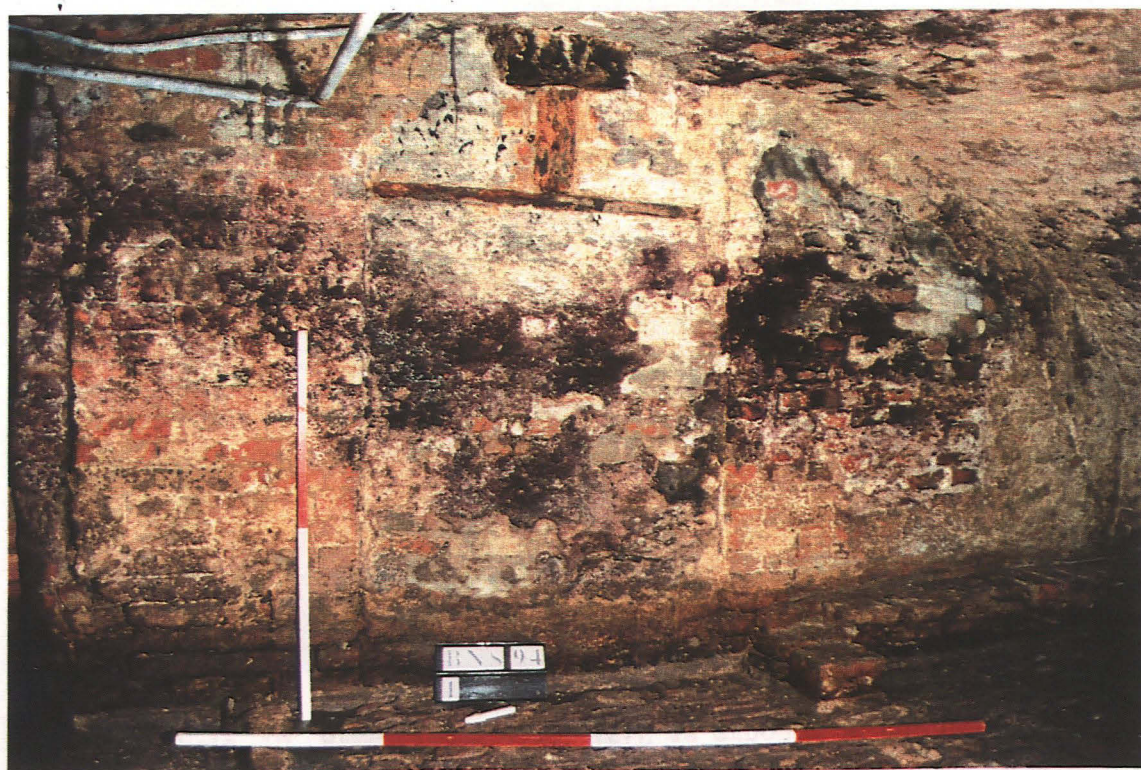
In the centre of the easternmost wall elevation [Fig. 4], a blocked entrance [2] was clearly visible (photo. 8). This was an earlier (perhaps original) entrance to the chamber - making the flagged pathway, [18], which led from the modern doorway, of secondary construction. Adjacent to the blocking, on the south-east side, was a low, brick-built, structure, [3], which was also a secondary build. The bricks were modern in appearance and it is likely the structure demarcated a storage area, perhaps associated with the recently destroyed Boston Blitz public house.

Photo. 8 Looking south-east at south-east elevation of vaulted cellar; incorporating wall [1] and original (blocked) doorway [2]

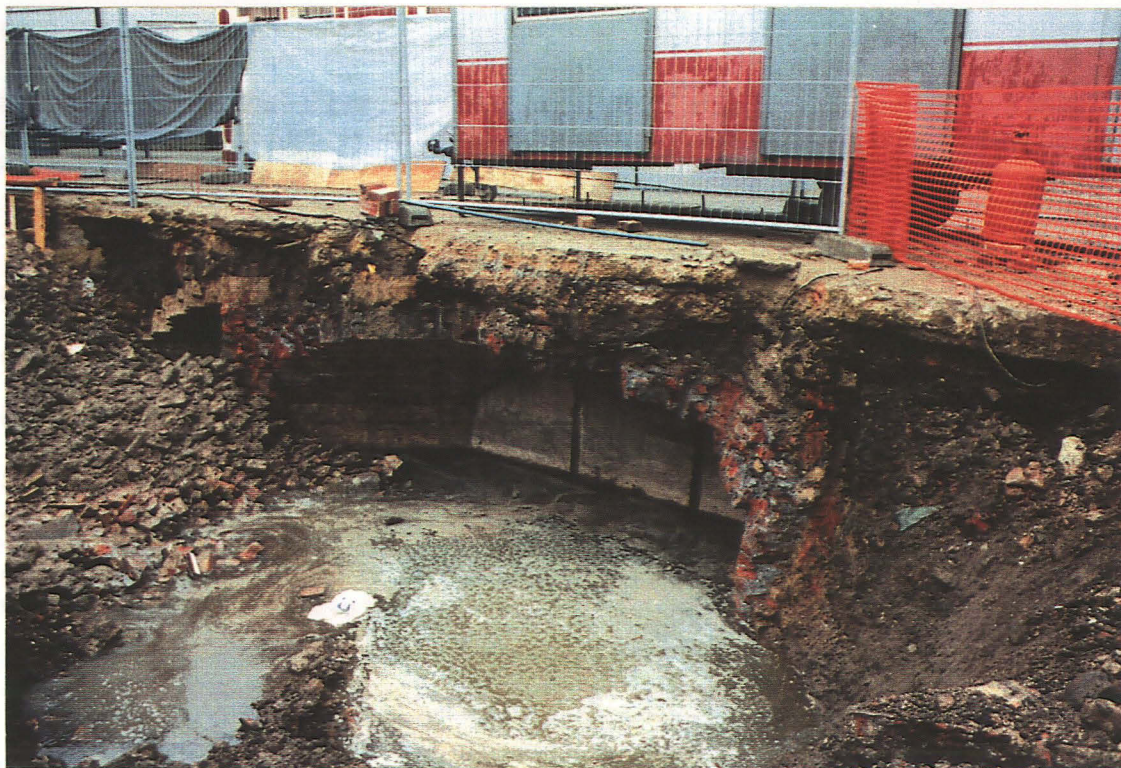
Photo. 9 View of cellar blocking [10] after demolition, looking west

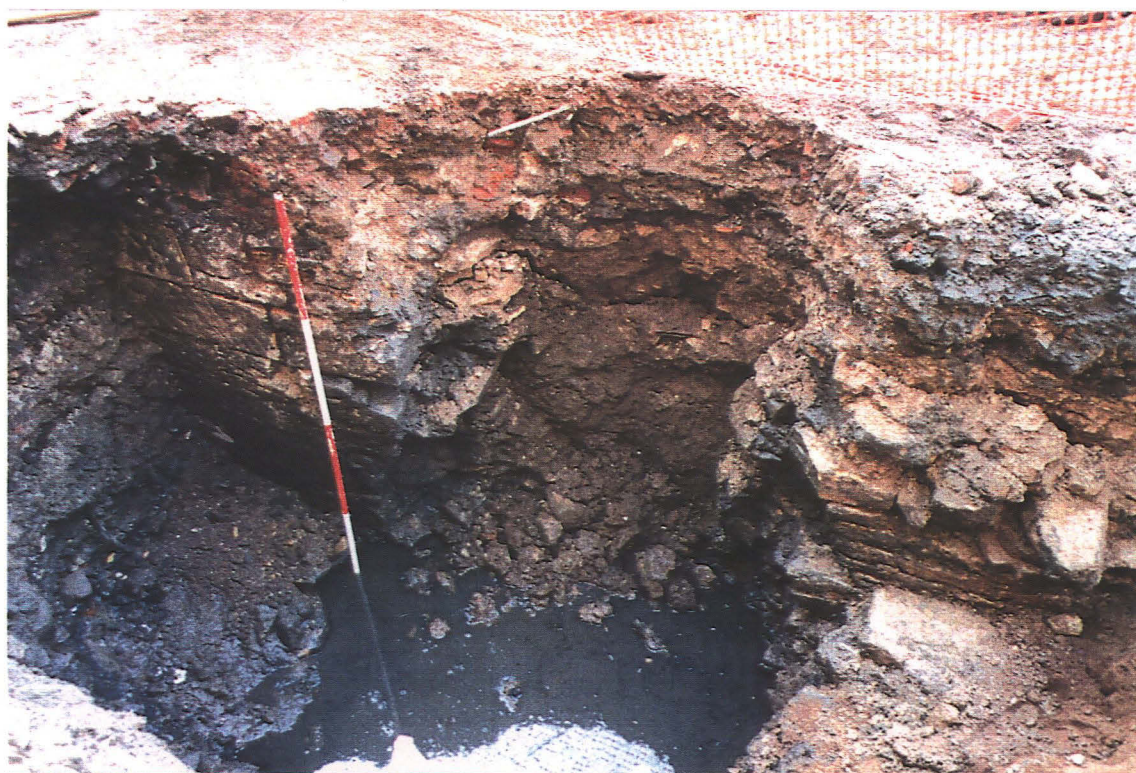
The wall was made from medium to large-sized limestone ashlar blocks (up to 1.0m in length), bonded with yellow sandy mortar. Its depth was at least 3.0m: its width greater than 70cm. At a point approximately 2.0m below the modern ground surface, distinctive black, organic, deposits were cut through by the machine, which appeared to butt against the face of the wall - it was assumed these deposits lay within the backfilled medieval Barditch, though detailed relationships between structure and soils could not be determined for safety reasons. It was noted, however, that the matrices on each side of the wall (where damaged by the mechanical excavator) were different: on the north side, there were extensive rubbish-type deposits (implying rapid accumulation), whereas, on the south side, cleaner brown soils predominated.

Photo. 10 View of stone wall [21], as exposed in contractors trench, looking south
