LINDSEY ARCHAEOLOGICAL SERVICES

Spridlington, Lincolnshire
Anglian Water Sewerage Pipeline across land
in and to the south of Spridlington

Archaeological Watching Brief

LAS Report N°. 772

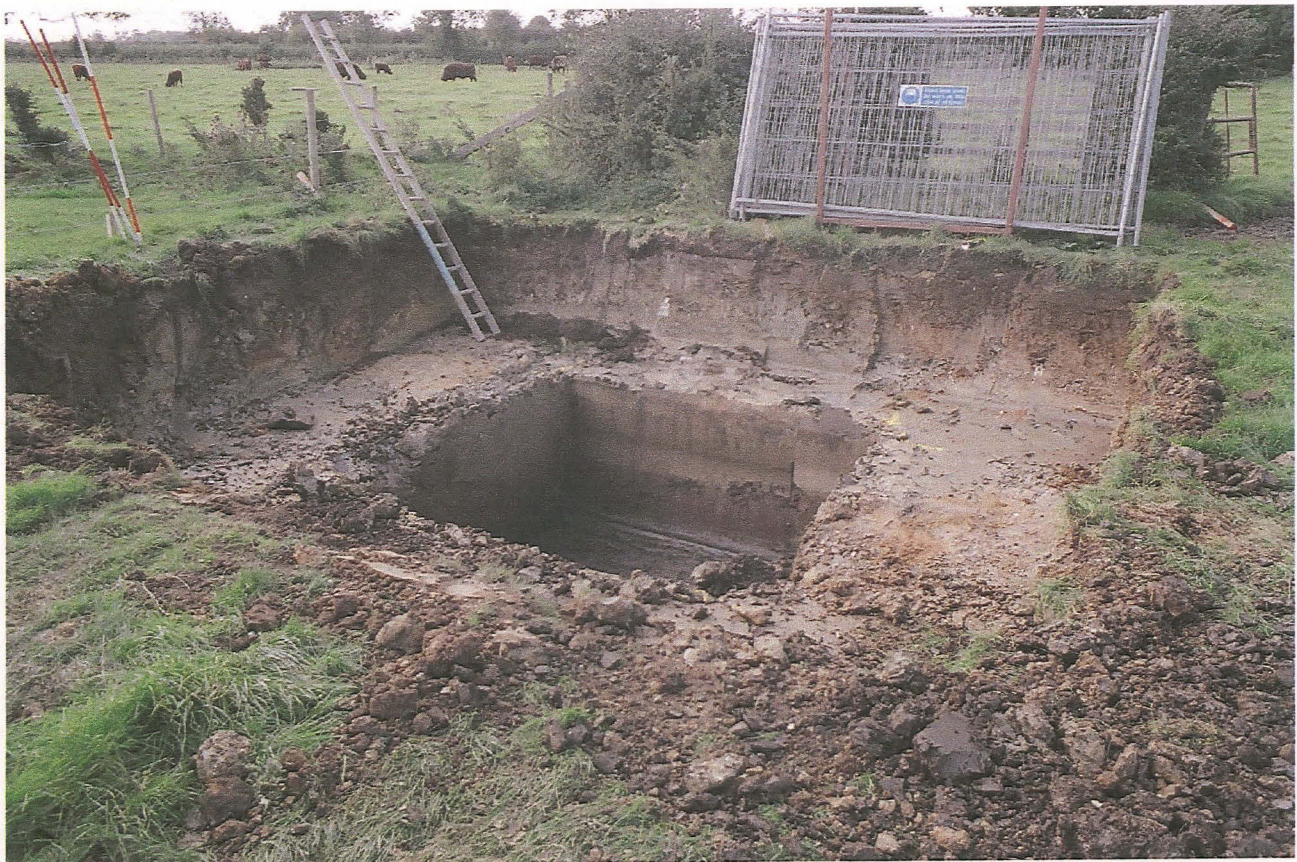
Pl. 2 Stratigraphy of manhole 6 with sectioned ridge and furrow to the south

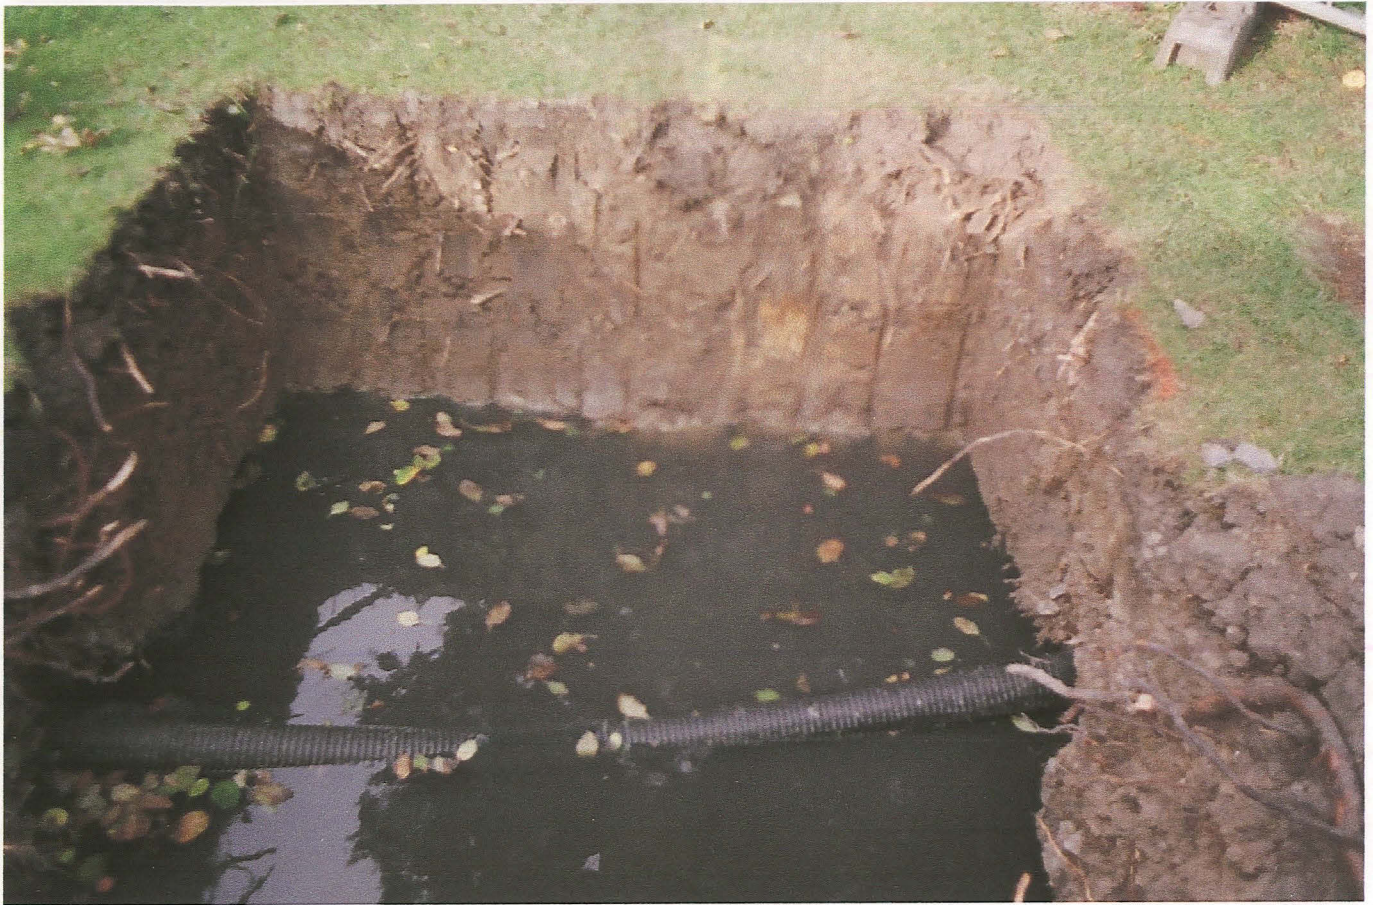
Pl. 3 Manhole 7 showing flooding from damaged land drains

In order to create a contractors compound, an area of agricultural land c.50m by 60m was stripped of topsoil to the south-west of Faldingworth Road. The topsoil was 0.20m in depth and consisted of a dark grey/brown silty clay. No discernable subsoil layer was noted beneath the topsoil, probably as a result of long term deep ploughing. The natural geology occurred at a depth of 0.20m below the present ground surface and was a mid orange brown silty sand and grey clay mix. No archaeological finds or features were noted during these works. A second area of similar dimensions and depth was stripped c.130m to the south prior to the creation of a small self contained pumping station (Fig. 2). The first phase of the Spridlington sewage installation scheme entailed the drilling a 0.20m diameter polytetrafluoroethylene (PTFE) sewage pipeline from the site of the pumping station across known medieval ridge and furrow fields to the east (Pl. 1). The manhole pits along this section of the pipeline were machine excavated 3.00m by 3.00m in plan. The topsoil and subsoil was removed to a depth of c.0.20m from the present ground surface to reveal a mid red/brown clay silt natural. The natural geology continued undisturbed beyond the final formation depth. No archaeological finds or features were observed in any of the 10 manhole pits (Pl. 3).

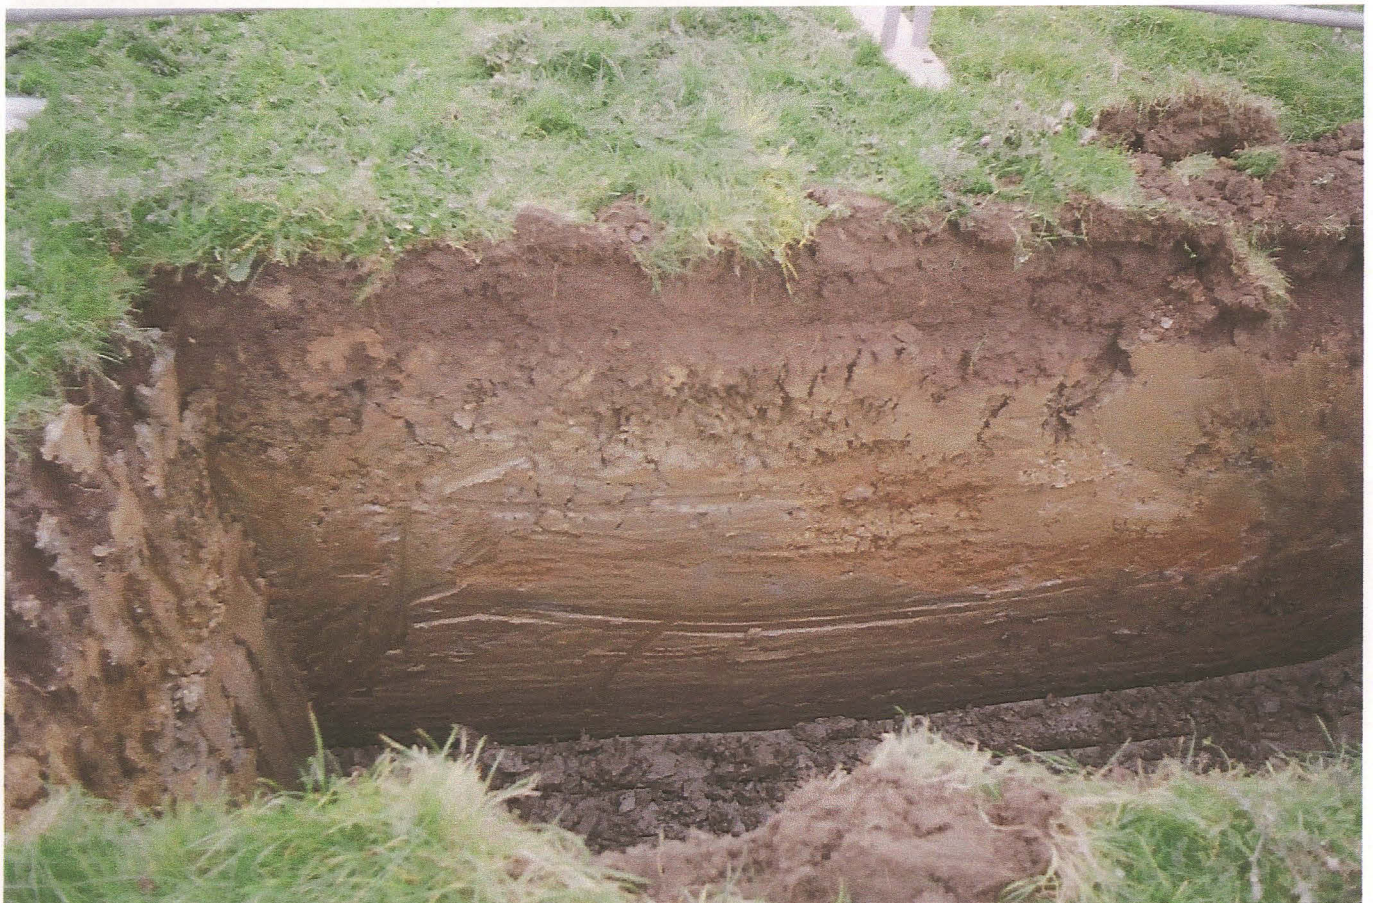
Fig 4. View showing the typical stratigraphy of the ridge and furrow field to te southwest of the village

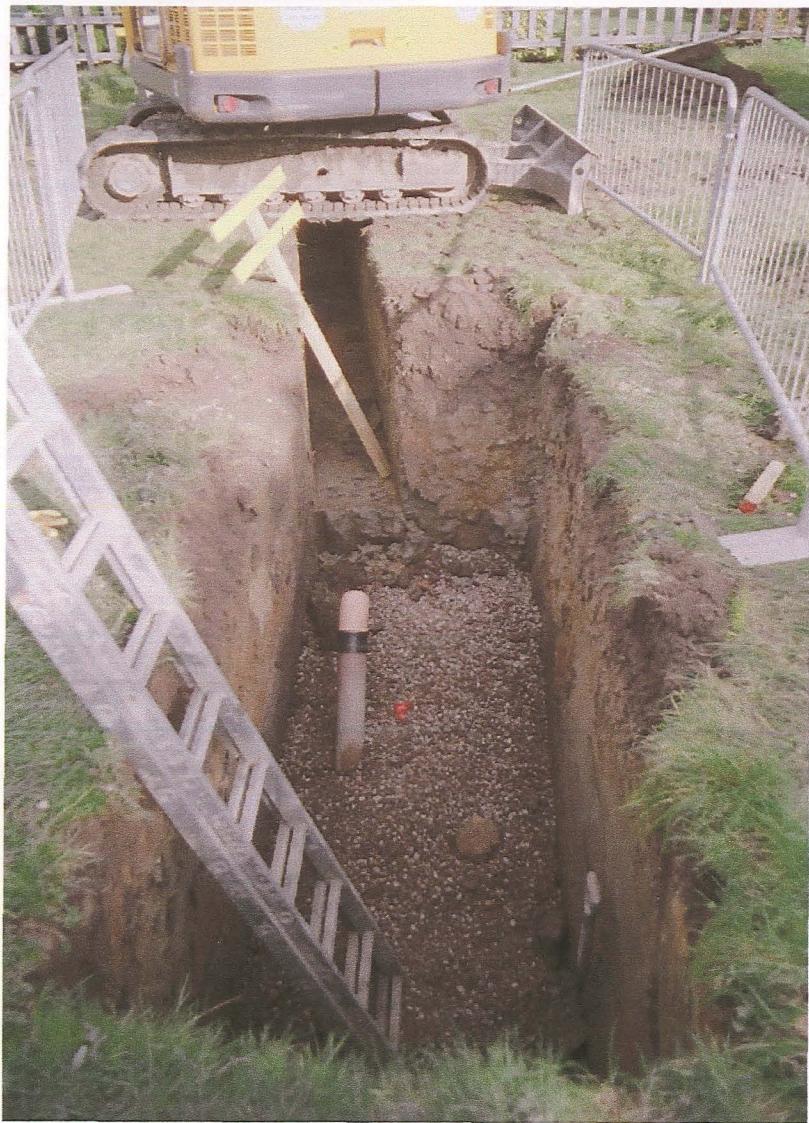
Fig 5. Partially completed pipe linkage leading from the main pipe to properties along the main street

The development consists of a new sewage pumping station and a c.500m long pipeline crossing roughly level arable farmland and continuing through the village of Spridlington with machine dug manholes and linkages along its length (Pl. 5). Upstanding earthworks forming a surviving medieval ridge and furrow farming system were noted in the pasture field crossed by the drilled pipeline.

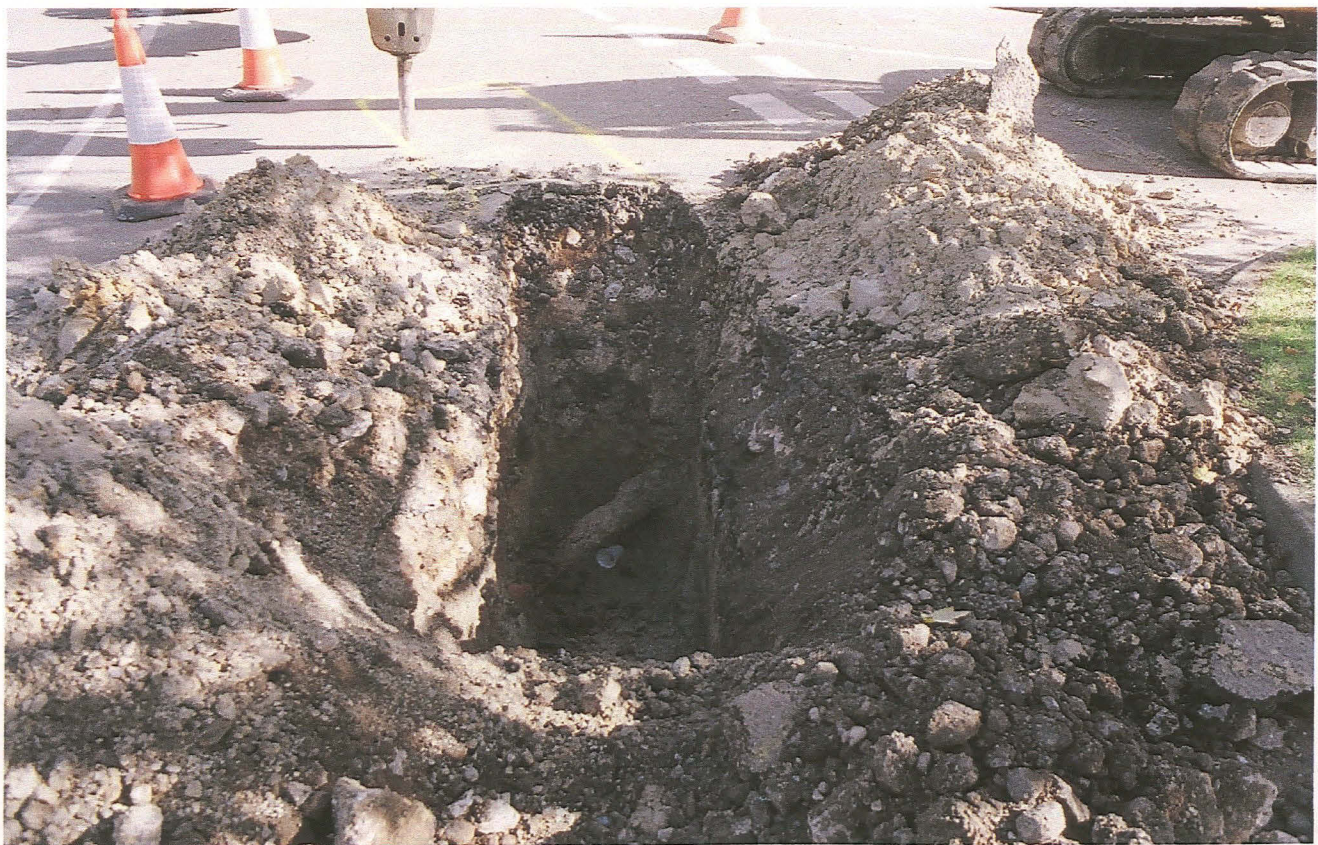
Fig 6. General view showing the deep nature of tarmac and road make-up along main street
