**BICKER FEN SUBSTATION, LINCOLNSHIRE**

**TEMPORARY STRUCTURES AND NEW TOWERS**

**ARCHAEOLOGICAL EVALUATION**

**NAA 05/52**

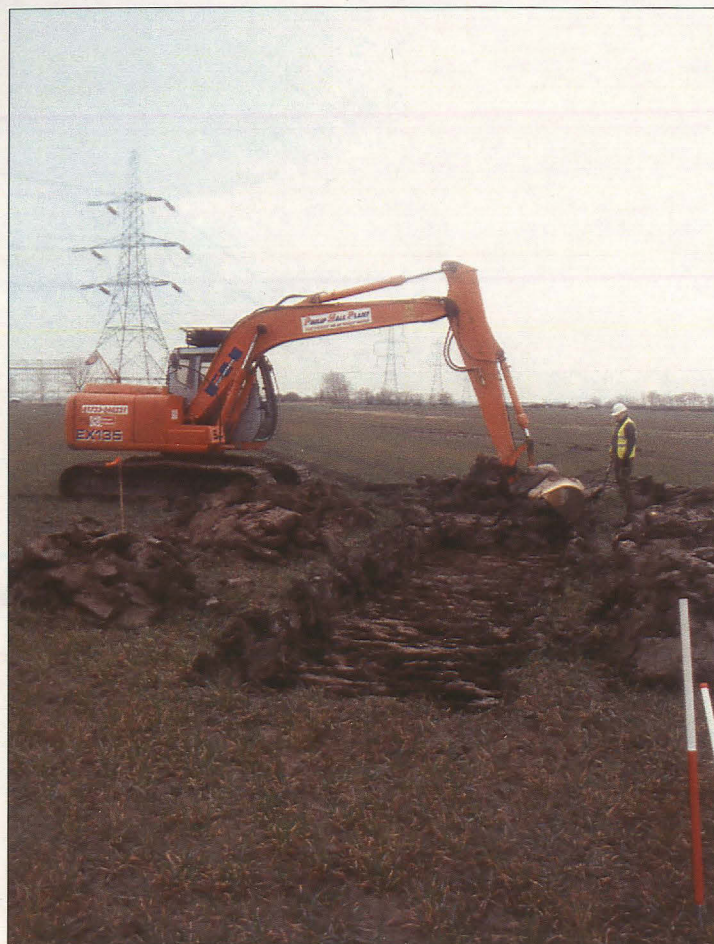
- 3.7 This comprised a north-east to south-west arm measuring 10.6m in length by 2m wide and a north-west to south-east arm measuring 10.5m in length, aligned along two sides of the proposed temporary tower (Plate 1). The trench was excavated to an approximate depth of 0.5m with 0.25m of waterlogged topsoil (200) overlying the natural heavy clay-silt subsoil. Again the upper 0.25m of subsoil (201) had been disturbed by deep ploughing, and there were the remains of land drains running approximately east to west (these were not excavated, but see paragraph 3.11 below, for examples). No features or deposits of archaeological interest were encountered. The trench began filling up with water as soon as it was excavated.

*Plate 1 Bicker Fen substation: trench 2 during excavation*

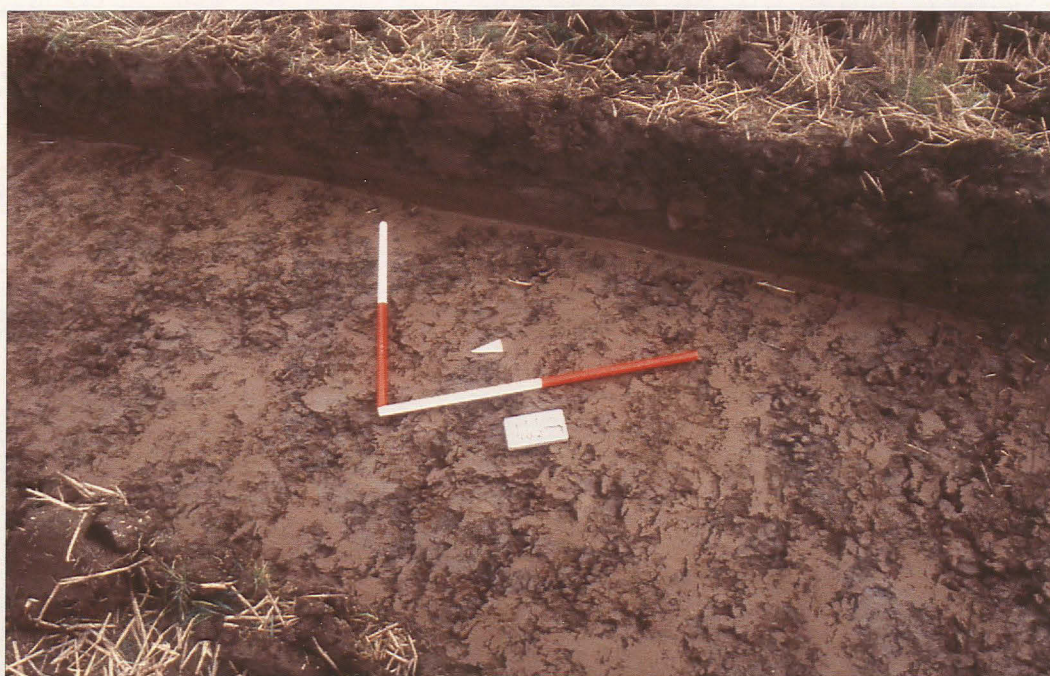
- 3.12 Cut through part of layer 504 and into layer 505 in the south-western half of the trench was a shallow u to v-shaped gully (502) running from the east (parallel to the field boundaries) and curving southwards at its western end. Approximately 2m of gully were visible, up to 0.15m deep and 0.3m wide (Figure 4, Plate 2). The gully was filled with a homogenous grey-brown silt containing pieces of burnt straw. The existence of burnt straw, the shape in plan and the fact that the gully cut through part of the disturbed subsoil indicates that this was the turning point for a subsoil plough scar, possibly using a 'duck's foot' plough.

*Plate 2 Bicker Fen substation: trench 5 showing feature 502*
