**ARCHAEOLOGICAL INVESTIGATIONS
AT TATTERSHALL CASTLE,
TATTERSHALL,
LINCOLNSHIRE
(TTC04)**

Work Undertaken For
The National Trust

January 2005

A.P.S. Report No. 107/04

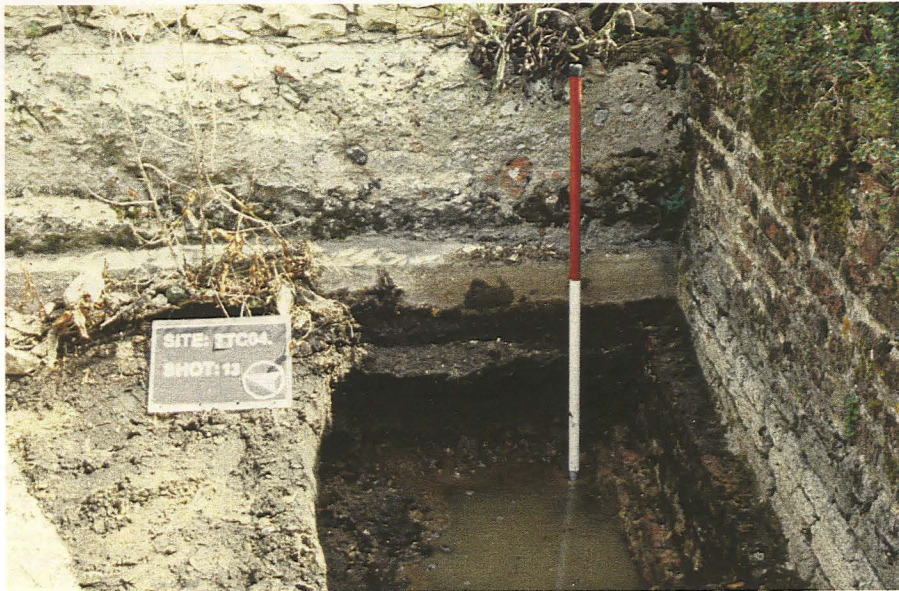
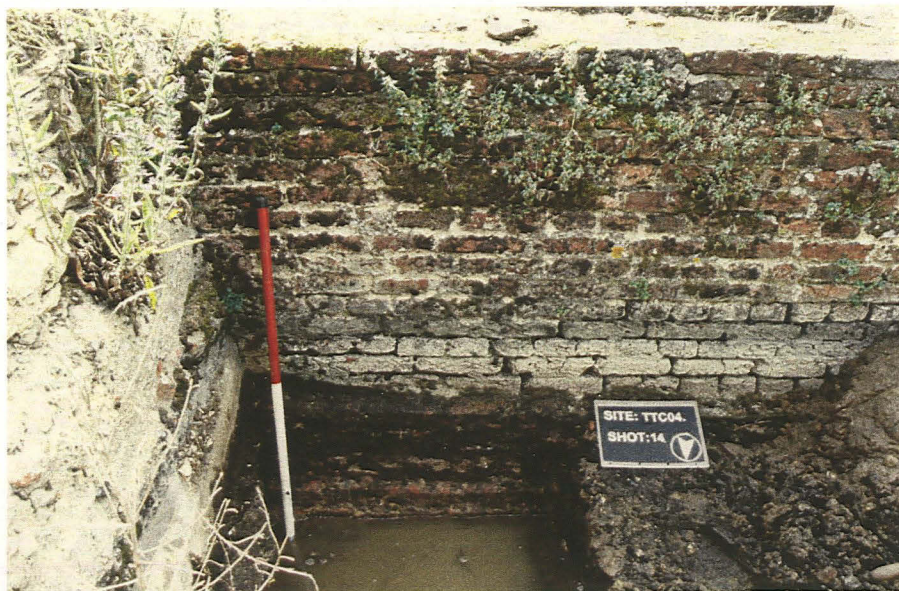
Plate 8 Test Pit 5,
looking east.

Plate 9 Test Pit 5,
looking south.

This test pit was between the two kitchen range structures. The main moat retaining wall forming the east side of the Test Pit was constructed of concrete and limestone blocks (114, 142, 143, 144, 145, 146).

Along the south side of the Test Pit was a mortared brick wall (113) that extended to the depth of excavation (Figs; 6 and 9; Plates 8 and 9).

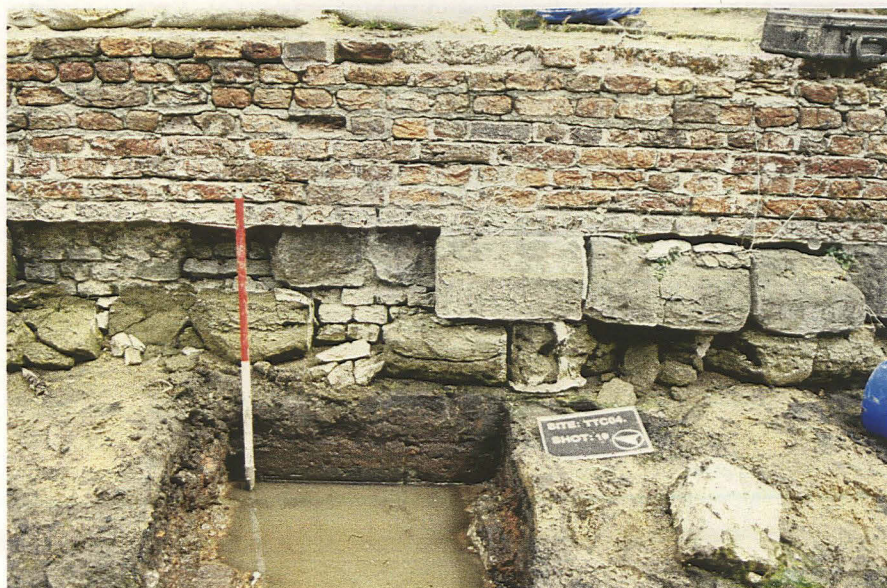
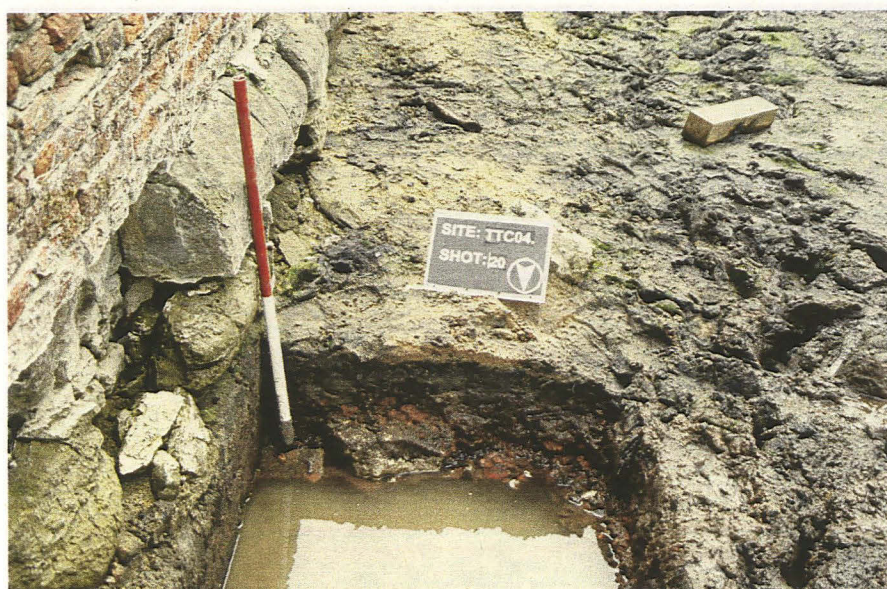
Plate 10 Test Pit 6,
looking east.

Plate 11 Test Pit 6,
looking south.

Providing the east side of the Test Pit was a wall. The upper part of this, above the Test Pit, is mortared brick. This brick elevation rests on an intermittent facing of concreted stone (124), the upper blocks chamfered and approximately 0.30m x 0.50m. This part of the wall displays significantly more water damage than other sections, probably due to being in the zone of alternate wetting and drying (Figs. 6 and 10; Plates 10 and 11). Behind the stone

face of the wall brickwork was visible.
