**60 Boston Road, Horncastle, Lincs.  
Archaeological Watching Brief**

**Site Code: HCBR 05**

**LAS Report No. 806**

**March 2005**

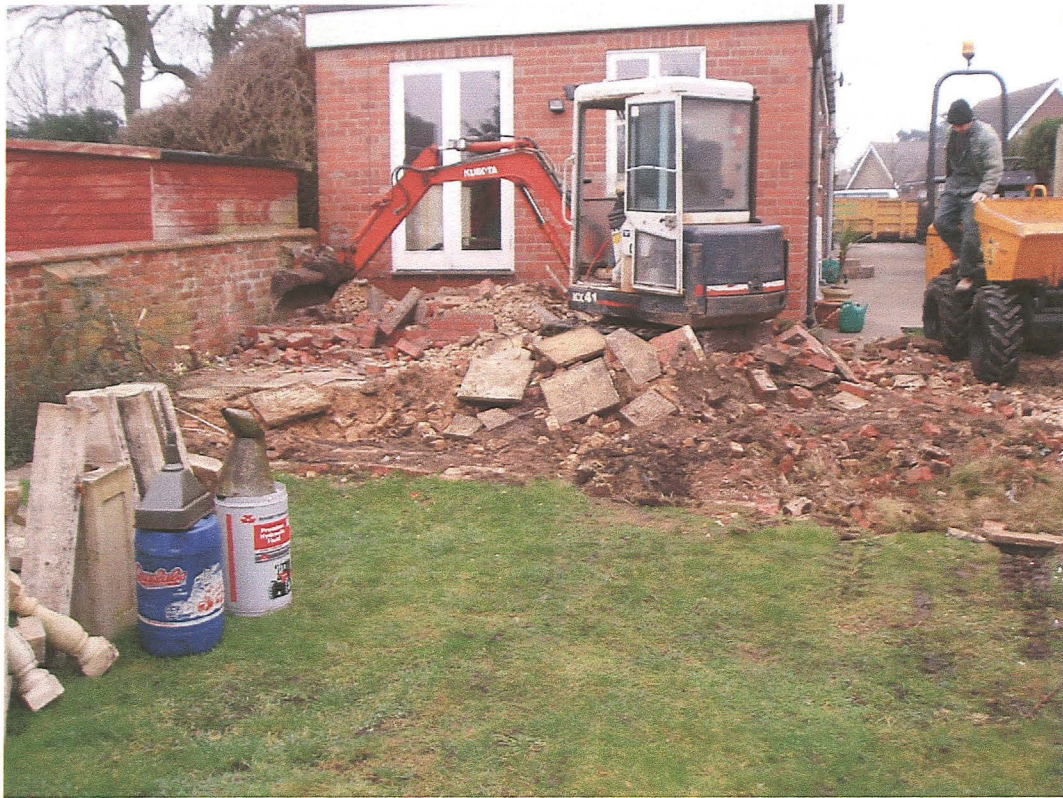
PI. 1 View of the rear of 60 Boston Road Horncastle during the removal of the patio, looking east.

Groundworks on the site began with the removal of a modern red brick and yellow concrete flagstone patio which occupied the area to the south of the previous extension which was to be developed into the living room extension (1). A bedding layer for the patio was encountered after the removal of the bricks and flagstones which consisted a layer, approximately 0.14m in depth, of a mid brown silt sand with modern bricks and concrete (2). The area for the living room extension was lowered to this horizon and footings were subsequently excavated.

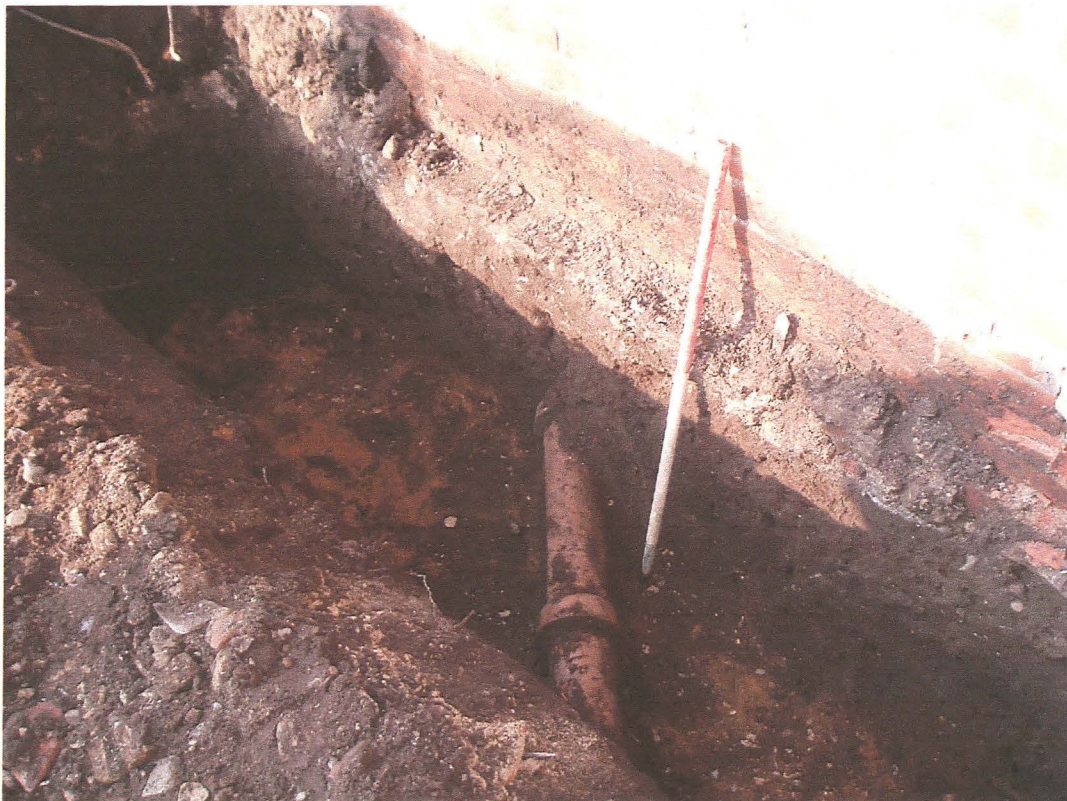
PI. 2 View of northern footing excavated to the natural sandy gravel (8), showing foundation of party wall, looking north (scale 1m).

The most northerly footing of the development was excavated first. The foundation trench was laid out up against the boundary wall to the north of the property. It was excavated to a depth of 1.18m below original patio level exposing the foundation of the previous extension at its easterly extent and the boundary wall along its northern extent. Beneath both the boundary and extension walls a mass of dark grey brown silt sand topsoil with occasional quartz pebbles (13) (0.46m in depth) which lay above a similar deposit with slightly more frequent quartz pebbles (14) which produced two sherds of Roman pottery (see **Appendix 2**) (0.16m in depth). A live salt glazed waste pipe (10) was encountered roughly half way across the trench which ran northwest-south east towards a manhole on the south westerly corner of the existing building. No clear cut for the laying of the pipe was visible, if 13 had been deposited before the waste pipe it had been backfilled with the same material. Beneath 13 was a natural yellow sandy gravel (8) which was the depth at which the foundations were laid.

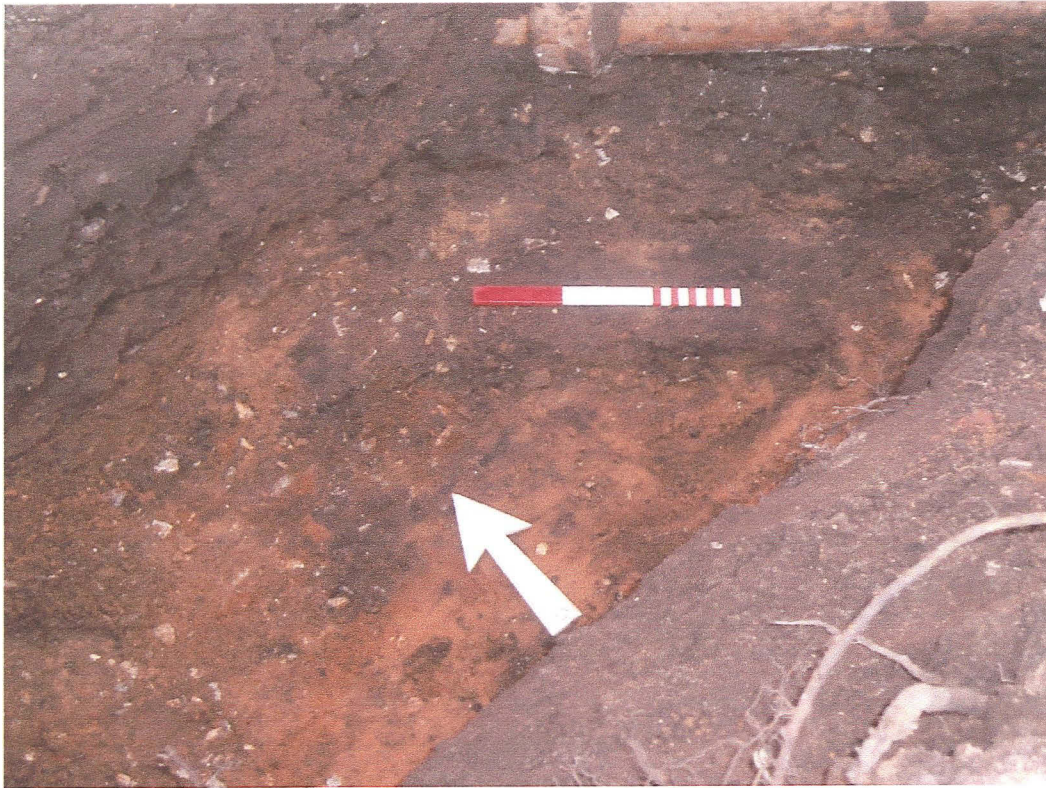
Pl. 3 (above) Features 4 and 5, looking north east (scale 0.30m).

At the base of the trench cut into the natural yellow sandy gravel (8) were two possible post holes. Post hole 4 was an irregular oval 0.34m at its greatest width and 0.04m deep it contained a mid brown very slightly silty sand with 10% angular quartz pebbles (5). The second feature 6 had diffuse edges and contained a mid brown very slightly silty sand with in excess of 20% angular quartz pebbles (7). The relationship between these two features was unclear, feature 6 was almost definitely the result of rooting and the irregular sides and base of feature 4 would also suggest that it had been affected by

plant activity. Neither feature produced any finds.

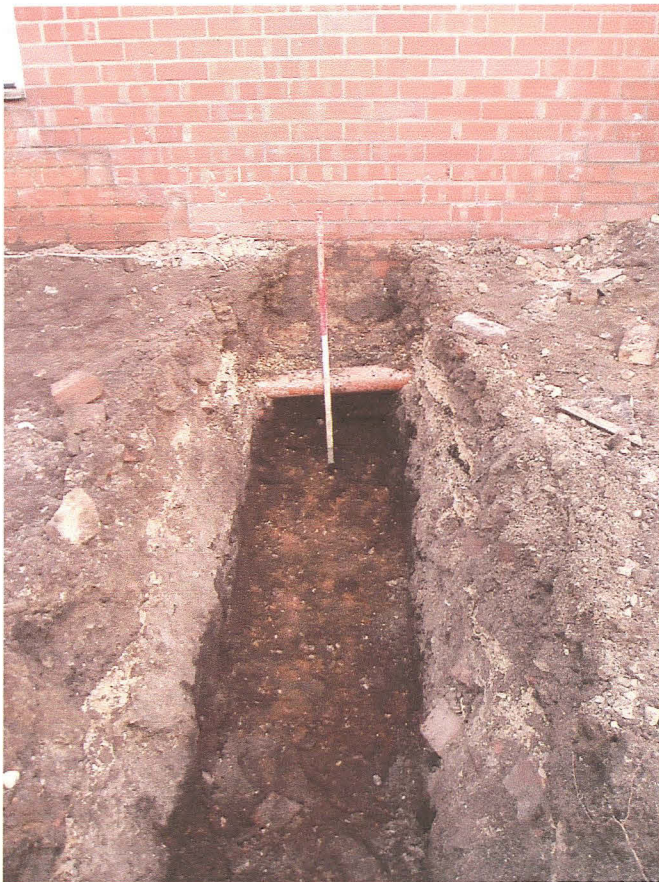
Pl. 4 (left) View of central footing, looking east (scale 1m).

The second foundation trench monitored was excavated eastwards from the existing extension as a support for the structure. The salt glazed drain (10) was also encountered but a narrow cut (12) excavated up against the foundation of the existing extension was evident cutting a make up layer of modern concrete and mortar fragments (3). Cut 12 contained the salt glazed pipe (10), a bedding of pea gravel (11) and a light brown silty sand with bricks and mortar (9).
