**1 Hall Lane, Branston, Lincs
Archaeological Building Recording**

Site Code: HLB 05

**LAS Report No: 812
March 2005**

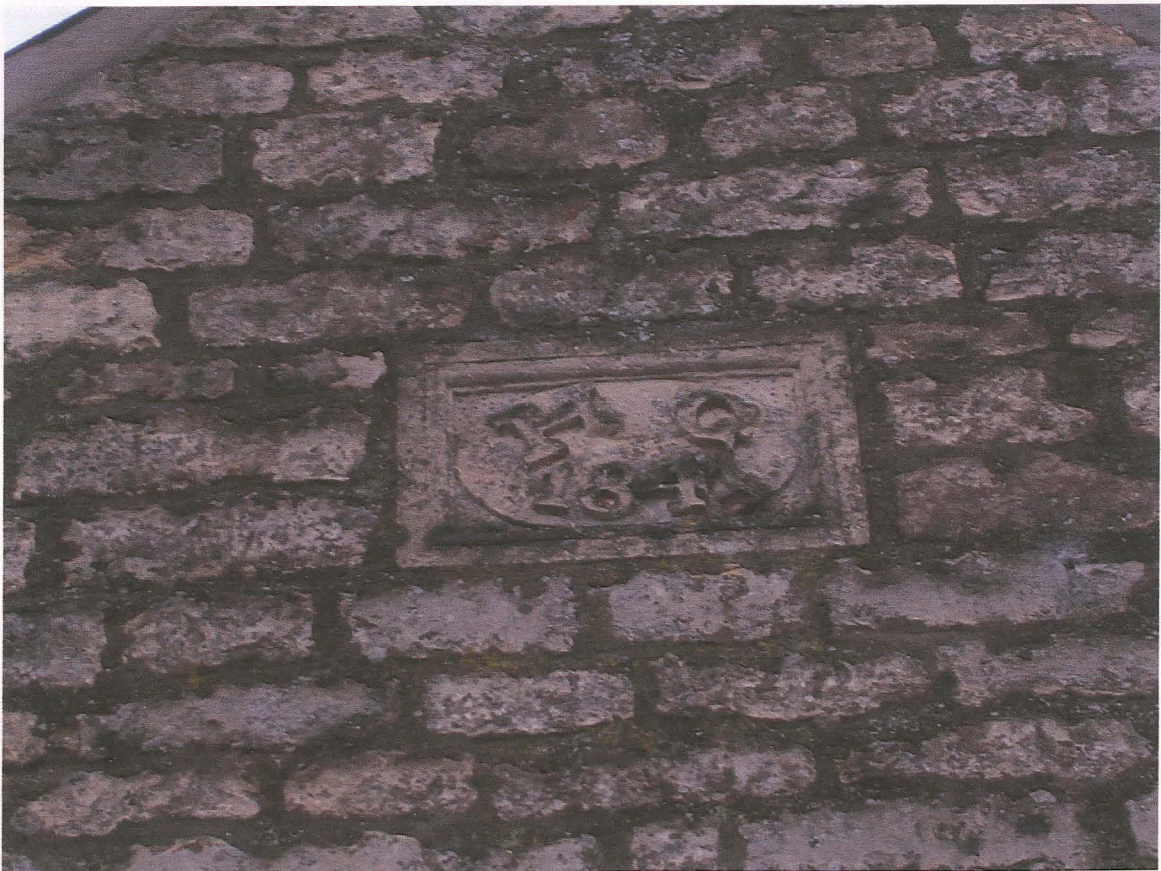
The outbuilding was located to the south of an 'L' shaped two and a half storey stone building, now known as Summerdale (Fig. 2, Pl. 1). Summerdale has been extended to the south, west and within the angle of the 'L' (Pls. 2, 3 and 4). Evidence of other buildings associated with the farm complex can still be seen. To the west is a former hayloft which has a date stone inscribed with 1841 on its northern elevation (Pls. 5 and 6) and a converted barn (Pl. 7).

Pl 6 Date stone (1841) on north gable end of hayloft

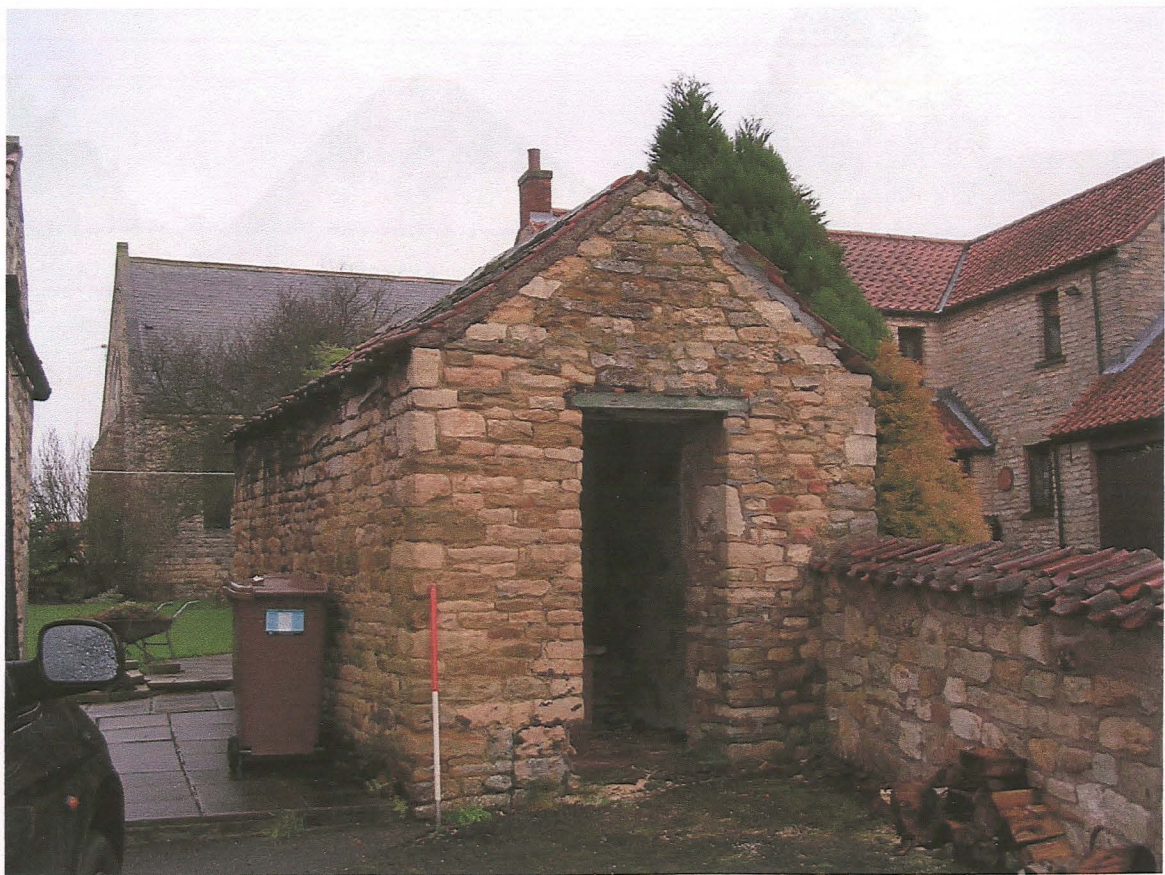
The outbuilding is a single-storey, two-cell structure constructed in roughly dressed limestone with a pantile roof (Fig. 3, Pls. 8 and 9). It measures 5.40m long and 2.70m wide. It stands 1.90m to eaves height and 2.80m to ridge height. Bonding is in a cream lime mortar similar to the colour of the stonework. The limestone courses were of varying heights and the wall thickness was c.0.50m. Quoins were evident but appear not to be dressed.

The west gable showed evidence that the roof pitch was originally steeper, and had been altered and raised, presumably when re-roofed with the pantiles. The east gable had been completely rebuilt, above an inserted door.

The west cell was 2.29m long, 1.67m wide and 2.12m high, with a lath and plaster ceiling 9" red quarry tiles on the floor. Its entrance was c.1m wide and appeared to have an altered, or possibly repaired, western jamb (Pl. 8). There was also evidence of repair above the lintel. Inside there was a

Pl. 8 The outbuilding north and west elevations, looking east. Note raised gable and rebuilding above door lintel. Scale 1m

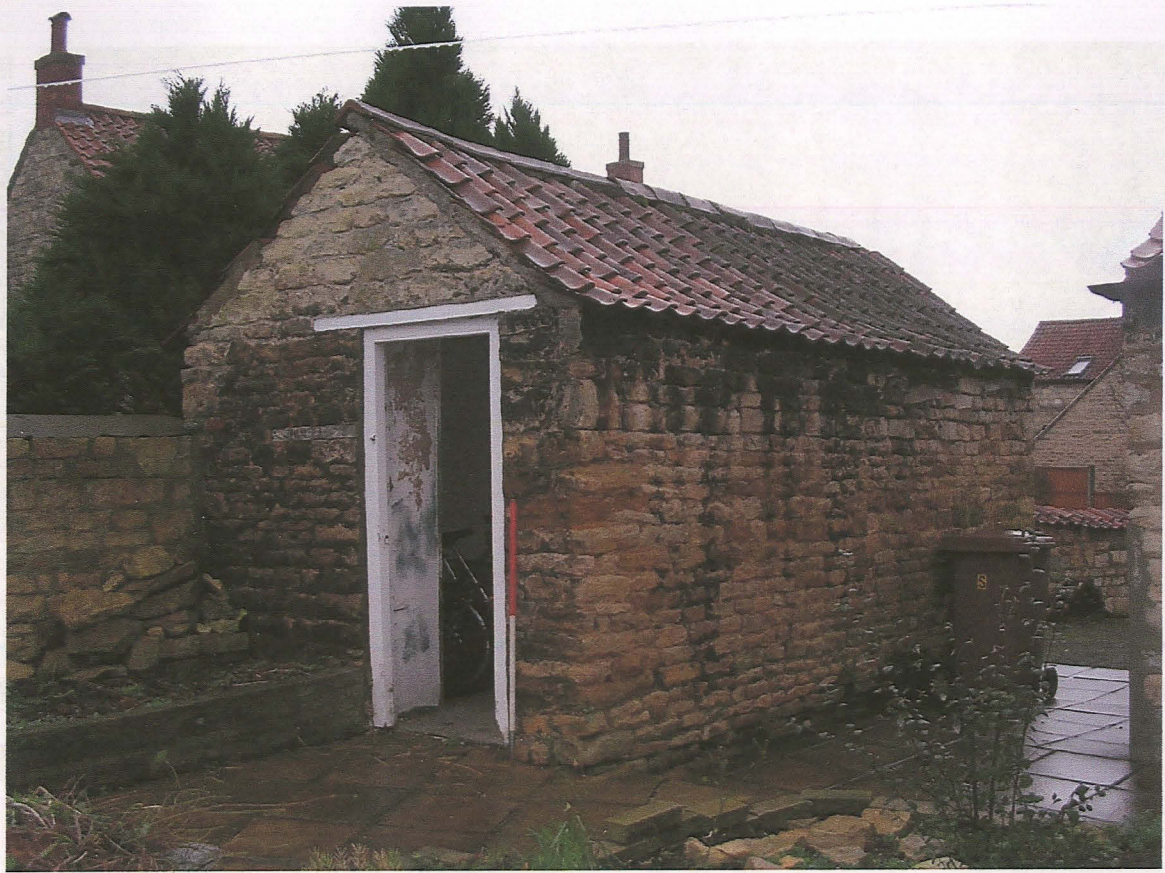
The eastern cell had an inserted door on its east wall and modern plastering which hid any earlier features which might have been present (Pl. 15).

Pl. 9 The outbuilding, inserted door and rebuilt gable in east elevation, looking south west. Scale 1m

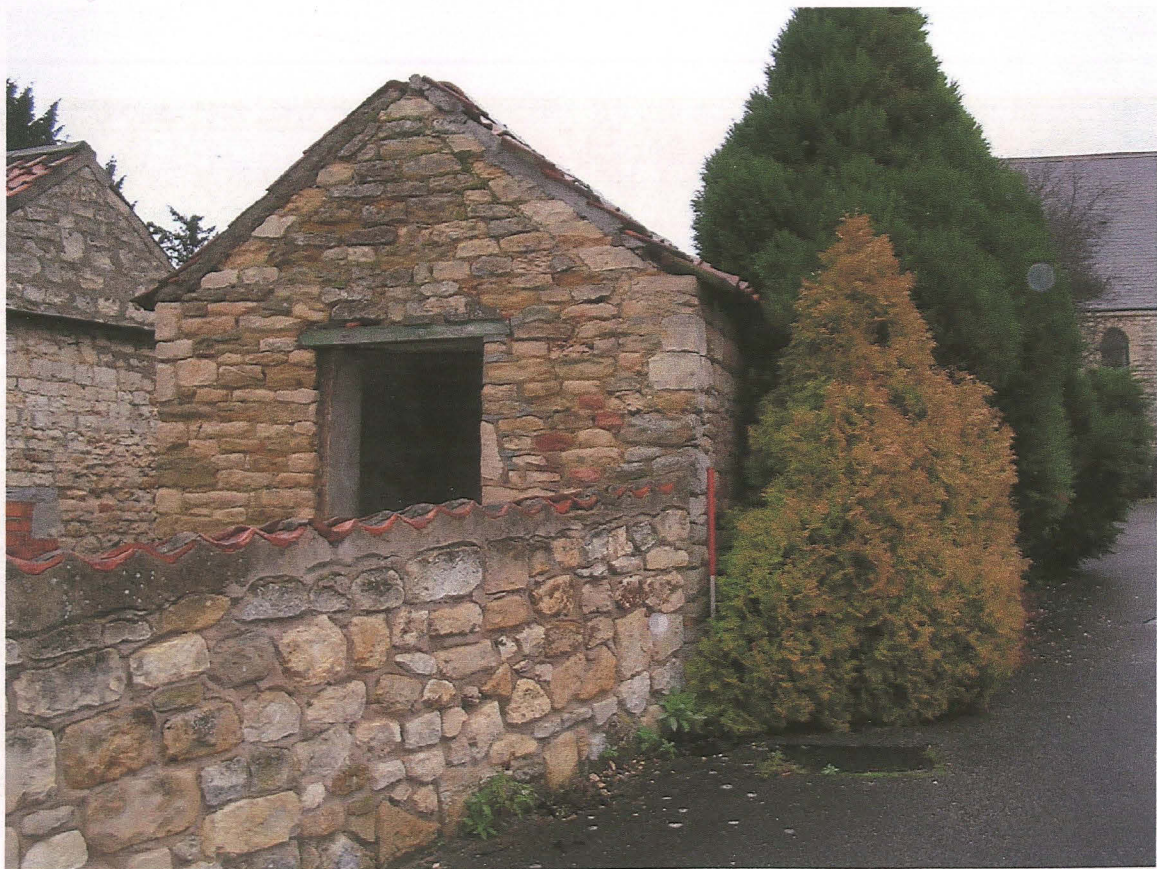
The south wall has been incorporated into the present southern boundary wall (Pl. 10), which separates Summerdale from a modern house to its south. The boundary wall butts the south-west and south-east corners of the outbuilding. A timber lintel was seen in the south wall 0.48m from the southwest corner of the building. It supported an opening 0.75m high and 0.80m wide, now blocked with stone (Pls 11, 12). There was no sign of the opening on the internal elevation which had been plastered over.

Pl. 10 Outbuilding in relation to later boundary wall which butts southwest corner of building. Looking east. Scale 1m

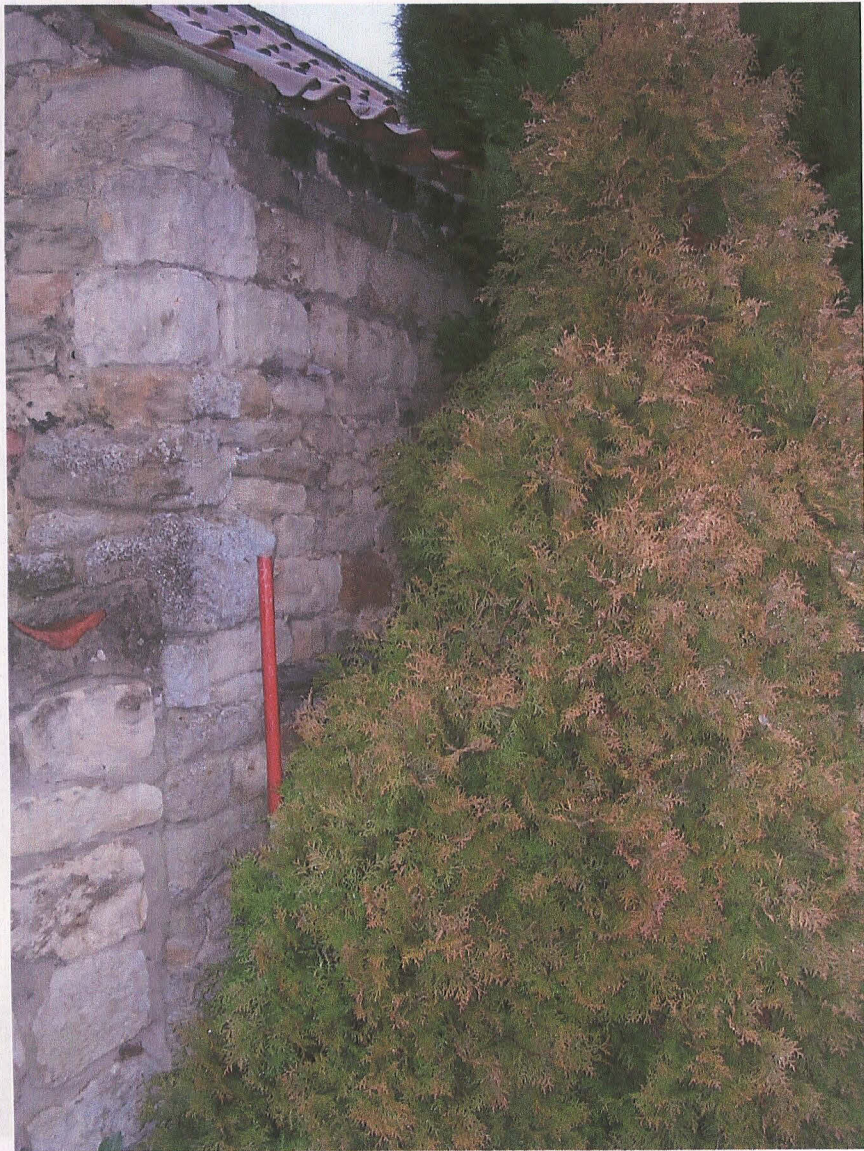
The presence of a very low opening on the south elevation of the structure suggests the outbuilding may have originally been used as a pig sty. The west door to the building may have been raised when the function of the building altered. The east door is a modern insertion, presumably contemporary with the division of the building into two cells.

Pl. 11 Blocked entrance in south elevation, to right of 1m scale.

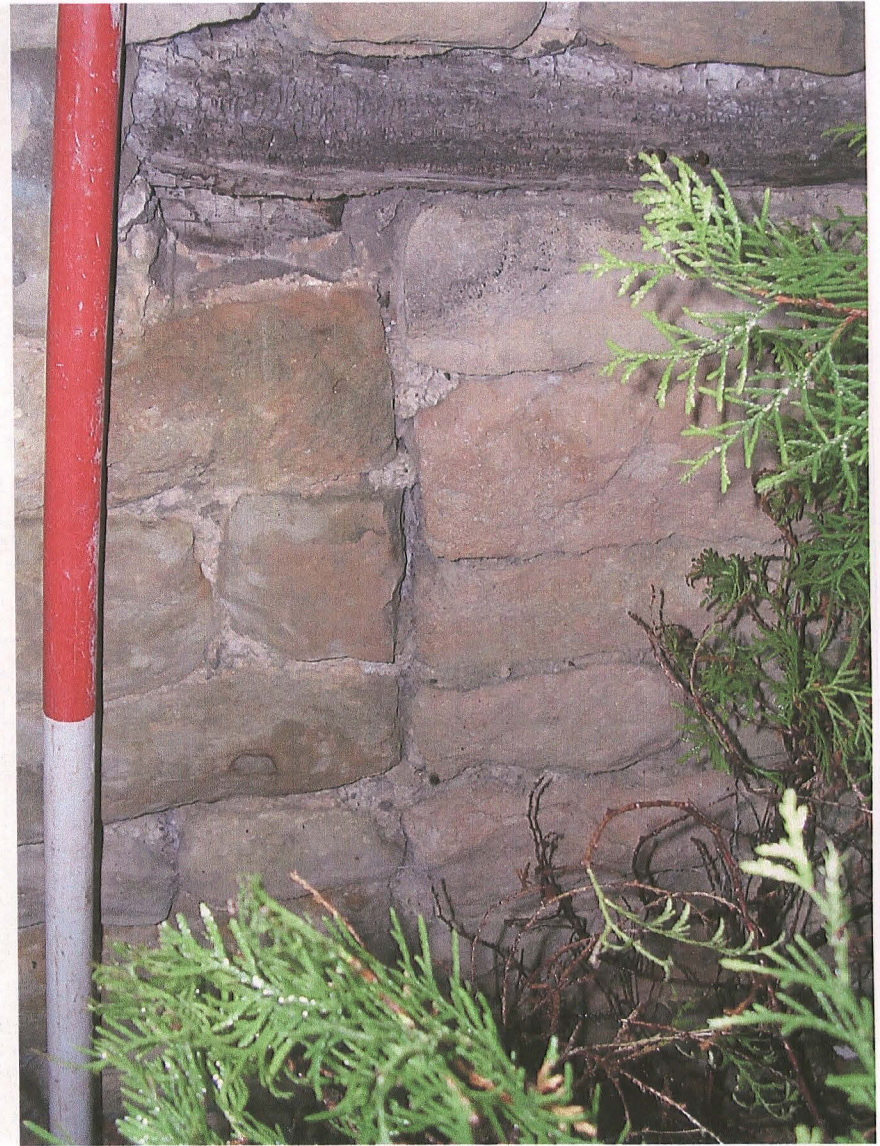
Pl. 12 Detail showing blocking below wood lintel. Scale 1m

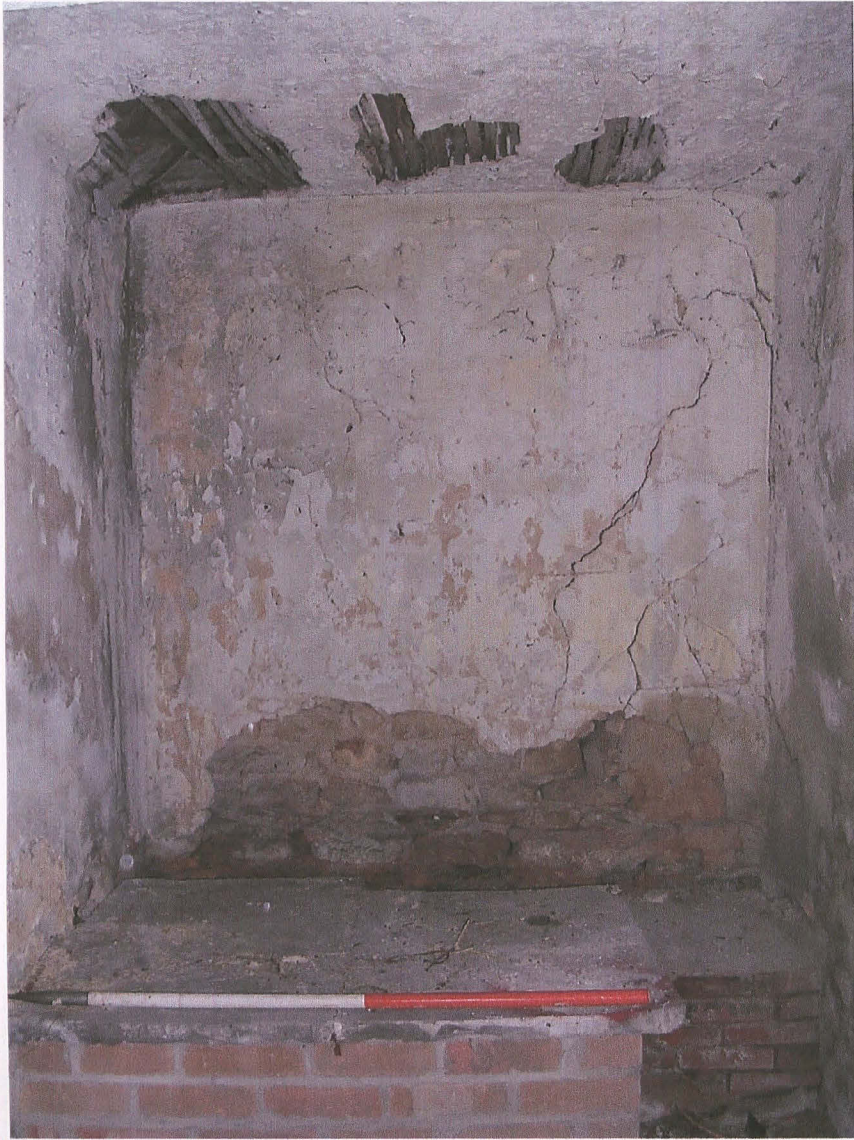
modern brick bench, 0.40m high and 0.54m wide, along the east wall. Built against the brick bench was a brick plinth with a stone slab surface, 0.58m high and 1.22m x 0.98m, probably built in the 1950s or later which had originally supported an oil storage tank for the central heating system (Pl. 13). At the front of the plinth the brickwork was half a brick thick.

Pl. 13 Interior of west half of outbuilding, looking east. Plinth for oil tank in front of brick bench. Scale 1m

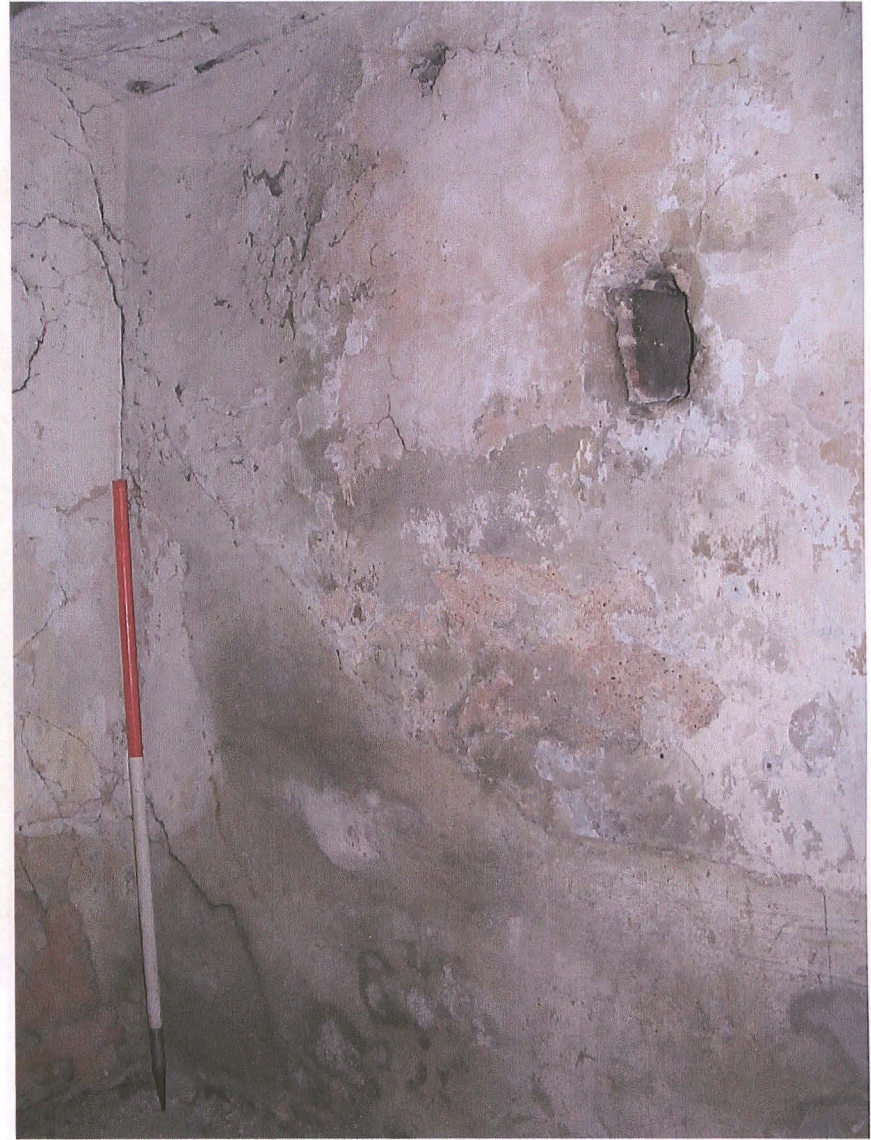
A possible vent, 0.19m high and 0.16m wide, was located 1.60m above the ground floor, c.1.10m east of the south-west corner of the outbuilding (Pl. 14).

Pl. 14 South wall internal elevation showing vent. Scale 1m

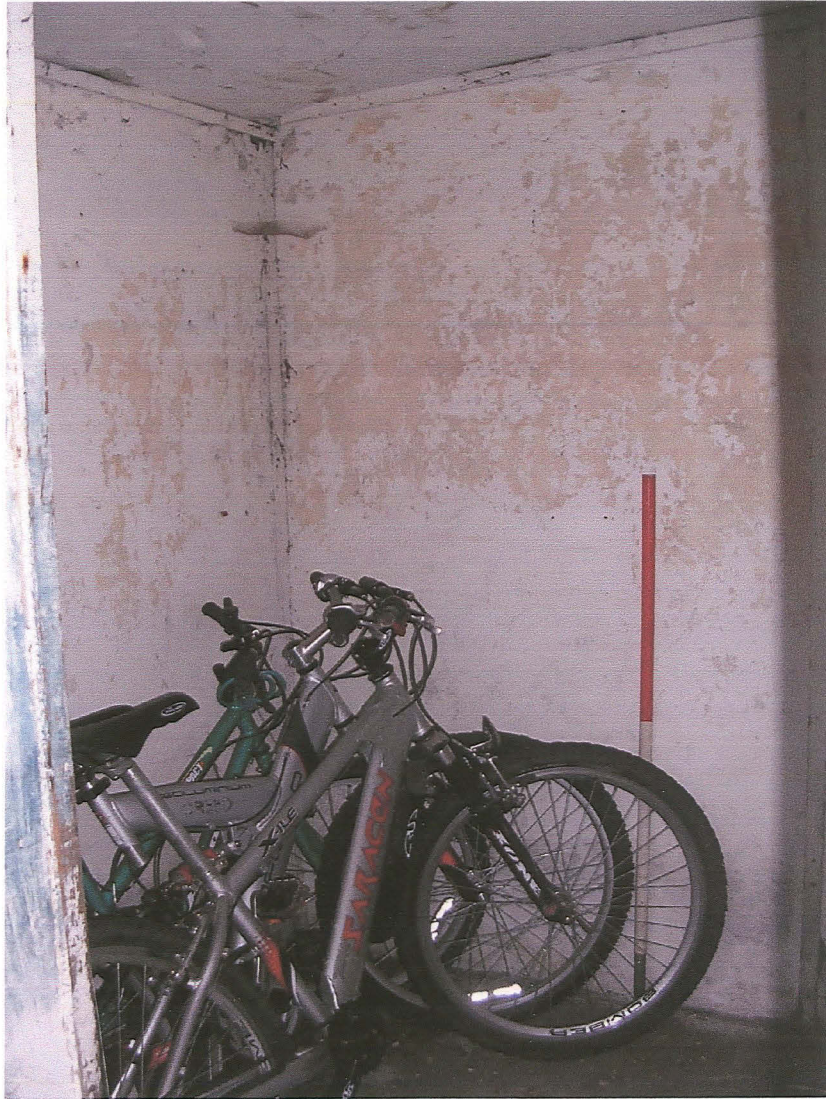
Pl. 15 Internal view of east cell, looking west. Scale 1m.
