**Thorngate House, Broadgate, Lincoln
Archaeological Evaluation**

**NGR: SK 97761 71181
LCNCC Accn No.: LTG 02
Site Code: 2002.451**

**LAS Report No. 626
November 2002**

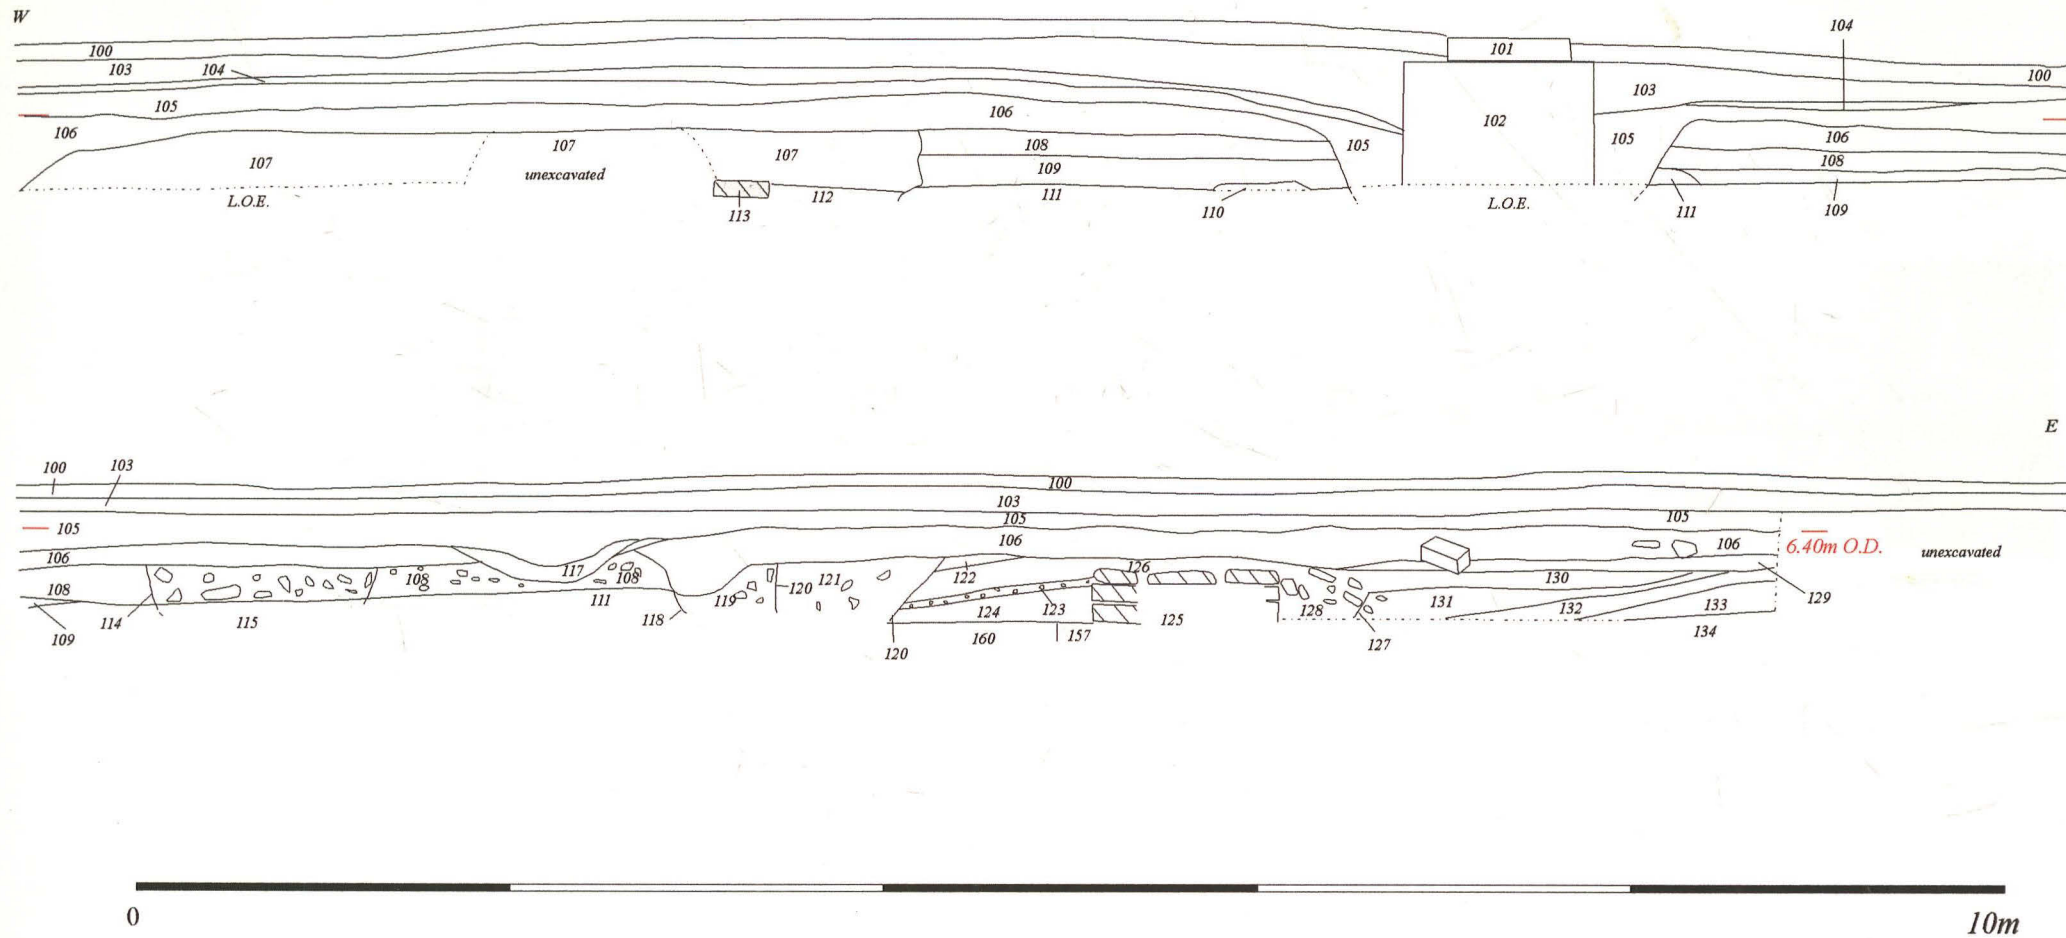
Figure 3. Thorngate House, Lincoln. North Section.

Results (Figs 2 and 3)

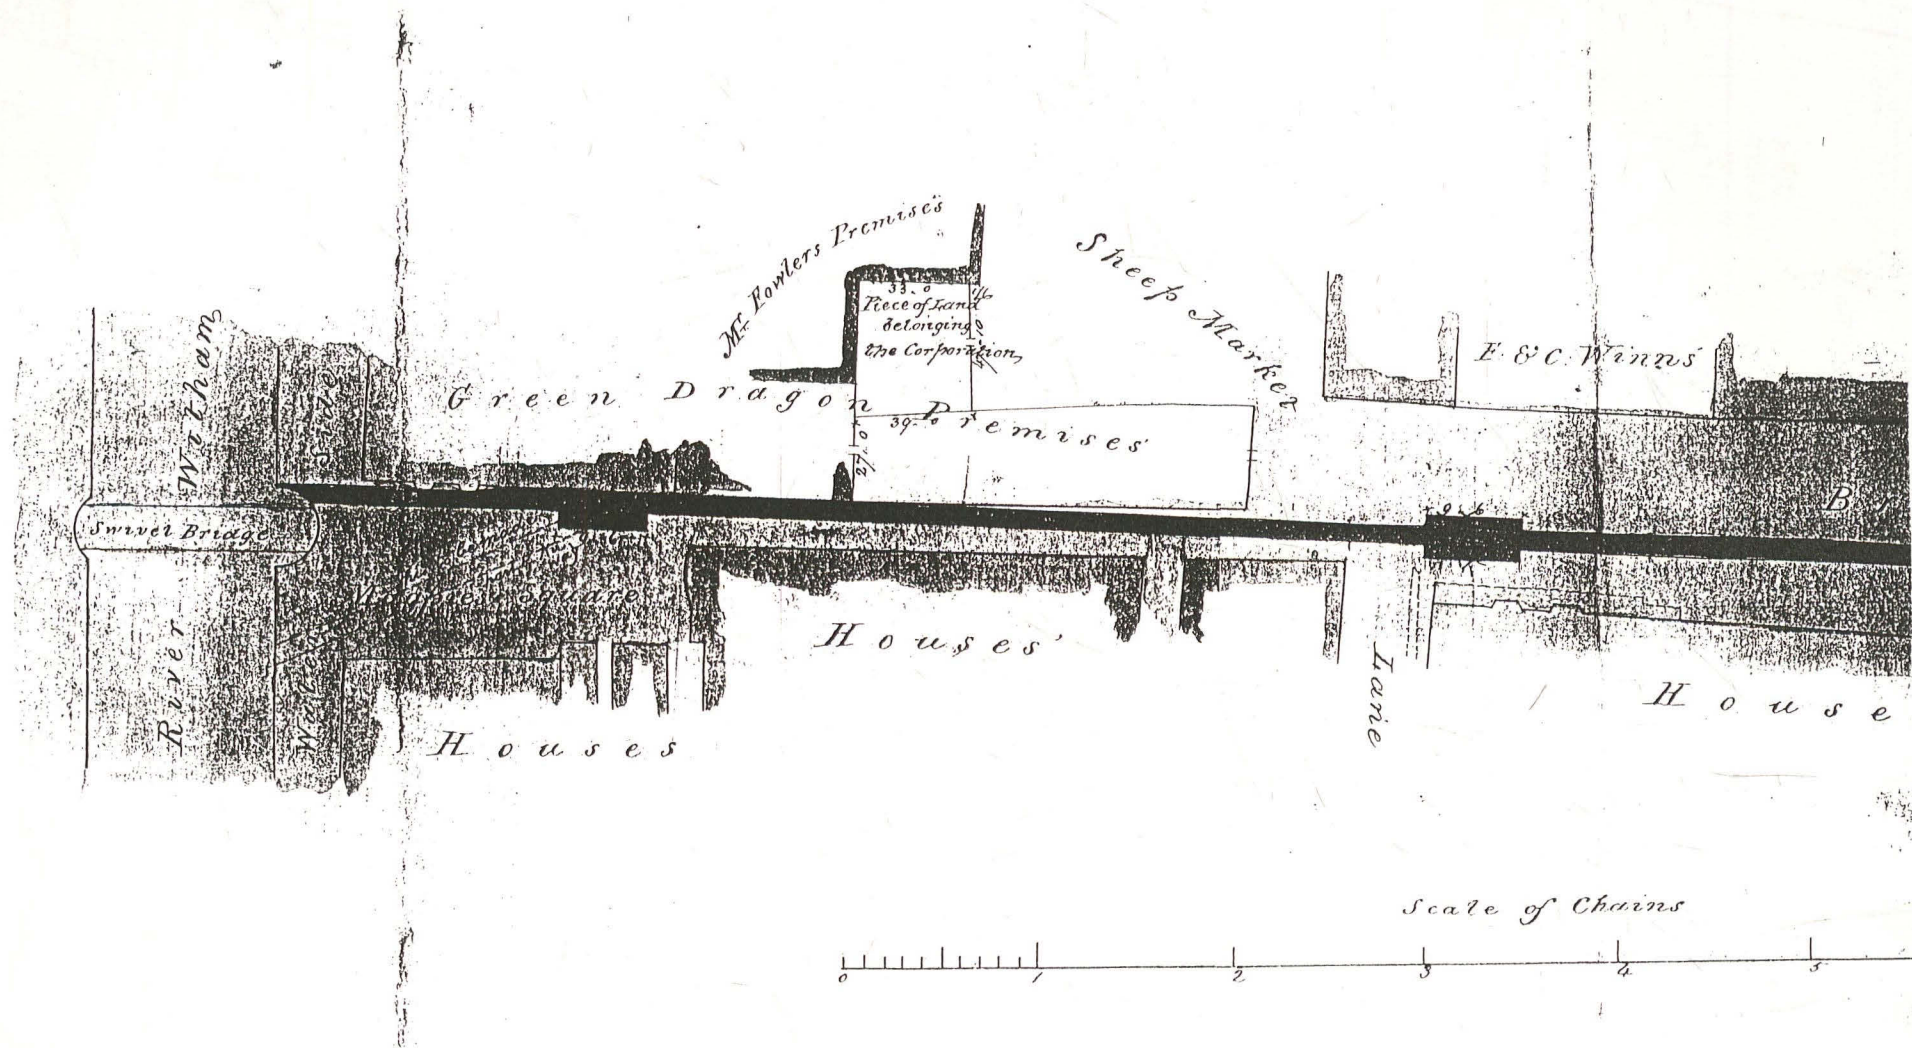
Fig. 4 Part of a plan for a proposed tunnel to be built in Broadgate, Lincoln. J.S. Padley
 May 24th 1826. Lincoln City Library, ref 429.

could have been earlier. The northern part of the Thorngate House site lay within the Sheep Market, recorded by Padley in 1826 on his plan for a proposed 'tunnel' (sewer) to run along Broadgate down to the river (Fig. 4, Lincoln City Library, ref. 429). This may have been the reason for clearance of the site in the later medieval/early post-medieval period.

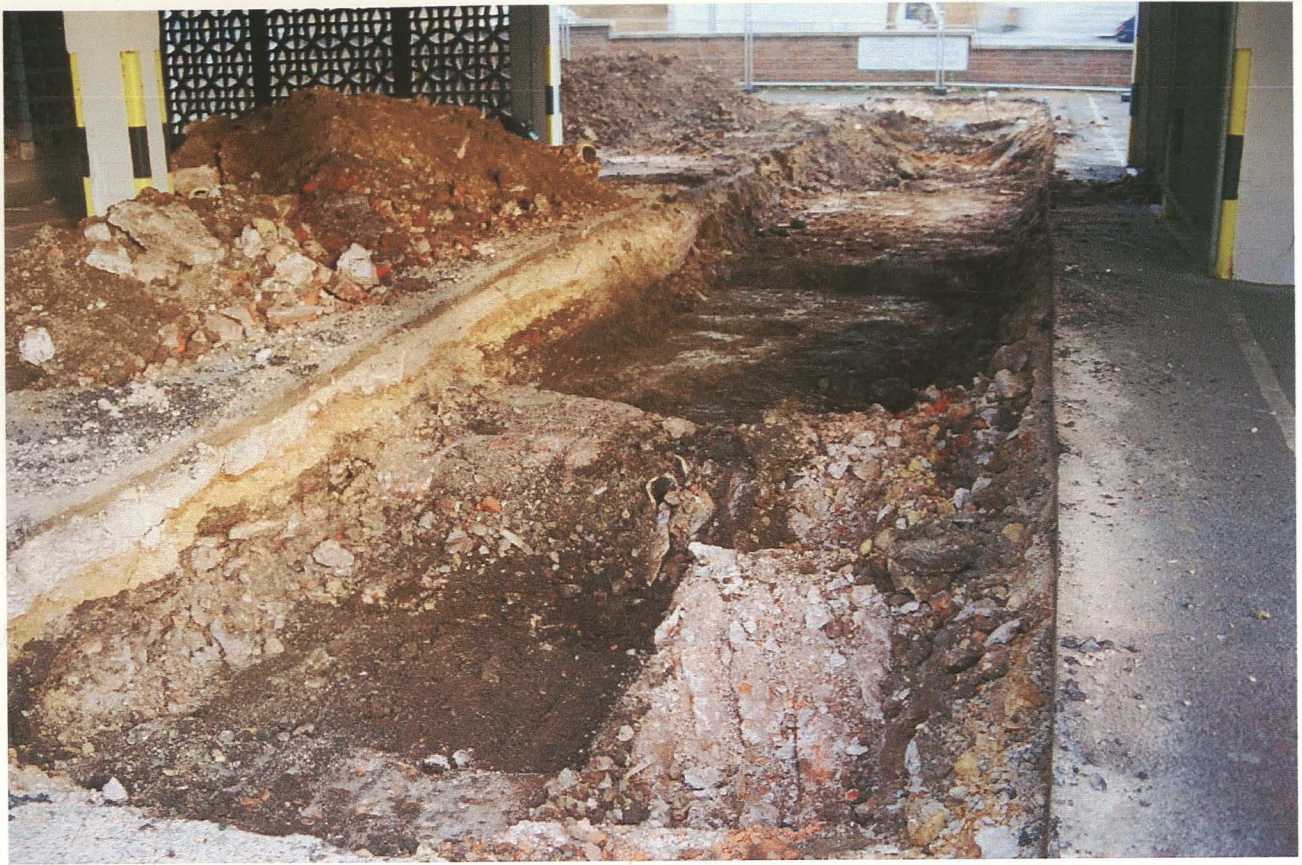
Pl. 1 General view of trench looking east, before cleaning, with concrete 107 in foreground. Note broken sewer pipe in centre which originally ran along the length of the trench.

The trench was excavated to a maximum depth of 0.80m. The tarmac surface of the car park (**100**) overlies a sequence of concrete (**103**) sand (**104**) and limestone chip (**105**) layers of makeup. This surfacing is contemporary with a manhole (**101/102**) on the edge of the trench and its connecting sewer pipe **151**, encased in concrete, which crossed the full width of the trench. Layer **106**, a levelling deposit of dark brown soil with brick rubble was beneath **105** and sealed the site. Below **106** at the west end of the trench was a foundation of concrete with a crushed brick aggregate, **107**. It was at least 0.30m deep, extending below the base of the trench and beyond its west, north and south edges. An area within the concrete was c.1.75m square. It is not known what structure the concrete originally supported (Pl. 1). Cutting through the concrete was a ceramic sewer pipe, which originally ran the length of the trench but was removed by the machining.

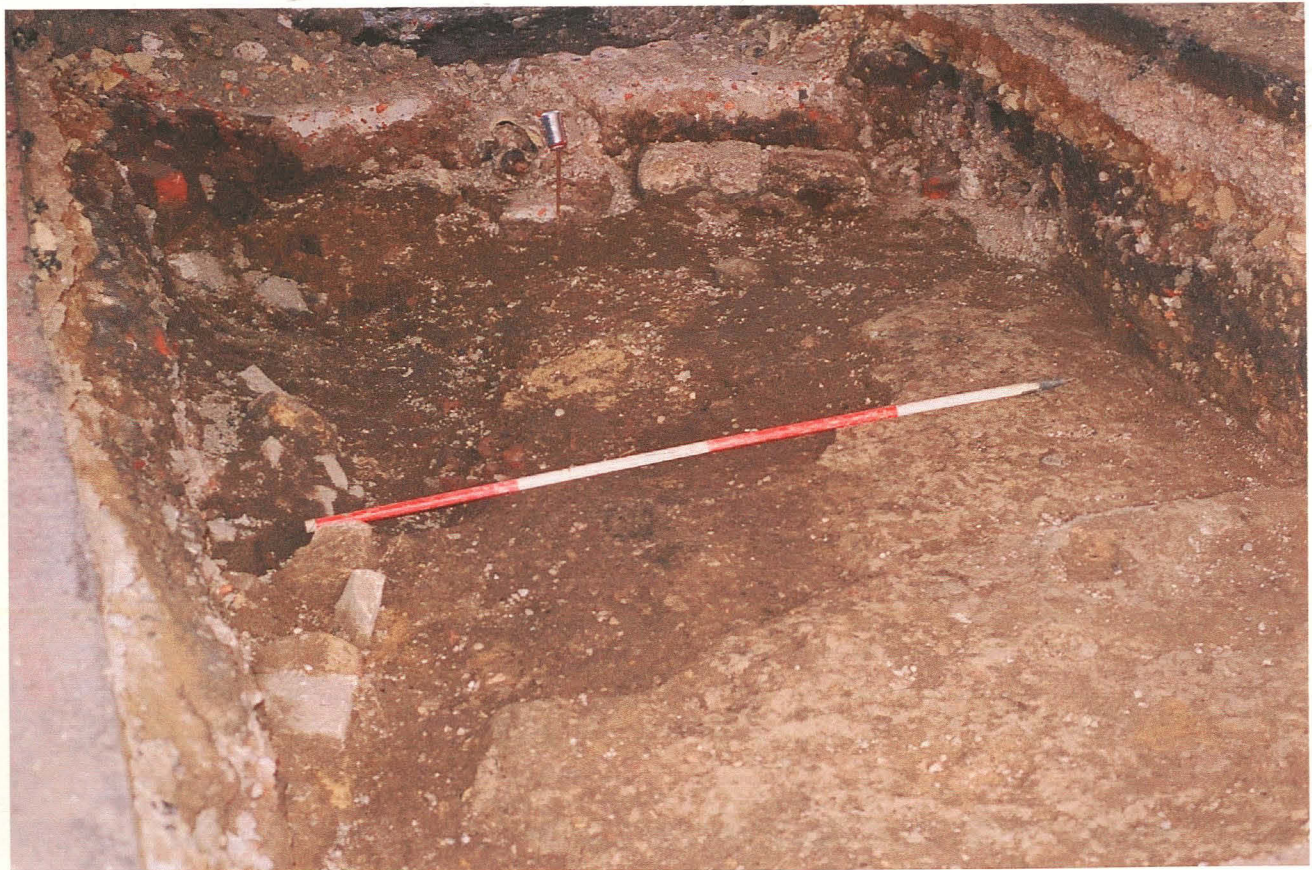
Pl. 2 Pit 149 (top left) cutting through walls 148 (foreground) and 113 (top centre). Scale 2m.

Levelling layer **106** sealed six pits, **149**, **114**, **144**, **142**, **146** and **159**. **149**, on the south side at the west end of the trench, was at least 2.75m in diameter and contained large quantities of brick tile and limestone rubble (Pl. 2). Some of the stone derived from walls **148** and **113**, which were cut through by the pit (see below). Pit **144**, part of which was revealed near the centre of the trench, on its south side, contained mid 17-18th century pottery. It cut through small pit **146** to the west (Pl. 3). Pit **142**, which contained numerous pieces of crushed brick, was to its east (Pl. 4) and **159** was at the east end of the trench (Pl. 12). This was broad and shallow and contained dark brown soil with brick rubble, almost indistinguishable from layer **106**, and cut into layer **135** (see below).

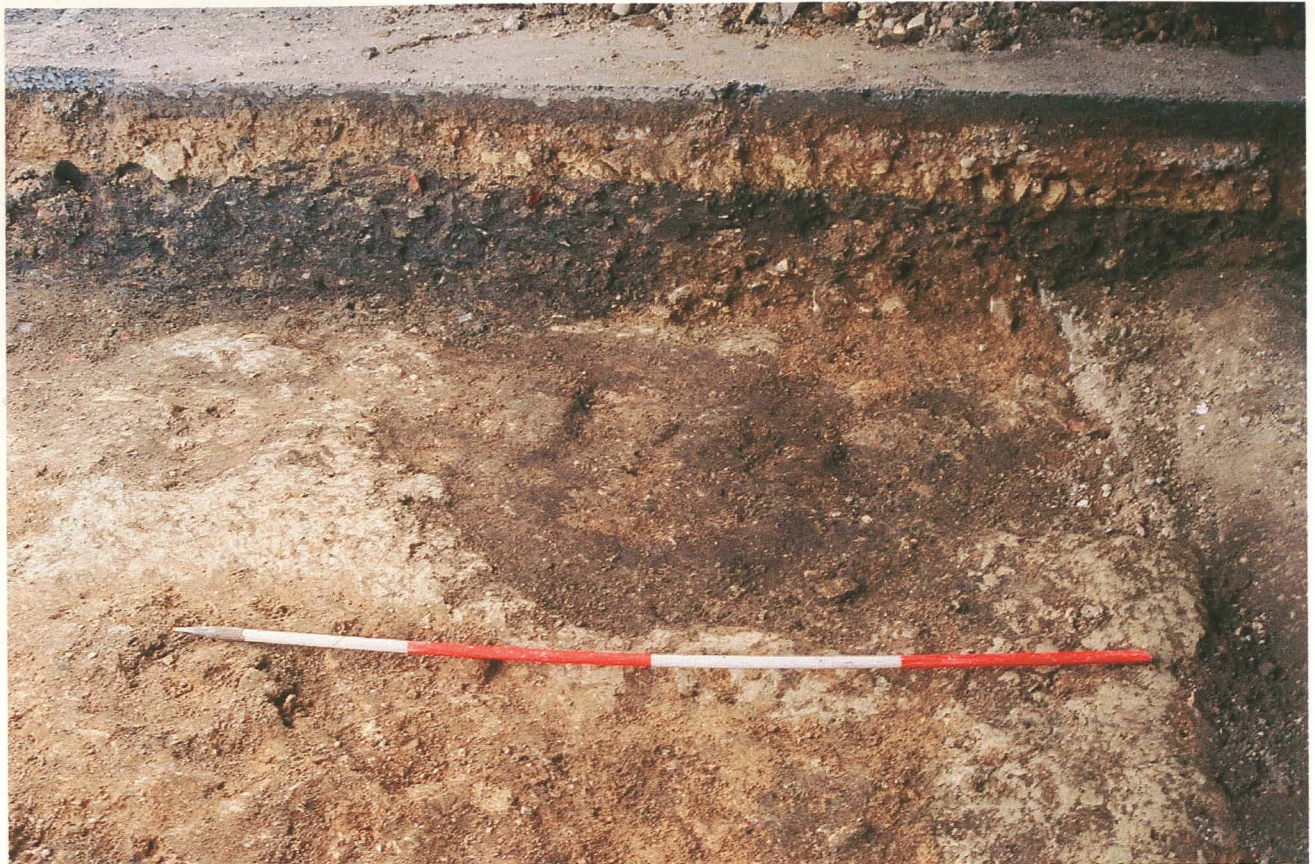
Pl. 3 South side of trench with modern pits 142 and 144 beneath the limestone makeup.

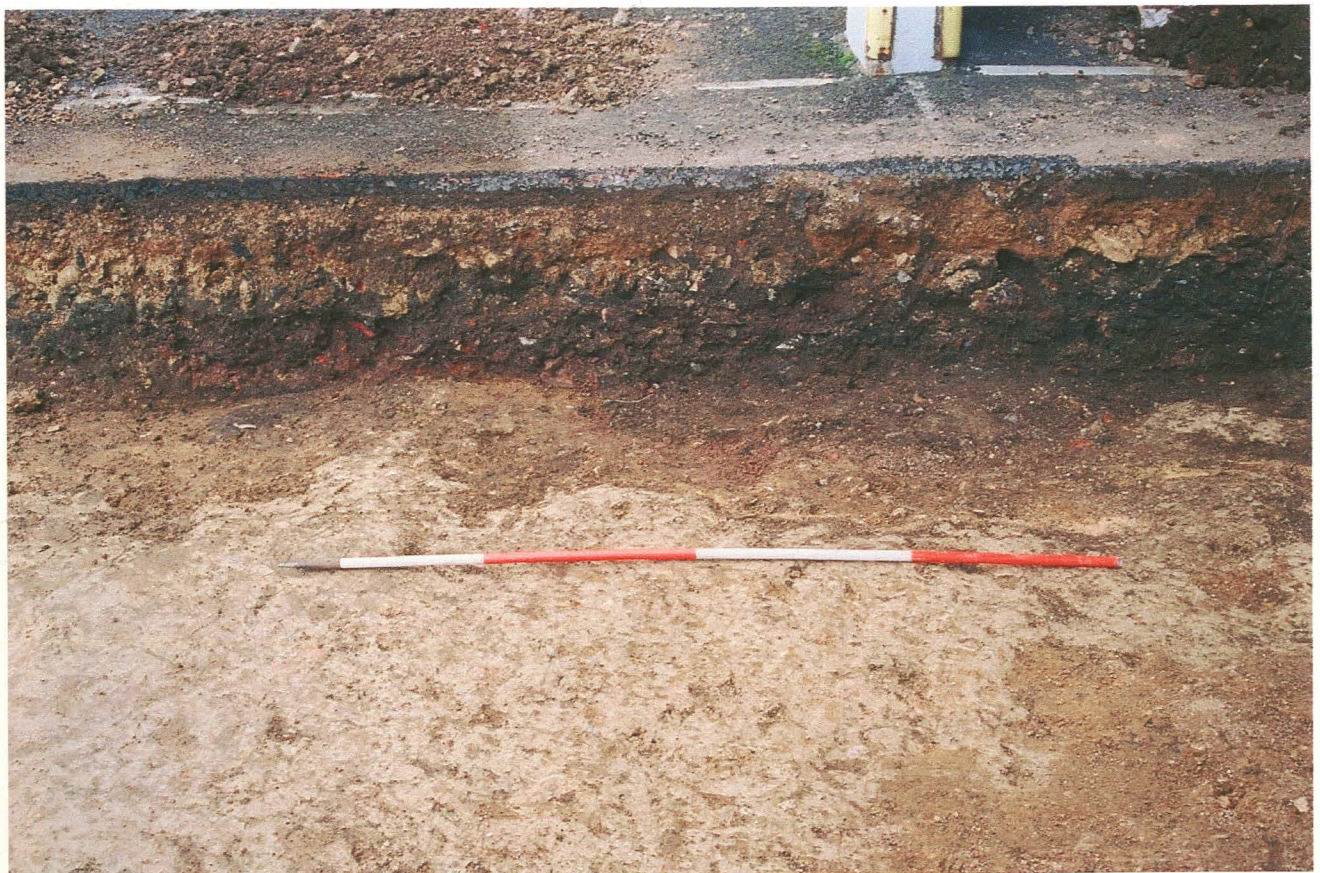
Pl. 4 South side of trench with modern pits 144 and 146 beneath the limestone makeup.

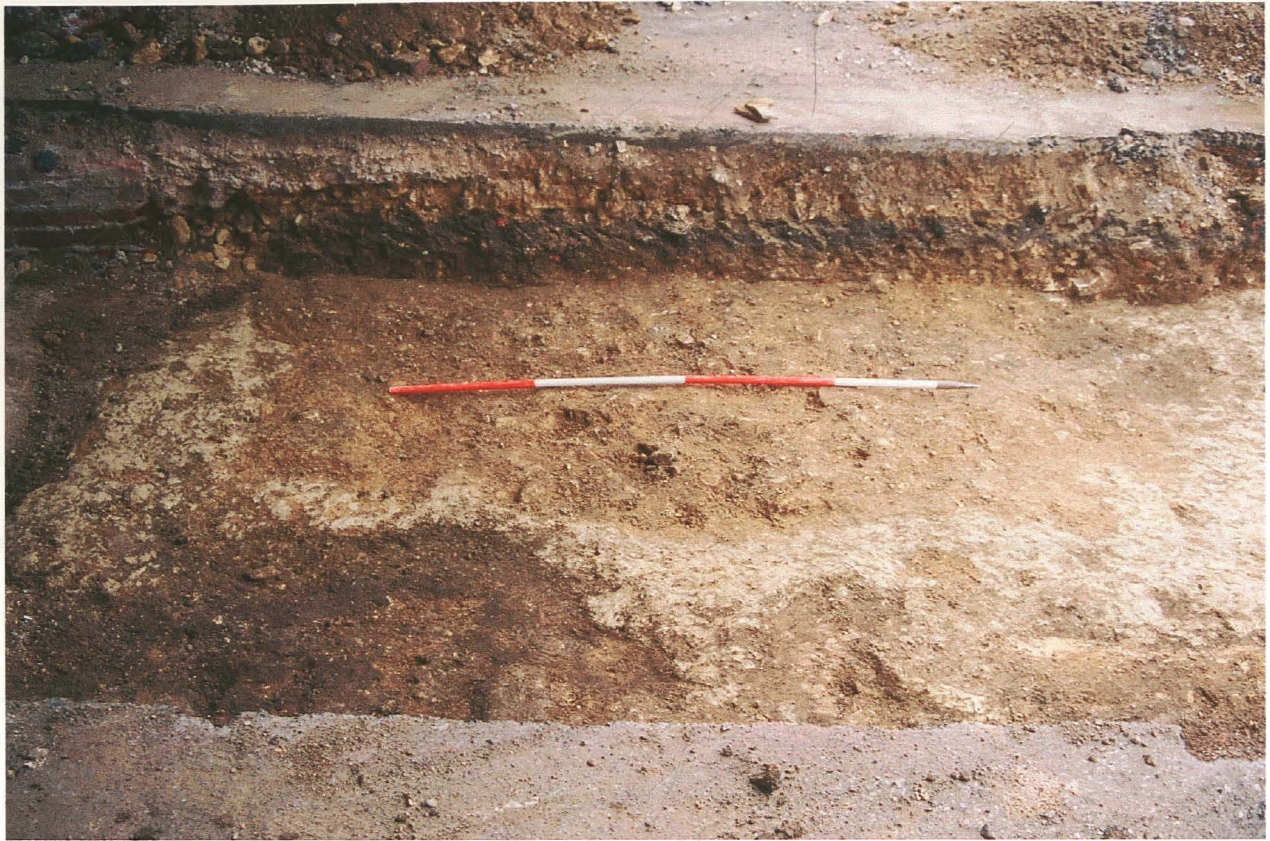
Pl. 5 Demolition layer 109, overlying clay floor 111, looking north. Scale 2m.

Beneath **108** was a thick layer of orange mortary sand **109**, up to 0.16m thick, which contained large quantities of roof tile and may have been a demolition layer (Pl. 5). A sample of tile was retained but could not be more closely dated than to confirm that the material was medieval in date.

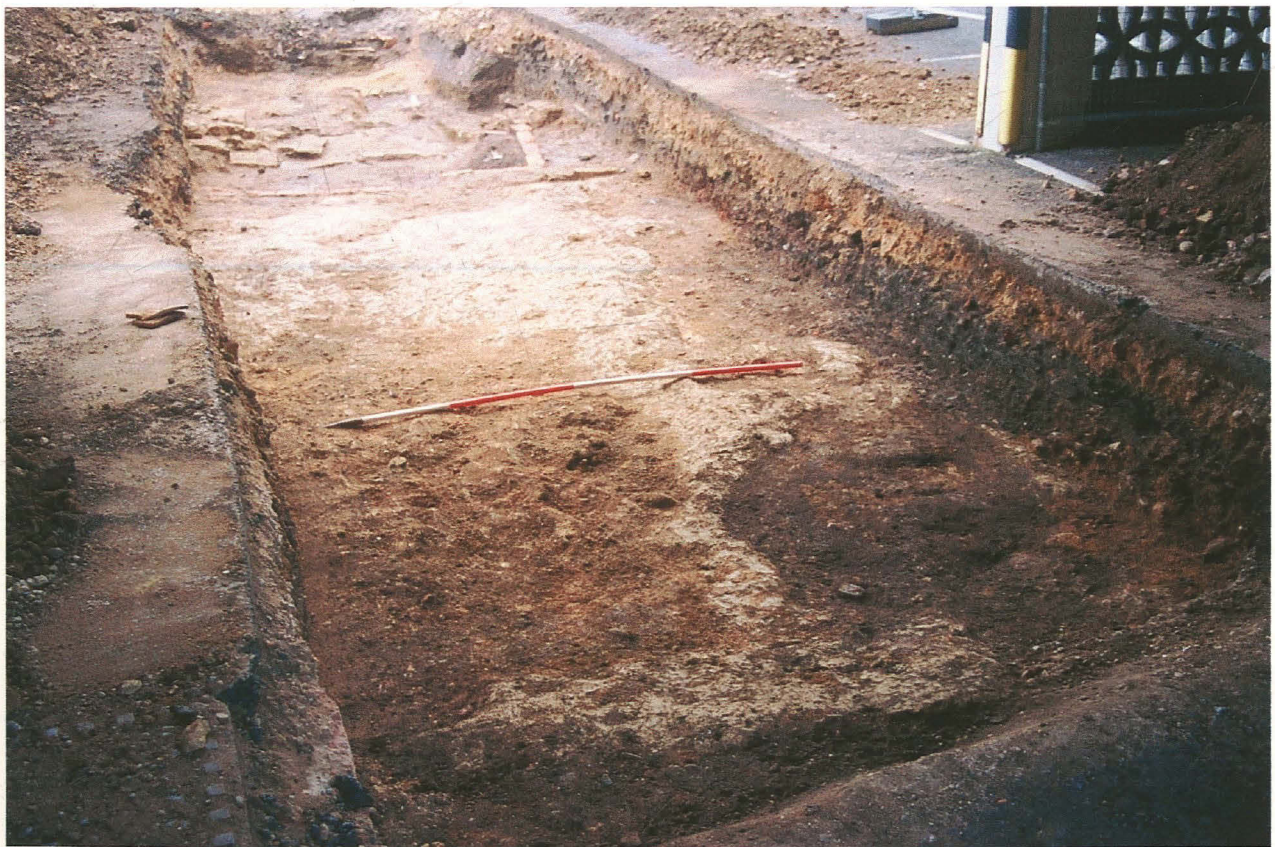
Pl. 6 General view of clay floor surface 111, west of sewer pipe 151, looking east. Scale 2m

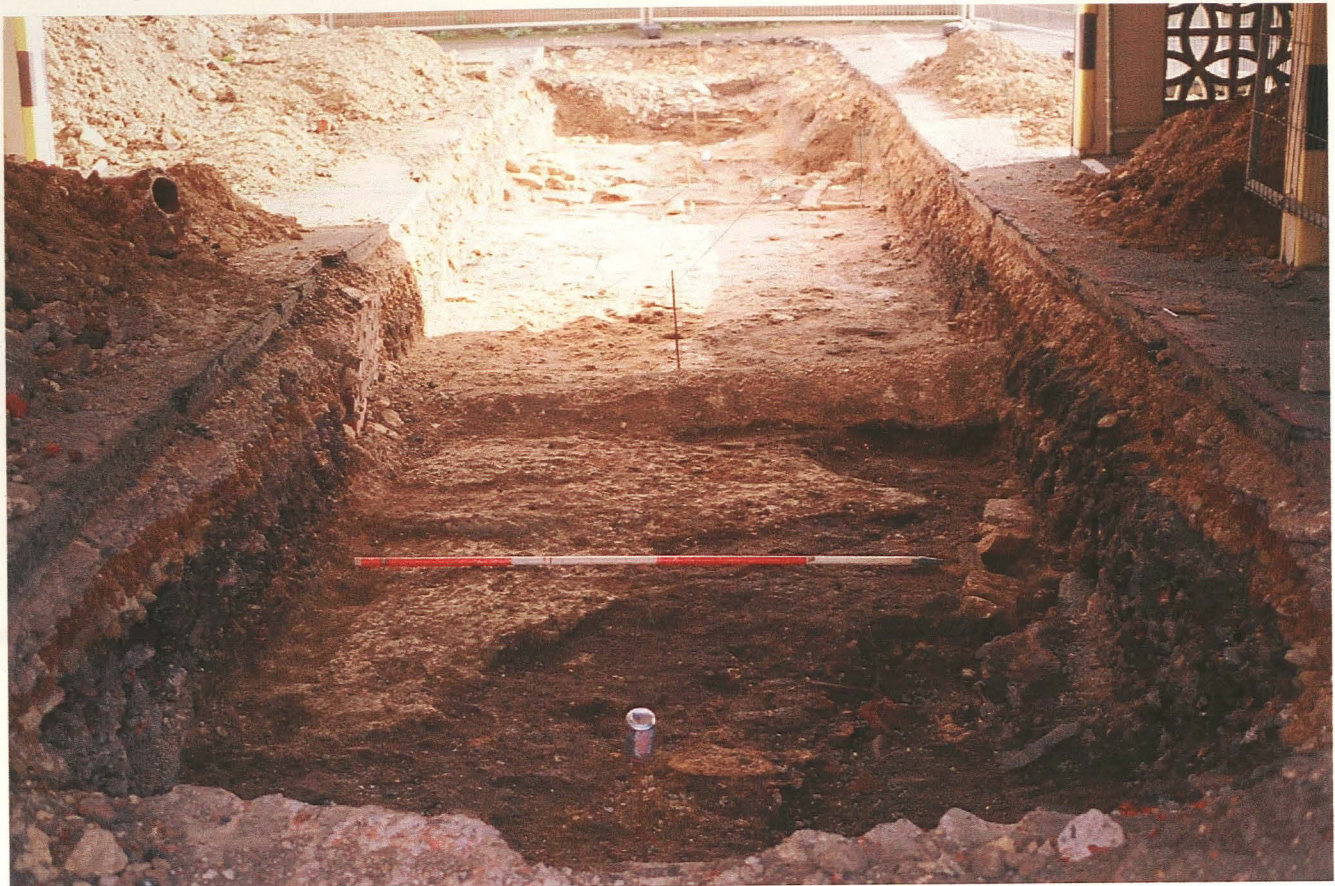
Pl. 7 General view of clay floor surface 111, east of sewer pipe 151, looking east. Scale 2m

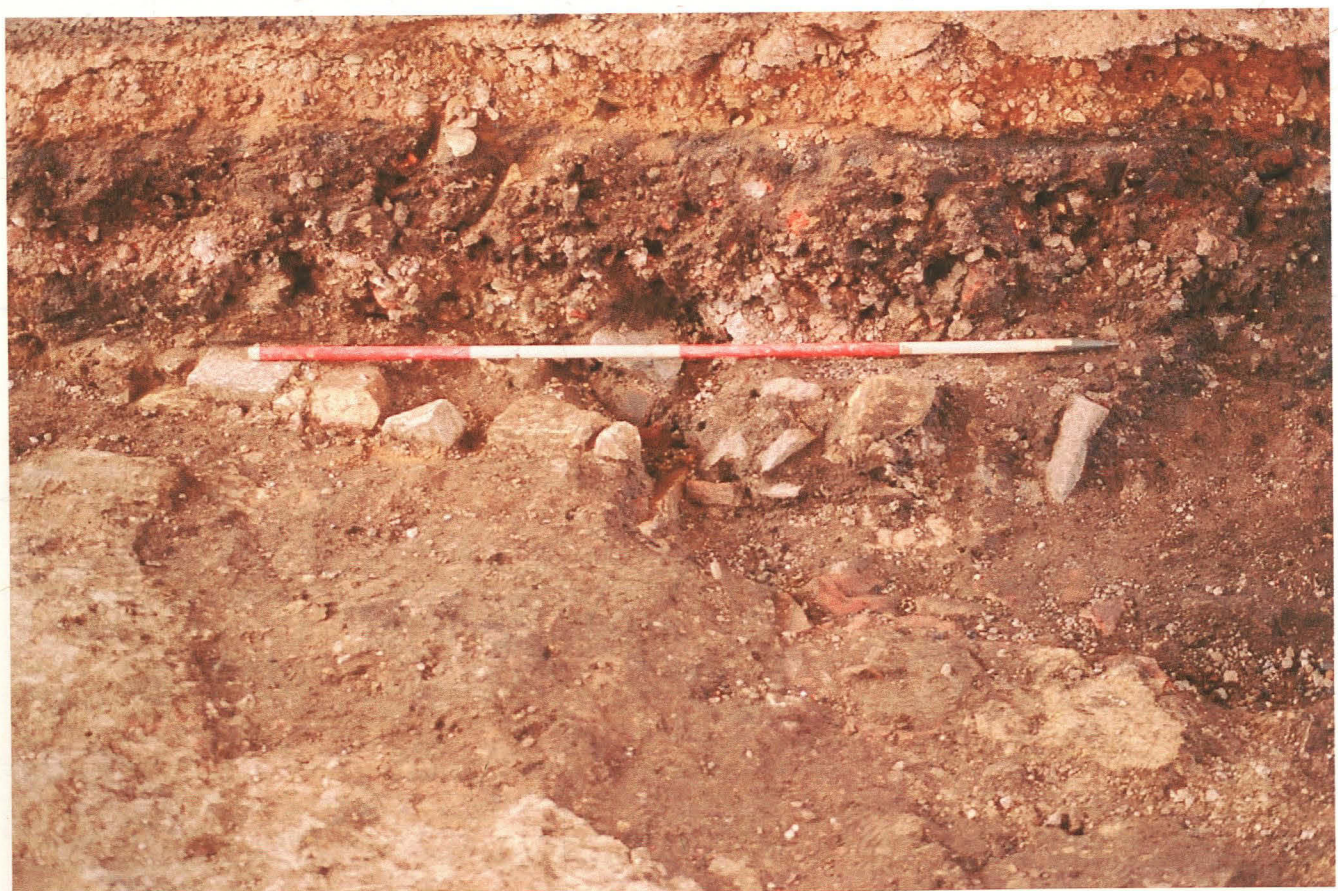
Pl. 8 Wall 148, cut by pit 149 (right), looking south. Scale 2m.

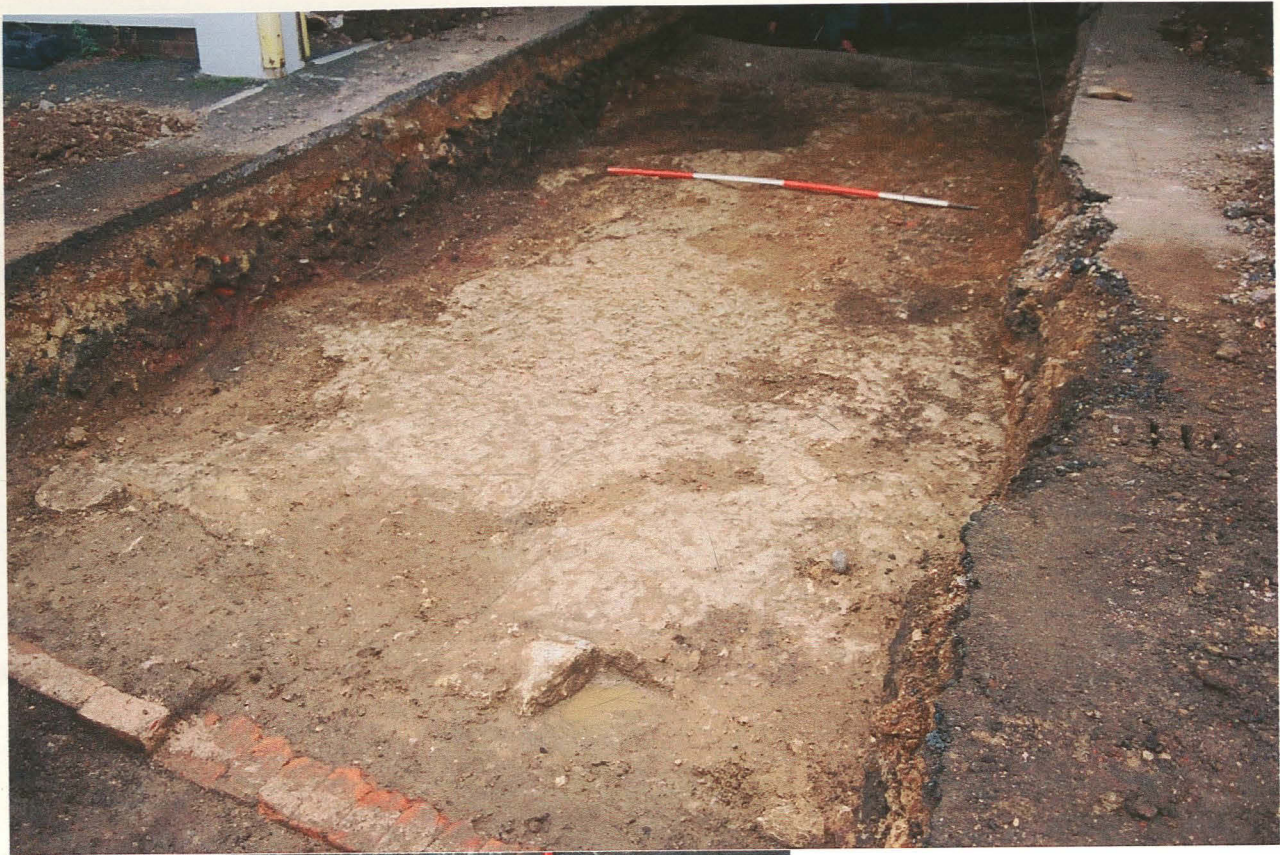
Pl. 9 (above) Foundation trench 119 at edge of clay floor 111. Scale 2m.

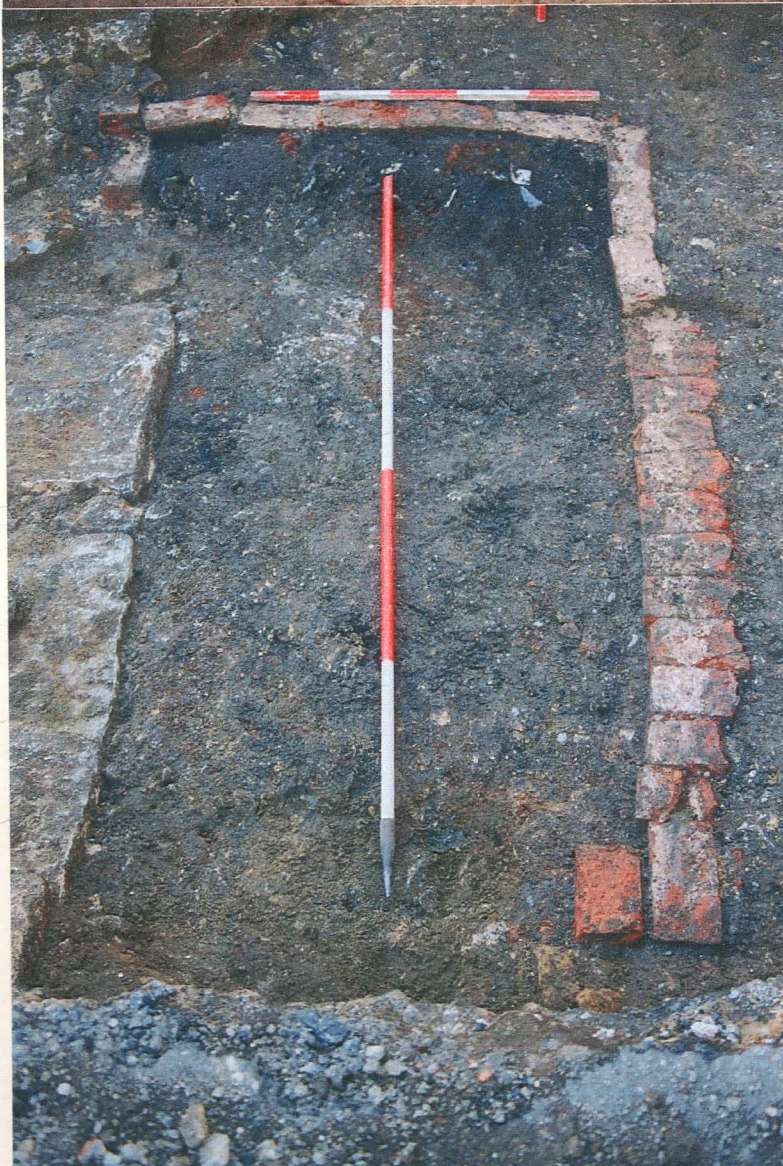
Pl. 10 (left) Victorian brick-lined cess pit 138. Looking south, Scales 0.50m and 2m.

The eastern edge of wall **119** was cut through by **120/121** which contained a Victorian cesspit with brick walls (**138**) (Pl. 10). The base of the pit was clay lined (**140**) and contained a black coal and charcoal stained ashy deposit **139** with numerous pieces of crockery, glass and tobacco pipe fragments (see Appendix 3). The material ranged in date from c.1860 to the late 1890s. The east wall of the cesspit had rested on top of a broad limestone wall **125**, but was disturbed, and removed, by the machining of the trench.

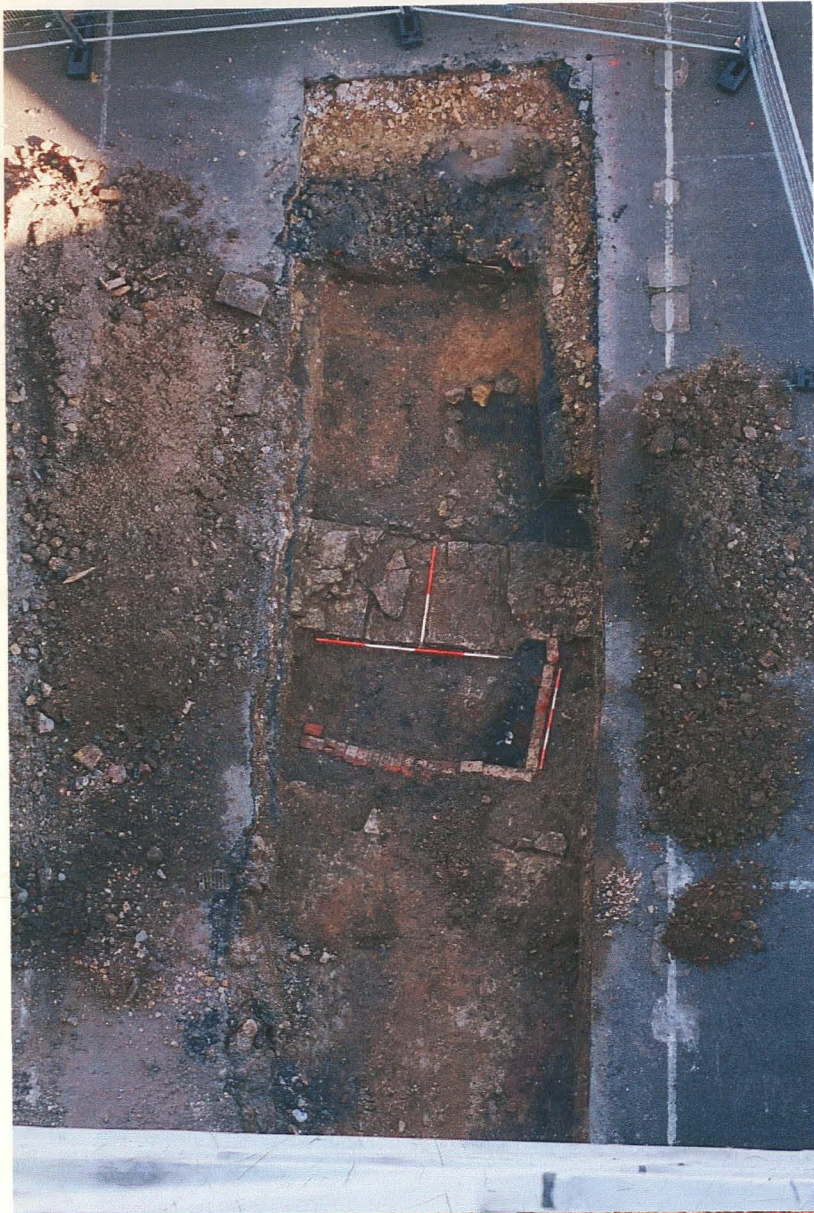
Pl. 11 (Left) General view of east end of the trench from roof of Thorngate House, showing wall 125, with Victorian brick-lined cess pit to left. Looking north, Scales 2m and 1m.

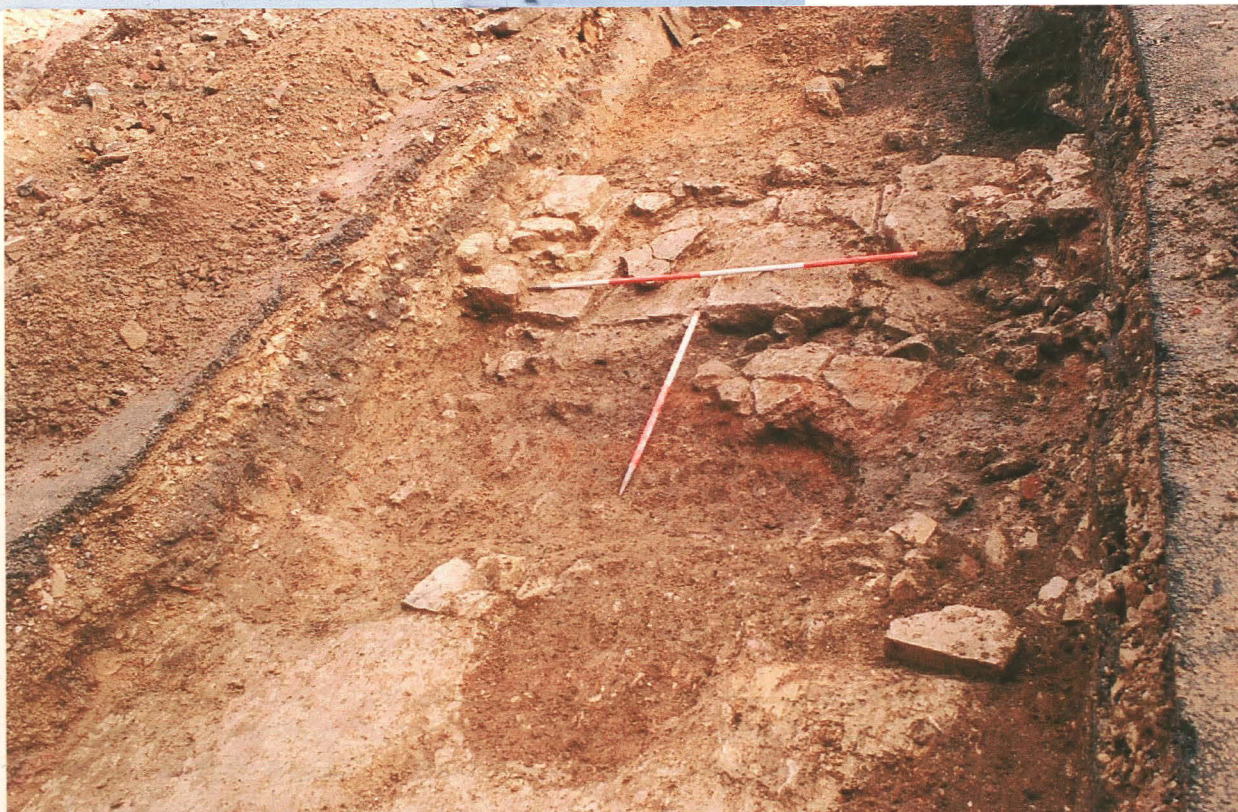
Pl. 12 Wall 125 looking north showing demolition layer 126 beneath 106. Scales 1m.

stone, which are interpreted as being part of **119** were recorded sitting on top of the more substantial stones of an earlier wall **125** (see below and Pl. 12).

Removal of the cesspit lining **140** revealed an area of stonework **156** c.1.10m long and a maximum of 0.65m wide, which may be all that remains of an earlier wall, cut to the south and west by the wall **119** and by the wall **125** on its east side (Pl.12).

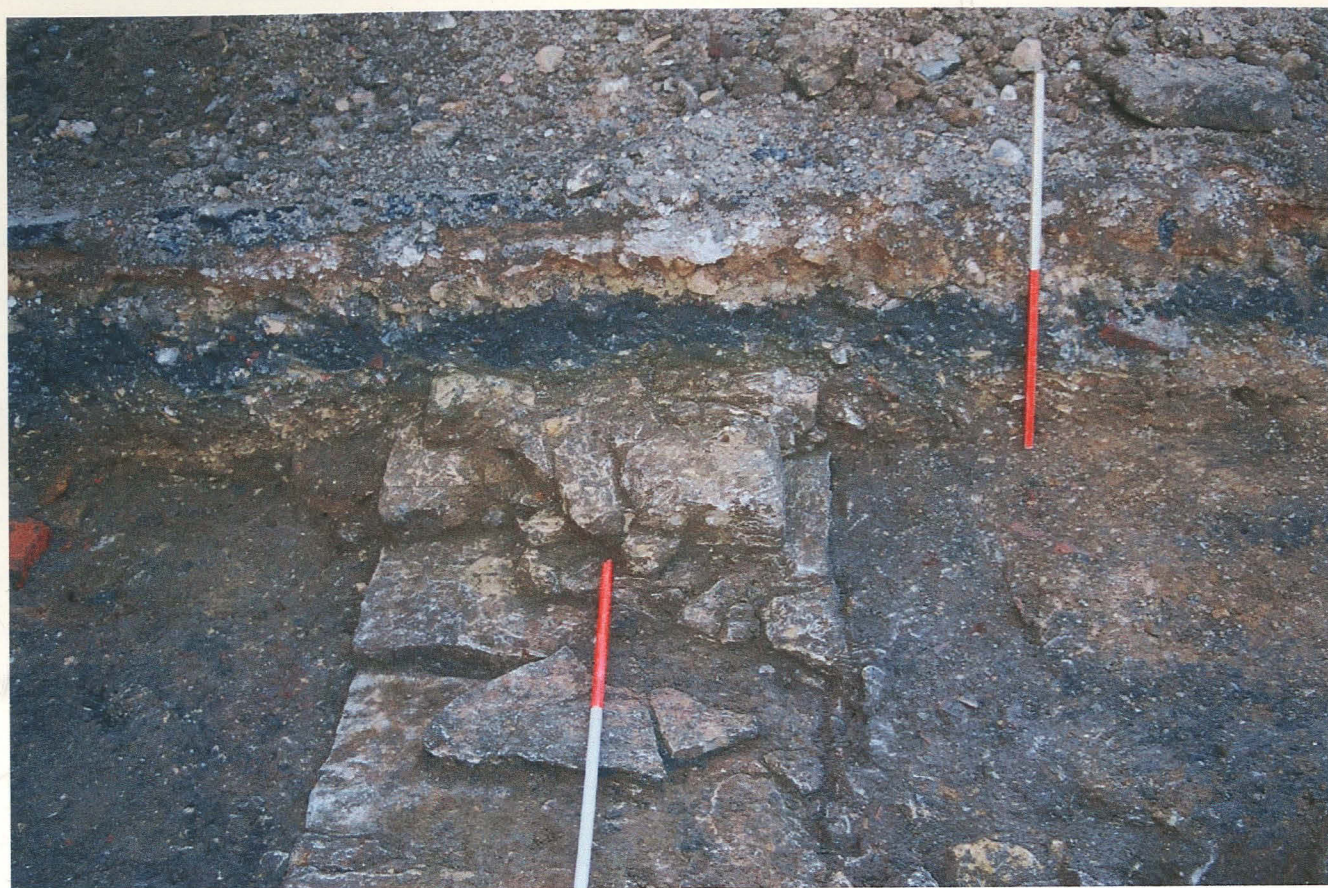
Pl. 13 East end of trench looking south showing pit 159 in section cutting through sand 135 (left) and 137 (right).

Wall **125** was 1.10m wide at the base of the trench and was revealed to a height of 0.40m in the trench 6.50m west of the present street frontage. It is constructed in limestone and bonded in clay. Three courses of stonework were revealed, the lowest of which was slightly offset by 0.10m on the east face. This may be the first foundation layer as at that level the foundation trench **127** containing small pieces of stone and tile **128**, was visible east of the wall. Less well-defined was a similar deposit **162** on the west side of the wall containing pieces of stone, derived from **156** which may be its western foundation trench (Pl. 13).

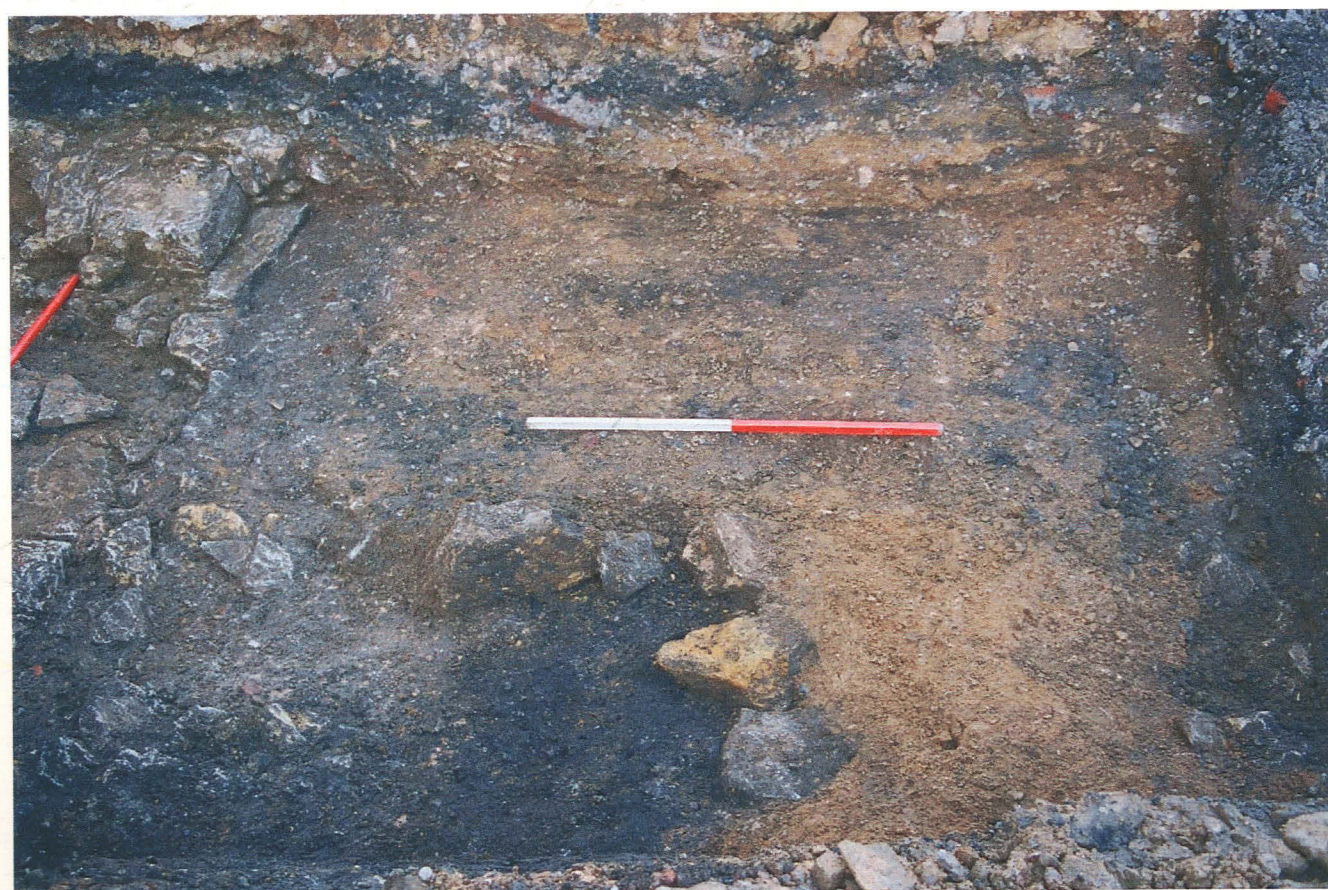
Pl. 14 East end of trench looking north showing foundation trench 128 next to wall 125 (left) cutting sequence of mortar layers 129-134 in section. Layers 133 and 134 are visible in plan beyond the scale and 137 (left) and 135 (right) below the scale. Scale 1m.

East of wall **125**, and cut by its foundation trench, was a series of mortary surfaces **130,132,134**, possibly remains of floors, interspersed with trample layers **129, 131** and **133** (Pl. 14). The foundation trench contained pottery and tile of 13-15th century date while material from **131, 132, 133** and **134** was of 13th century date. Overlying layer **133** to the south was a thick band of orange mortary sand **135** which contained a single fragment of ridge tile of 12-13th century date. This, in turn overlay a possible pit **136** which contained pieces of limestone and a fill of dark brown soil, **137** (Pl. 15). It contained several fragments of roof tile of medieval date and cut through the foundation trench of the wall **125**.

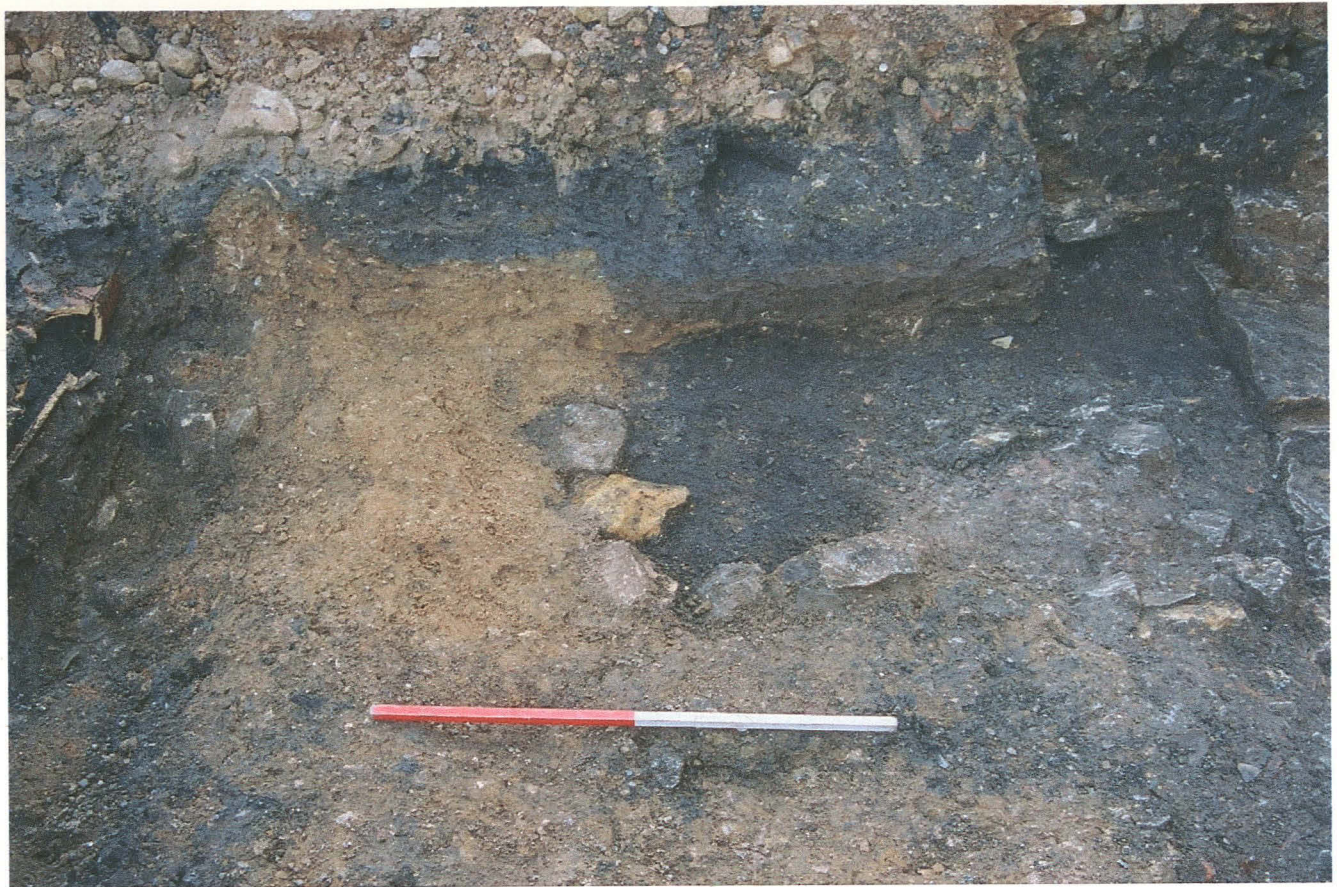
Pl.15 Area west of wall 125, after removal of cesspit 138, showing robbed wall 119 in foreground and crossing south end of the wall 125, with earlier stonework 156 to right of small scale. Scales 1m and 2m
