**Holmes Wharf, Carholme Road, Lincoln**

**Archaeological Watching Brief**

**LAS Report No. 814**

**May 2005**

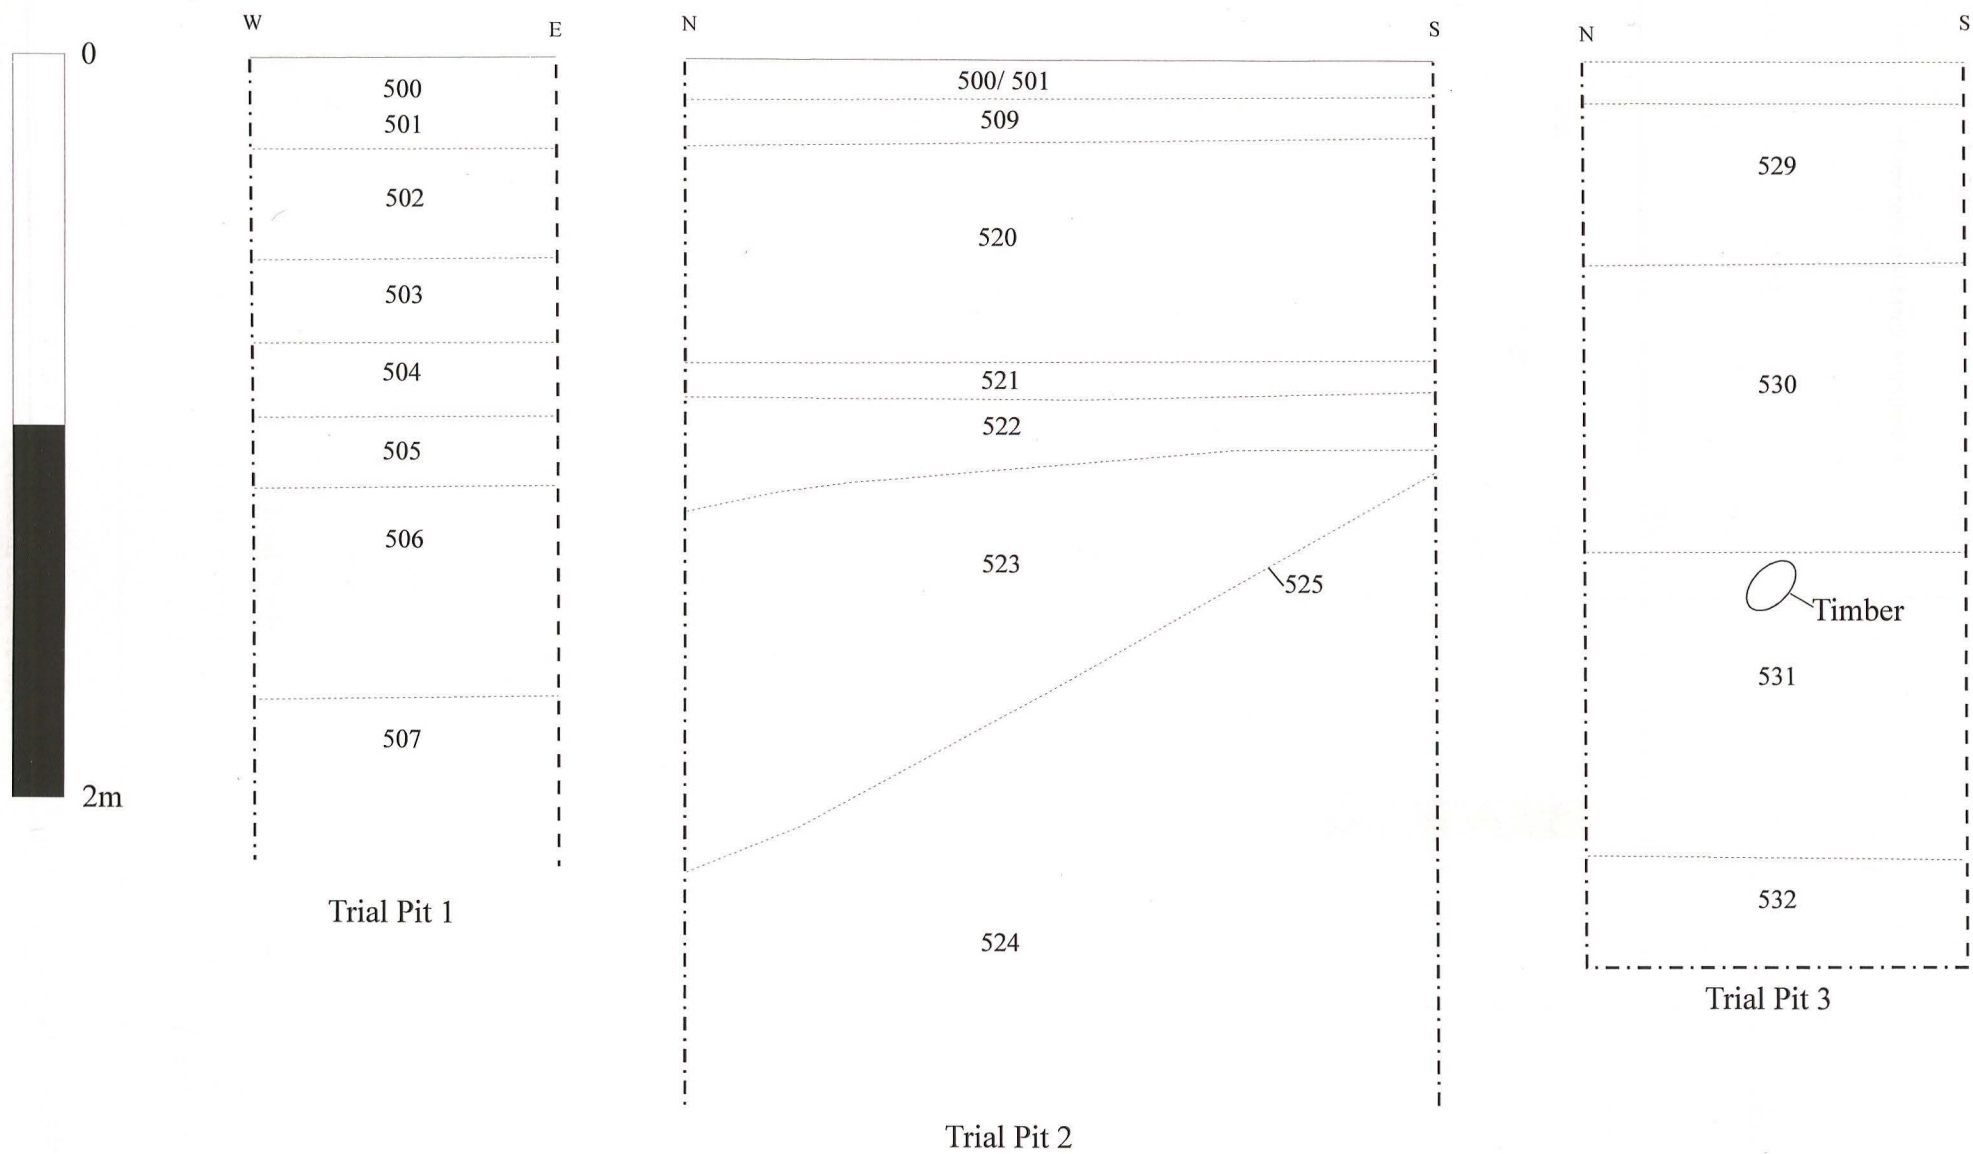
Fig. 3 Profiles and sections across deposits recorded in Trial Pits 1-3 (Claxton, after Tann).

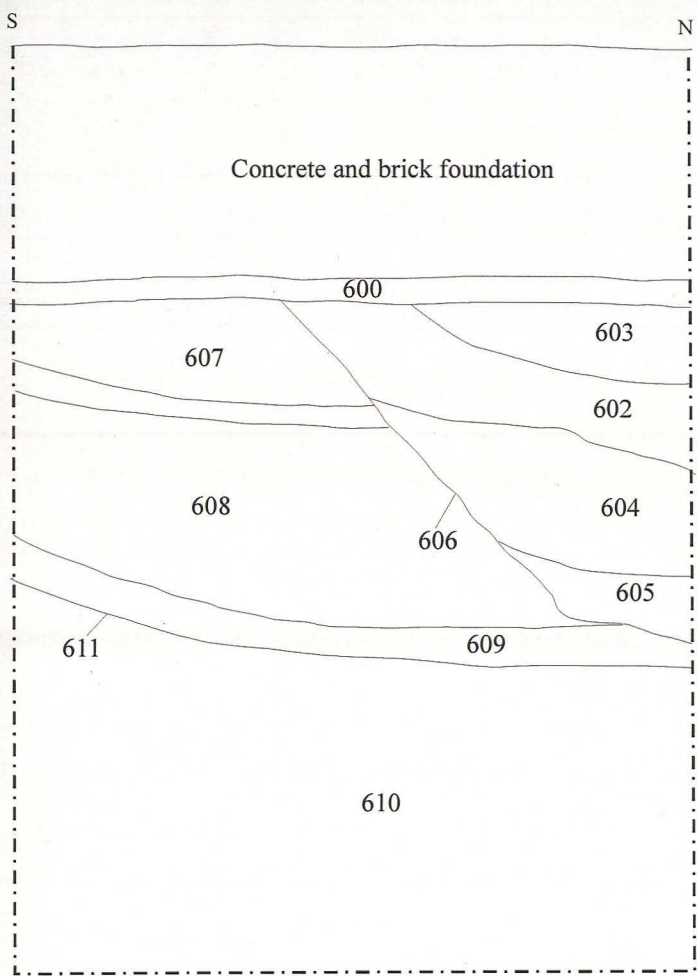
Trial Pit A

**Fig. 4** Profiles and sections across deposits recorded in Trial Pits A-F (Claxton, after Tann).

This trench was excavated 2m from the northern boundary of the site, behind the remaining properties fronting onto Carholme Road (Pl. 8). The ground conditions were poor, and frequent collapse of the trench sides prevented detailed recording. At the northern end of the trench was part of a steep-sided ditch or pit **606**, at least 1.5m wide, with its base 2.2m below ground level. Its primary fill was a black silt **605**, overlain by a shell-rich deposit **604** which contained numerous limestone chips. This fill layer, and the cleaner silts above it, appeared to be deliberate backfilling of the feature. Slate and roof tile fragments were present in the upper surviving fills. Two sherds of 18th-19thC pottery were found in a levelling layer **600**, sealing the backfilled feature (Appendix 2).

Feature **606** cut through several layers of made ground to the south. The layers exhibited a slight slope downwards to the north, and may have been fills of an earlier deep feature **611**, at least 2.5m

wide. A medieval roof tile fragment was found in a sand layer **601** within this feature. At the base of this feature, 2.3m below present ground level, was the black silt primary fill **609**.

Ditch or pit **606** seemed to be a more rapidly backfilled feature than its precursor, and may simply be a refuse pit associated with early development of the site. The adjacent and earlier feature **611** could be part of a boundary ditch crossing the site, but its profile may be too broad for this.

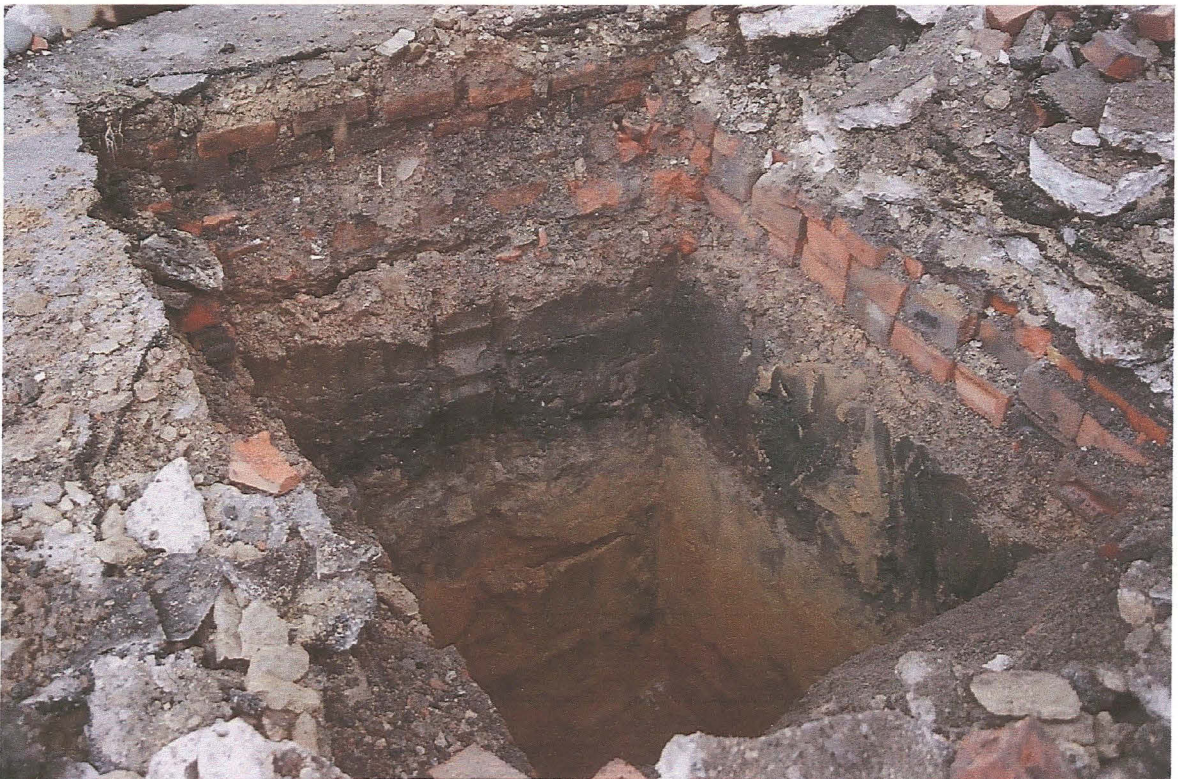
PI. 2 Deposits in the face of Trial Pit 1.

The combined 0.25m of tarmac **500** and concrete **501** across this part of the site covered 0.3m of carefully laid but unmortared and unused bricks **502** (Pl. 2). These complete bricks had frogs, and were inscribed 'LINCOLN', which suggests a nineteenth century date. Each had been closely laid in rows, and there were three courses on edge; there had been no attempt to bind the bricks. The bricks extended to a mortared brick foundation **508** along the western and southern edges of the geotechnical trial pit, and seemed to serve no other purpose than to raise the ground level with solid material.

Beneath the loose bricks was a 0.2m thick layer of mortar and fine brick rubble **503**, probably from demolition of buildings along the frontage. This covered 0.25m of dark brown clay **504**, possibly a buried topsoil. Below it was 0.2m of sandy grey clay **505**, incorporating frequent shells and occasional pieces of brick and post-medieval pottery. Late medieval pottery, roof tile and animal bone was present in the 0.55m thick mixed dry sandy material **506** below the grey clay; the overlying layer **505** may represent a waterlogged deposit from a temporarily raised water table. The mix of inclusions suggests a deliberate dumping of refuse here, probably to reclaim land.

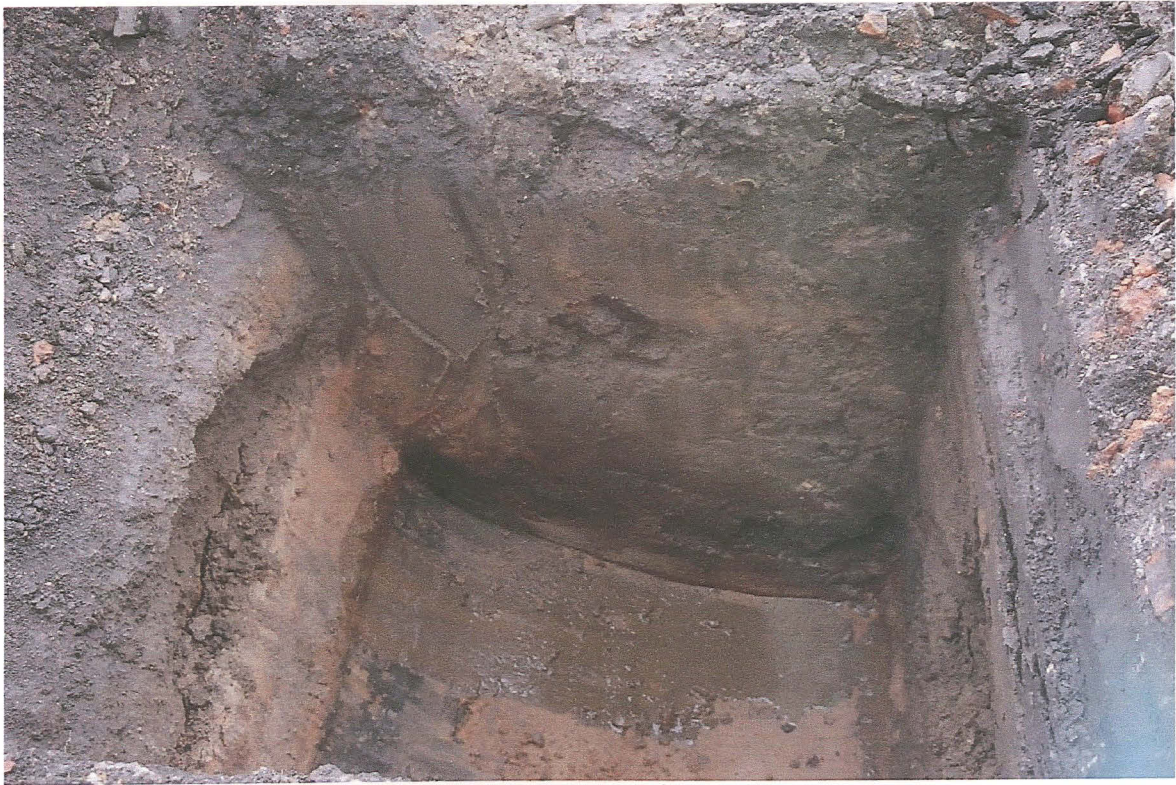
PI. 4 Deposits in the east face of Trial Pit 2.

Beneath the dark soil was 0.1m of dirty sandy gravel **521**, over 0.15m of sand **522** (Pl. 4). A very mixed deposit **523** of brown loam with mortar, brick and roof tile fragments, and post-medieval pottery was covered by the sand layer. At the southern edge of the trial pit this layer was 0.05m thick, sloping abruptly down a further 1.05m at the northern side of the trial pit. It sealed a sand deposit **524**, which continued to the base of the trial pit.

Interpretation of the profile of **523** was difficult as so little was exposed. It may be that the southern edge of a backfilled channel **525** was clipped by the trial pit, but it is equally possible that part of a west-east aligned deep post-medieval ditch was encountered.

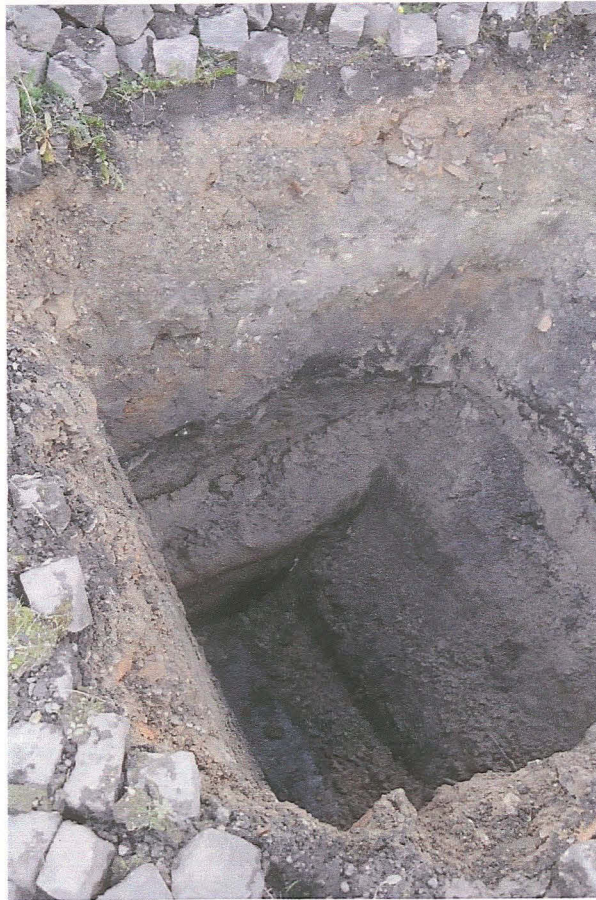
PI. 6 Deposits in Trial Pit 4.

Below the sand was a dark brown/black organic silt **532**, which became denser towards the base of the trial pit (Pl. 6). The layer was at least 0.3m thick.

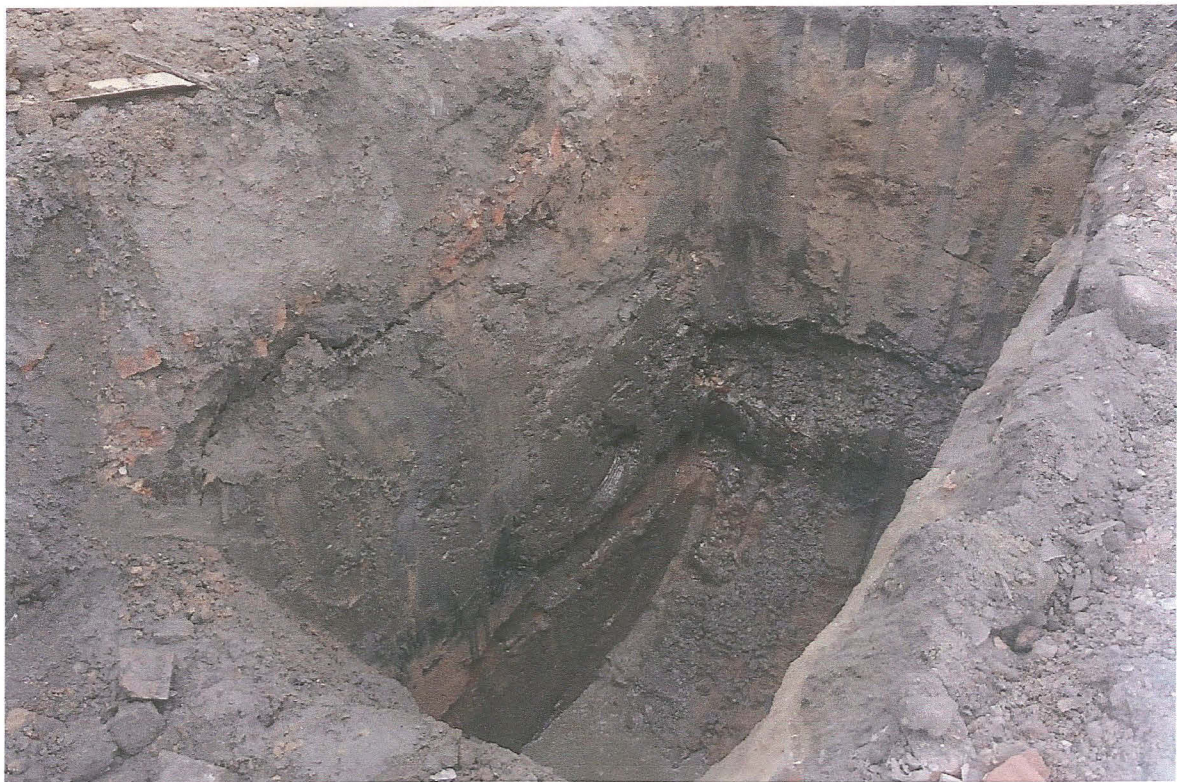
**Pl. 8** Dark fill at the base of ditch 606, Trial Pit A (looking north-west).

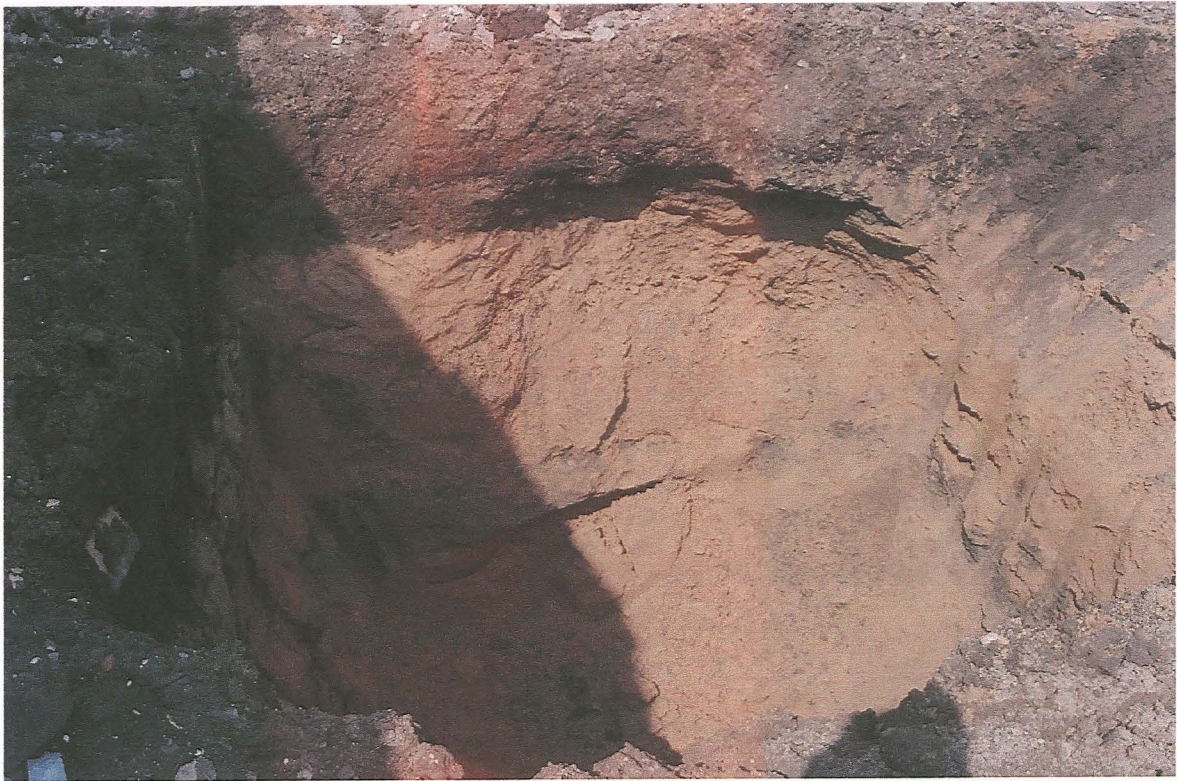
**PI. 9** Sand deposit in Trial Pit B, possibly representing a bank alongside the Foss Dyke canal.

This 2m x 1.5m trench was excavated mid-way between the west and east site boundaries, and 1.7m north of the southern boundary. A series of lenses of silt and ash **612** covered a silt layer **613** which contained coal fragments and a sherd of 17th-18thC pottery. Below them, 0.6m below ground level, was a 0.8m thick sand layer **614**. As that layer covered a 0.25m thick band of compact grey/green silt **615**, the upper sand has been interpreted as a deliberate artificial deposit, probably a bank alongside the Foss Dyke canal (Pl. 9). The green/grey silt **615**, 1.4m below ground level, may represent a buried topsoil. This could possibly have pre-dated the excavation of the Foss Dyke canal here, but the bank may well have been a later improvement of the canal margin. Beneath the compact layer was thick yellow sand deposit **616**, which appeared to be an undisturbed naturally produced layer.

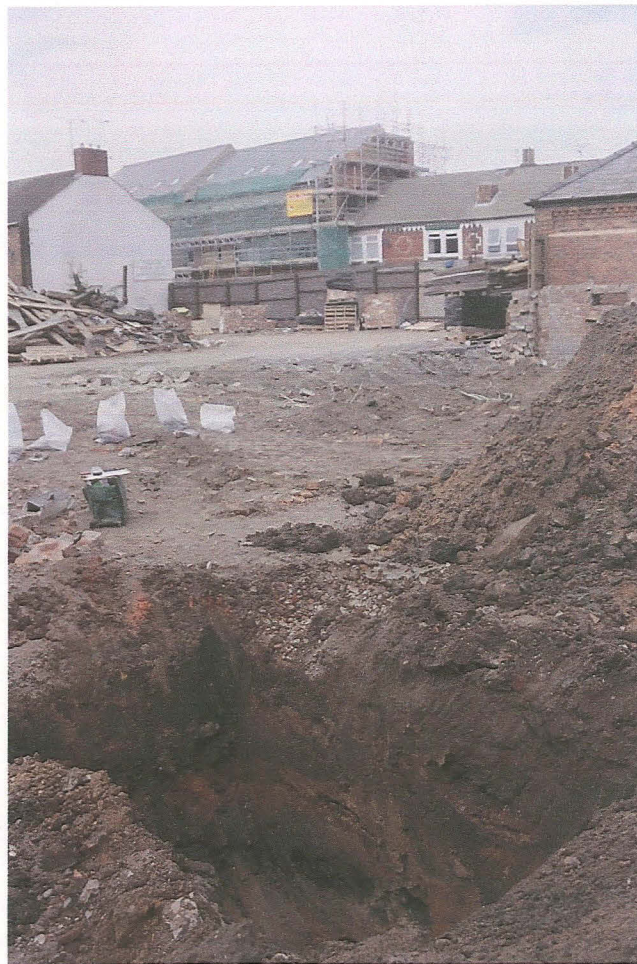
**PI. 10** Trial Pit C (looking north-west towards Carholme Road).

This trial pit was excavated to the south-east of the centre of the development site, and revealed multiple layers of silts and sands (Pl. 10). Mortar and roof tile fragments were present in a thin layer of black silt **621**, 1.1m below ground level, and all the deposits above this are thought to have been introduced. White glazed china fragments and a piece of clay tobacco pipe stem were found in these layers. The black silt, possibly a canal dredging layer, covered 0.35m of light brown sand **622**, and beneath this was 0.25m of peaty sand **623** which may represent vegetation growing on a marshy ground surface 1.5m below the present ground level. It overlay undisturbed orange sand **624**.

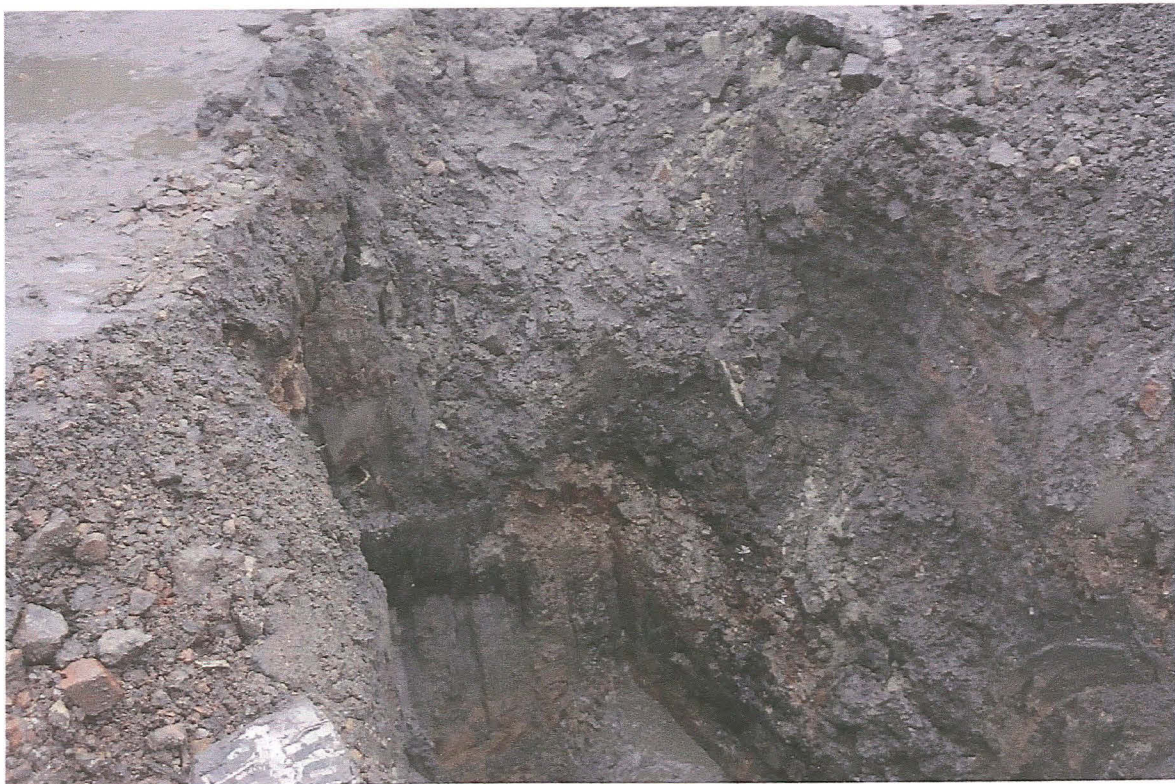
PI. 12 Trial Pit F (looking east). The sloping black silt 639 may be at the base of ditch 640/611.

The trench encountered disturbed ground above a ceramic drain **635**. The drain had been excavated through a deposit with brick rubble and mortar **637**, with an underlying deposit **638** which contained a sherd of 14th-17thC pottery. Beneath this, 2.1m below ground level, was a black silt layer **639** which sloped down towards the south. This may have been the primary fill at the northern side of a ditch

**640**, presumably the same feature as **611**. A grey sand layer **641**, cut by the ditch, had a virtually flat interface with the underlying orange sand **642**, and may represent discolouration by leaching of material from the ditch (Pl. 12). It is possible that it is the fill at the base of an earlier deep feature recut by **640**, although the flat profile makes this unlikely.

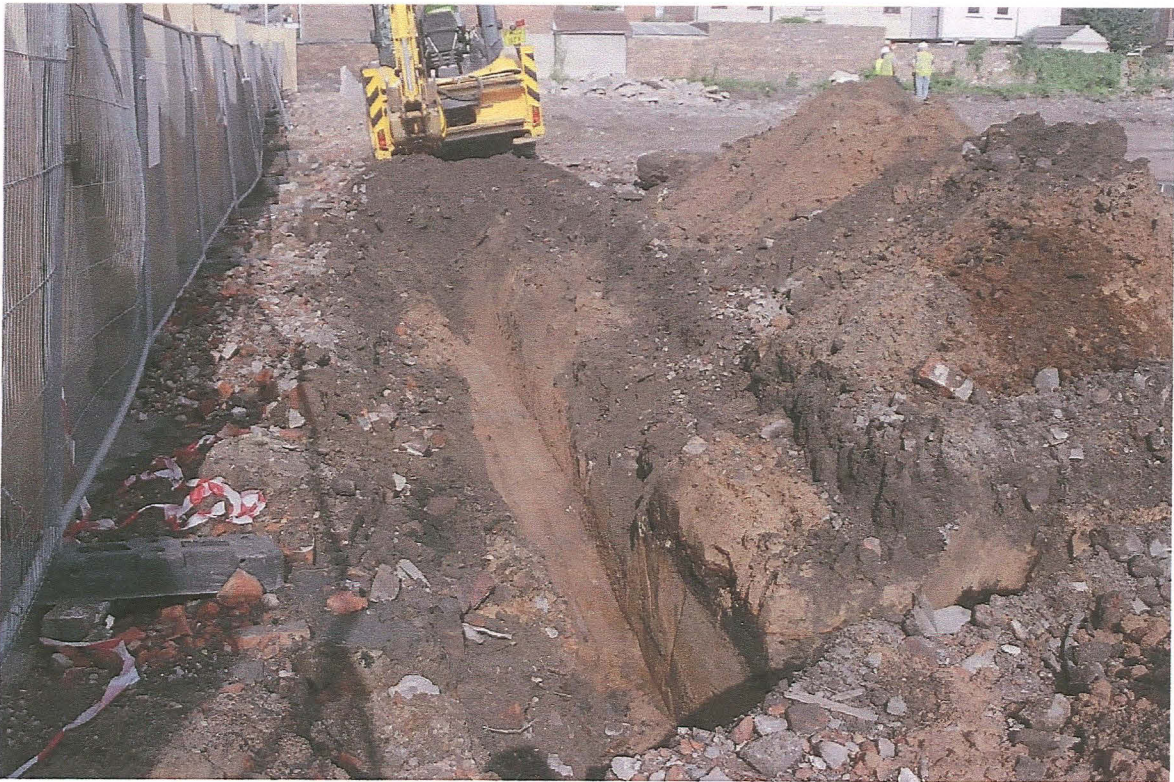
**PI. 13** Trial Pit E was excavated alongside the southern edge of the site (looking west). The sand may be part of an upcast bank of the adjacent canal.

A 0.6m wide trench was excavated parallel to the site's southern boundary, in order to establish whether any steel tie-rods fixing the stone wall of the Foss Dyke canal protruded within the site. The trench was excavated 1.5m to the north of the site boundary (Pl. 13). No trace was found of any fixings associated with the canal. The trench did reveal a single north-south aligned brick wall foundation **643**, 22.6m west of Holmes Road (Pl. 14). The upper surviving course was about 0.5m below ground level, and the base was about 1.5m below ground level, cut into an orange sand deposit. It was unclear whether the sand was part of the bank seen in Trial Pit B, as the trench was not deep enough to reveal its thickness. This was part of the same foundation seen on an earlier visit and is interpreted as a foundation of 'Mr Keyworth's house' shown on early twentieth century plans of the site.

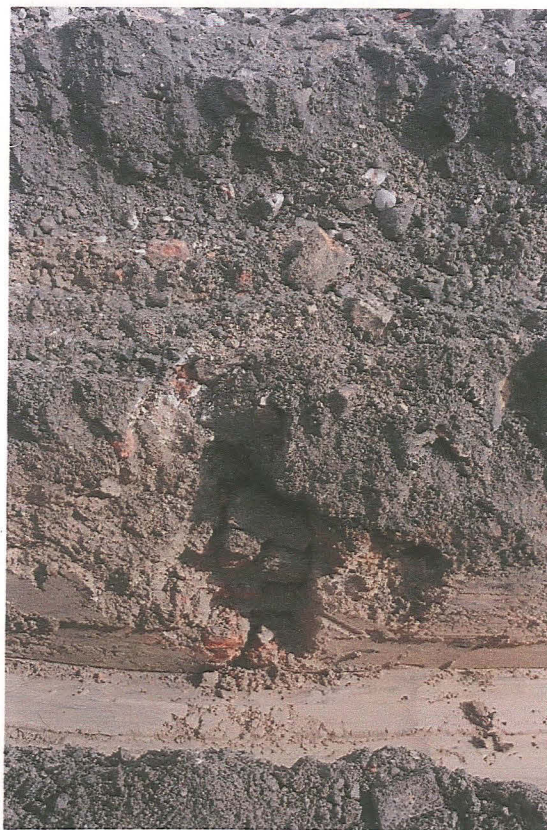
**PI. 14** Brick wall foundation 643, in the northern face of Trial Pit E. This may be part of Mr Keyworth's house.

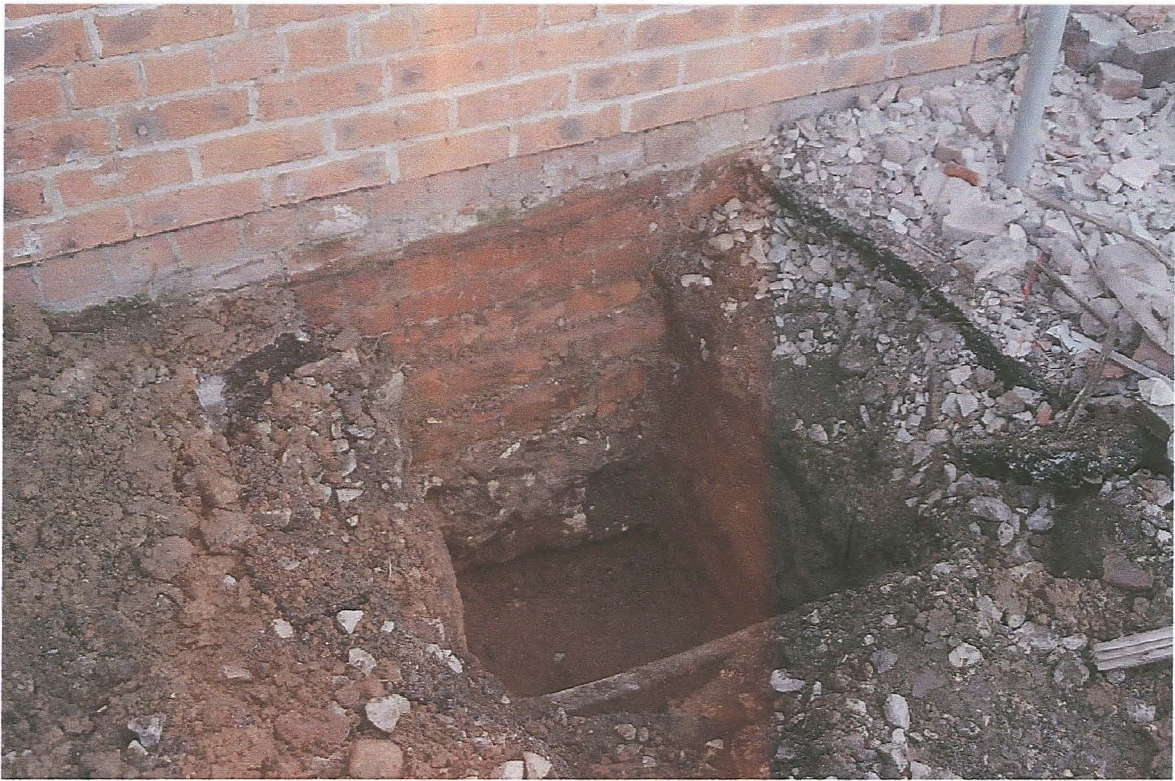
**PI. 15** Trench G exposed the foundations of the adjacent surviving building (looking east).

Hand-dug trenches **Trench G** and **Trench H** excavated against the gable-ends of adjoining buildings were also inspected. The renovated older building alongside Carholme Road (College Mews) had brick foundations **645** (including two offset courses) extending 0.6m below the tarmac-covered yard surface. The brick foundations overlay a 0.4m thick layer of stone rubble **646**, which sealed sand **647** (Pl. 15). To the south, the adjoining structure is on a breeze-block foundation. Along the western boundary of the site, the brick foundations **648** of structures beside the site were up to eight courses deep, but were not substantial.

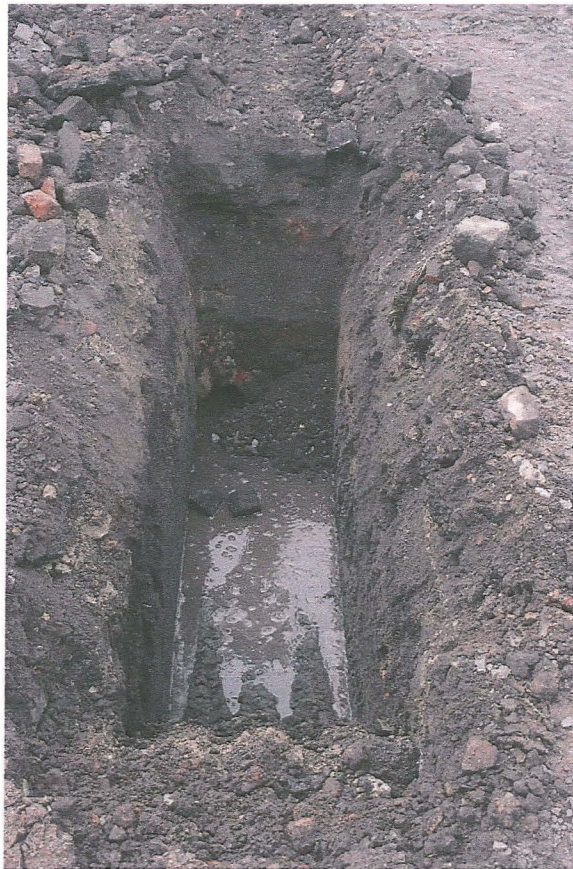
**PI. 16** Part of a brick culvert 650 and a brick wall 649 were seen at the southern end of Trench J (looking south).

**Trench J**, excavated by machine, exposed a west-east aligned brick wall **649** 15m from the western side of the site, at the southern side of a deep deposit of dark grey silt **653**. By coincidence, the northern end of an arched brick culvert **650**, protruding about 0.65m north of the wall, was clipped by the trench, releasing water from the culvert (Pls. 16 and 17). It appears that the culvert had formerly linked to the feature crossing the site, and had remained open when the feature had been backfilled. It was not possible to tell if the culvert linked the feature with the present course of the Fosse Dyke, and it may have served only to drain the site of Mr Keyworth's premises into the feature.

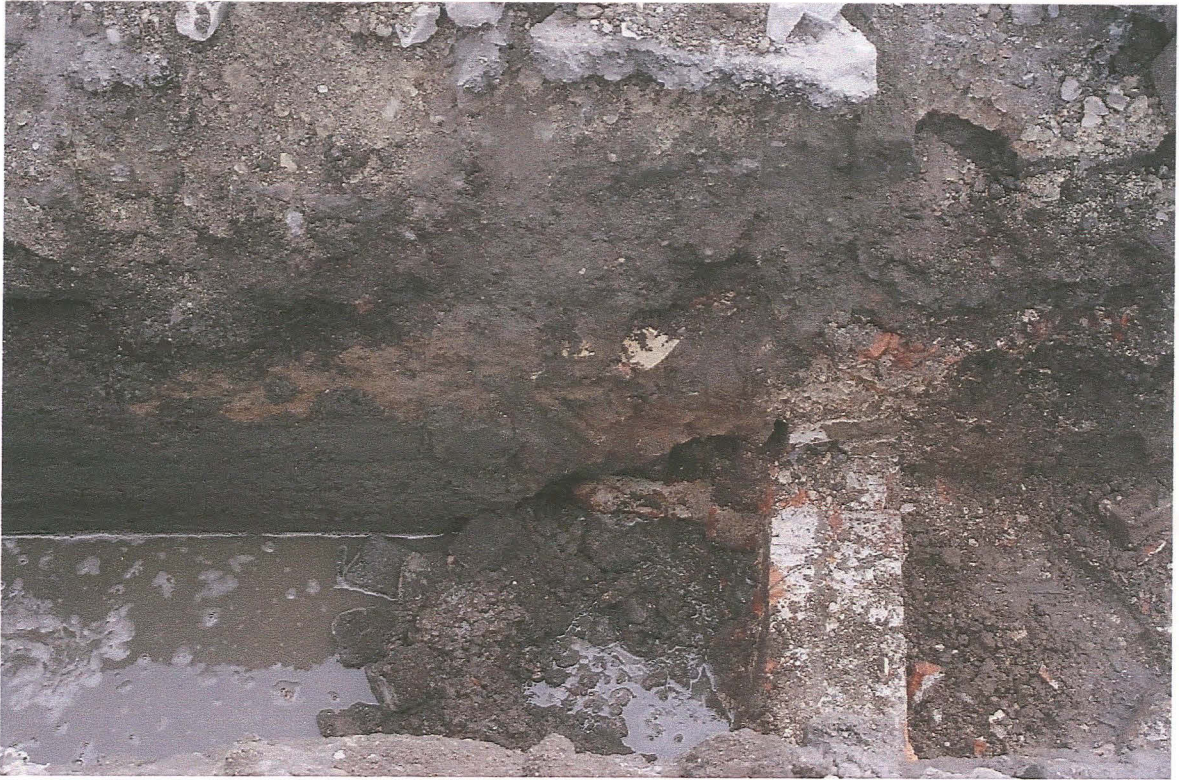
Pl. 17 Detail of deposits beside the culvert 650 and wall 649, Trench J (looking east).
