**21-25 St Catherines, Lincoln
Archaeological Evaluation**

**Report
for
Allbrite Homes Ltd**

LAS Report 813
May - April 2005

**21-25 St Catherine's, Lincoln
Archaeological Evaluation
NGR: SK 98200 71883
Planning Application No. 2004/0434/F
Conservation Area Consent 2004/0435/CAC
Site Code: LISC 04
LCNCC Accn No.: 2004.246**

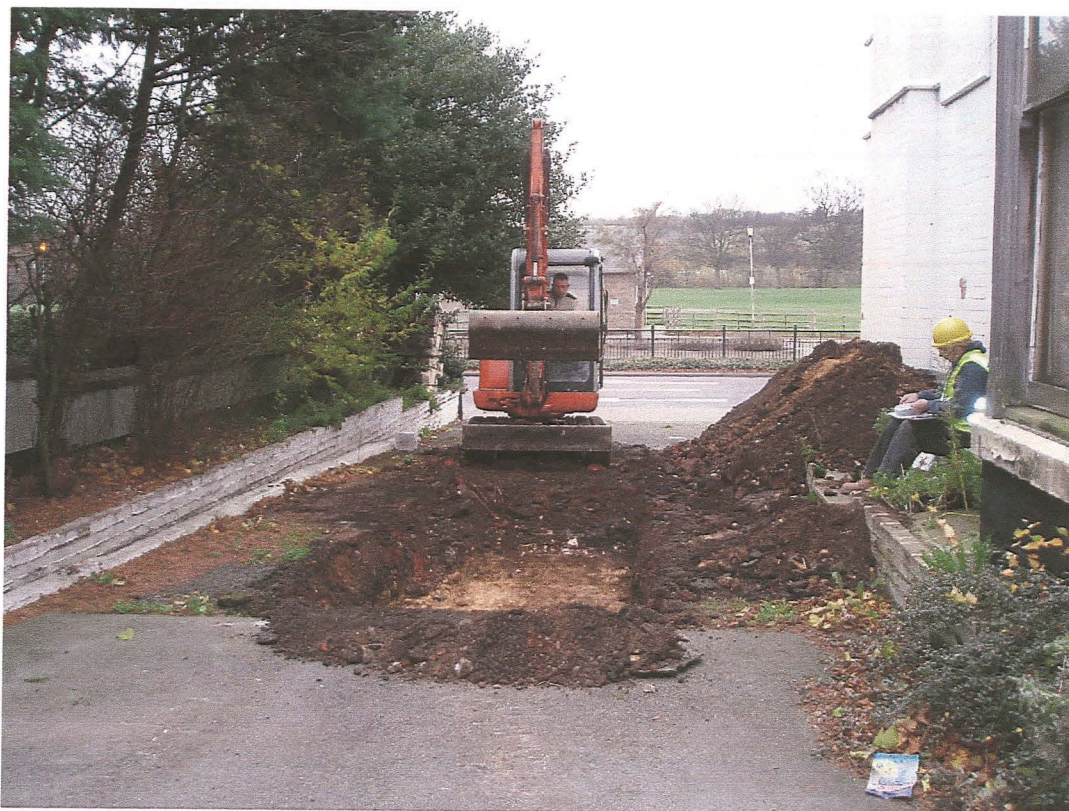
Pl. 1 21 – 25 St Catherines, Lincoln, trench location view looking east.

The single trench was placed in the driveway north of 21-25 St Catherine's (Pl. 1). Tarmac and rubble hardcore 0.25m deep, **100**, containing medieval tile, sealed a 0.12m dark black brown silt with modern clinker, brick and limestone fragments, **101** (Pl. 2). Beneath was compact brown clay silt **102** which tapered towards the east end of the trench (Pl. 2).

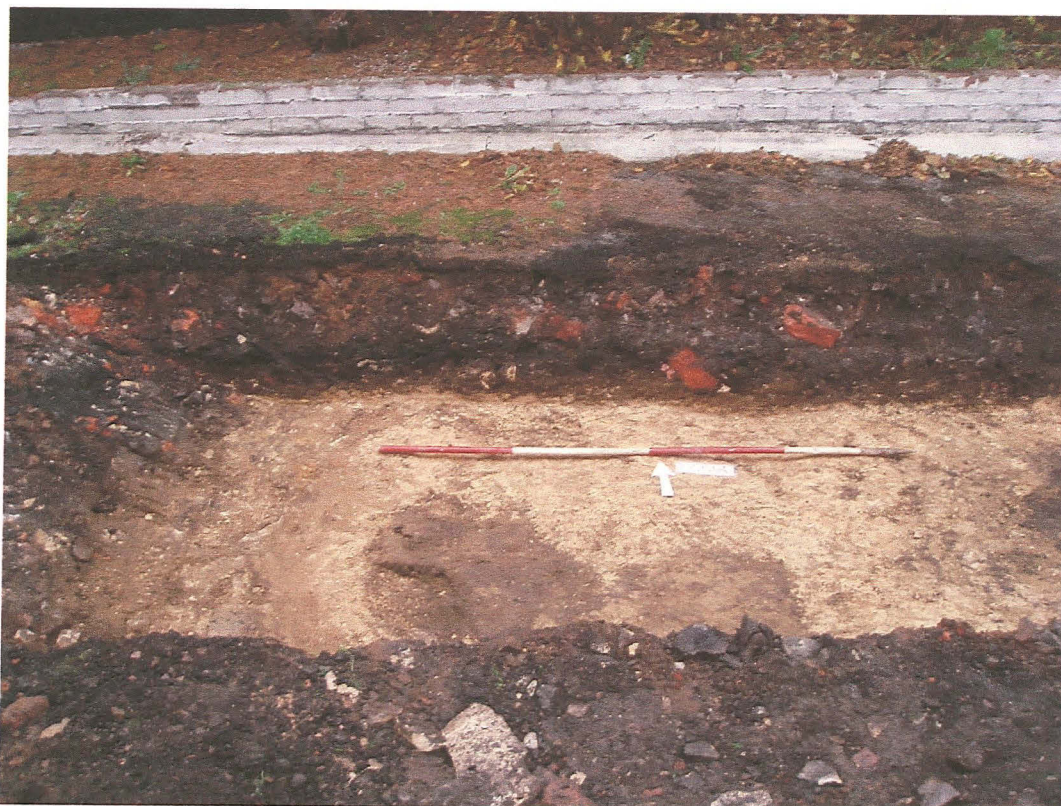
Pl. 2 Scoops 103 and 105 cutting into crushed limestone 107, with limestone fragments 108 to left of ranging pole and scoops. Looking north. Scale 2m.

An oval scoop, **103**, 1.04m x 0.70m x 0.07m, located at the western end of the trench, was sealed by **102** (Pl. 2). Filling the scoop was a light brown clay silt, **104**, which contained a fragment of 13th – 16th century tile and a sherd of 13th – 14th century Lincoln ware pottery. To the south-east of **103** was another similarly sized scoop, **105**, also filled with light brown clay silt, **106** (Pl. 2). These scoops cut a layer of cream yellow crushed limestone, **107**, which was up to 0.18m deep at the west end of the site (Pl. 2). Also at the west end of the trench was pale brown clay silt with limestone fragments, **108**, orientated north/south (Pl. 2).

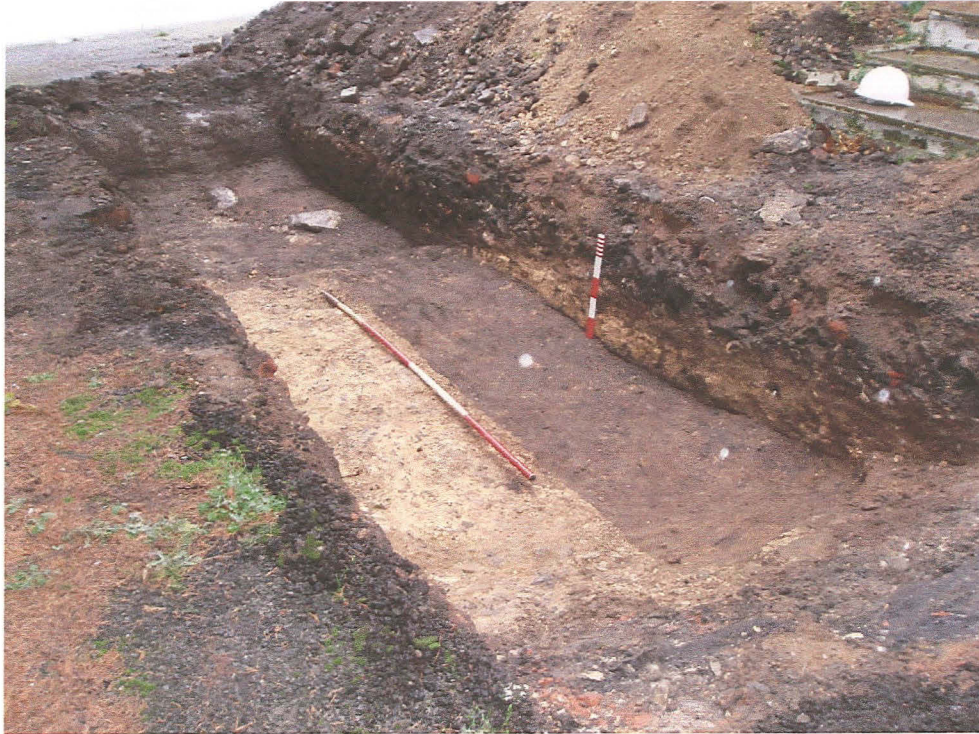
Pl. 3 Slot through crushed limestone 107 exposing layer 109 beneath. Pit 116 is in the south-east corner of the trench. Looking south-east. Horizontal scale 2m, vertical scale 0.50m.

Below **107** and **108** was a 0.20m layer of dark brown silt sand, **109**, containing a sherd of late 9th – mid 11th century pottery, a single sherd of glazed 12th century pottery, a late 13th – mid 14th century Lincoln Glazed ware sherd and a fragment of 13th – 16th century tile (Pls. 3 and 4). Cutting into **109** was a pit over 1.50m long, **116**, filled with a mixture of orange sand and dark brown silt, **117**, and two large limestone fragments close to the pits edge (Pl. 3). A similar piece of limestone was noted in possible posthole **120**, filled with dark brown silt, **121**.

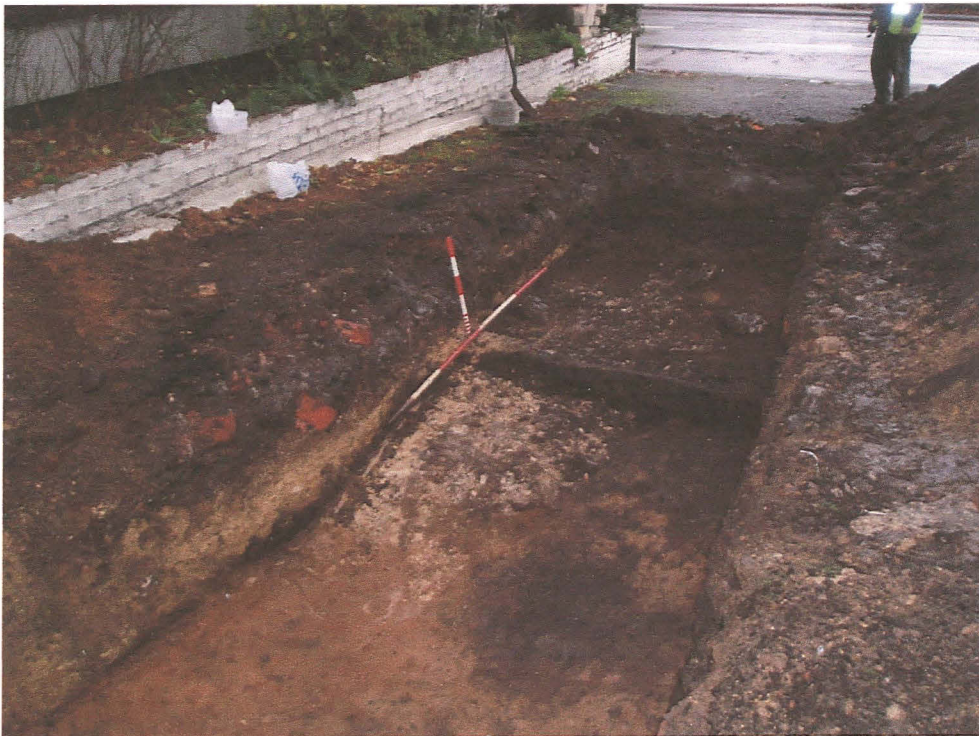
Pl. 4 Limestone rubble 110 with pit 115 to the south-west. Looking north-east. Horizontal scale 2m, vertical scale 0.50m.

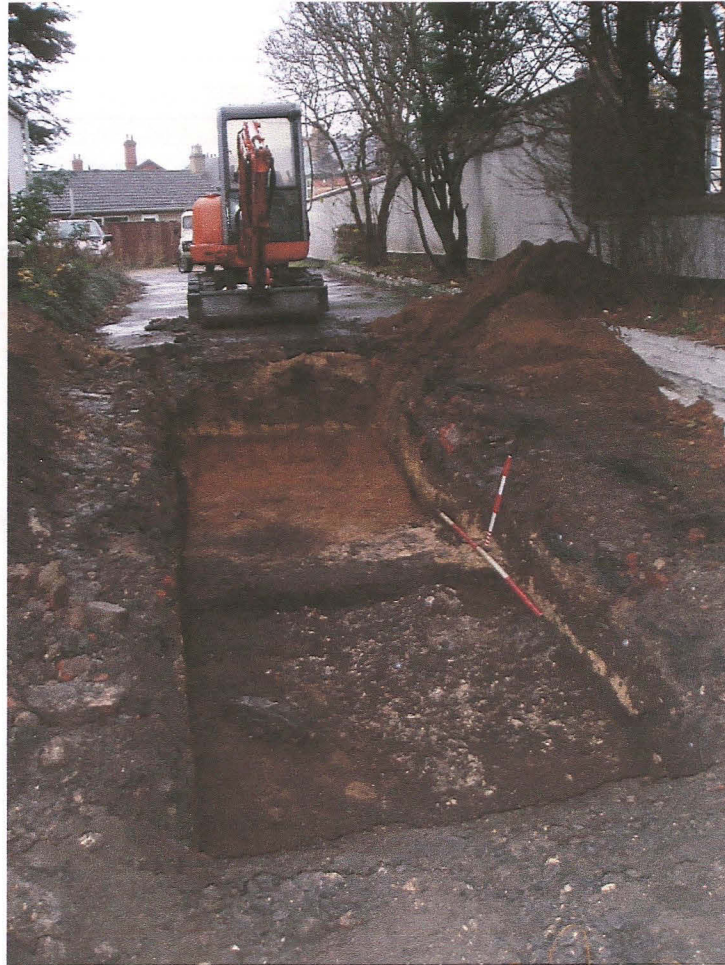
Pl. 5 General view of trench. Limestone rubble 110 cut by later features (113, 116, 118 and 120). Looking north-west. Horizontal scale 2m, vertical scale 0.50m.

Beneath **109** was a possible oval pit, **115**, 0.88m x 0.86m, unexcavated, filled with, **114**, a possible posthole, **118**, 0.40m in diameter, filled with dark brown sand silt, **119**, and a larger, pit, **113**, over 1.50m long, filled with dark brown sand silt and orange brown sand, **112** (Pl. 5). Sealed by these features was a layer of limestone rubble, **110**. A dark brown sand silt, **118**, appeared to be below **110** in the north-eastern corner of the trench. The earliest archaeological deposit sealed natural orange sand **111** (Pls 5 and 6).

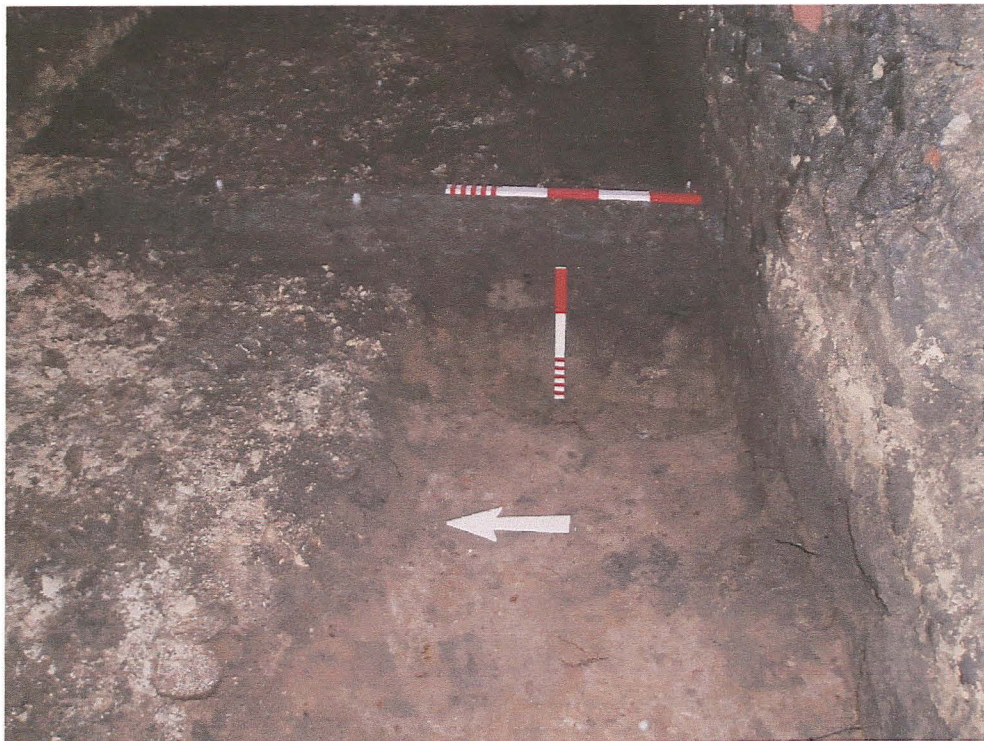
Pl. 6 West facing section through central deposits, including pit 113 which cuts 110. Horizontal scale 0.50m, vertical scale 0.30m

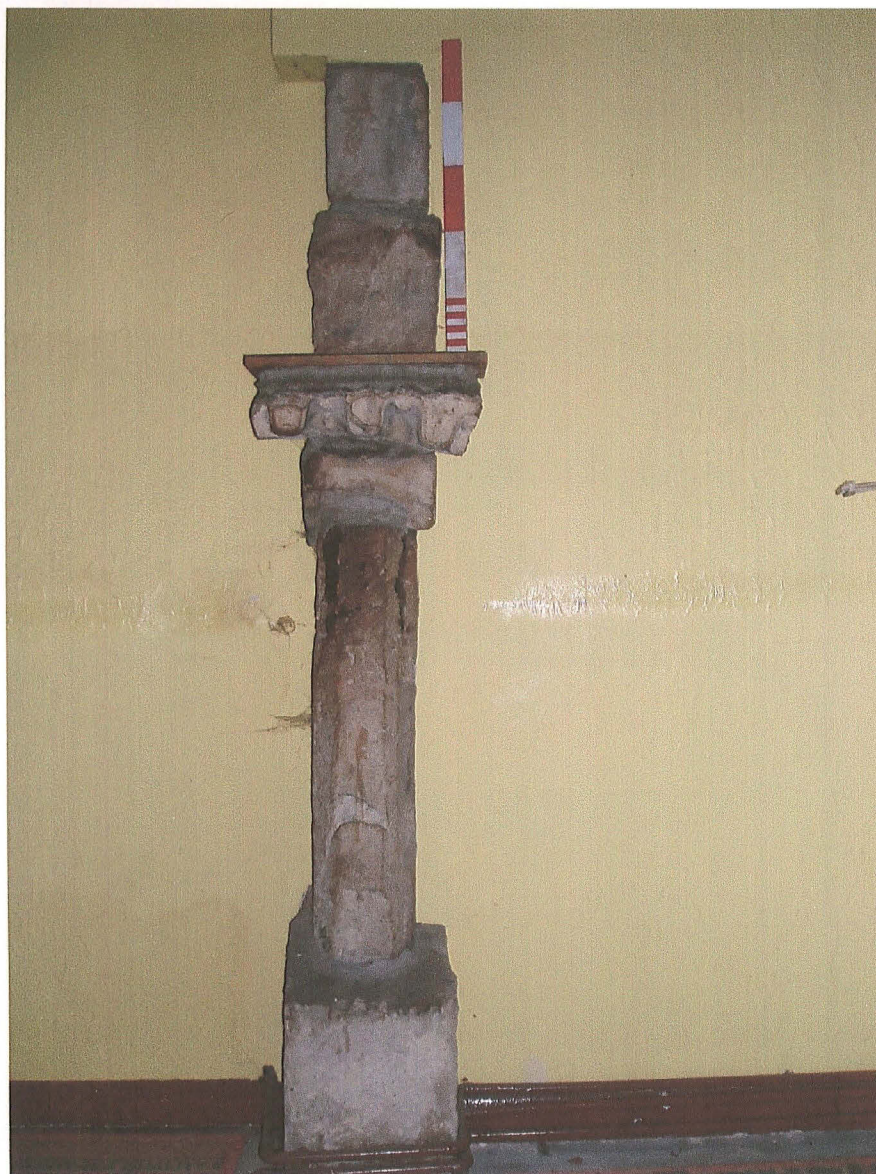
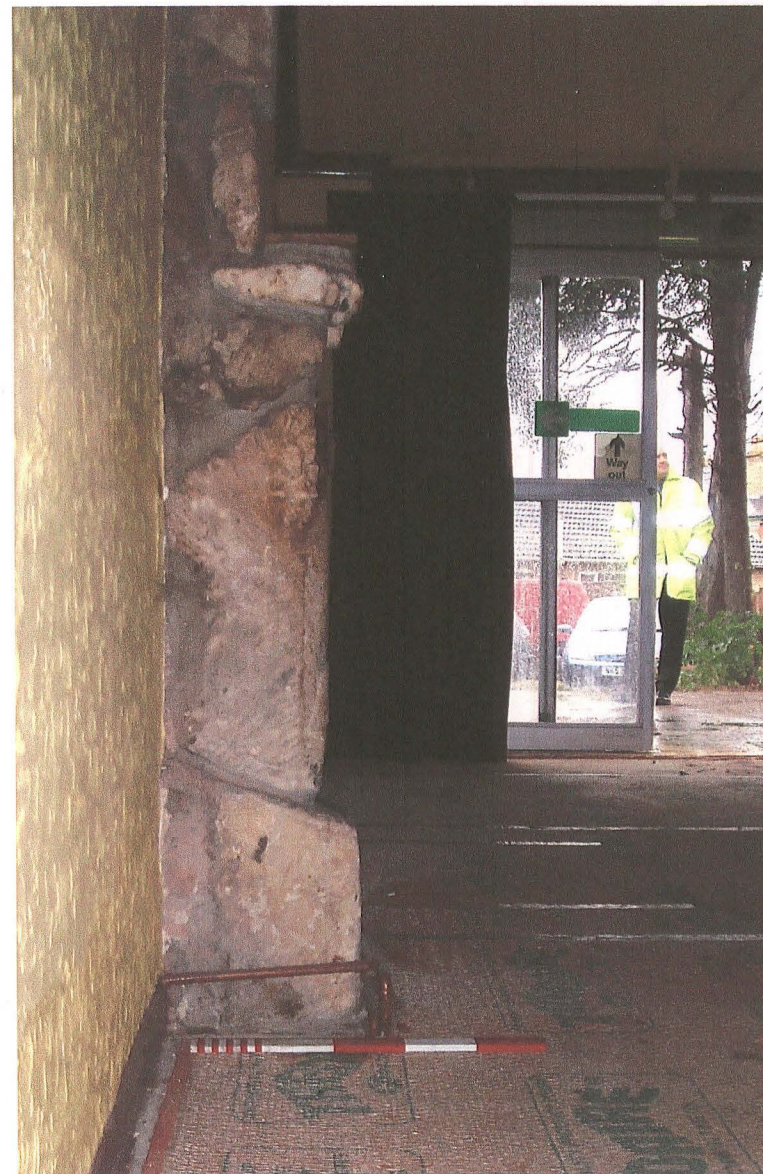
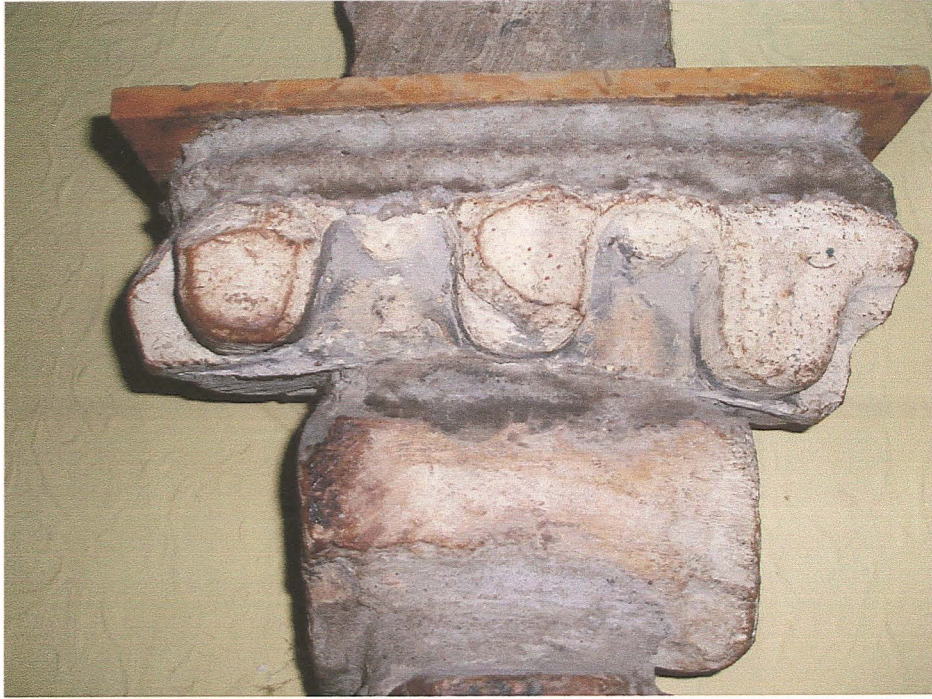
A single column or pillar had been built against the south wall of the room. It comprised a mixture of limestone rubble and reused architectural fragments. Most were undiagnostic but a large very worn decorated piece may be an arch capital of 12th century date (Pls. 7, 8 and 9).

Pl. 7 25 St Catherines. Modern 'feature' pillar in conservatory incorporating pillar capital of possible 12th century date. Scale 0.50m.

Pl. 8 Side view of the conservatory pillar. Scale 0.50m.

Pl. 9 Detail of pillar capital in conservatory

There are substantial numbers of architectural fragments which have been used both inside the building and out. Unfortunately, few have distinctive decoration which is diagnostic of date or function but there is every likelihood that they originate from the medieval Priory located close to the site. The stones have been bonded in cement-based mortar which is probably harder than the stonework. Dismantling of the material will probably be almost impossible without damage to the stones.

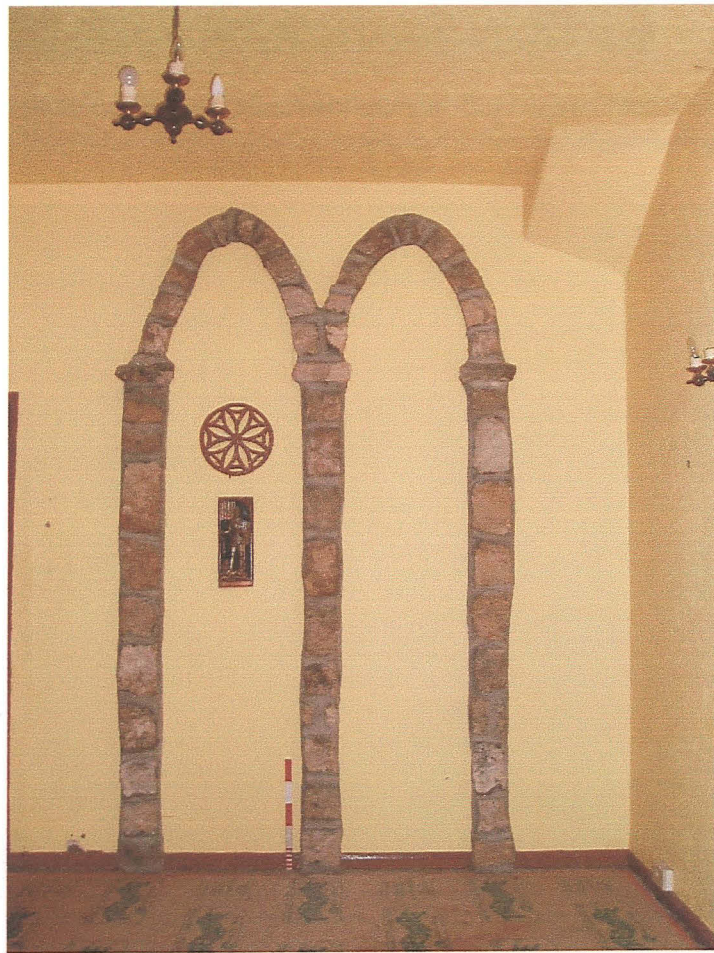
Built against the south wall of the conservatory was a blind arcade in Saxon style. Again the majority of the stone was undiagnostic and comprised a mixture of rubble and worked stone. The central column of the other arcade possibly had a moulded stone but render/ cement covered too much of the stonework to allow any positive identification (Pl. 10).

Pl. 10 Modern 'arch' in conservatory constructed with reused architectural fragments. Scale 0.50m.

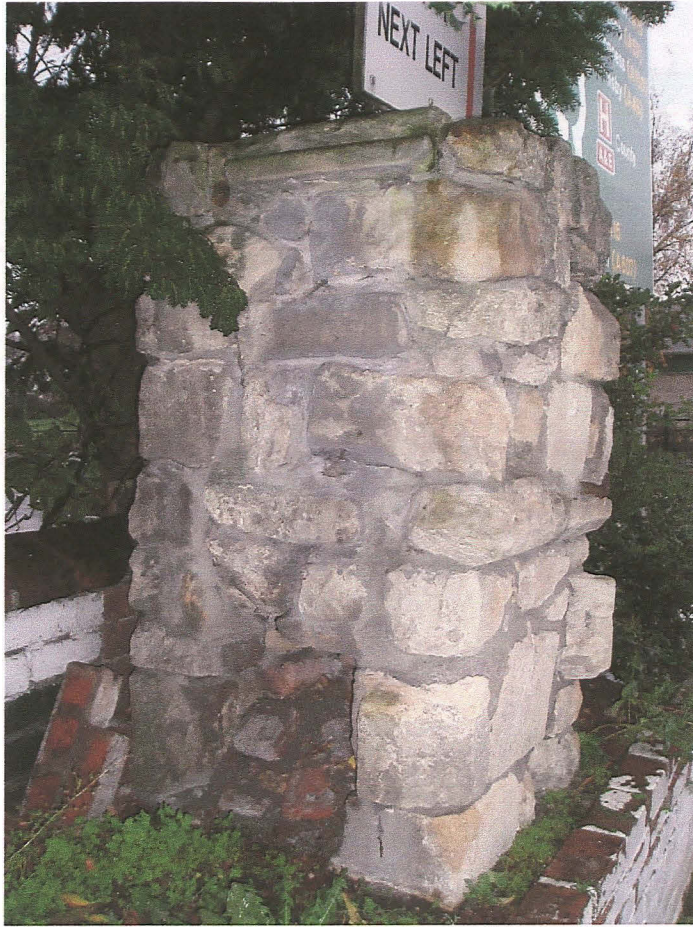
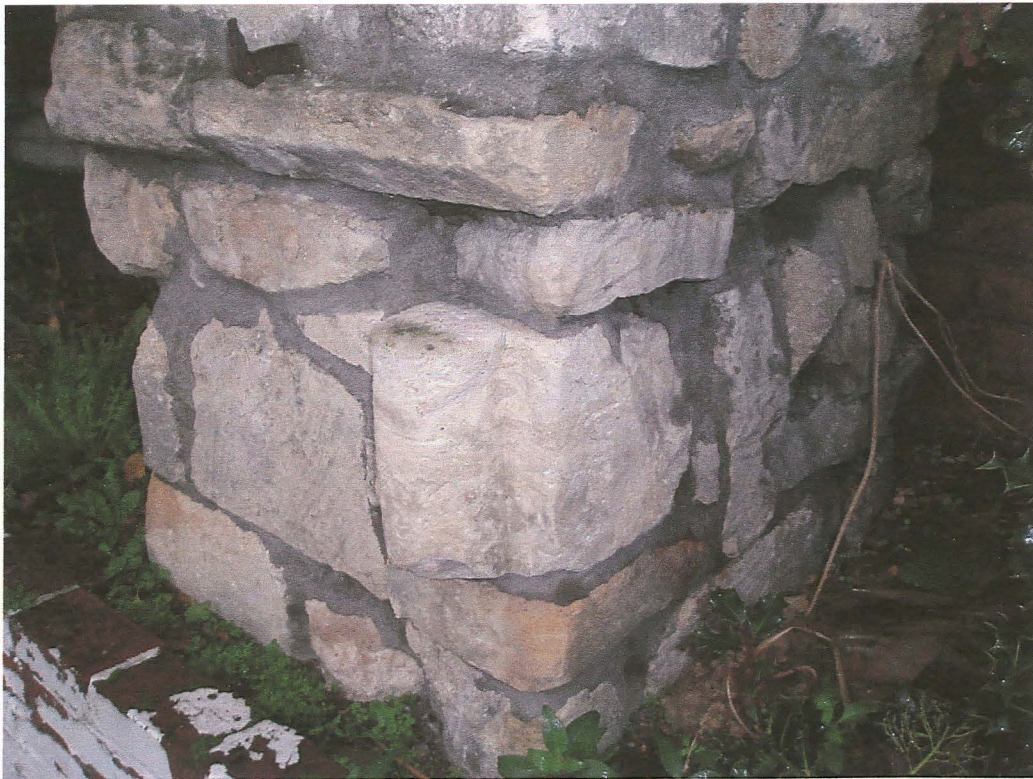
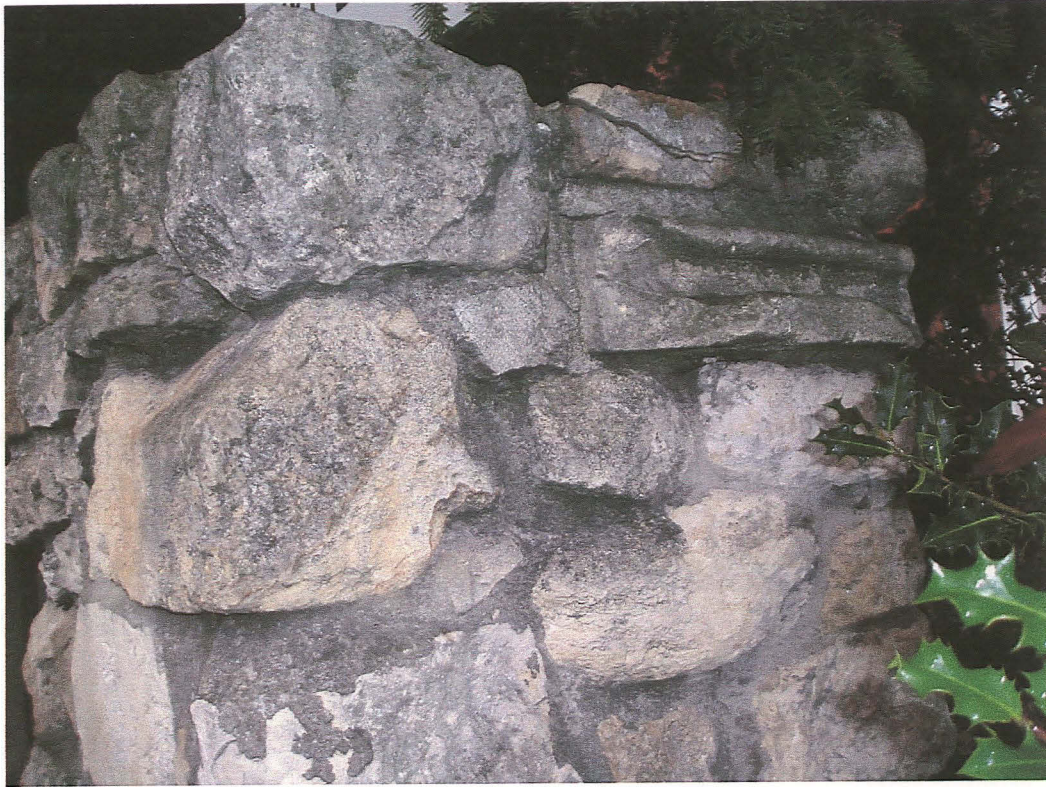
In the driveway to the north of the building, close to the northern boundary of the site are two piers constructed using architectural fragments and rough pieces of limestone rubble. Pier 1 near the front of the property contains two chamfered blocks of unknown date and a moulded piece of frieze (Pls. 11, 12 and 13). Pier 2, to the rear of the house, contained a chamfered block, possible the top of an pillar (Pls. 14 and 15).

Pl. 11 Pier in front garden of 21 St Catherines incorporating re-used masonry.

Pl. 12 Detail of pier showing chamfered blocks on south face.

Pl. 13 Detail of pier 1 showing architectural fragment close to the top of the east face (right hand side).

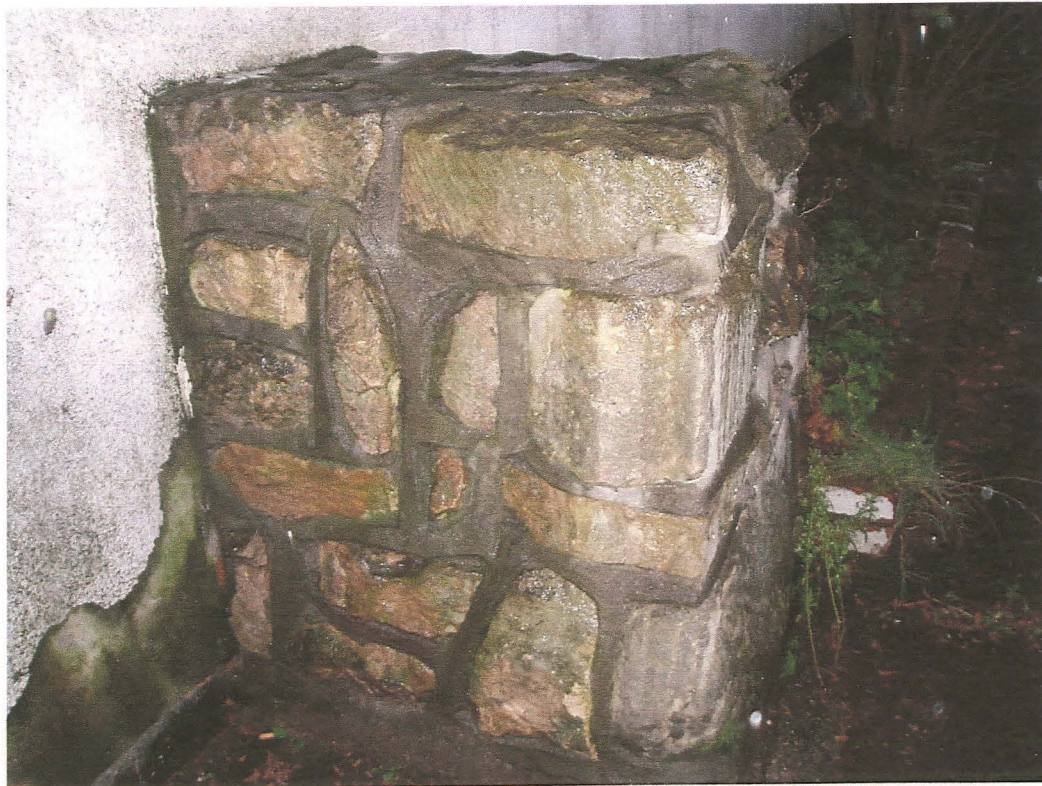
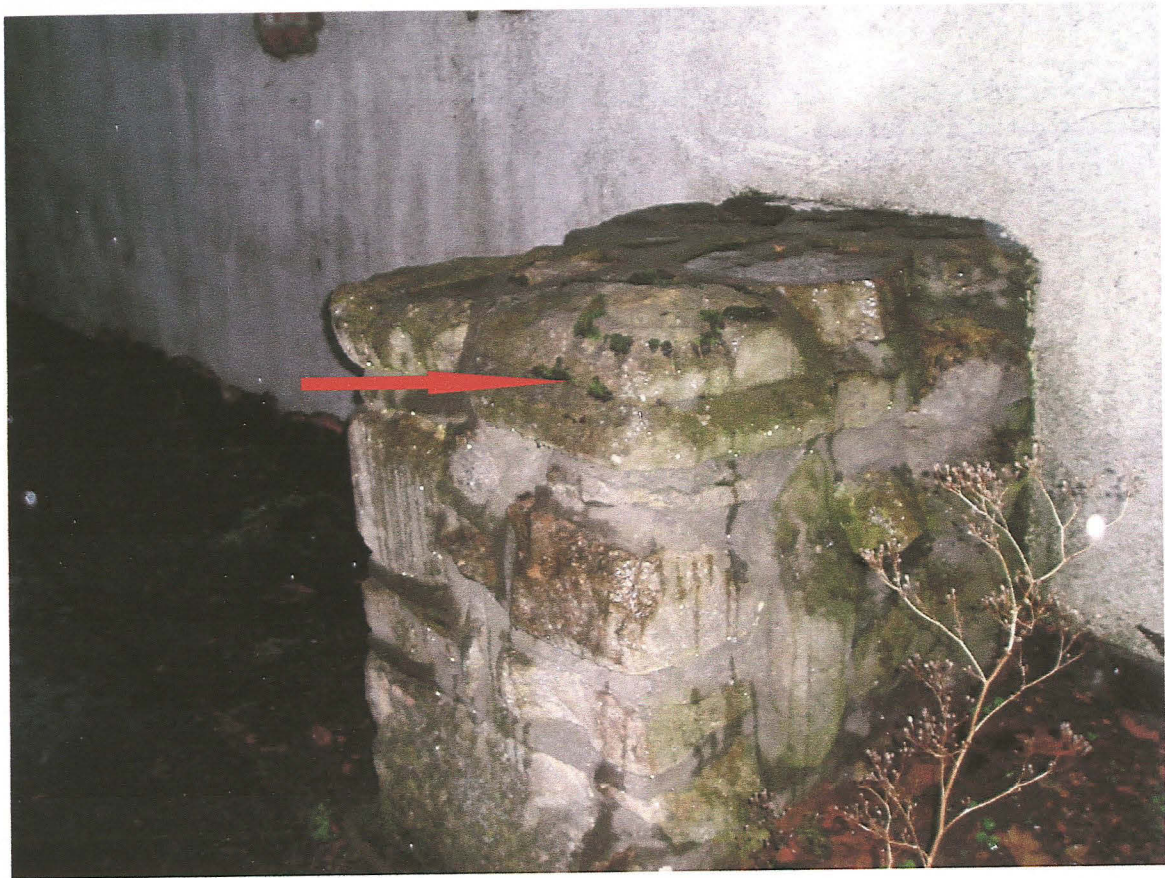
Pl. 14 Pier 2 at rear of 21 St Catherines incorporating re-used masonry. West face.

Pl. 15 Detail of pier 2 showing possible column capital on top of the pier (upside down).
Looking northwest.
