**Flood Relief Pipeline, Waddington, Lincs.
North Hykeham DG5 Flooding Scheme**

Archaeological Watching Brief

**LAS Report No. 800
May 2005**

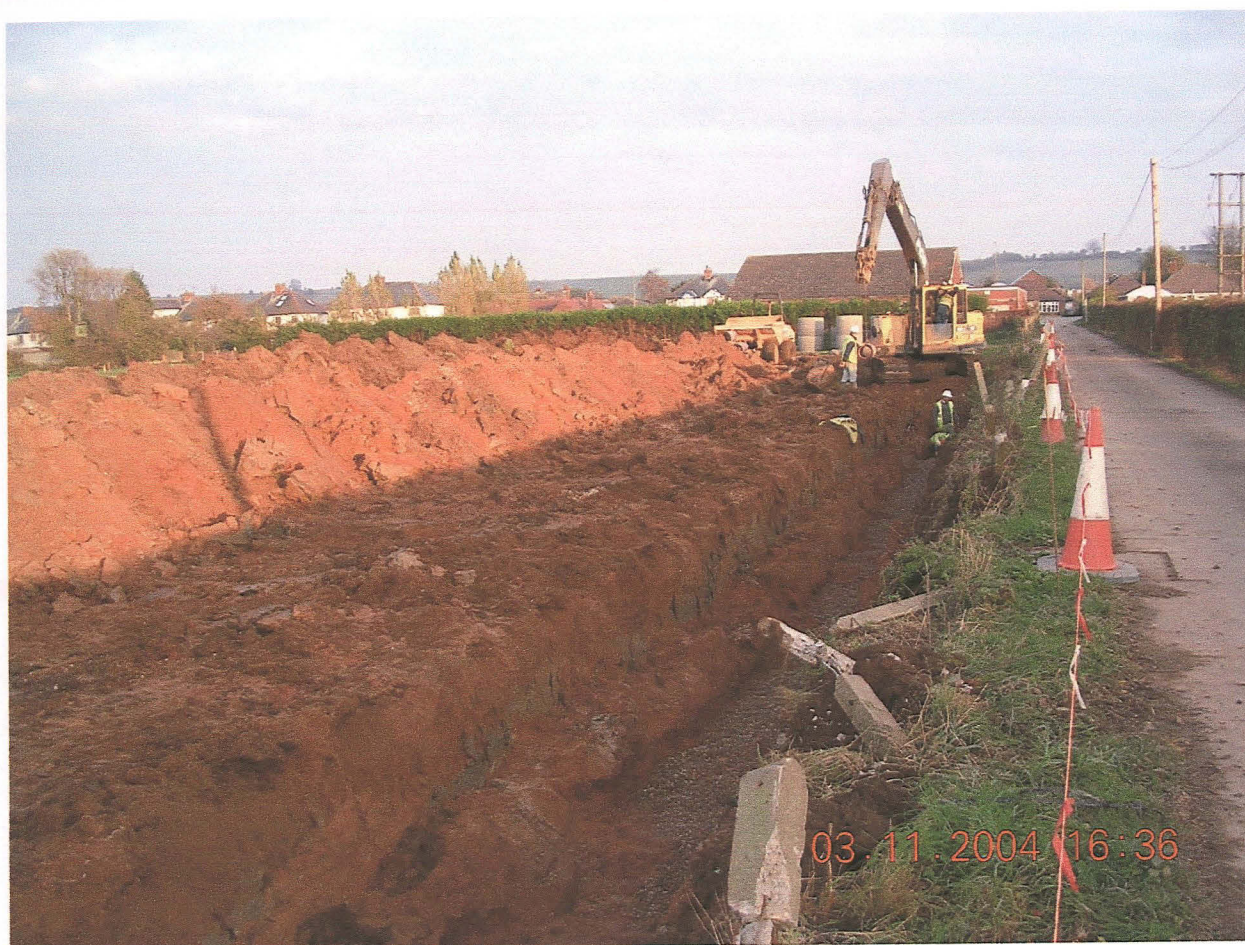
Pl. 1 The pipeline route (looking east towards Brant road).

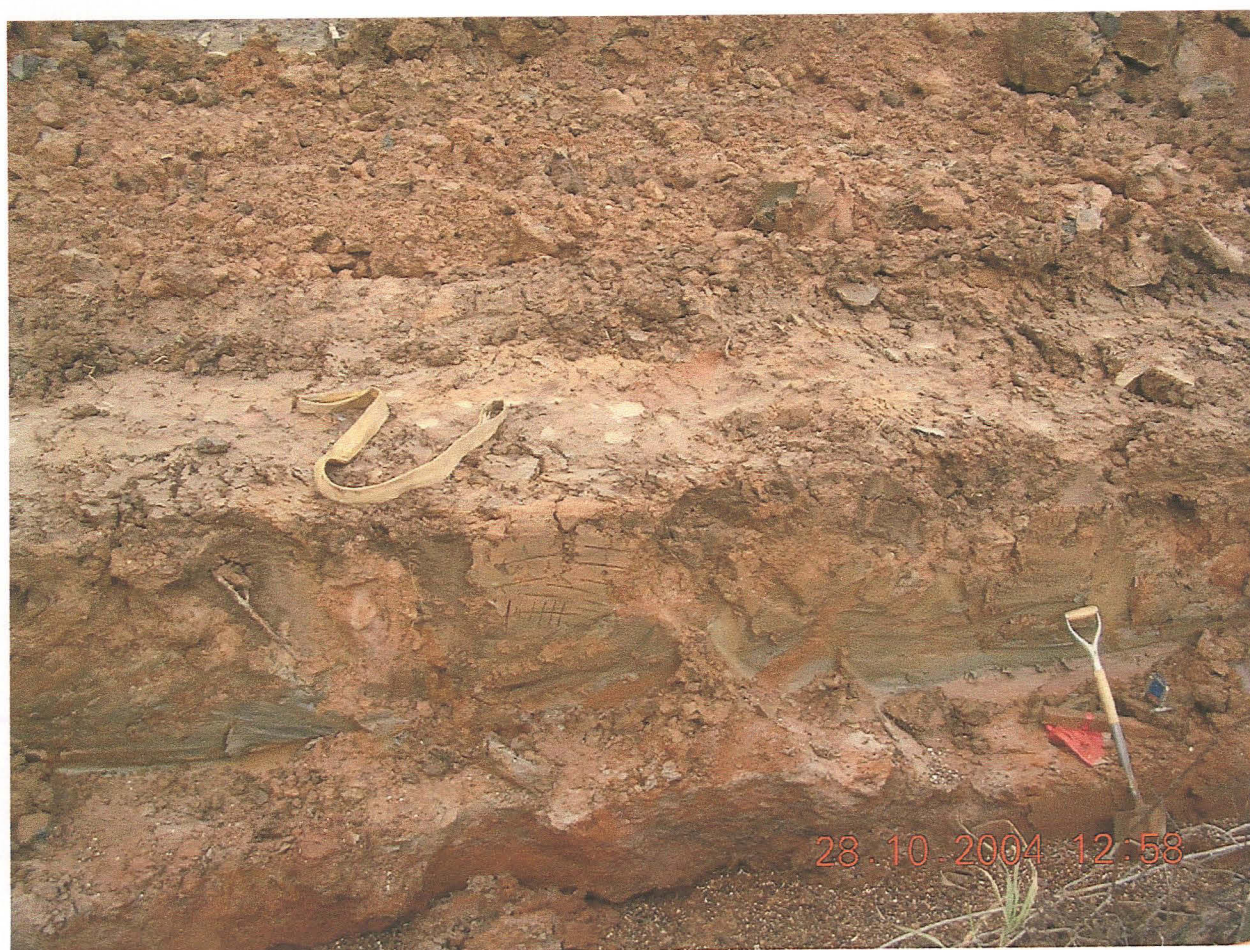
The sequence of deposits in the trench face varied considerably between the treatment works compound and Brant Road. At Observation 1, about 100m south of the compound, the topsoil covered 0.35m of yellow sandy clay 2, above a 0.4m thick band of light grey clay 3 (Figs. 2 and 3a; Pl. 2). The colour of this layer indicated the decomposition of organic material, probably vegetation, in waterlogged conditions. Beneath it was 0.15m of yellow sandy clay 4, above a layer of brown sandy clay 5 with horizontally laid twigs and other organic traces. Layer 5, at least 0.35m thick, was interpreted as material deposited by a river or stream, and the deposits above it seemed to be the results of different episodes of alluvium. Further south, red clay 6 was exposed below 5 at the base of the trench in places, but did not form a continuous layer.

Pl. 2 Deposits visible in the trench face beside the access road.

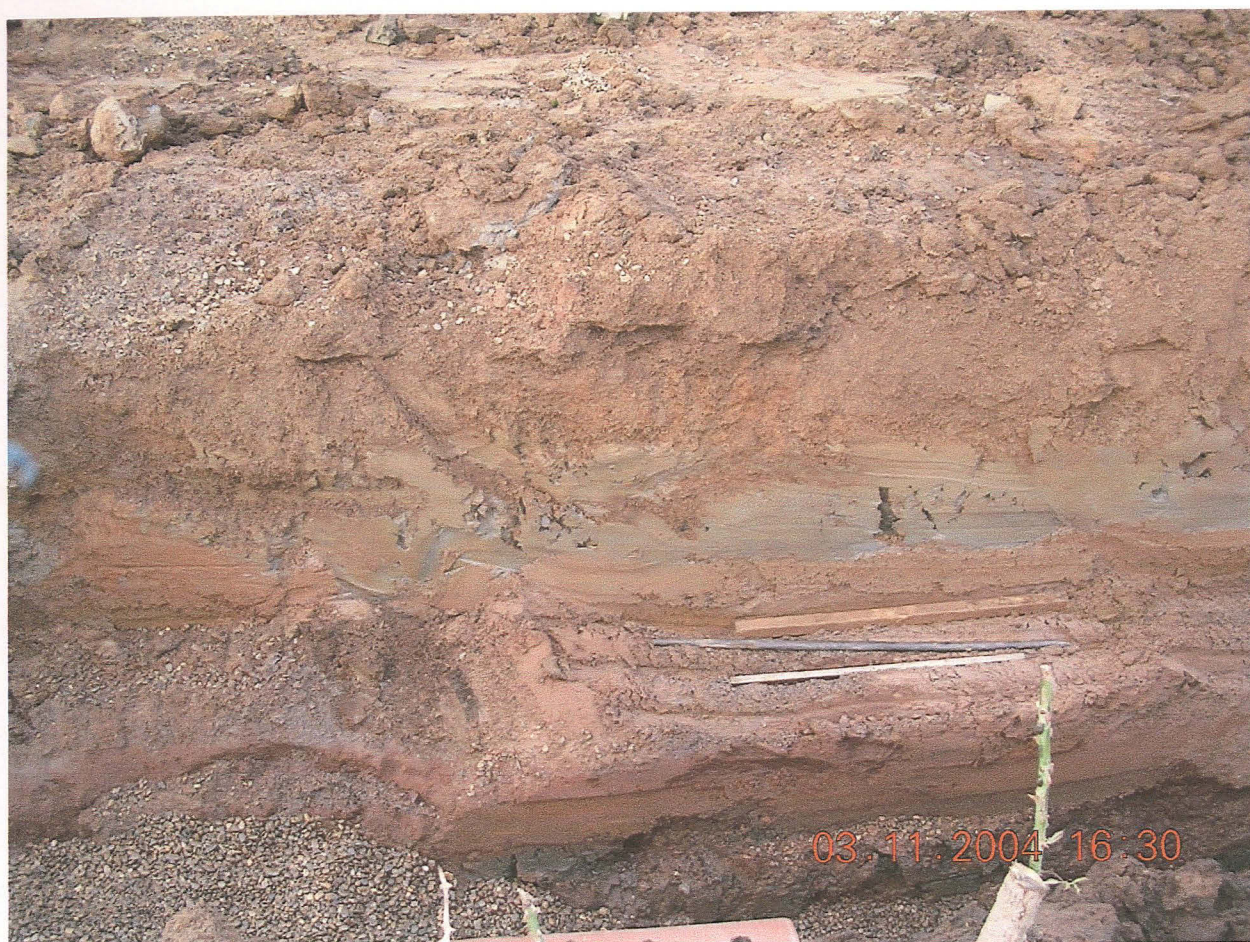
Immediately north of the Social Club, there was no trace of red clay, but dark grey firm lias clay 15 was visible at about 2.5m below the ground surface (at a depth of about 4.6m OD). Above the clay were several layers of sands and gravels, with a yellow clay 8 and an underlying grey clay 9 probably representing the flood alluvium seen in the trench to the north (Figs. 2 and 3b).

Pl. 3 Deposits visible in the trench face north of the Social Club building.
