Ulceby Cross Service Station
Ulceby Cross, Nr Alford, Lincs
Archaeological Watching Brief
NGR: TF 41273673
Site Code: UCSS 05
LCC Museum Accession Number: 2005.36
Planning Application: N191/01/934/03.

LAS Report No. 816
April 2005

**Ulceby Cross Service Station, Ulceby Cross, Nr Alford, Lincs
Archaeological Watching Brief**

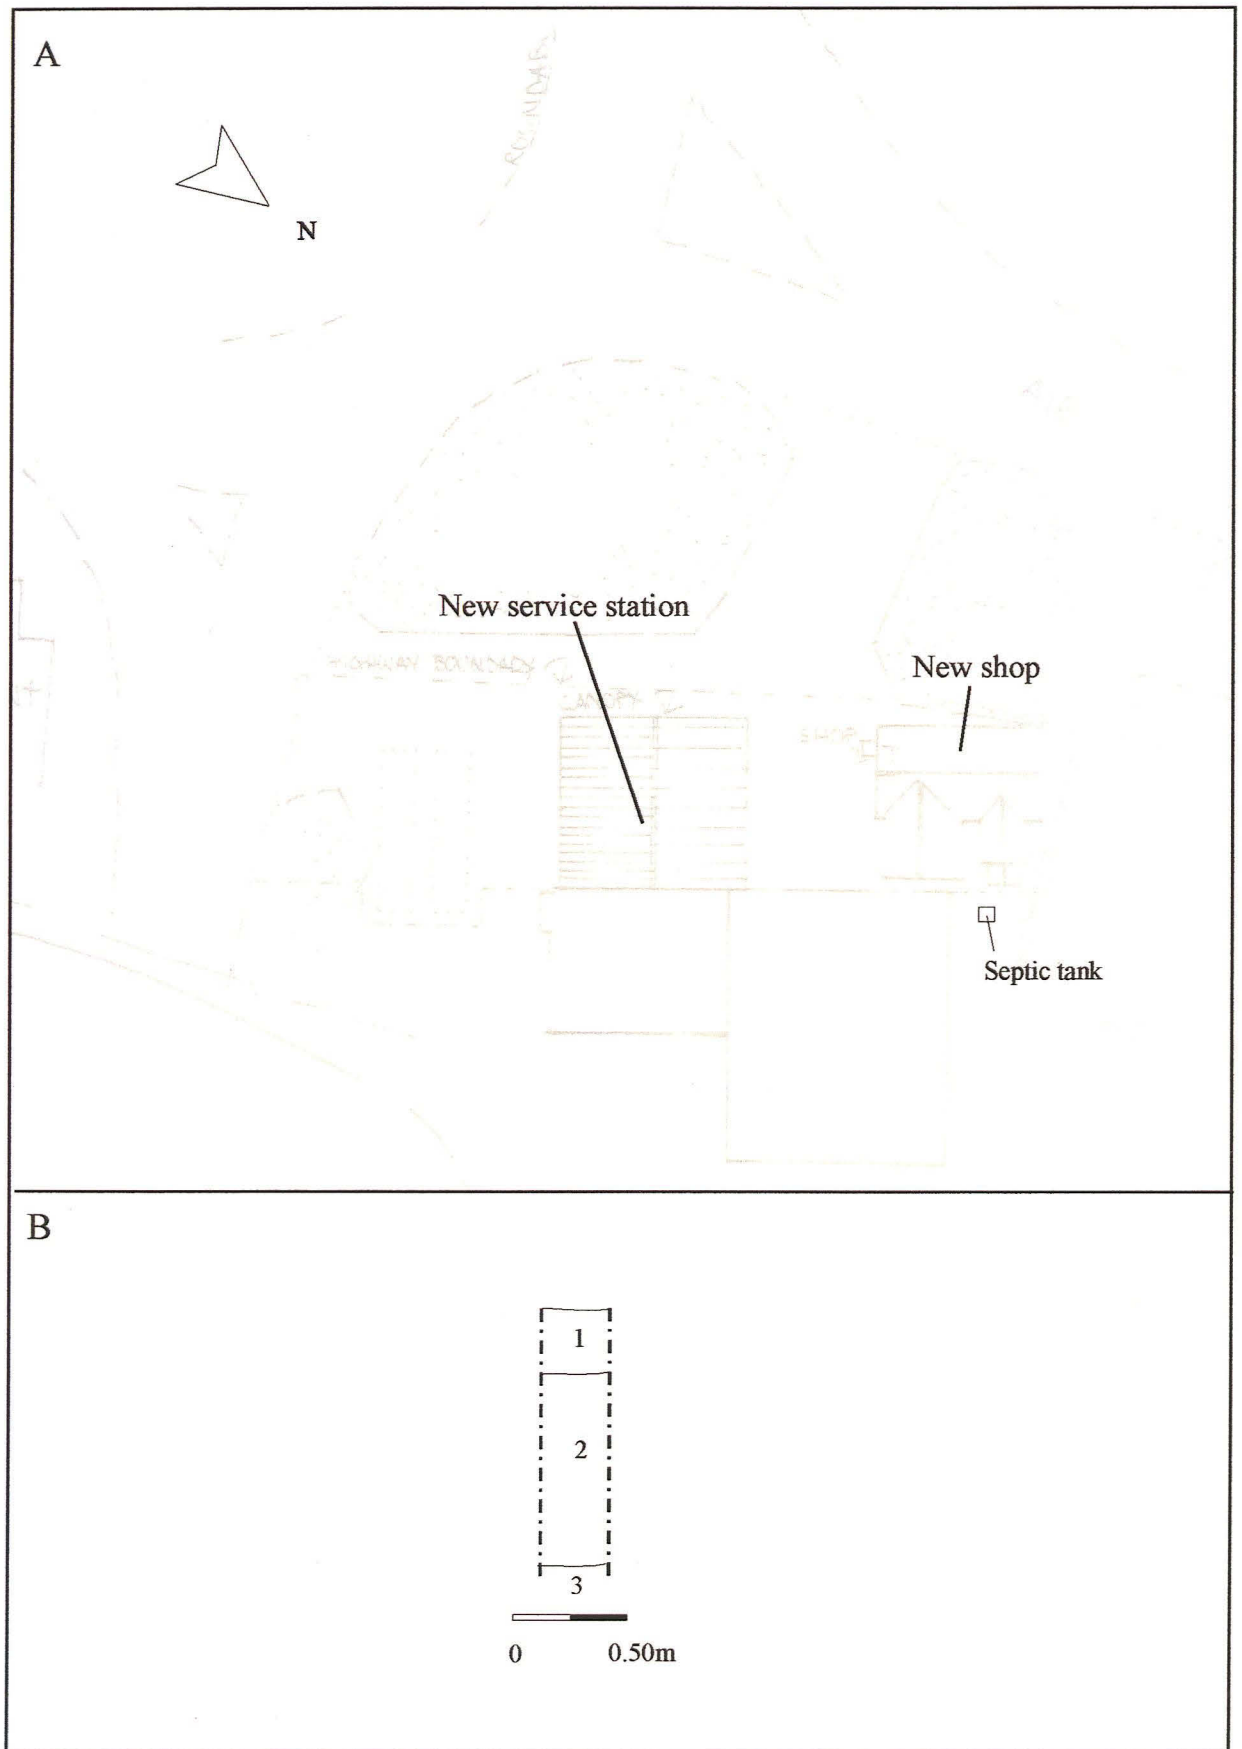
Work on the septic tank, c.2m to the north of the current shop, began by removing 0.28m of topsoil, **1**. This sealed a 0.82m deep plastic red brown clay, **2**, which was above limestone brash, **3**. No archaeology was noted in plan or section.

Fig 2 A) Location of the new service station, shop and septic tank at the Ulceby Cross service station.
B) Section seen in the side of the Septic tank.

Since the septic tank produced no archaeology it was decided by the Built Environment Officer, Dr Beryl Lott, that the later phases of the service station and shop groundwork did not require a watching brief because they overlay areas already disturbed by the present service station.
