**The Calceby (Lincolnshire) Rebuild Project:**

**Archaeological Monitoring during the Renewal of the  
Electricity Transmission Network in parts of  
Driby, Calceby and South Ormsby**

**EAST MIDLANDS ELECTRICITY plc**

**FEBRUARY 1995**

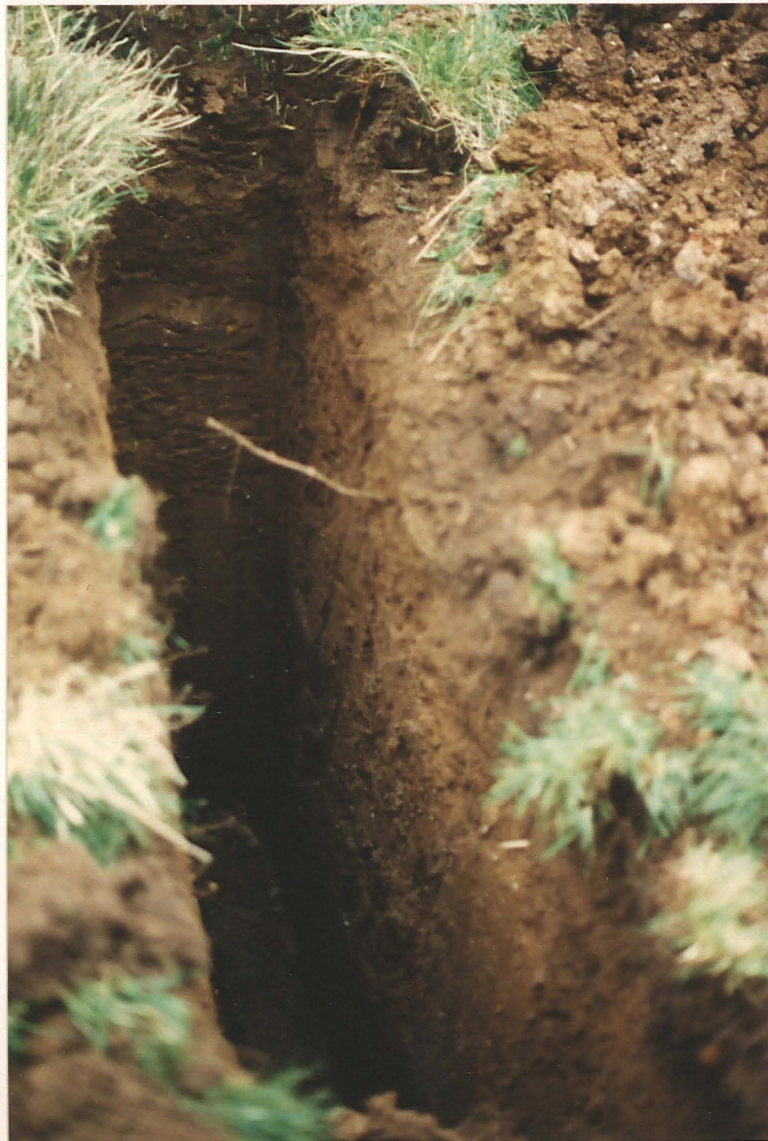
**Pl. 3 Face of Hole 1, looking north to base of hedge**

1. The first hole monitored at Driby was against a hedge at the northern side of grassland east of a small stream (Pls. 1 and 2). The hole cut through 0.2m of topsoil, above 1.45m of brown clay loam with chalk inclusions (Pls. 3 and 4). The lowest layer revealed was a dark brown clay with few chalk pieces which extended below the trench base. No finds were found in or beside this hole.

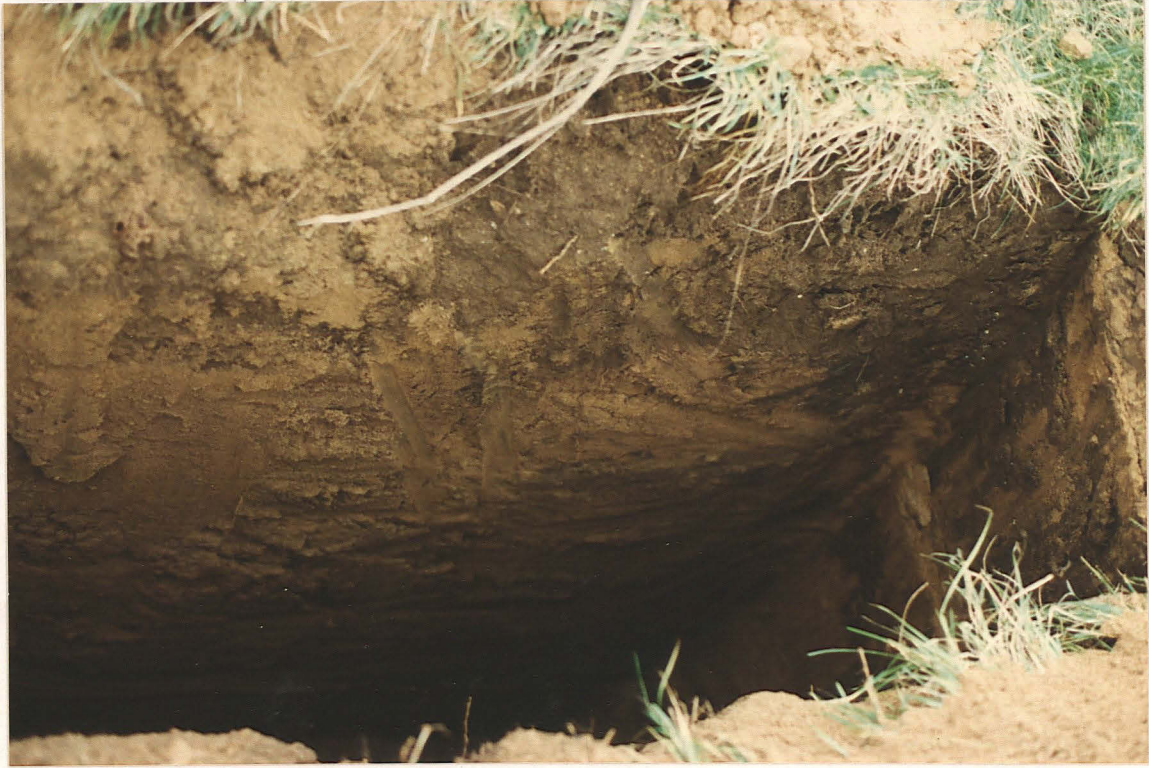
Pl. 10 Faces of Hole 5

5. The hole was dug on the eastern roadside verge, east of the field containing the ruins of St. Andrew's Church (Pl. 9), and in a deep cutting. Below the turf, the section revealed 0.4m of dark brown sandy loam with small fragments of chalk. One animal bone, a fragment of roof tile and a 18-19th century brick was found in that soil. Below that layer, and extending beyond the trench base, was a very light brown sand layer (Pl. 10).

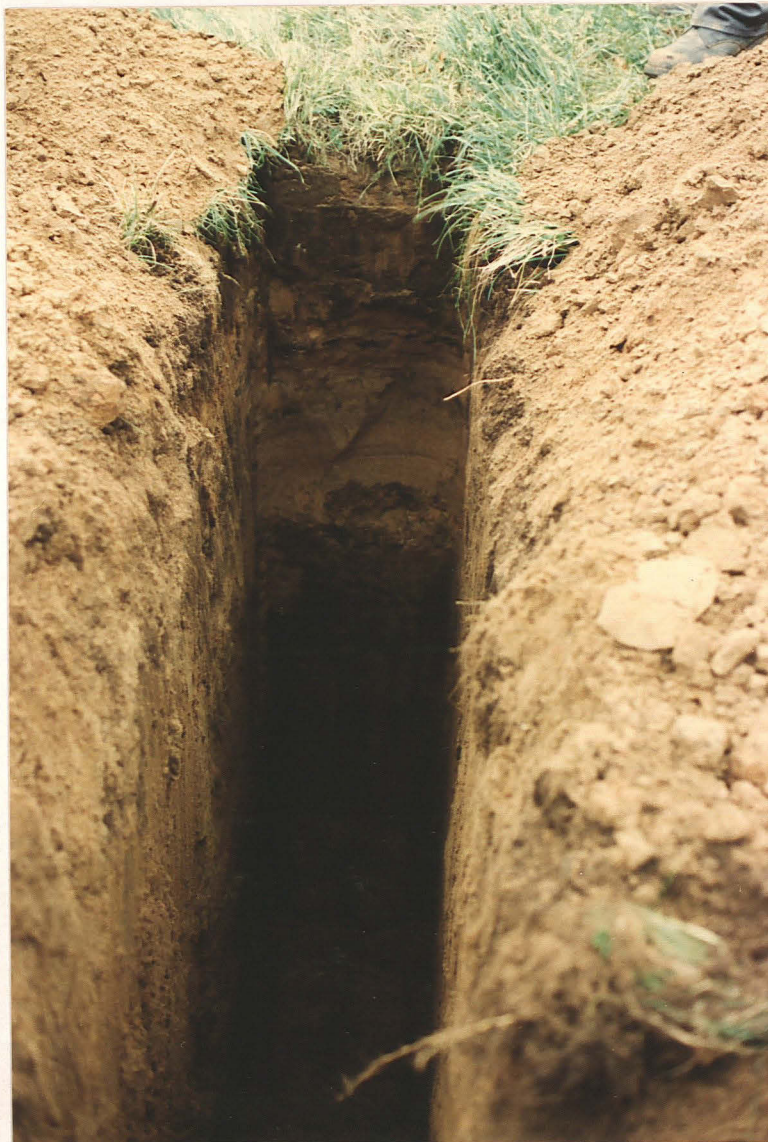
Pl. 11 Stratigraphy within Hole 6

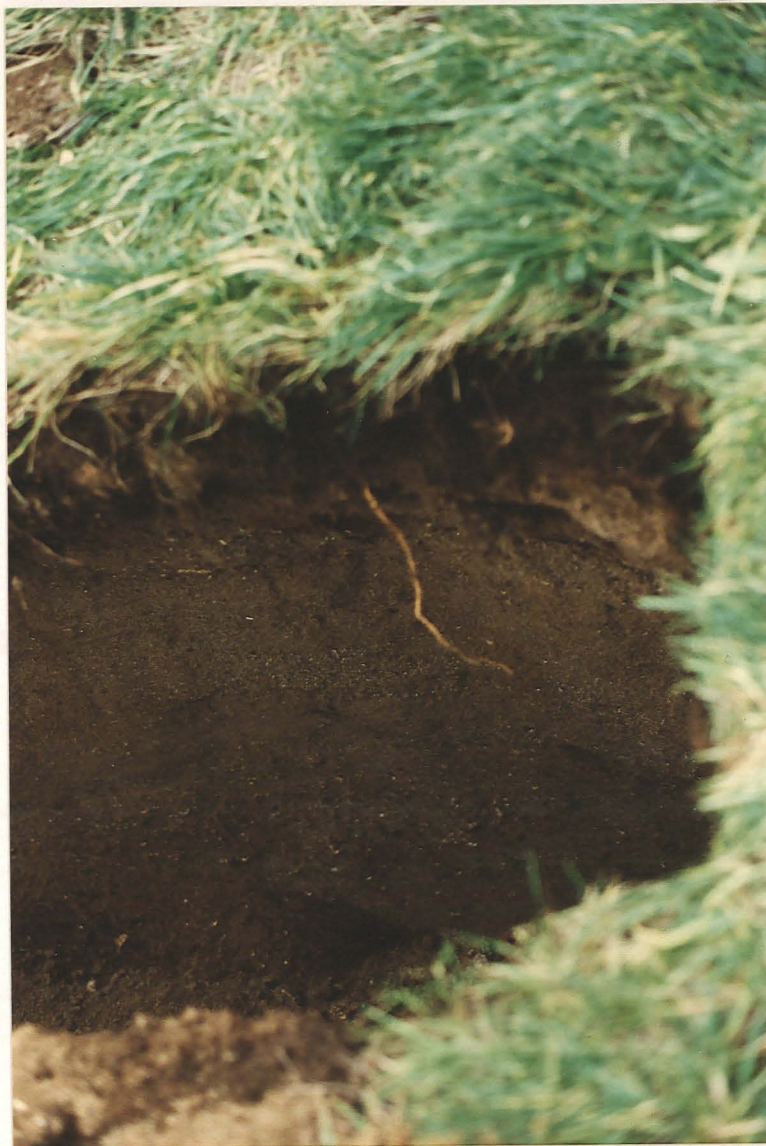
**Pl. 12 Sand deposit in sides of Hole 7**

7. On the western verge, NW of 'Hillcrest' the topsoil overlay clean light brown sand. At the top the grain size seemed very fine, becoming coarser towards the trench base (Pl. 12). Three post-medieval pottery sherds were found in the topsoil.

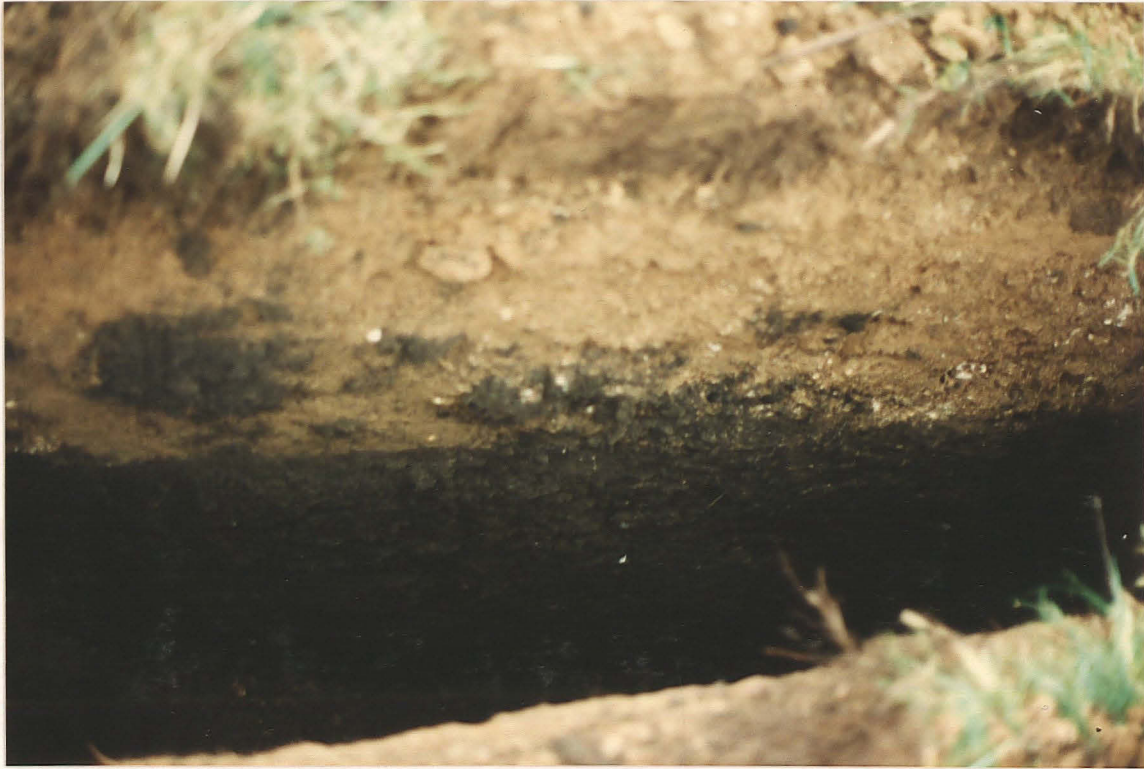
**Pl. 14 Section across Hole 11 at A16 junction, showing peat deposit**

The hole cut through topsoil above 0.16m of chalky clay which may have been re-deposited. Between 0.3m and 0.95m below the present verge surface sand was recorded, but this was found to cover 0.1m of peat with twigs and fragments of small branches (Pl. 14). The base of the hole was in a peaty sand deposit.

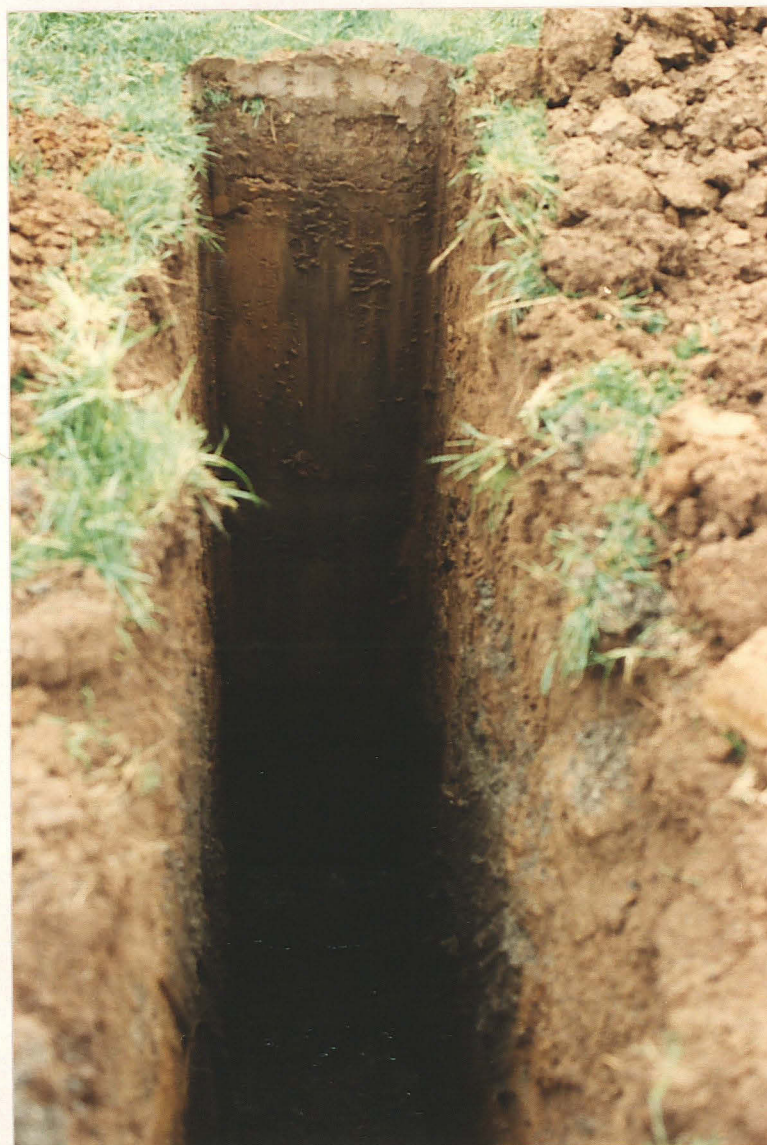
**Pl. 24 East face of Hole 16, showing organic material near the trench base (depth 2m)**

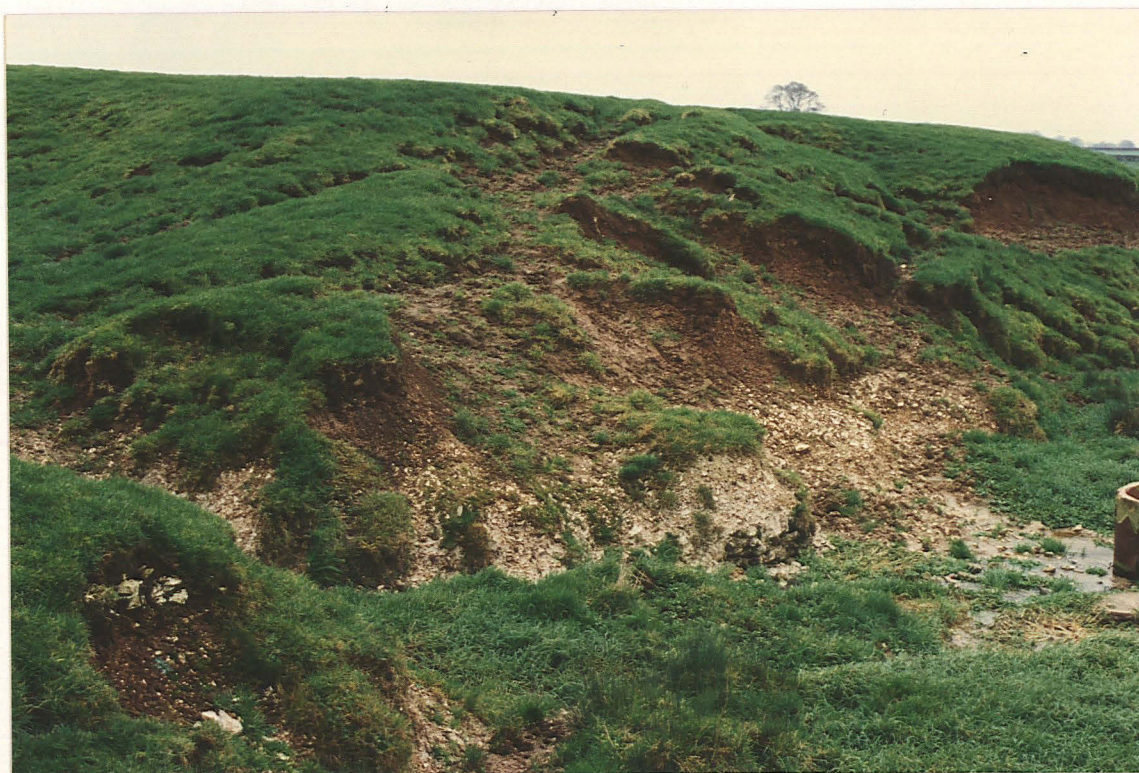
**Pl. 27 Chalk strata exposed beside small stream, south of Bluestone Heath Road. On the extreme left, small chalk blocks above dark brown soil may represent a medieval building foundation (looking SW).**

On the southern side of Bluestone Heath Road, an inspection of molehills across the pasture field with earthworks resulted in the collection of medieval pottery sherds. The sections of the high ground cut by a small stream contained quantities of chalk apparently *in situ* but higher than to the north. An adjacent exposure may have been chalk blocks from a medieval building foundation (Pl. 27).

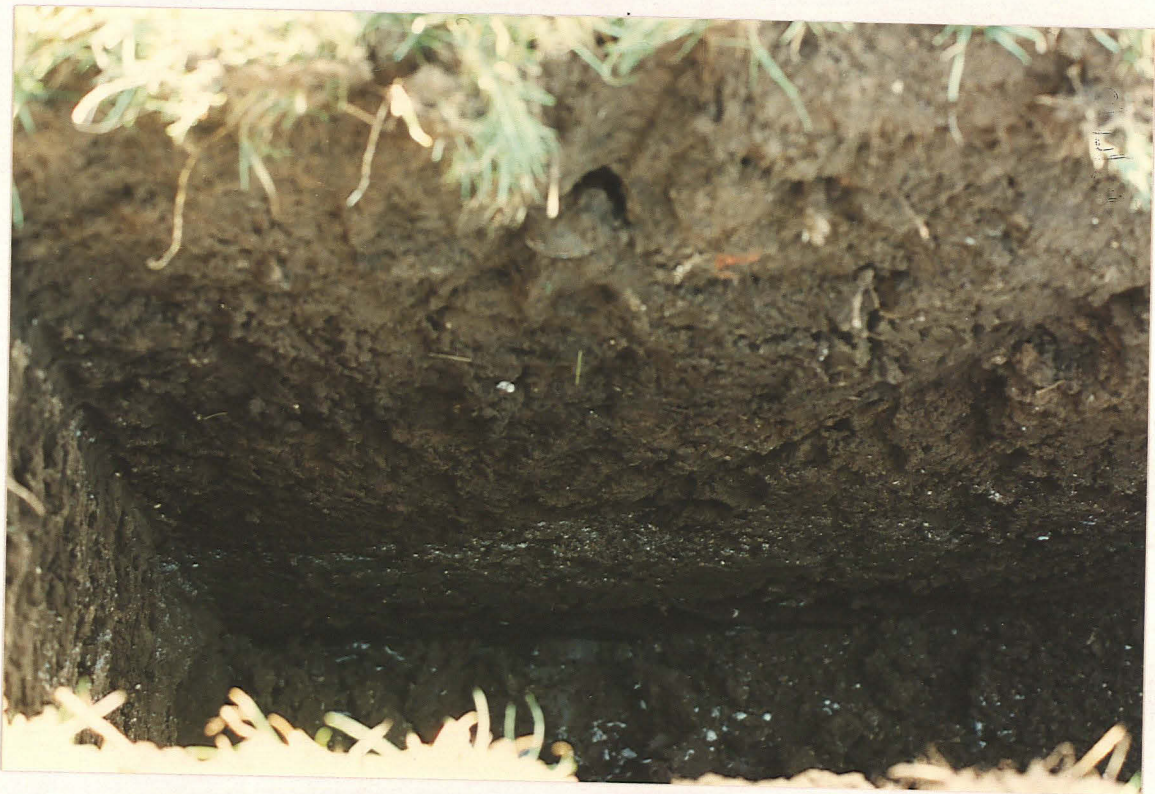
Pl. 31 Section of Hole 22, with the lower chalky layer dipping to the left, perhaps indicating an early field boundary (depth 2m)

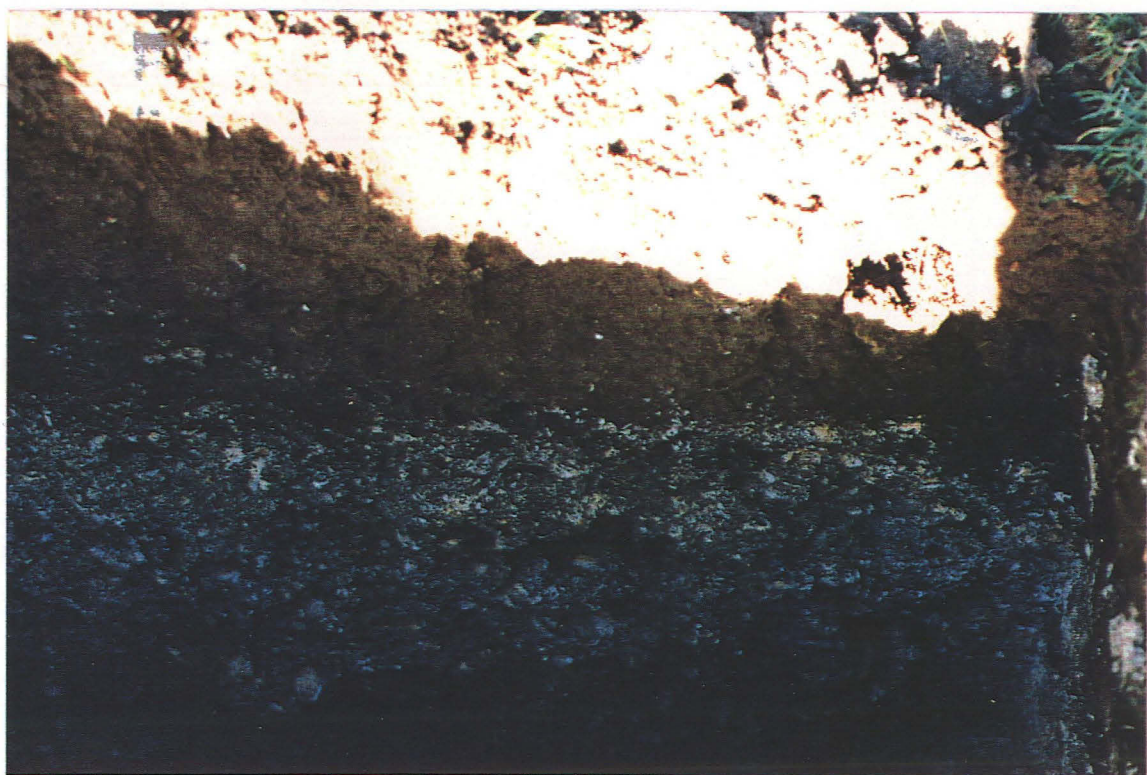
**Pl. 37 Stratigraphy in Hole 23**

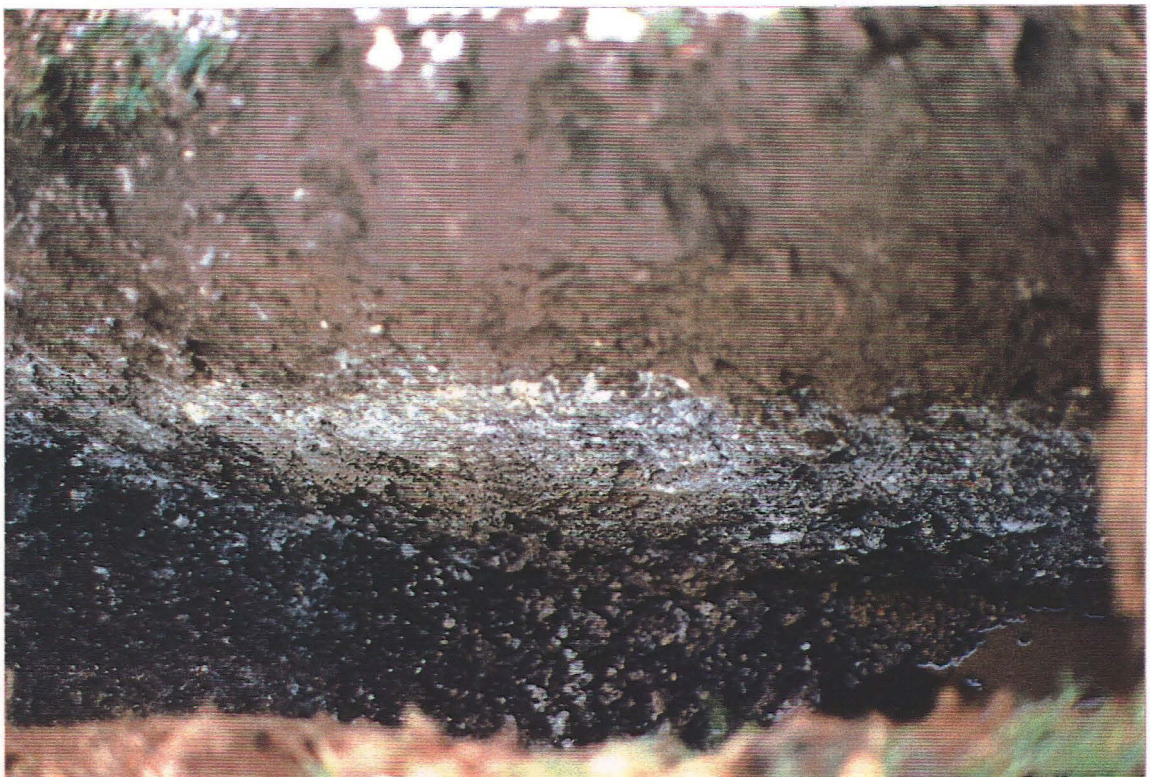
**Pl. 40 Section of Hole 32, showing chalk above humic material**

32. A hole was dug for a supporting stay east of Pole 23 and on the east side of the small watercourse. The trench face showed topsoil 0.15m thick above a layer of chalk 0.2m thick (Pl. 40). Beneath the chalk was 0.3m of dark brown humic soil, covering solid chalk. The sequence seemed to reflect excavation or scouring of the small stream; it may flow on an entirely artificial alignment but no datable material was recovered. A single Blackware pottery handle, of local manufacture and dating to the 17th century, was found.

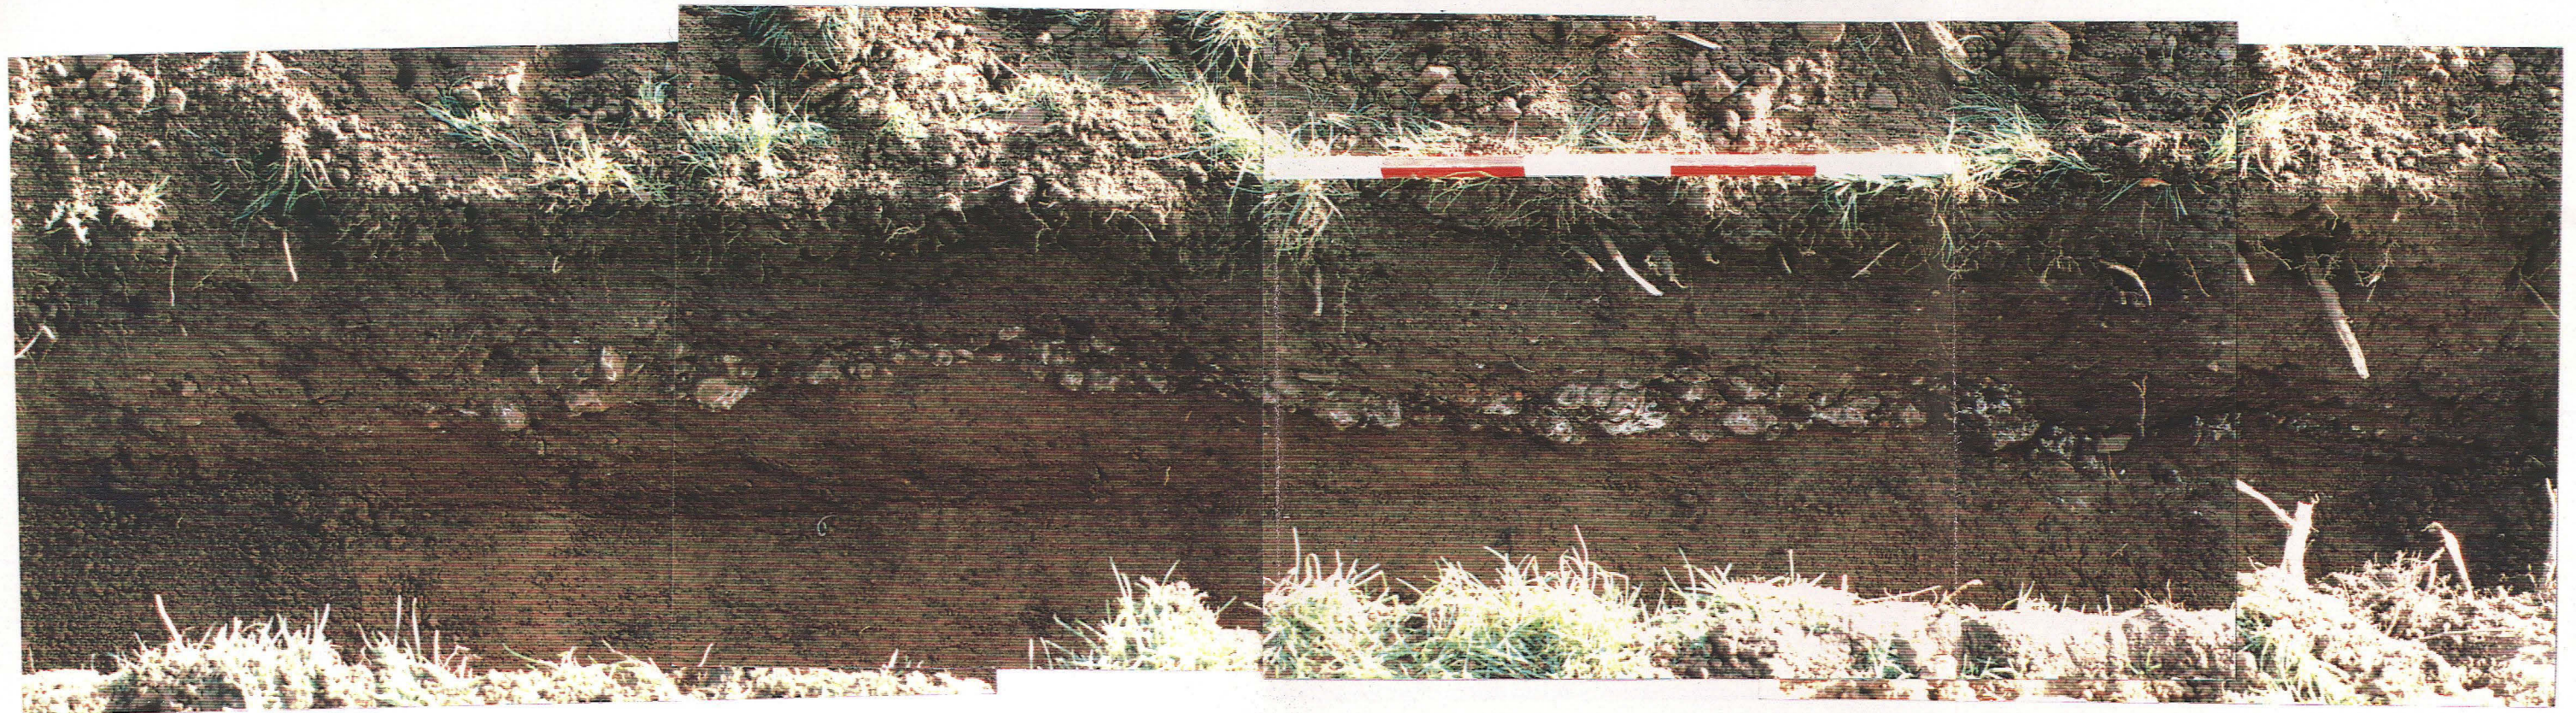
Pl. 45 Composite photograph of chalk rubble surface in east face of Hole 36 (scale divisions 0.2m)

**36.** A shallow earth feed trench was cut to the SW of pole 35, to a depth of about 0.65m and a length of about 9m. The topsoil varied in depth between 0.2 and 0.25m, and overlay a layer of dark brown sandy loam which exaggerated the previous uneven profile (Figs. 5-7). A thin layer of irregular angular stones, chalk lumps and pebbles formed a metalled surface below the loam, dipping into a pronounced NW-SE depression at the SW end (Pl. 45). Six sherds of Toynton/Bolingbroke pottery, dating to the 16th-17th centuries were found in situ within, and at the base of, that surface. The underlying material was orange/brown sand, similar to that seen in the pole hole.

The metalled surface represents the only recognised significant archaeological feature damaged by the monitored works. Considerable co-operation was forthcoming from the East Midlands Electricity field team (Pl. 46), allowing the author sufficient time to examine, illustrate and record photographically the exposed trench faces before the trench was backfilled. It may be a previous medieval course of the South Ormsby to Brinkhill road, but a waterlogged area 50m to the east near Wood Farm would presumably have obstructed any track in winter. Explanations of the feature include an unrepaired localised drainage deterioration during or after the medieval period preventing use of a former road (which seems unlikely) or that the located track/yard area provided access to a roadside pond or small quarry.
