**EASTBECK FARM,  
STANTON BY LANGWORTH, LINCOLNSHIRE**

**ARCHAEOLOGICAL  
WATCHING BRIEF REPORT**

Site code	EFS 05
NGR:	TF 0670 7798
LCCM Acc No:	2005.89
Planning ref.	M04/P/0570

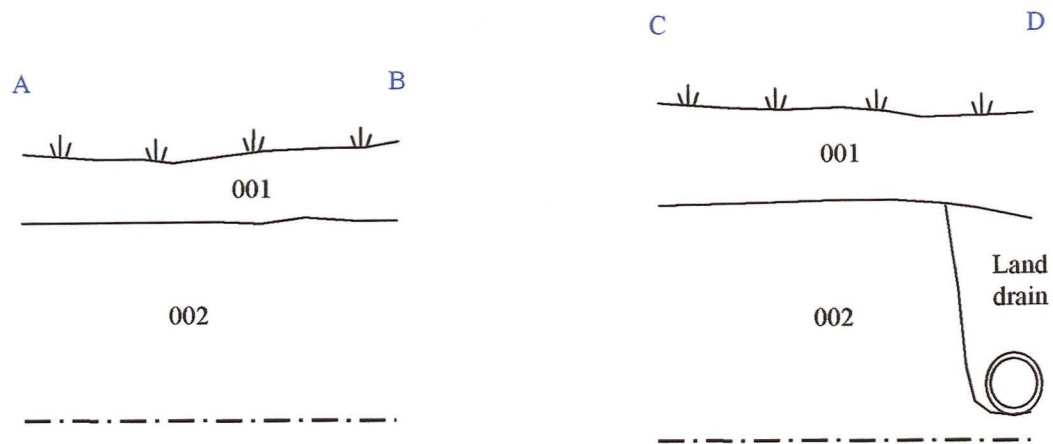
**Figure 3:** Sample sections at scale 1:20, with a sketch location plan of the foundation trenches at 1:200.

The foundation trenches were sealed by a layer of compact dark grey sandy clay, on average 0.20m thick, containing gravel, limestone rubble and hardcore. This layer, 001, appeared to be the remains of topsoil, heavily disturbed by the movement of plant and agricultural vehicles and recently partially covered by hard-standing.

Below topsoil 001 was layer 002, a friable to loose coarse sand of variable colour, with flint gravel inclusions: the natural drift geology. This deposit was cut by several field drains containing earthenware pipes, but no archaeological deposits or features were seen, and no artefactual material was recovered.

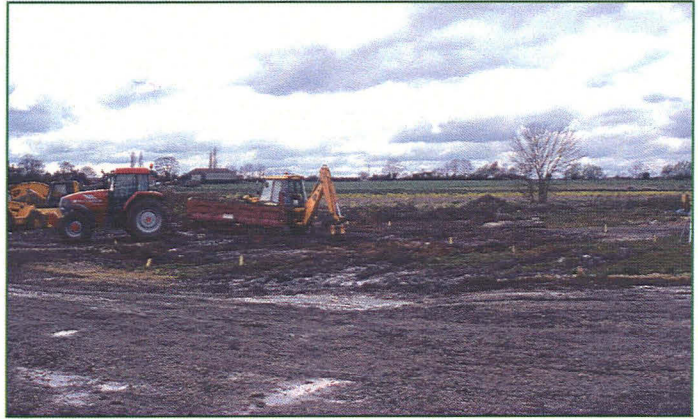
**Plate 1 (right):** General site shot during machining, looking north-west from the position of the poultry houses already constructed.

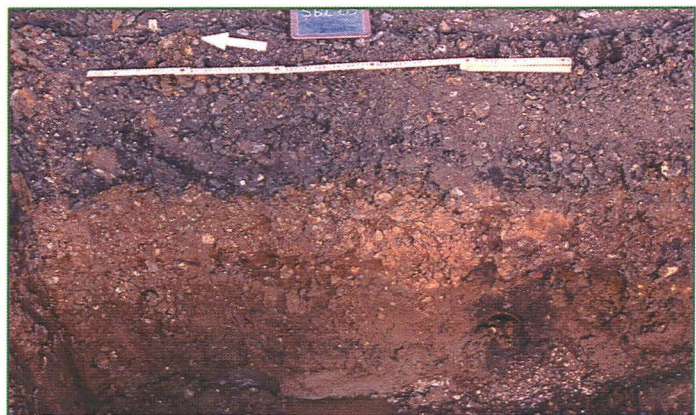
**Plate 3 (right):** Sample section 2 in foundation trench (shown as C-D in site drawings), looking east.

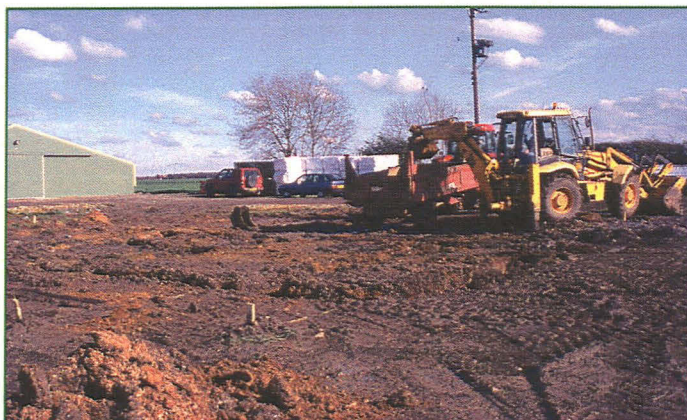
**Plate 4 (left):** General site shot on completion of the foundation trench excavations, looking south-east (the previously completed poultry houses are on the left of the picture).
