**Lincoln College, Monks Road, Lincoln
New Reception Area and Lift Tower**

Archaeological Evaluation

**LAS Report No. 831
June 2005**

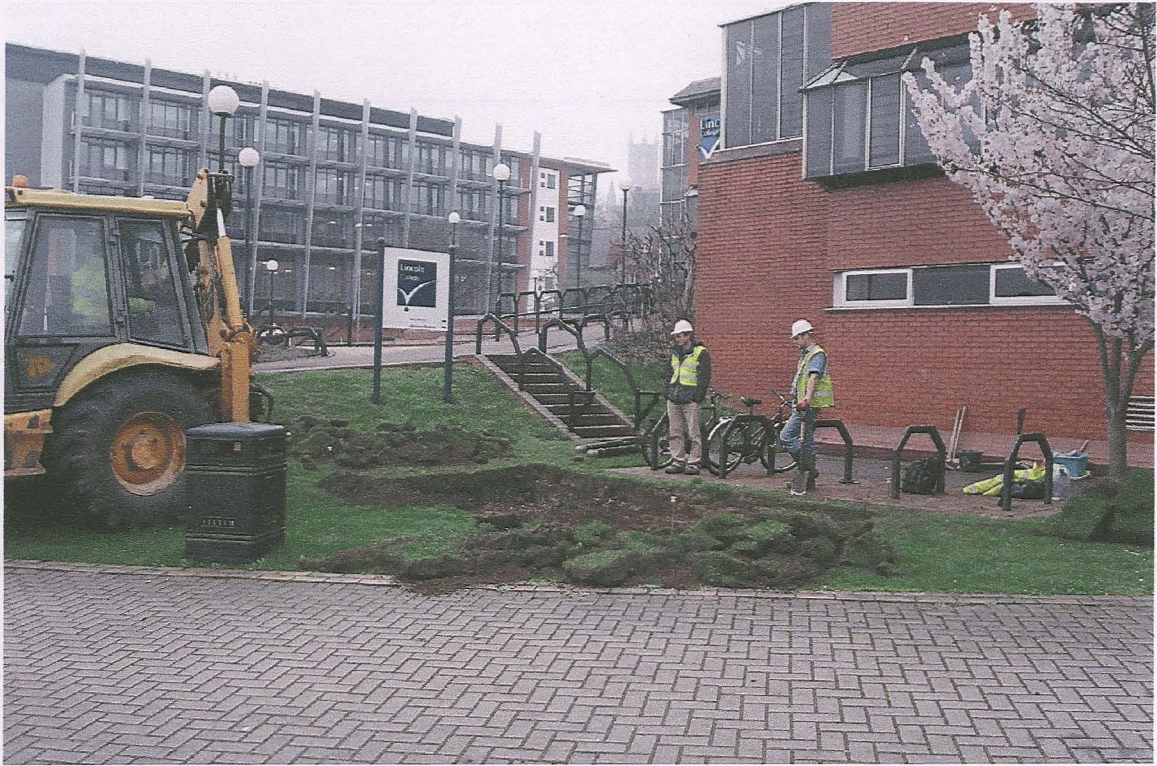
Pl. 1 General view of Trench 1, looking northwest

Trench 1 was positioned to evaluate the area of land that will be disturbed by the proposed extension at the front of the college, just north of Monks Road. Beneath the dark brown silty sand topsoil layer **100**, was a 1m thick layer of dumped modern deposits with frequent inclusions of rubble, brick and tarmac. This comprised the layers **131**, **129**, **125**, **124**, **101**. Beneath these was a mid orange brown sand with inclusions of brick and mortar, **132**. Beneath this was service trench **102**, which ran east/west and contained an electric cable. It was filled by **103**, a grey brown sandy silt with frequent inclusions of brick, rubble and limestone fragments, and contained one fragment of mid 12th to 15th century ridge tile. Beneath **132** was a dark brown grey sandy silt layer **105** which contained one fragment of 13th century ridge tile.

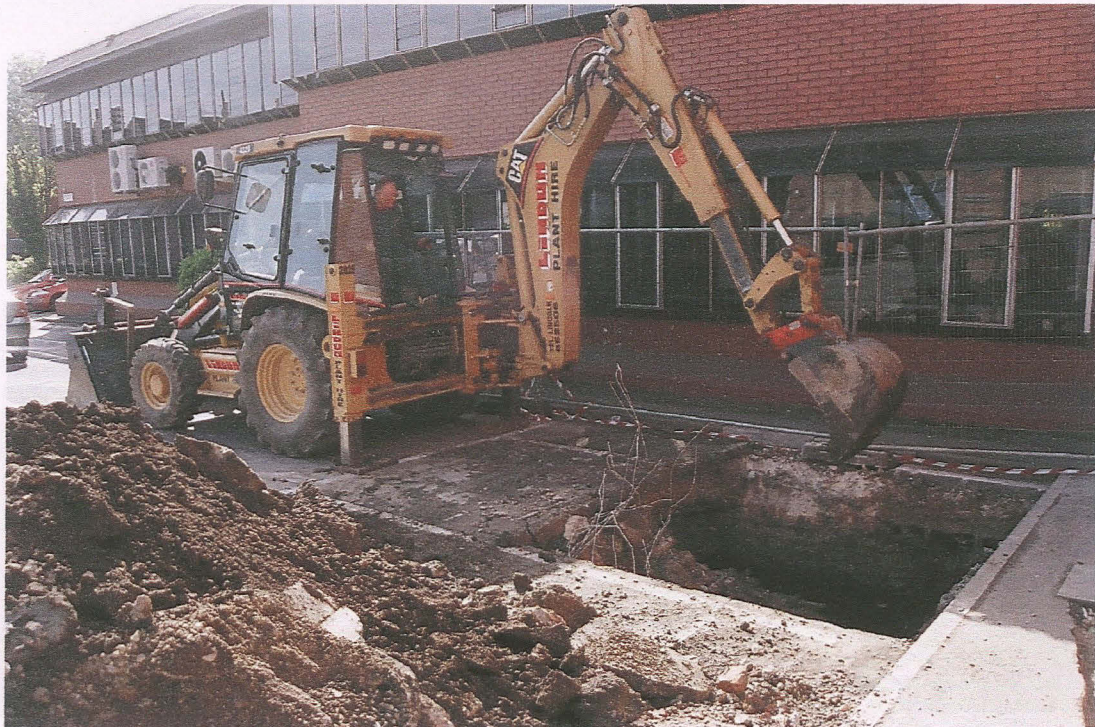
Pl. 2 General view of Trench 2, looking southeast

Trench 2 was located in the car park at the rear of the college. The area of the proposed lift shaft had been heavily truncated to a depth of 1.8m by modern features including two service pipes. In the south face of the trench, south of the modern pipes a sequence of archaeological deposits was revealed. Beneath the modern car park surface **200**, was a yellow sand and gravel bedding **201** which overlay **202** a 0.20m thick tarmac deposit. This had been placed over **203** a brick surface which was probably the floor of the former cattlemarket constructed in 1847. This overlay **204** a 0.20m thick concrete bedding layer which sealed **205** a 0.20 to 0.25m thick layer of brown grey compact clay and which overlay **206** a 0.10m thick layer of dark brown clay silt. Beneath this was **207**, the lowest deposit seen in the excavation, it was 0.70m thick and was a mid to dark brown sandy clay silt, with inclusions of limestone fragments and snail shells, possibly representing a former garden soil as seen in Trench 1. A borehole revealed natural deposits at 2.20m beneath the present car park surface (15.86m OD).

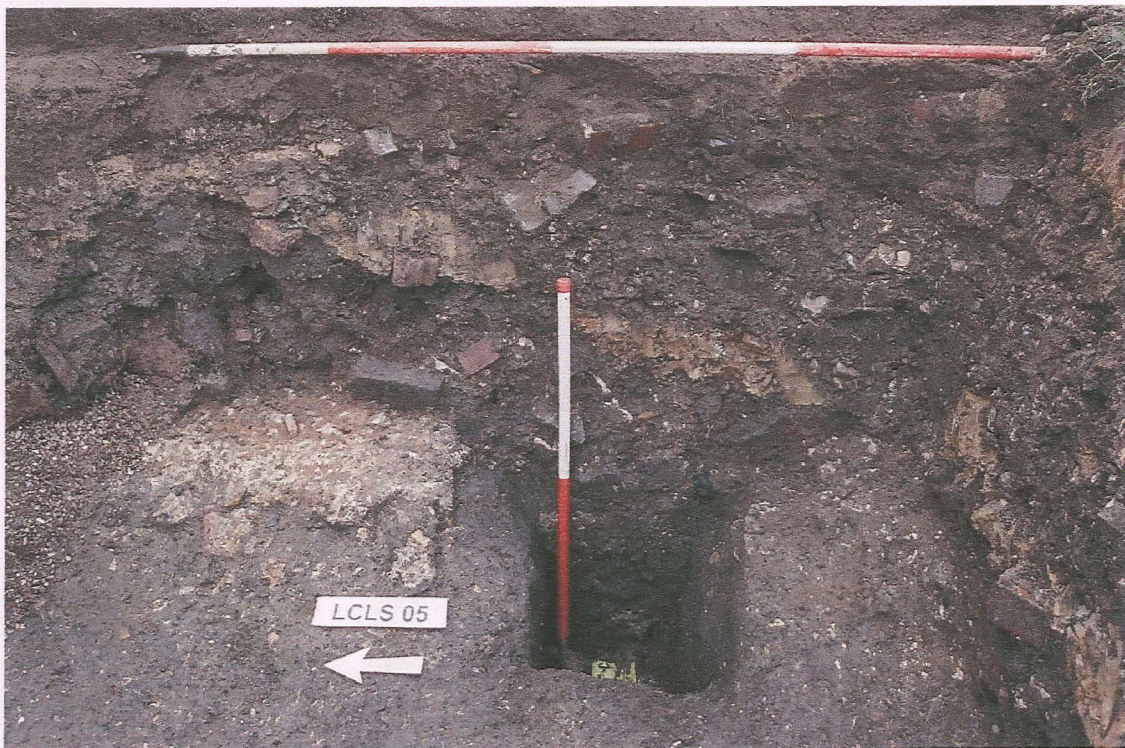
Pl. 4 Trench 1, east section showing modern trench 102, limestone wall 108 and layer 107. Scales 1m and 2m.

century tile, one sherd of mid 15th to 16th century pottery and one sherd of Roman greyware. Cutting layer **107** was **126** the base of the cut for wall **108**. It had a shallow profile and contained **127**, a brown grey clay silt with frequent inclusions of mortar and the wall **108**, which ran north/south along the eastern edge of the trench (Pls. 4, 5). **127** contained one fragment of nibbed tile mid 12th to 13th century. Wall **108** was composed of limestone fragments in a cream mortar.

The upper layers represent modern landscaping of the area probably associated with the construction work of the 1990's. However the evaluation shows that beneath 1m of modern material are surviving archaeological deposits. These included the remains of a possible medieval wall **108**, and associated layers including a possible clay surface **104**. These features contained pottery dating from the 12th to 15th century and may therefore be associated with the Dominican Friary founded in 1238, as the site

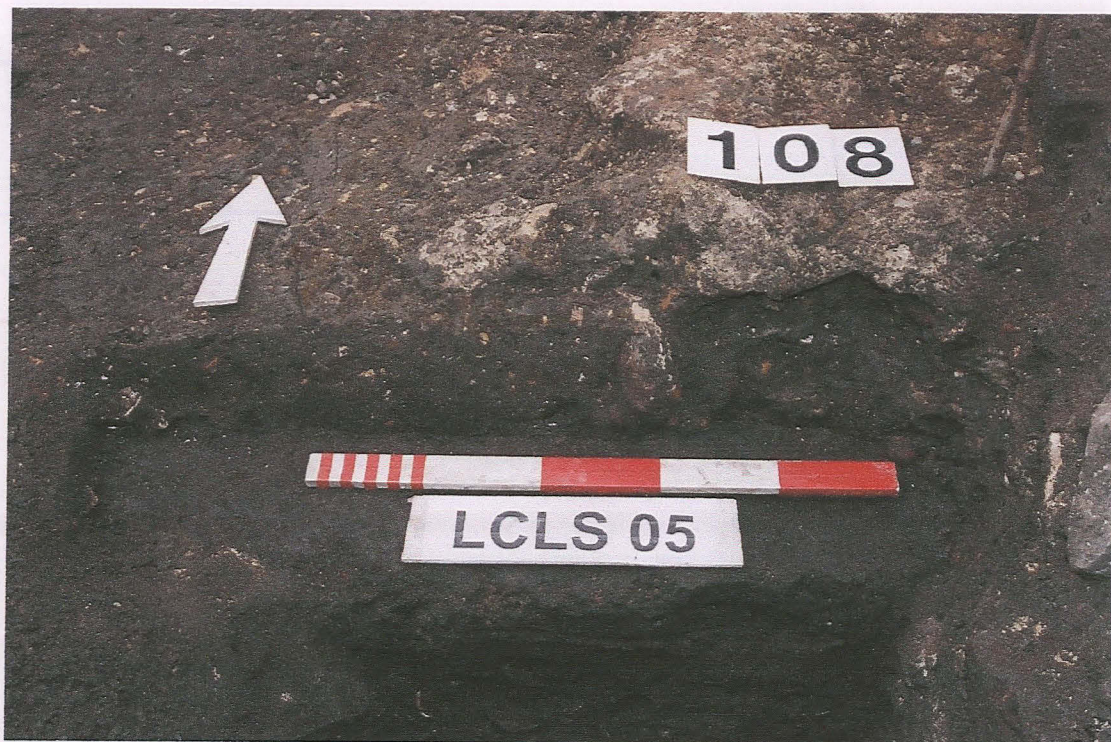
Pl. 5 Section through remains of wall 108, looking north. Scale 0.50m

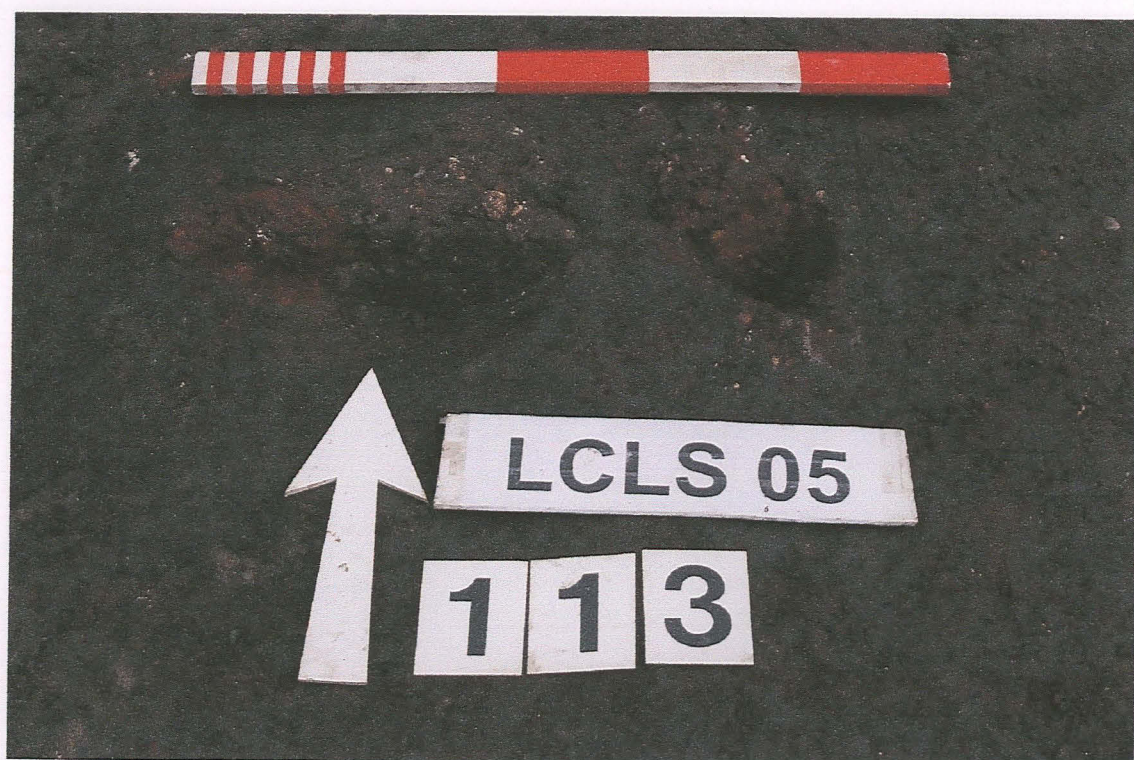
Pl. 6 View of stakeholes 113, 118 and 116, looking north. Scale 0.50m

Features **118**, **113**, **116**, **112**, **120** and **119** were all circular in plan ranging from 0.10 to 0.20m in diameter with irregular V-shaped profiles and contained orange iron rich silty clays (Pl.6). Although they were seen cutting layers **104**, **106** and **107** it is likely they are modern as Victorian pottery was found in **113**. They may have intruded from a higher level, but this relationship was removed by machining of the upper layers. Six of these features formed an east/west line and may represent a former fence line or line of stakes.

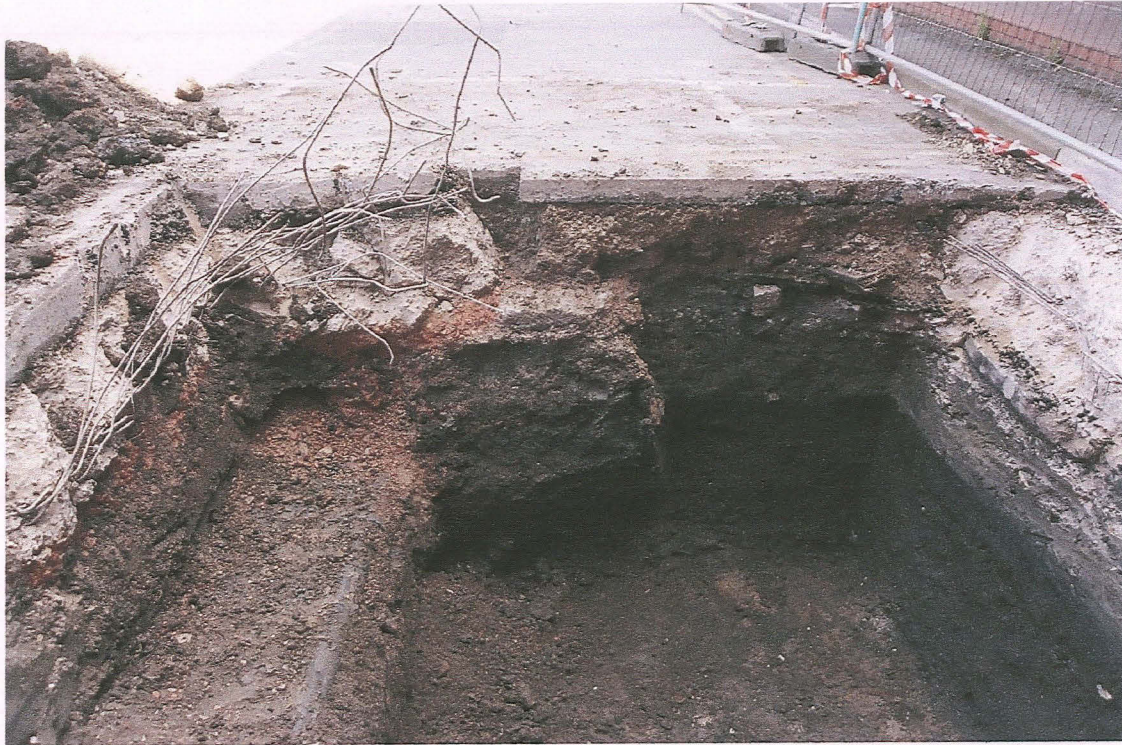
Pl. 7 Trench 2: East section showing sequence of deposits and modern disturbance.

Only a small area of the lift shaft was undisturbed by modern service trenches. However, the sequence of deposits visible in the face of the trench were similar to that seen in Trench 1. The dark brown clay silt **207** which appears the same as layer **107** in Trench 1 and similarly a dark brown clay silt (**106** and **206**) overlay these deposits in both trenches. In such a small exposure it is impossible to say that the layers represent the same deposits but hint at similar land use at this time. The level of natural encountered in the boreholes in Trenches 1 and 2 indicates a gentle fall of 1m in 16m to the south in ground levels, (gradient of 6.25%) which is still apparent today, in spite of modern landscaping.

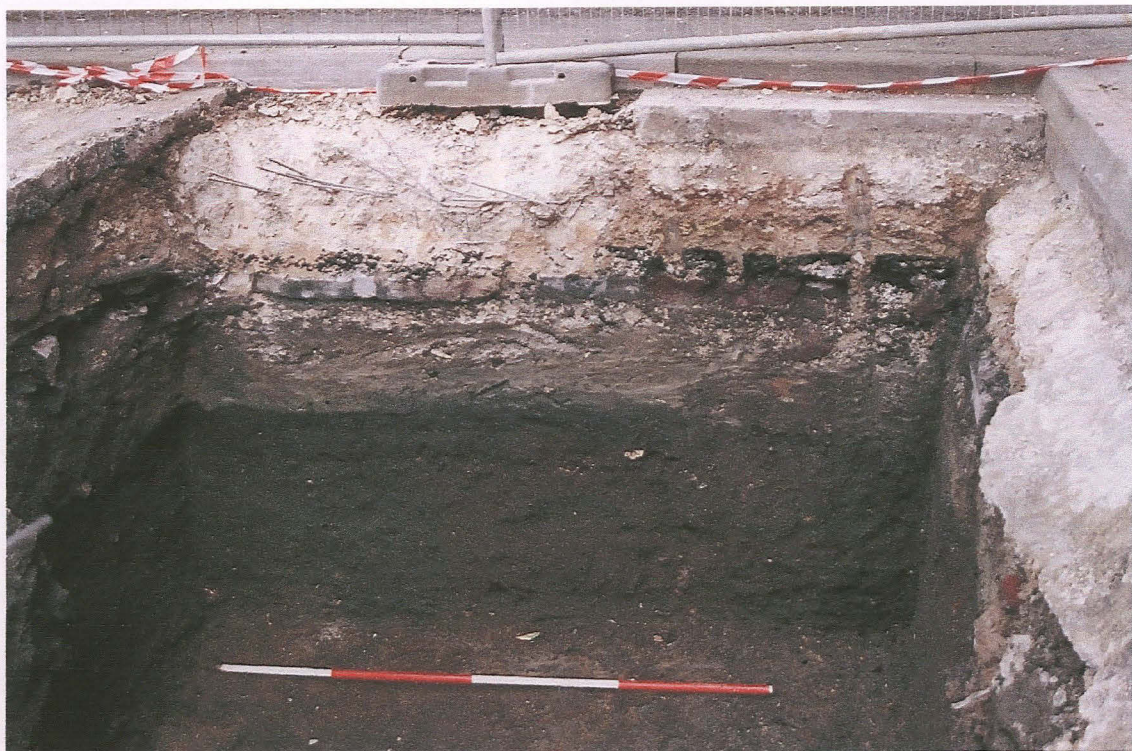
Pl. 8 Trench 2, west section, scale 2m.
