**Hall Farm, Snarford  
Lincolnshire  
Archaeological Watching Brief  
NGR: TF 0512 8236  
Planning Application No.: 99/P/0344  
Site code: SHF 03  
LCNCC Accn No.: 2003.26**

**Report for  
J Derbyshire Design Partnership  
on behalf of  
Mr and Mrs Pennell**

**LAS Report No. 645  
June 2005**

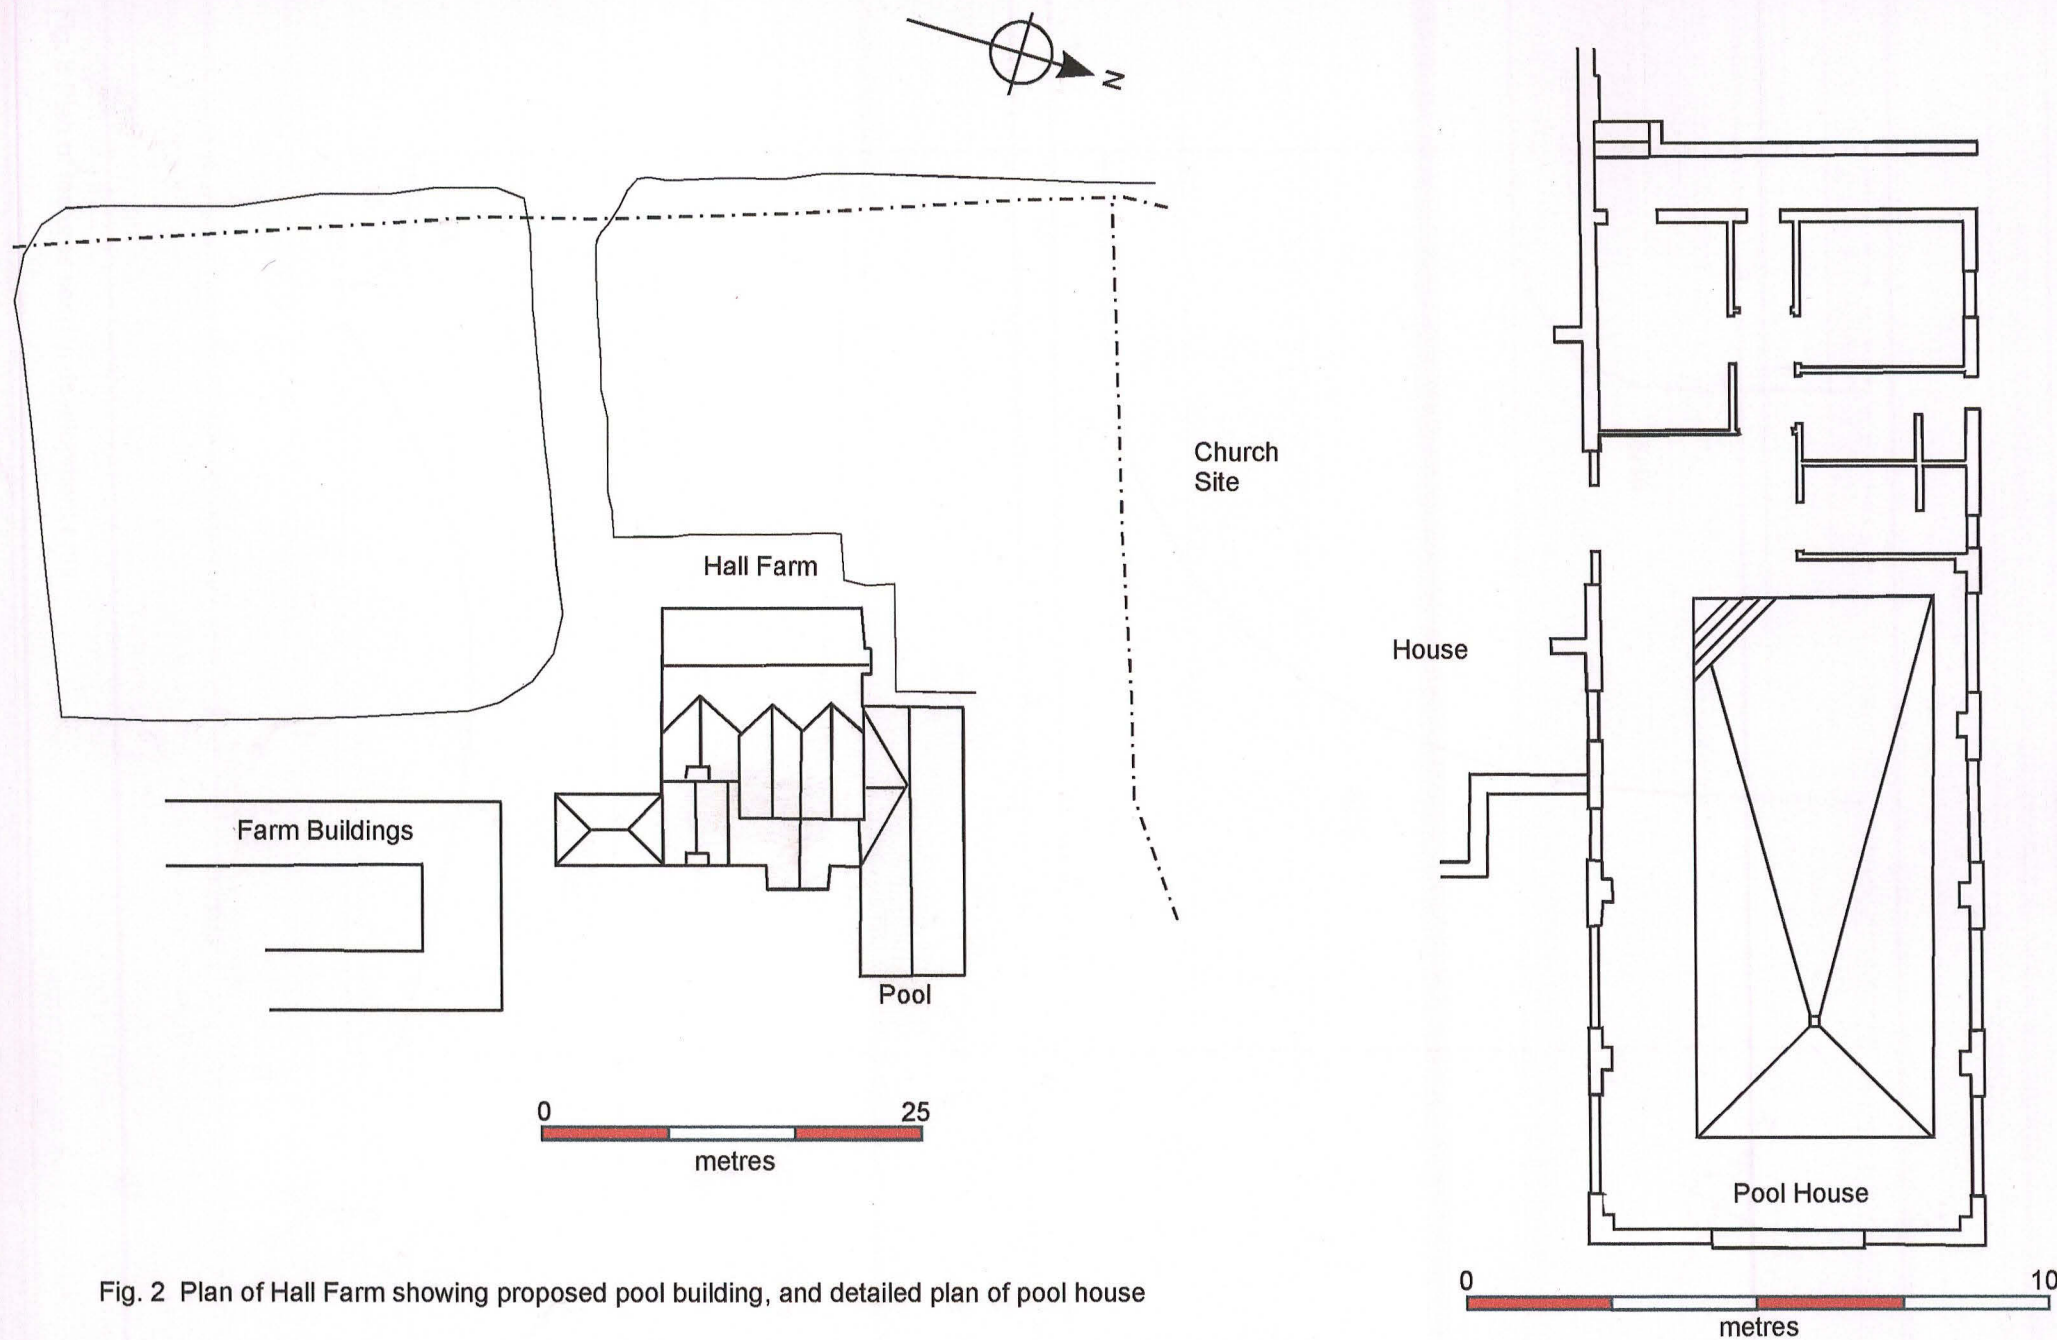
Fig. 2 Plan of Hall Farm showing proposed pool building, and detailed plan of pool house

Planning permission was granted to construct a swimming pool c.18.50m x 7m, to the north of Hall Farm subject to an archaeological watching brief being carried out during the groundworks phase of construction

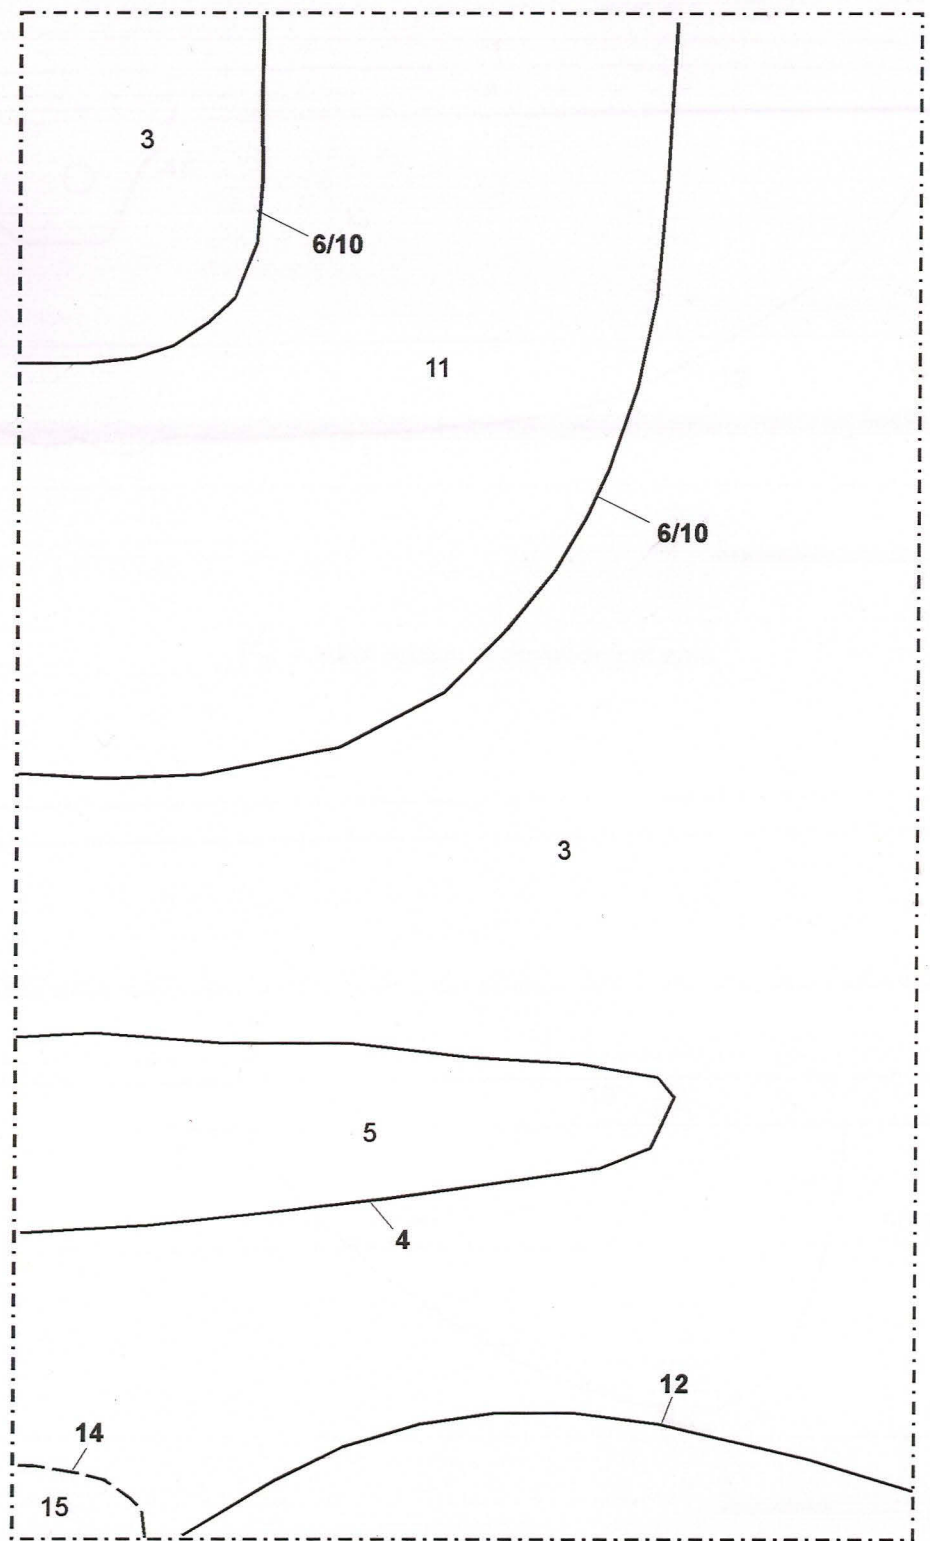
Fig. 3 Plan of features seen in development area

After the removal of the overburden **1** which contained frequent brick fragments and building debris, a subsoil layer was revealed, **2**, which consisted of a mid grey-brown silt with no inclusions. This layer covered a small area at the west end of the trench underneath a small brick shed which was demolished before work commenced. Most of the site was covered in a mixed layer of soil and brick fragments **18**, with some modern pottery throughout. This layer dates from the mid 20<sup>th</sup> century and is levelling for a tennis court (Mrs Pennell, pers.comm.). These deposits overlay the natural **3**, an orange yellow clay sand. Cutting this in the west end of the trench was the large pit **12**, which contained Victorian pottery and limestone fragments in its fill. The pit was cut by land drain **16**, to the north was pit **14**, which contained **15** a black silt that contained pottery of 18<sup>th</sup> to 20<sup>th</sup> century date.

To the east the natural was cut by a large ditch **6**, which measured 2.5m across. It contained black silt, **9** at its base and contained tile of 13<sup>th</sup> to 17<sup>th</sup> century date, one sherd of 16<sup>th</sup> to mid 17<sup>th</sup> century date and one sherd of mid 19<sup>th</sup> to 20<sup>th</sup> century date. Above this was the light grey silt **8**, which contained one sherd of 19<sup>th</sup> century pottery, and was overlain by the light grey soil **7**. This contained brick and three architectural limestone fragments which could have originated from one of the medieval buildings in the village. The ditch turned through 90° entering the trench through the north face and leaving through the east. Despite the Victorian pottery, the size of the ditch suggests it could be significantly older in date. Hall farm is located near the centre of the deserted medieval village of Snarford (Fig. 7), ditch **6** is likely to represent a boundary ditch associated with the medieval village. Similar ditches are shown on the plan of the deserted medieval village (West, 1969) and the aerial photograph of the area (Fig. 8). The later material in the fill could represent the recutting or infilling of the ditch at a later date. A smaller ditch, **4** running southeast/northwest was present to the west but tapered out before reaching the southern edge of the excavation. It contained **5** a dark grey silt with inclusions of limestone fragments and 18<sup>th</sup> century pottery sherds.

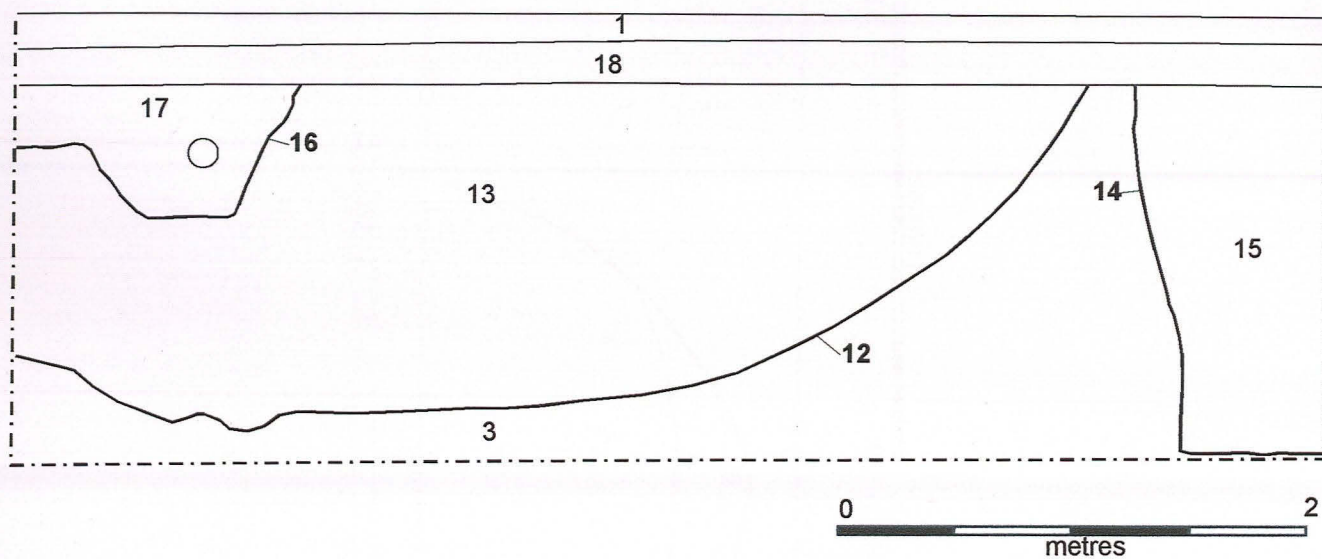
Fig. 4 West section of development area

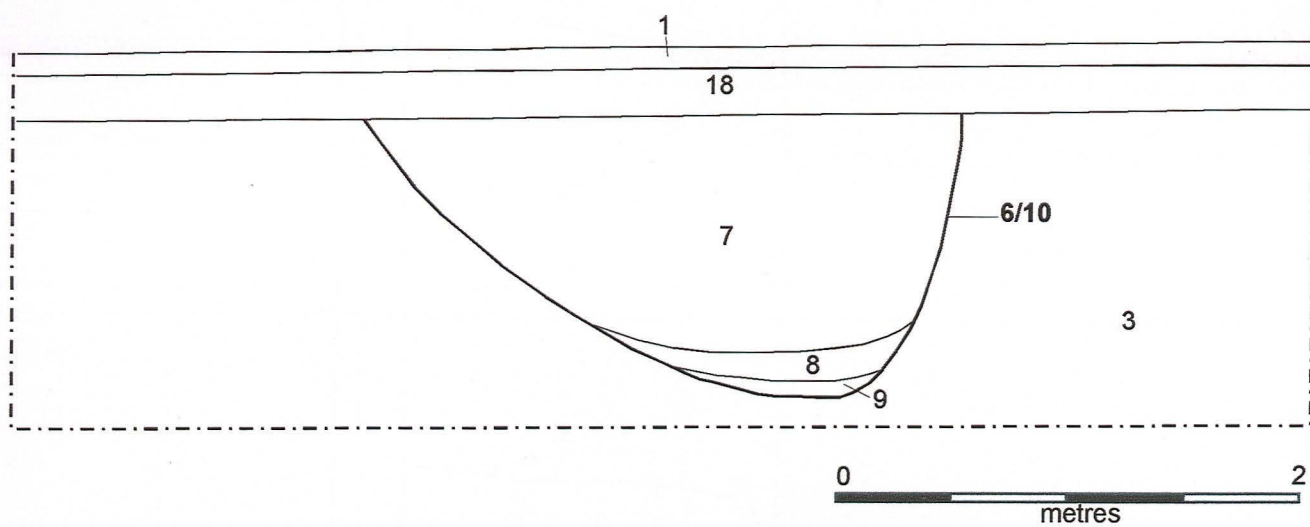
Fig. 5 East section of development area

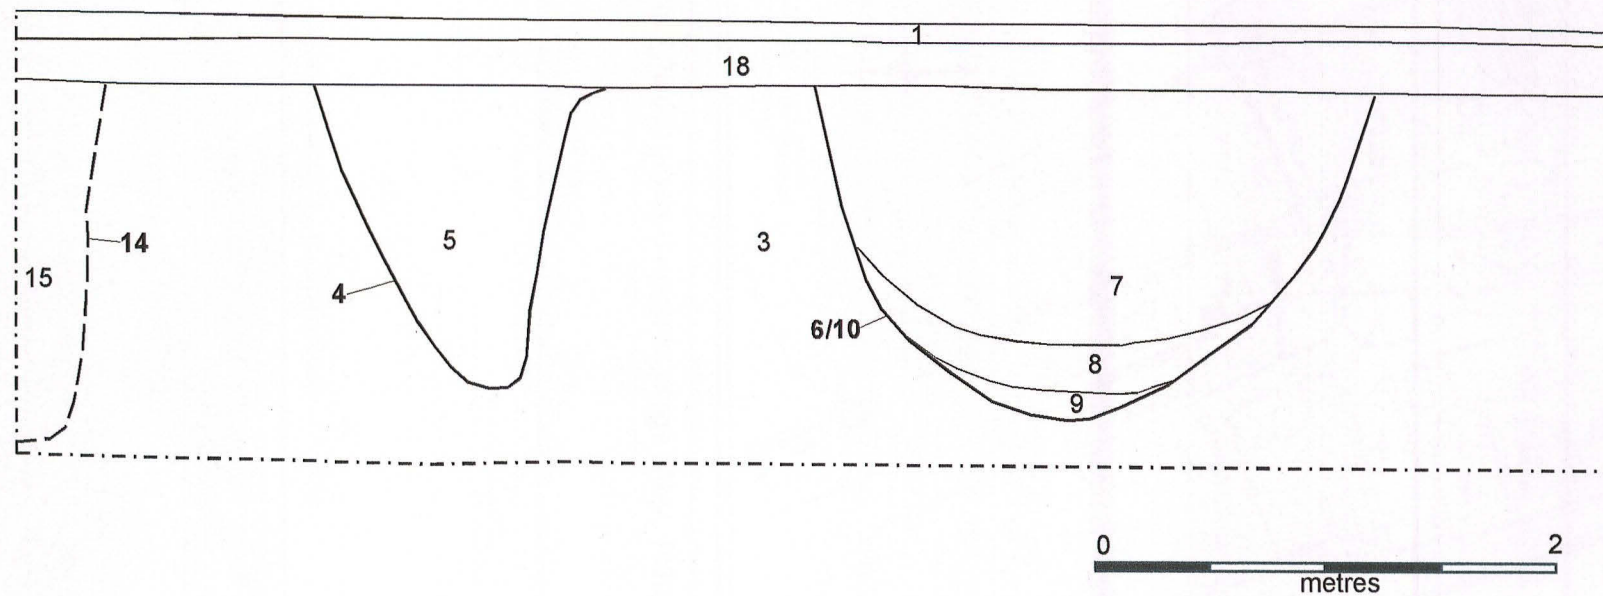
Fig. 6 North section of development area

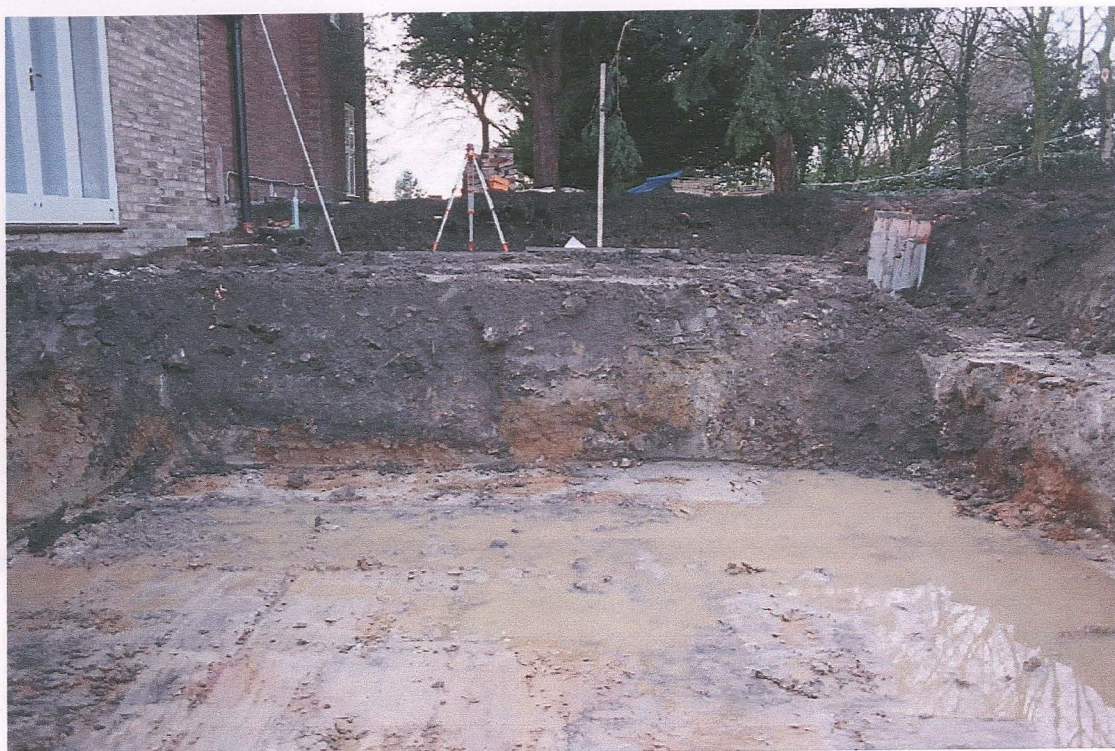
Pl. 3 View of southwestern face of excavation trench, showing pits 12 and 14

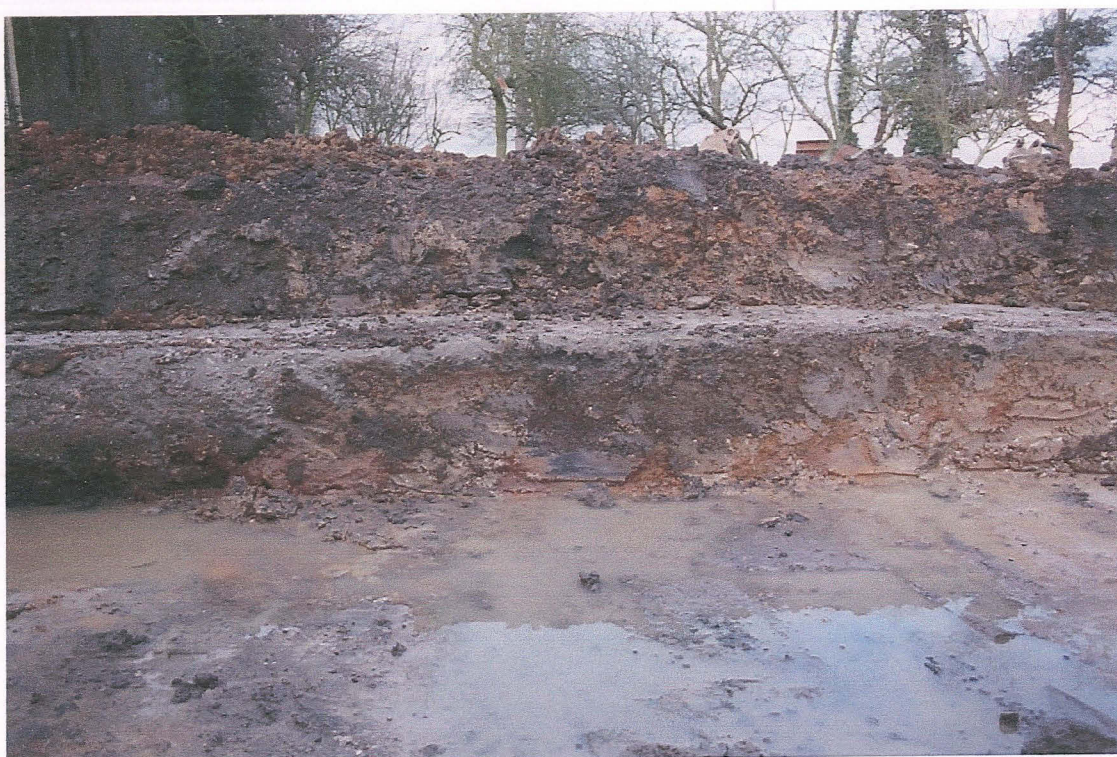
Pl. 4 View of north face of excavation trench showing ditch 6
