**ARCHAEOLOGICAL WATCHING BRIEF AND
STANDING STRUCTURE REPORT:
16-18 COLLEGE CLOSE, LINCOLN**

NGR: SK 97556 72626
SITE CODE: COCL05
ACC. NO.: 2005.130

Report prepared for Orchid Homes

June 2005

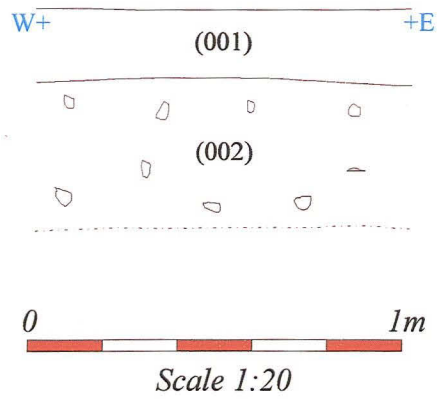
Fig. 4: Representative section (scale 1:20)

Prior to the excavation of the footings, the area was stripped of surface vegetation, revealing a dark grey/black loamy former garden soil, 001. Subsequent excavations showed this deposit to survive to a depth of 0.2m. Throughout the footing trenches, this sealed a ubiquitous dark brownish grey clayey sand, 002, containing frequent limestone chunks and fragments of ceramic building material (fig. 4). This extended beyond the maximum depth of excavation.

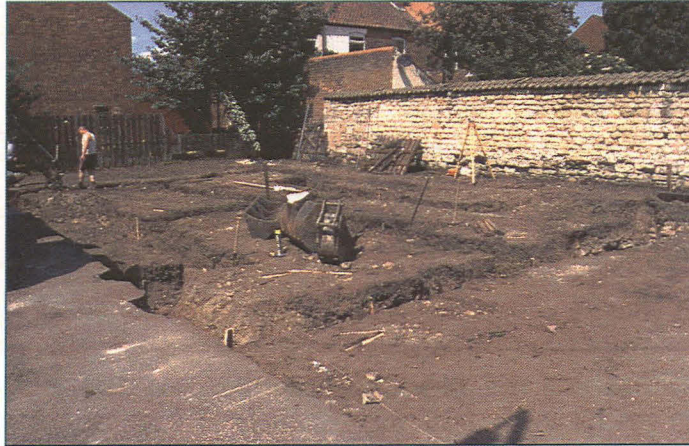
Pl. 1: General view of the development area after excavation of the footings. Looking north-west

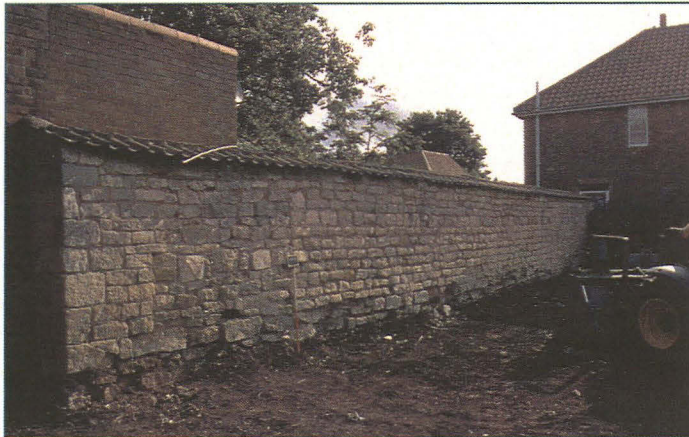
The stone boundary wall along the north side of the site has a length of 16.8m, a width of 0.5m and a height of 2.25m above the modern ground surface. It is largely composed of evenly sized dressed limestone blocks, set in a pale creamy sandy mortar with occasional gravel and brick fragments. At the east end of the wall is a probable later repair, which is composed of smaller more irregular fragments of dressed limestone in a dark brownish grey cement. To the west of this repair, is a noticeable vertical scar in the wall, which may represent the former position of a wall extending southwards into the development area. Immediately to the west of the vertical scar, a small rectangular hole in the wall face may represent a putlog hole, used to support timber scaffolding during the construction of the wall. A similar vertical scar was observed towards the west end of the wall, again believed to indicate a wall running south. A single large limestone block, which crosses this break, may indicate a later repair, when the cottages were demolished and the wall was maintained as a property boundary.

Pl. 2: Northern boundary of the site, looking east-north-east.

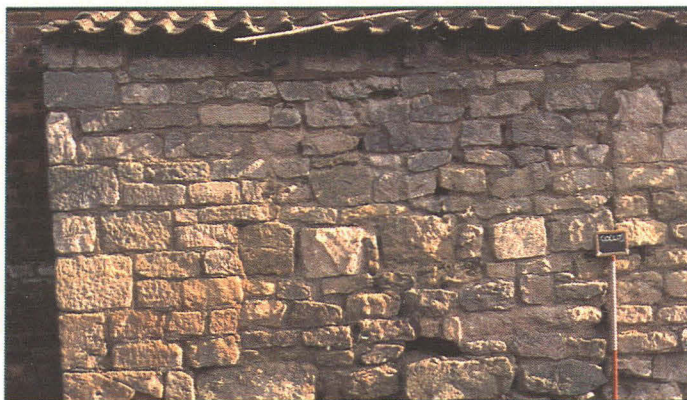
Both the east and west ends of the walls also appear to have been subject to later repair, using large, neatly dressed blocks. This most likely followed the demolition of the cottages, with the ends of the wall at this location being repaired to serve as a boundary wall. The east end of the wall is adjoined by a wooden boundary fence, while to the west, the north side of the wall adjoins the south wall of No. 2 Kenneth Street, which forms the remainder of the north boundary of the site.

Pl. 3: West end of the boundary wall, looking north. The scar indicating a possible wall running south is visible above the scale.

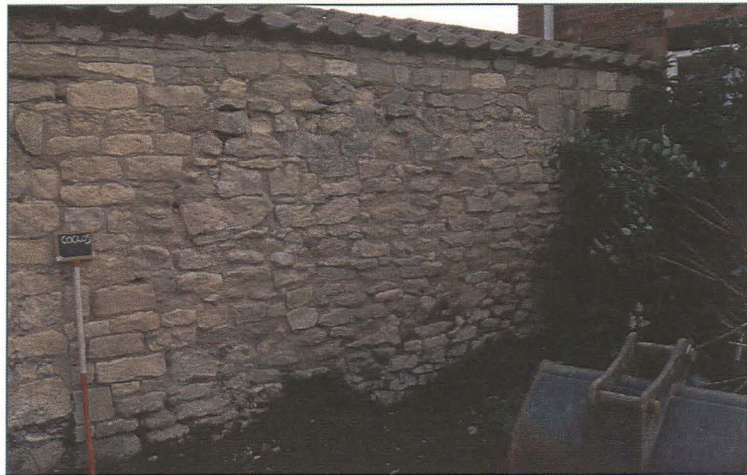
Pl. 4: East end of the boundary wall. The scar defining a former wall is visible to the immediate left of the scale. To the east, a repair in smaller stones is evident. Looking north-east.

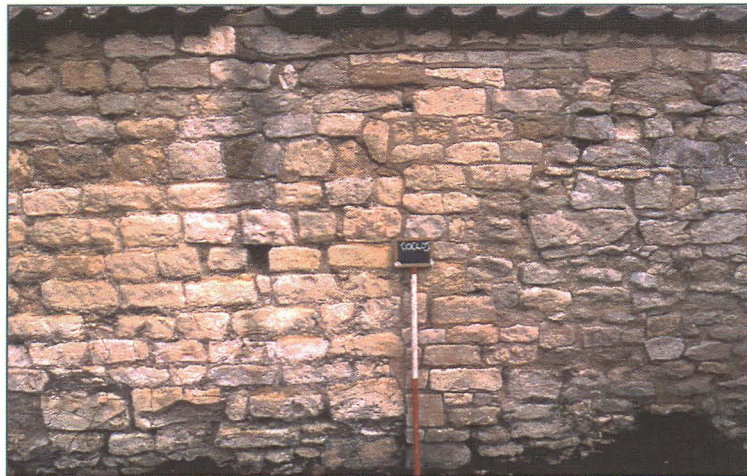
Pl. 5: Detail of scar at east end of wall. To the west is a possible putlog hole. Looking north.

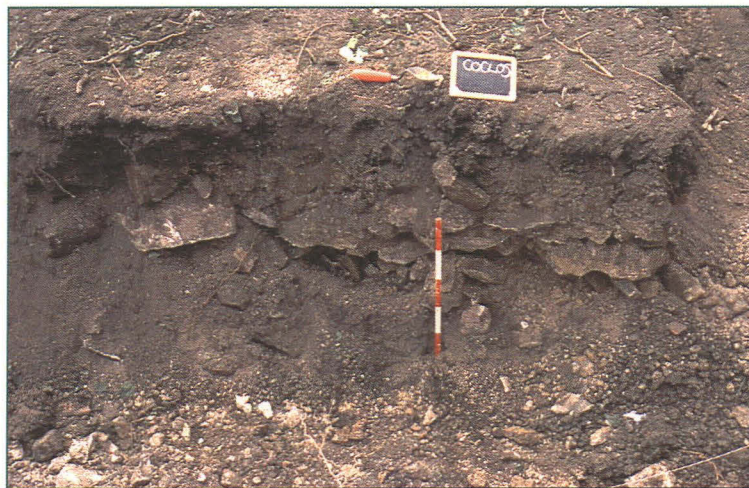
The only exception to this sequence occurred in the north-east corner of the footing trenches, where the truncated remains of a former wall, 003, were observed. This was directly below the topsoil and extended southwards into the foundation trenches for approximately 1.9m. For the most part, the excavations revealed a mixed rubble

The only feature of archaeological significance exposed during the watching brief was the remains of part of a wall of the former cottages that occupied the site, which was related to a scar in the north boundary wall. The wall exposed in the foundation trenches probably represents a party wall between two of the terraced properties. No other buried walls were observed, despite the presence of another scar in the wall towards its western end.

Pl. 6: North-east corner of the foundation trenches, showing the truncated remains of wall 003, which aligns with the scar in the boundary wall, shown in pls. 4 & 5. Looking west.
