The Grange, Rear of Nos. 45 - 51, Cross o' Cliff Hill, Lincoln

Archaeological Watching Brief

LAS Report No. 839

June 2005

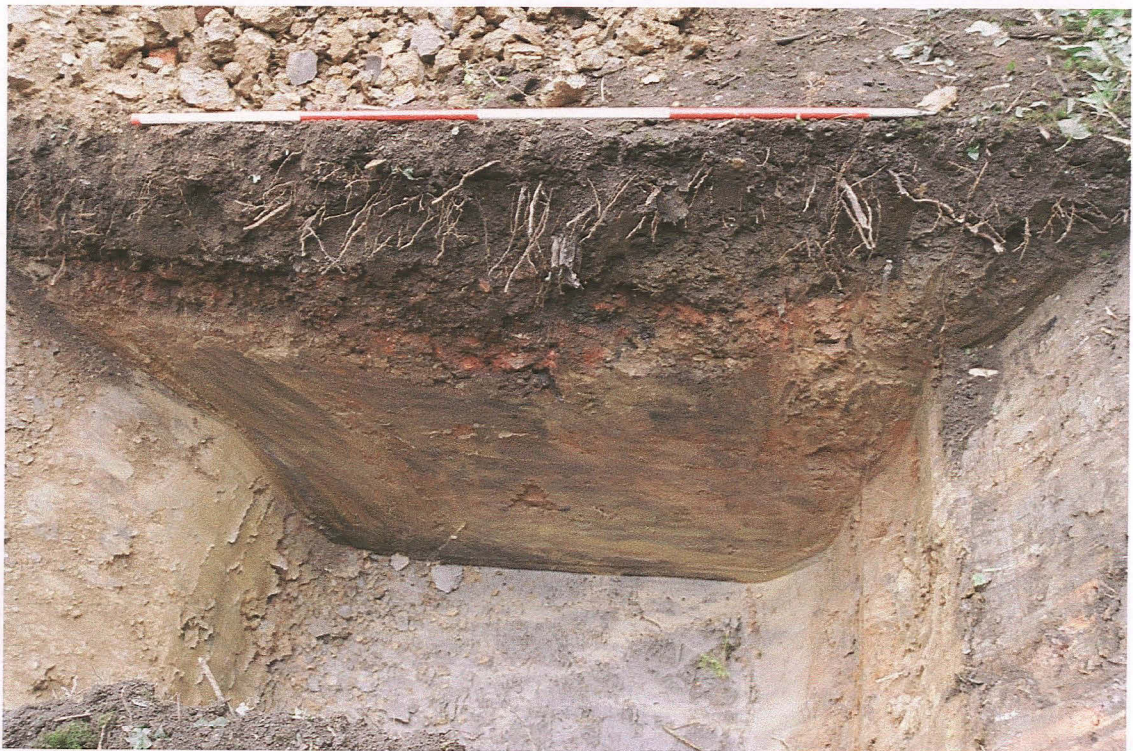
PI. 2 Trial Pit 2 (looking north-west).

In TP2, the grey/brown clay layer **21** sealed a 1.2m wide ditch **26**, aligned north-west/south-east. The 0.42m deep feature had been backfilled with a mixed clay fill **24** which incorporated frequent brick fragments. Near the base of the ditch was a clay land drain **25**, on a different angle to the ditch.

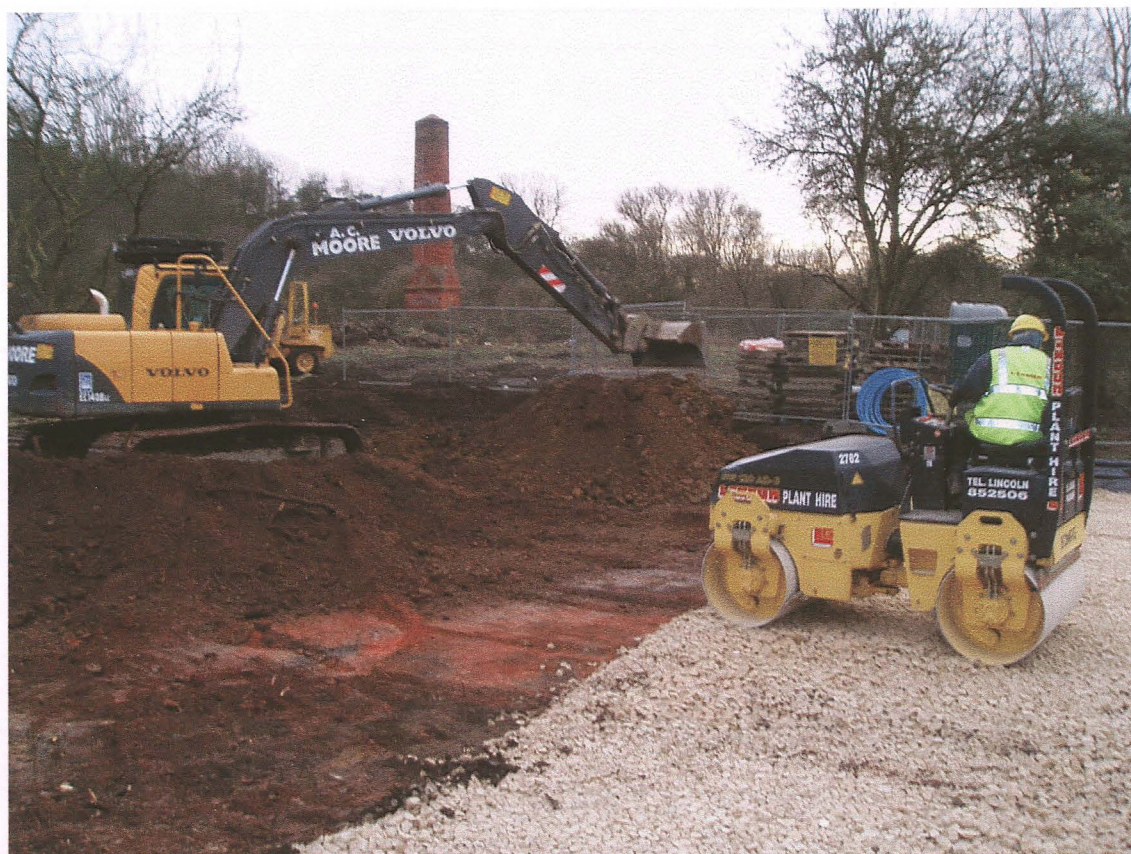
Topsoil stripping for the access road was monitored. The 0.4m thick topsoil layer **102** covered a 0.12m thick band of brickworks waste **103**, comprising mostly dense brick dust, but also rubble spread from demolished brick and concrete buildings (Pl. 6). This was above a 0.6m thick layer of yellow/brown sandy clay **104**, which covered a 0.08m thick brown loam with brick and charcoal flecks **105**. The yellow/brown sandy clay **106** below this also contained some brick fragments. The sequence suggested that topsoil had been stripped in the past, prior to spreading of waste material. All the material seen may have been redeposited, possibly as fill (although no pit edges were seen).

Pl. 6 Topsoil stripping for House Plot 3, showing a spread of brick dust 103. Looking south towards the brickworks chimney.

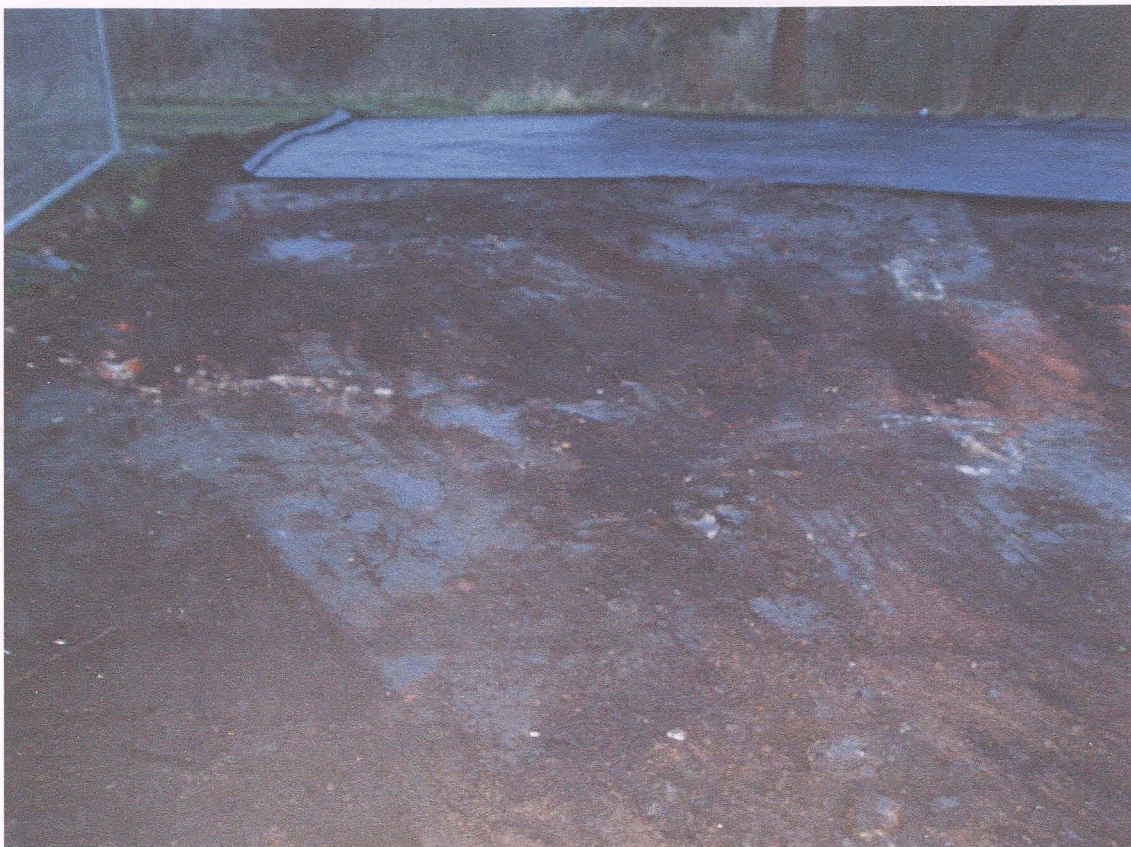
Close to House Plot 1, the 0.25m wide, brick foundations **100** of a small building were revealed (Pl. 7). The building had been 4m wide and at least 4m long. It was interpreted as of nineteenth or twentieth century construction. A building is not shown close to this position on the 1887 or 1904 Ordnance Survey surveys, but is marked on the map revised between 1904 and 1953 (OS 1889; OS 1907; OS 1953).

Pl. 7 Remains of brick wall foundation **100**, revealed during topsoil stripping for the access road and House Plot 1 (looking west).
