**Jasmine Cottage  
18 High Street, Scampton, Lincolnshire**

**Archaeological Watching Brief**

**LAS Report N°. 820**

**June 2005**

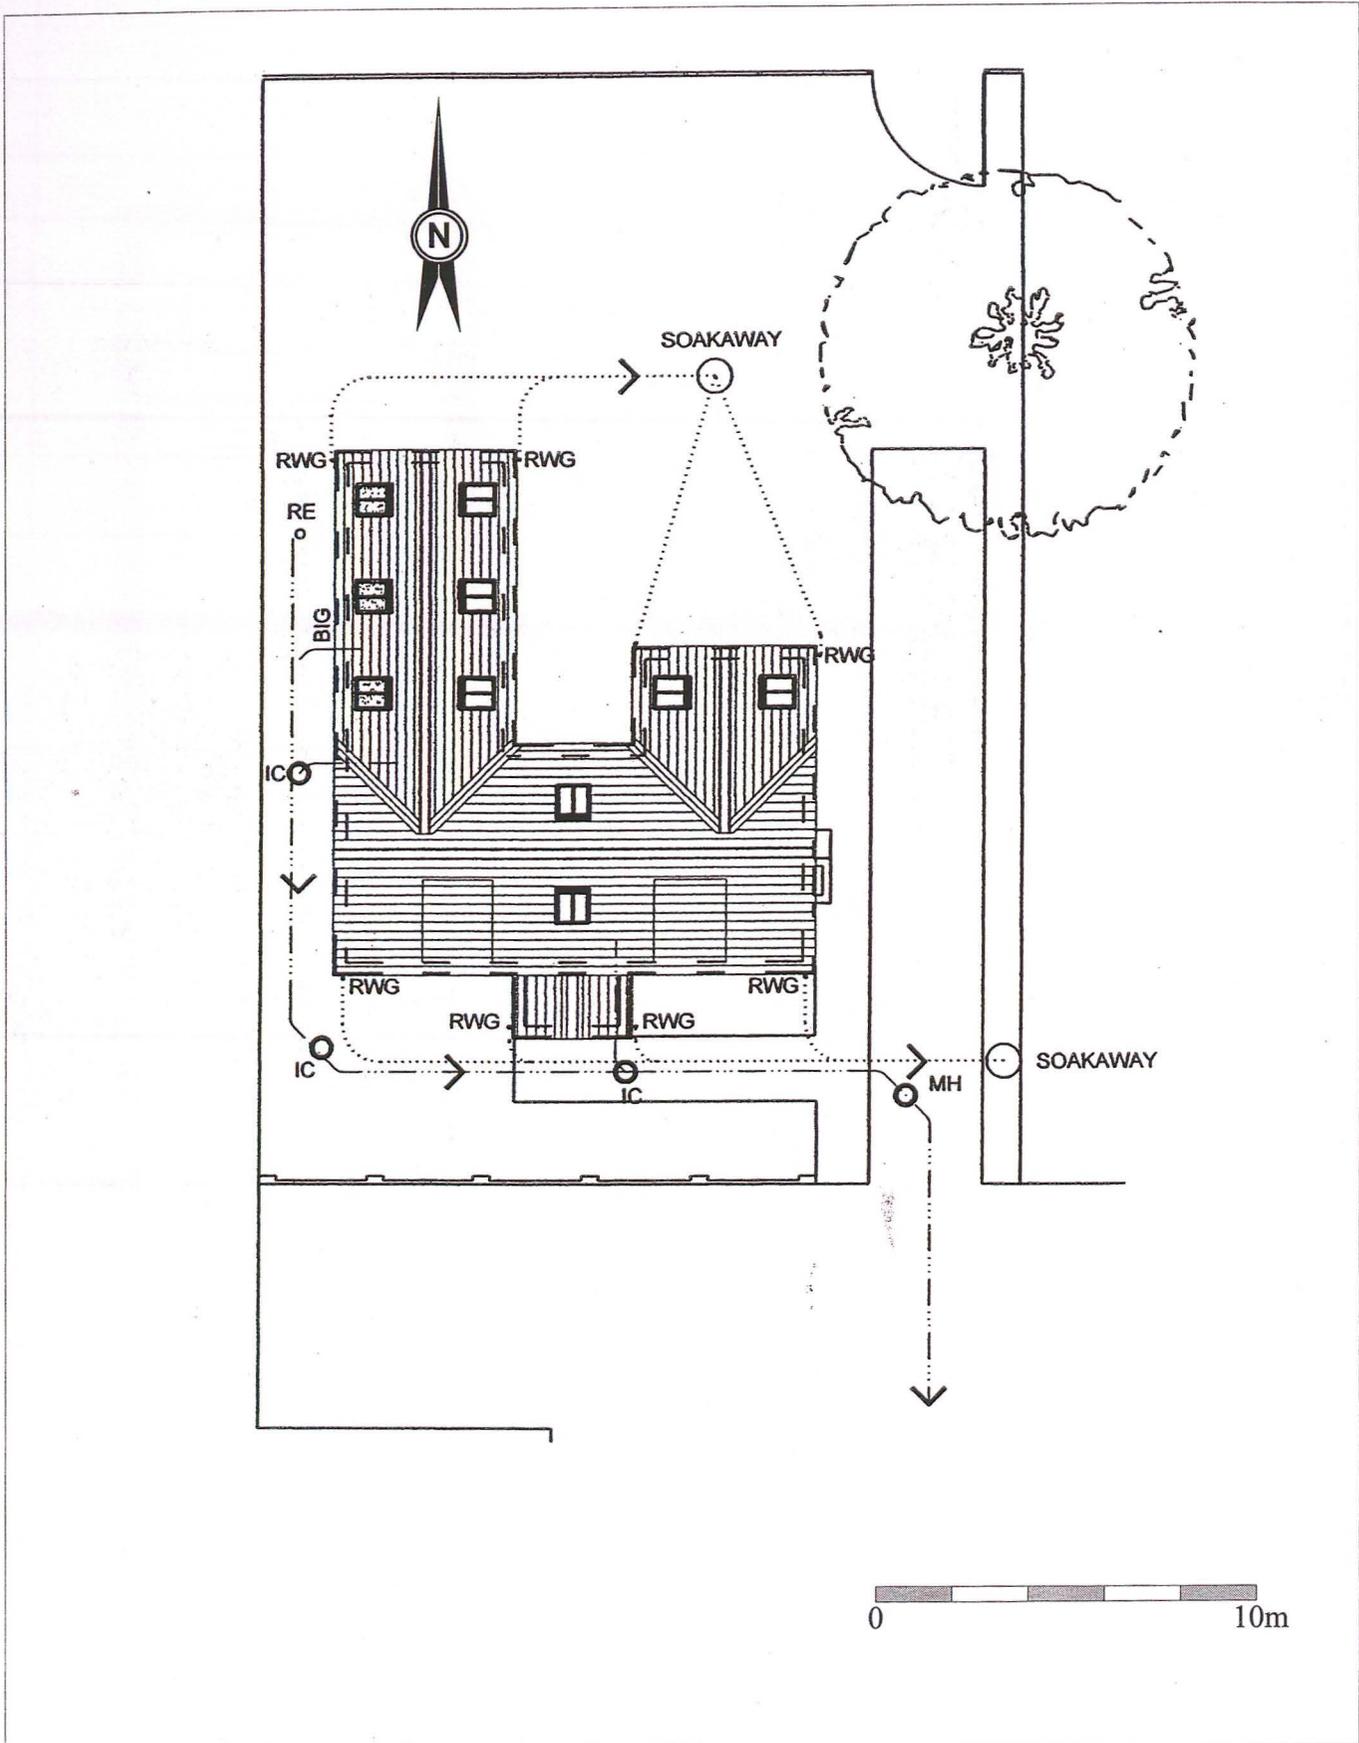
Fig. 2 Plan of the development area showing the location of the new house.

The village of Scampton is situated approximately 12km north-west of Lincoln off the A15. The study area is located close to the centre of Scampton village. The village itself is centred at around 30m A.O.D. The development consists of a single detached dwelling on level grass pasture to the rear of Jasmine Cottage 18 High Street, Scampton (fig 2).

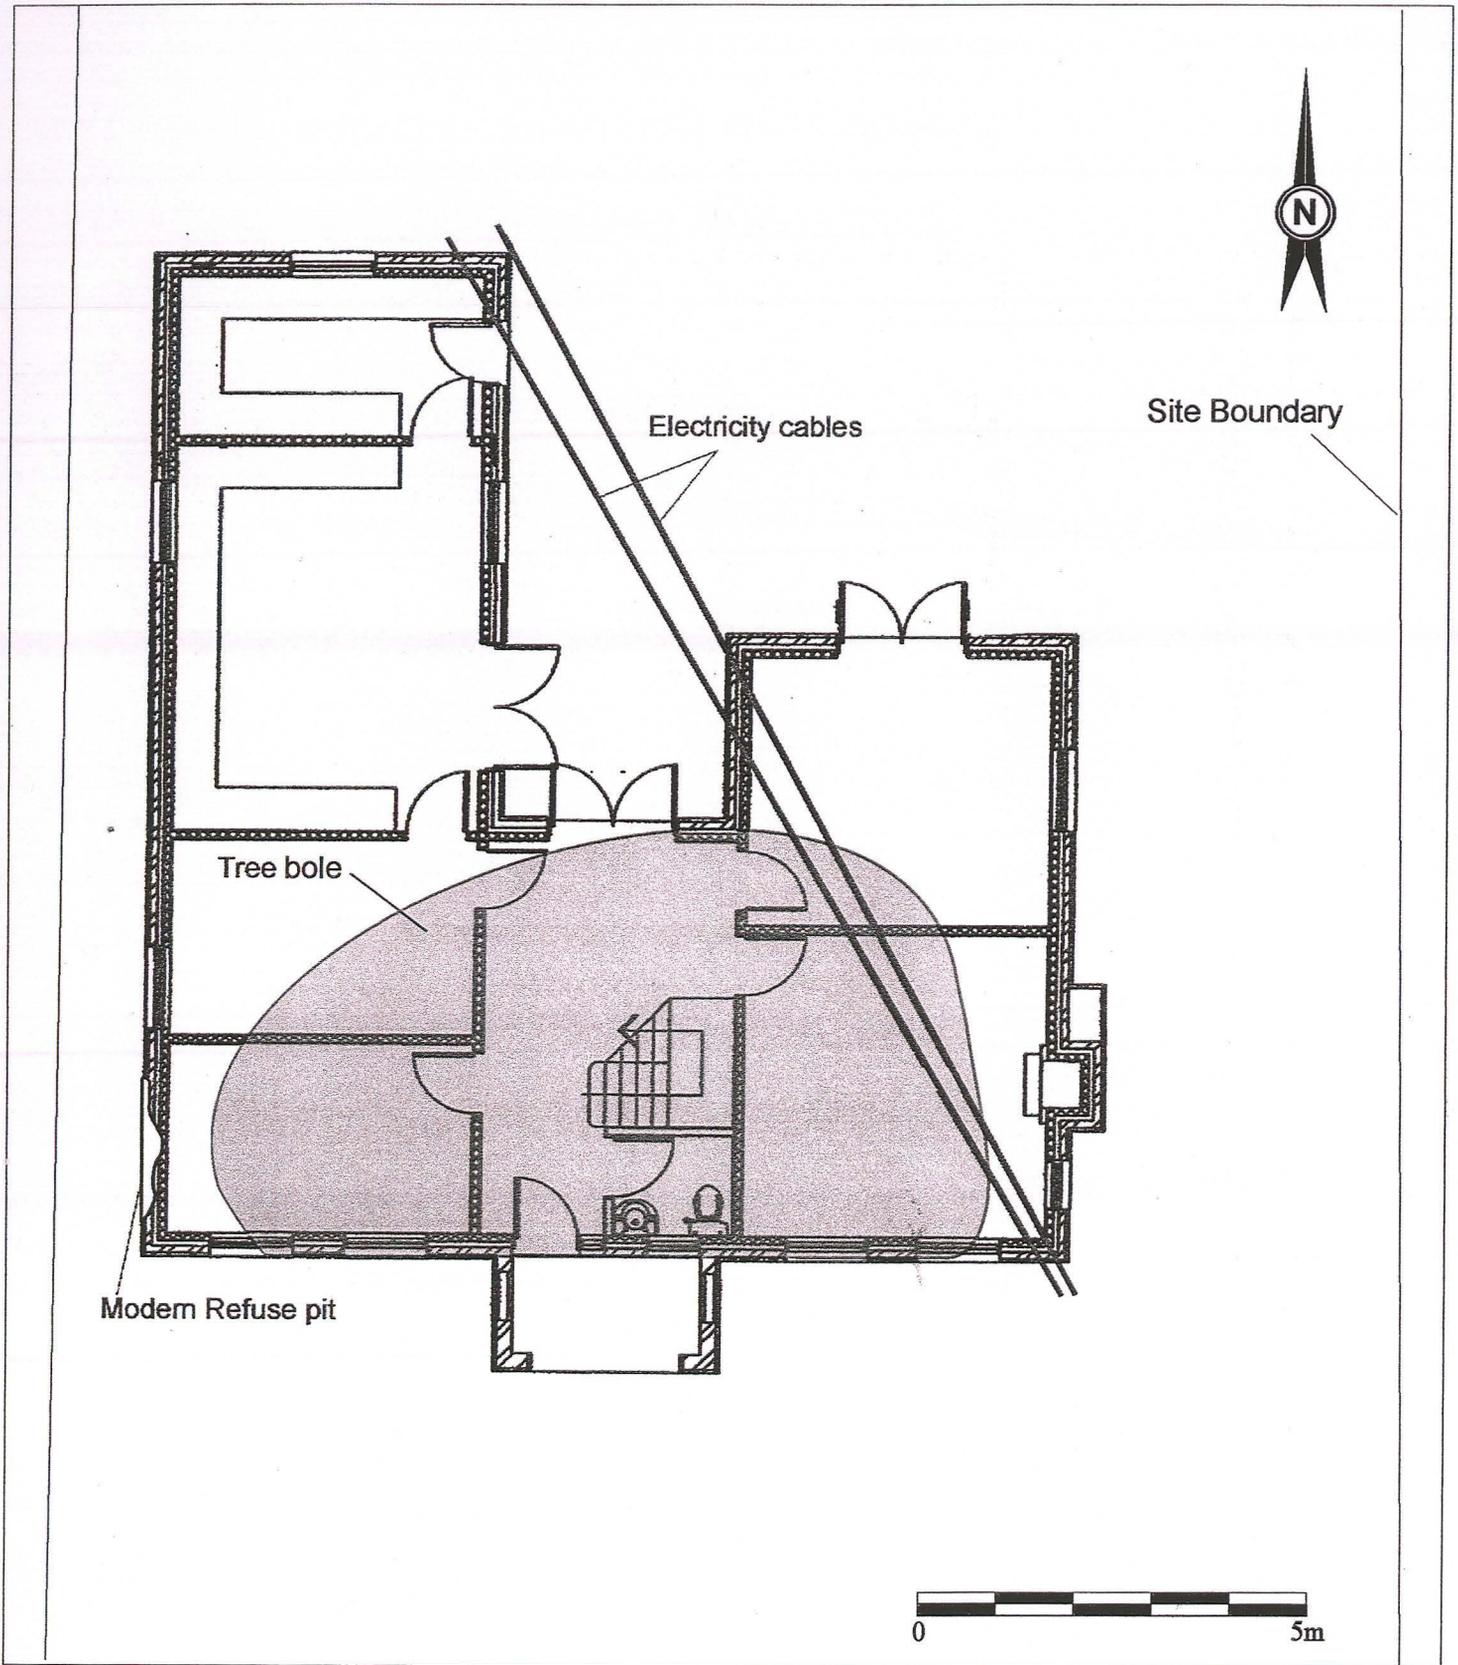
Fig. 3 Plan of the house footings and observed features (taken from a plan supplied by the client)

With the exception of a 0.45m deep early 20<sup>th</sup> century refuse pit (see Fig. 3) no finds or features of an archaeological nature were observed cutting into layer **101**. A single tree bole c.6.00m in diameter was noted at the southern end of the development. A mature horse chestnut tree had been removed by the land owner prior to the beginning of any work. The natural disturbance caused by root action and retained ground water in this area was substantial, but of little consequence archaeologically due to the obvious lack of any remains (Pl.4 and 5). Two unarmoured and unmarked electricity cables were

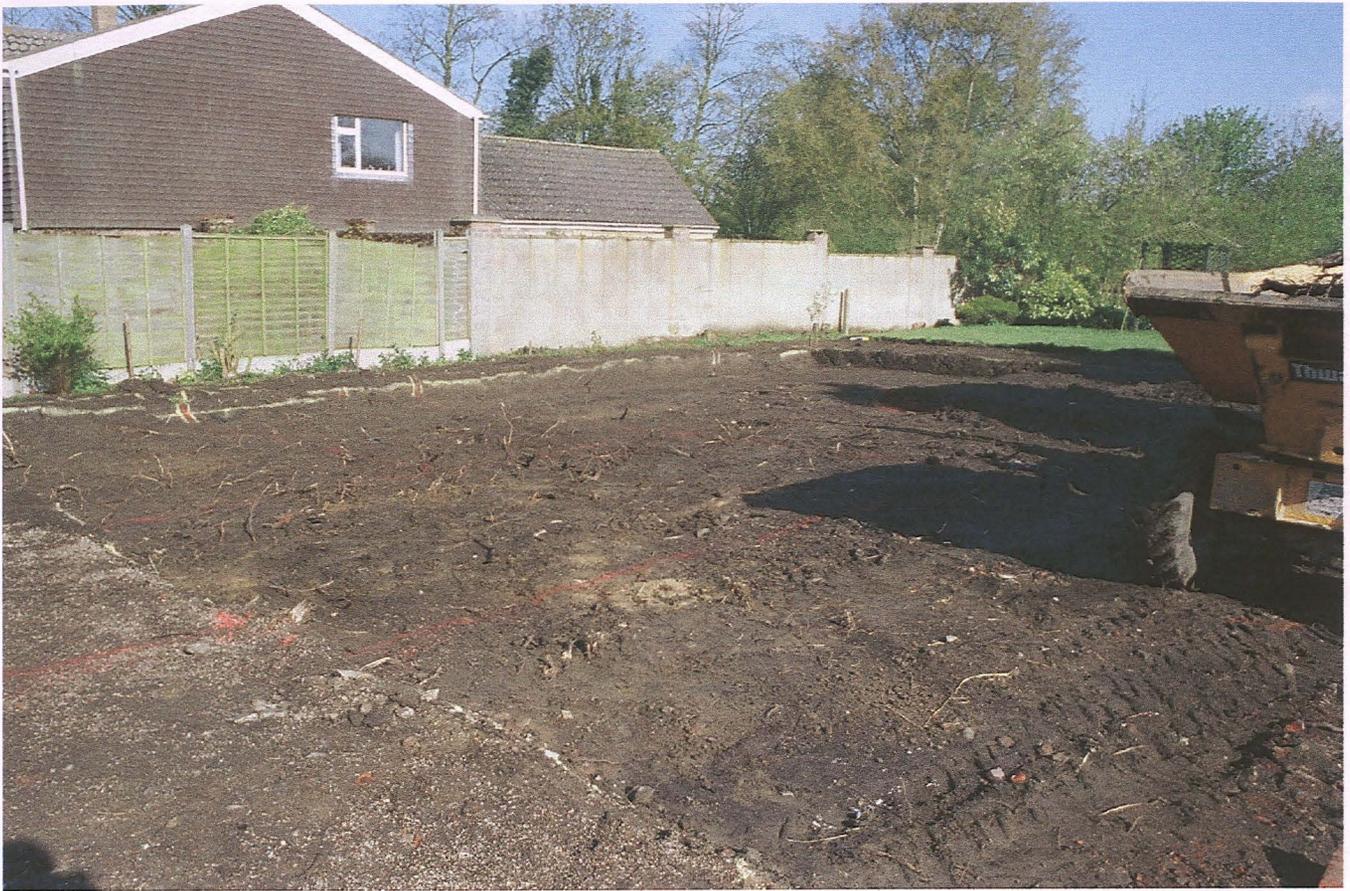
Pl. 1 Looking north-east across the stripped site

Overlying vegetation and approximately 0.10m of topsoil **100** were removed from the development area prior to the archaeological watching brief (Pl. 1 and 2). The excavation of the foundation trenches was undertaken by a JCB 3CX Sitemaster 4 Turbo equipped with a 0.60m wide toothed bucket. For the majority of the foundation plan the trenches were excavated to a depth of 1.00m from the present ground surface. Along the eastern boundary of the site the presence of conifer trees in the adjacent property necessitated a deeper trench with a final formation level of 1.40m below the present ground surface. All machining was monitored by LAS Archaeological Project Officer Richard Pullen MA PIFA. Foundation works were undertaken on the 27<sup>th</sup> April 2005 and took one day to complete. A full photographic record was maintained during the work.

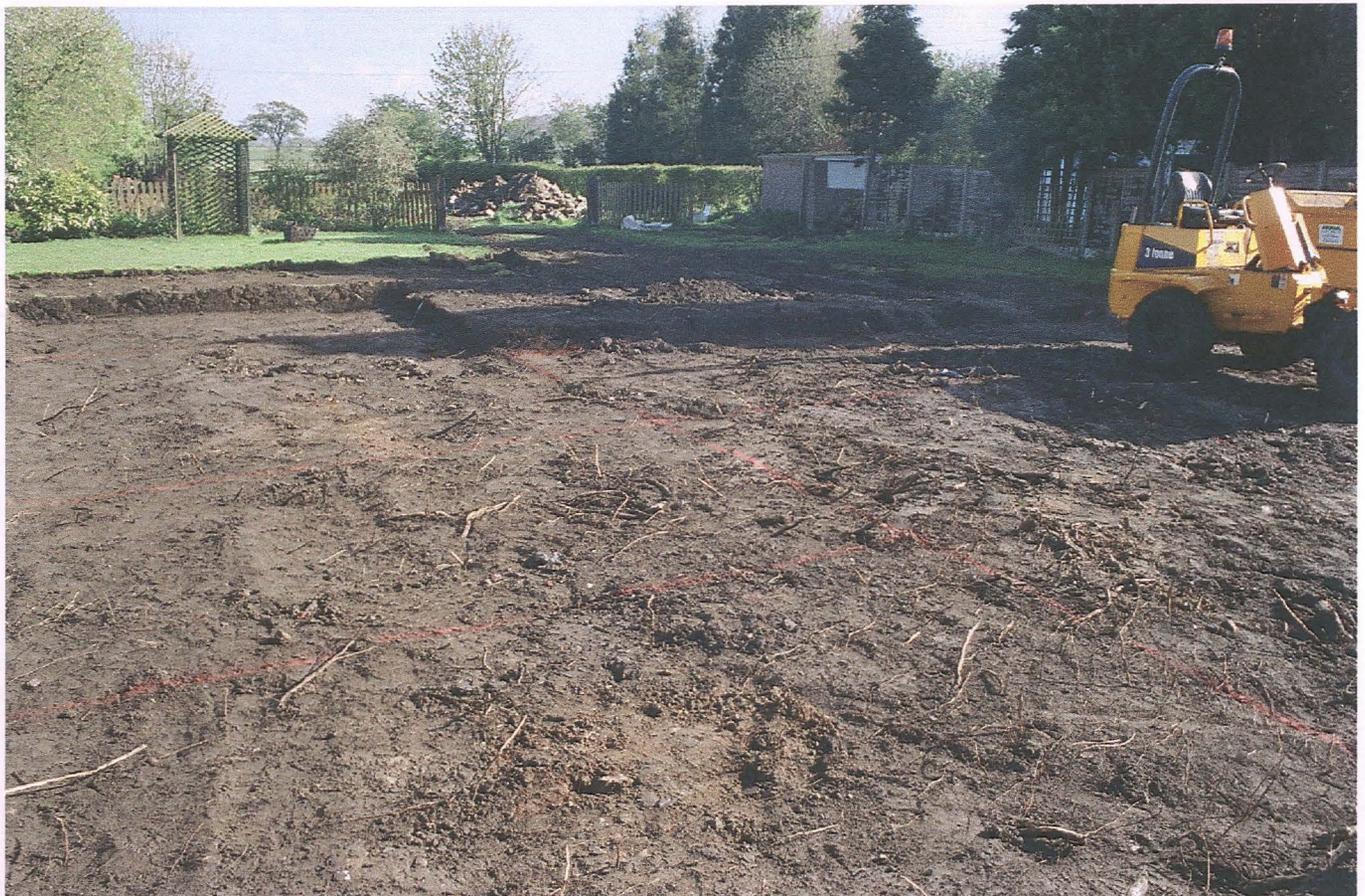
Pl. 2 Looking north-west across the development site

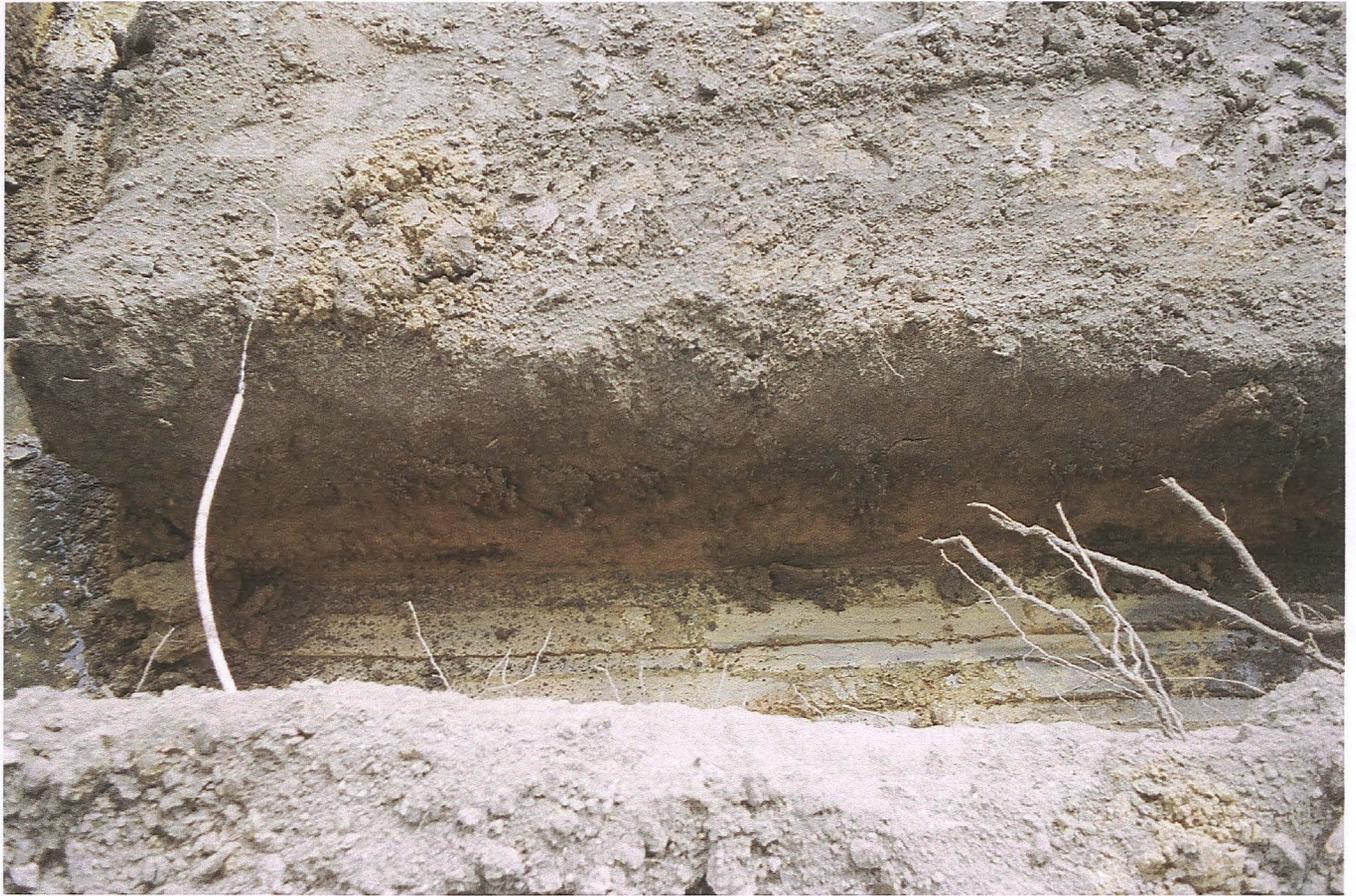
The topsoil **100** was a dark grey/brown silty clay that contained occasional small sub-angular sandstone fragments and demonstrably modern material including pottery sherds and window glass. The topsoil **100** had an overall depth of 0.25m. Beneath the topsoil a mid brown clay silt subsoil **101** was noted. Subsoil **101** had a depth of c.0.55m (Pl.3 and 4).

noted running north-south across the site at a depth of just 0.15m below the present ground surface (Pl. 3). The cables proved to be disconnected from any supply. At a depth of c.0.80m from the original ground surface a mid to light brown clay layer **102** was observed. Layer **102** represents the natural geology and continues undisturbed beyond the maximum final formation depth of 1.40m (Pl. 3 and 4).

Pl. 3 The horizontal stratigraphy of the eastern baulk of the site and one of the two cables noted during the watching brief.

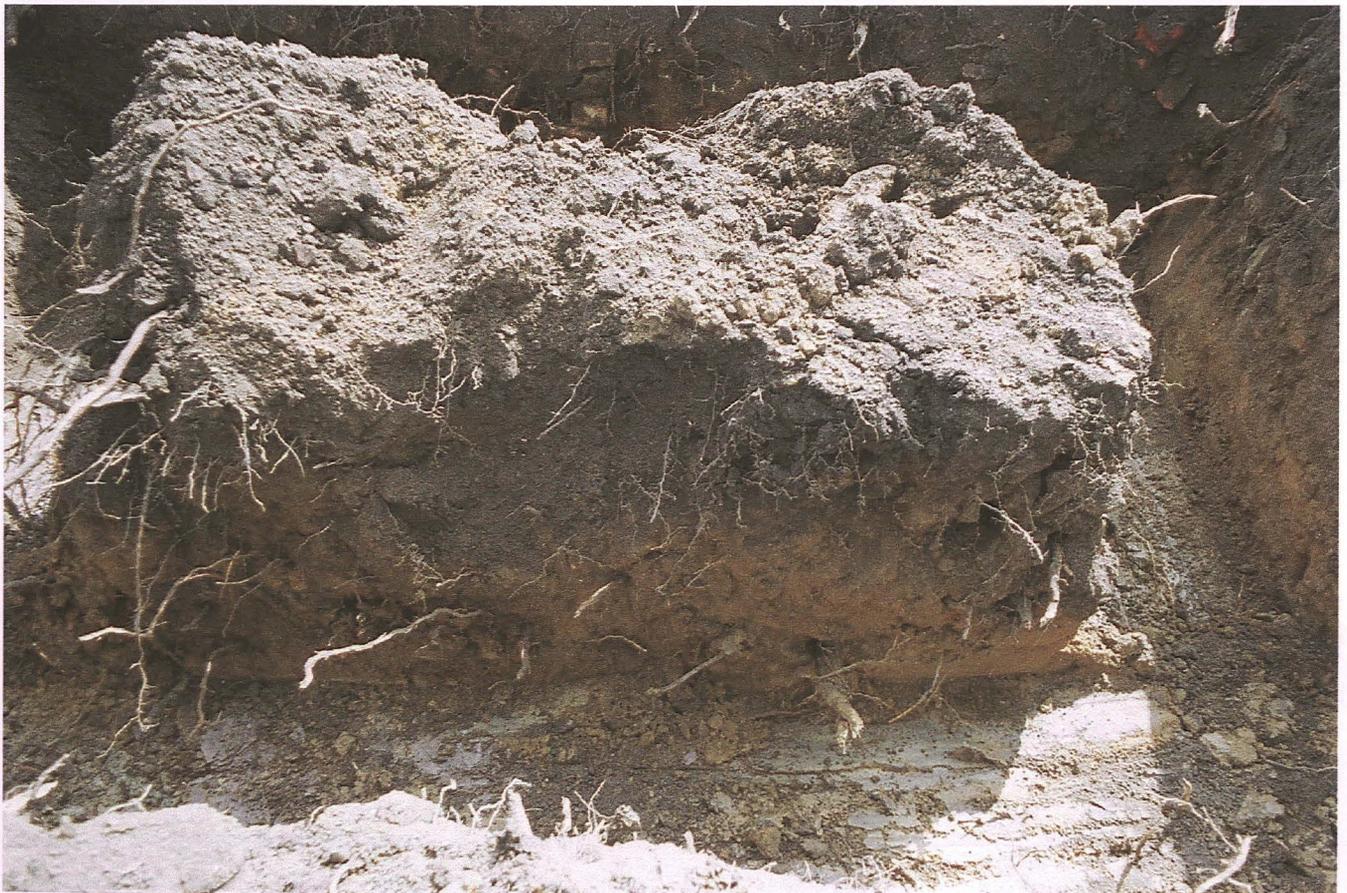
Pl. 4 Root action and stratigraphy in the southern baulk

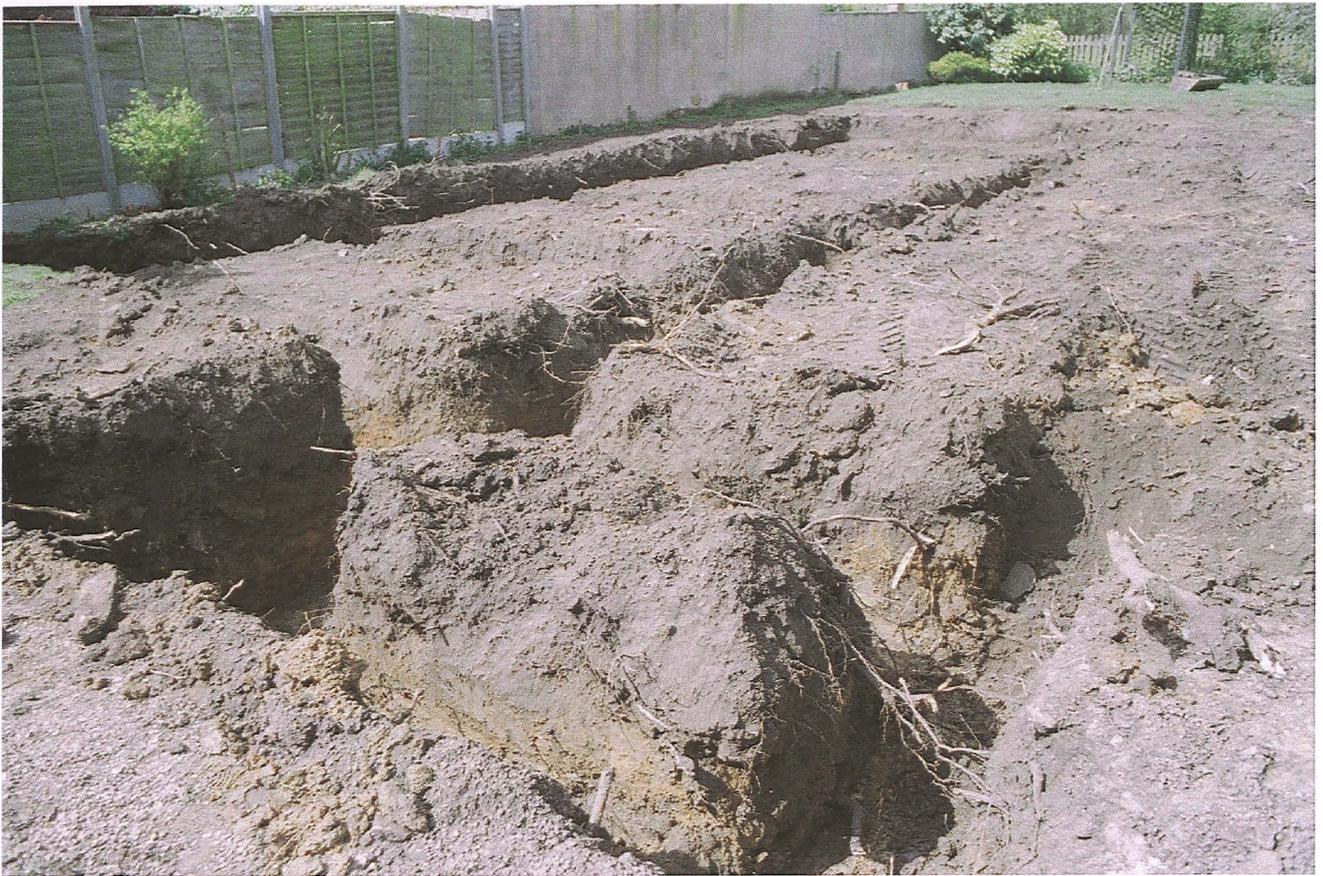
Pl. 5 Looking north-east across the excavated foundations showing root damage in the foreground

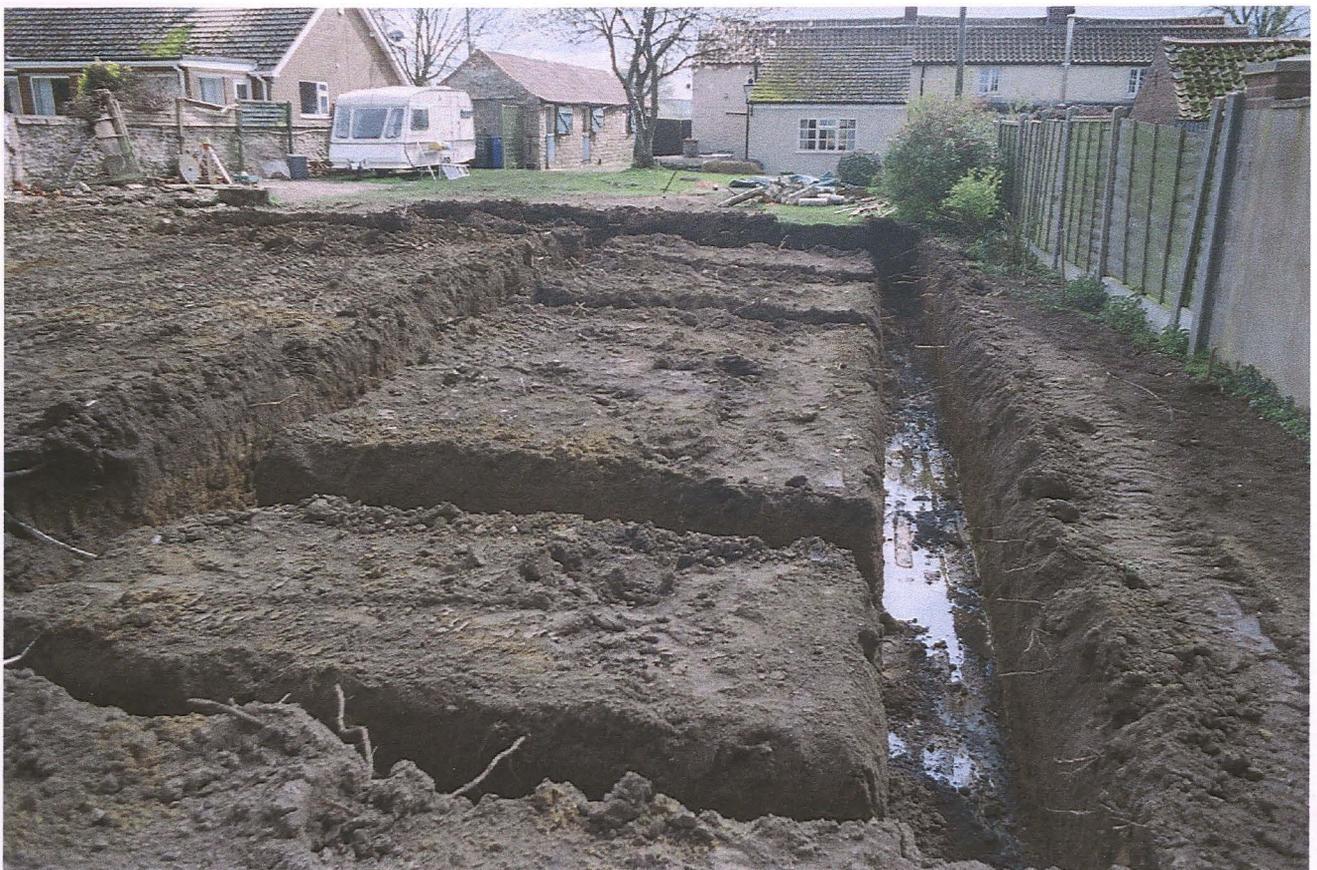
Pl. 6 A general view looking south at the finished foundation trenches
