**Former Service Station, Bourne Rd, Folkingham
Lincs.**

Archaeological Watching Brief

LAS Report No. 827

June 2005

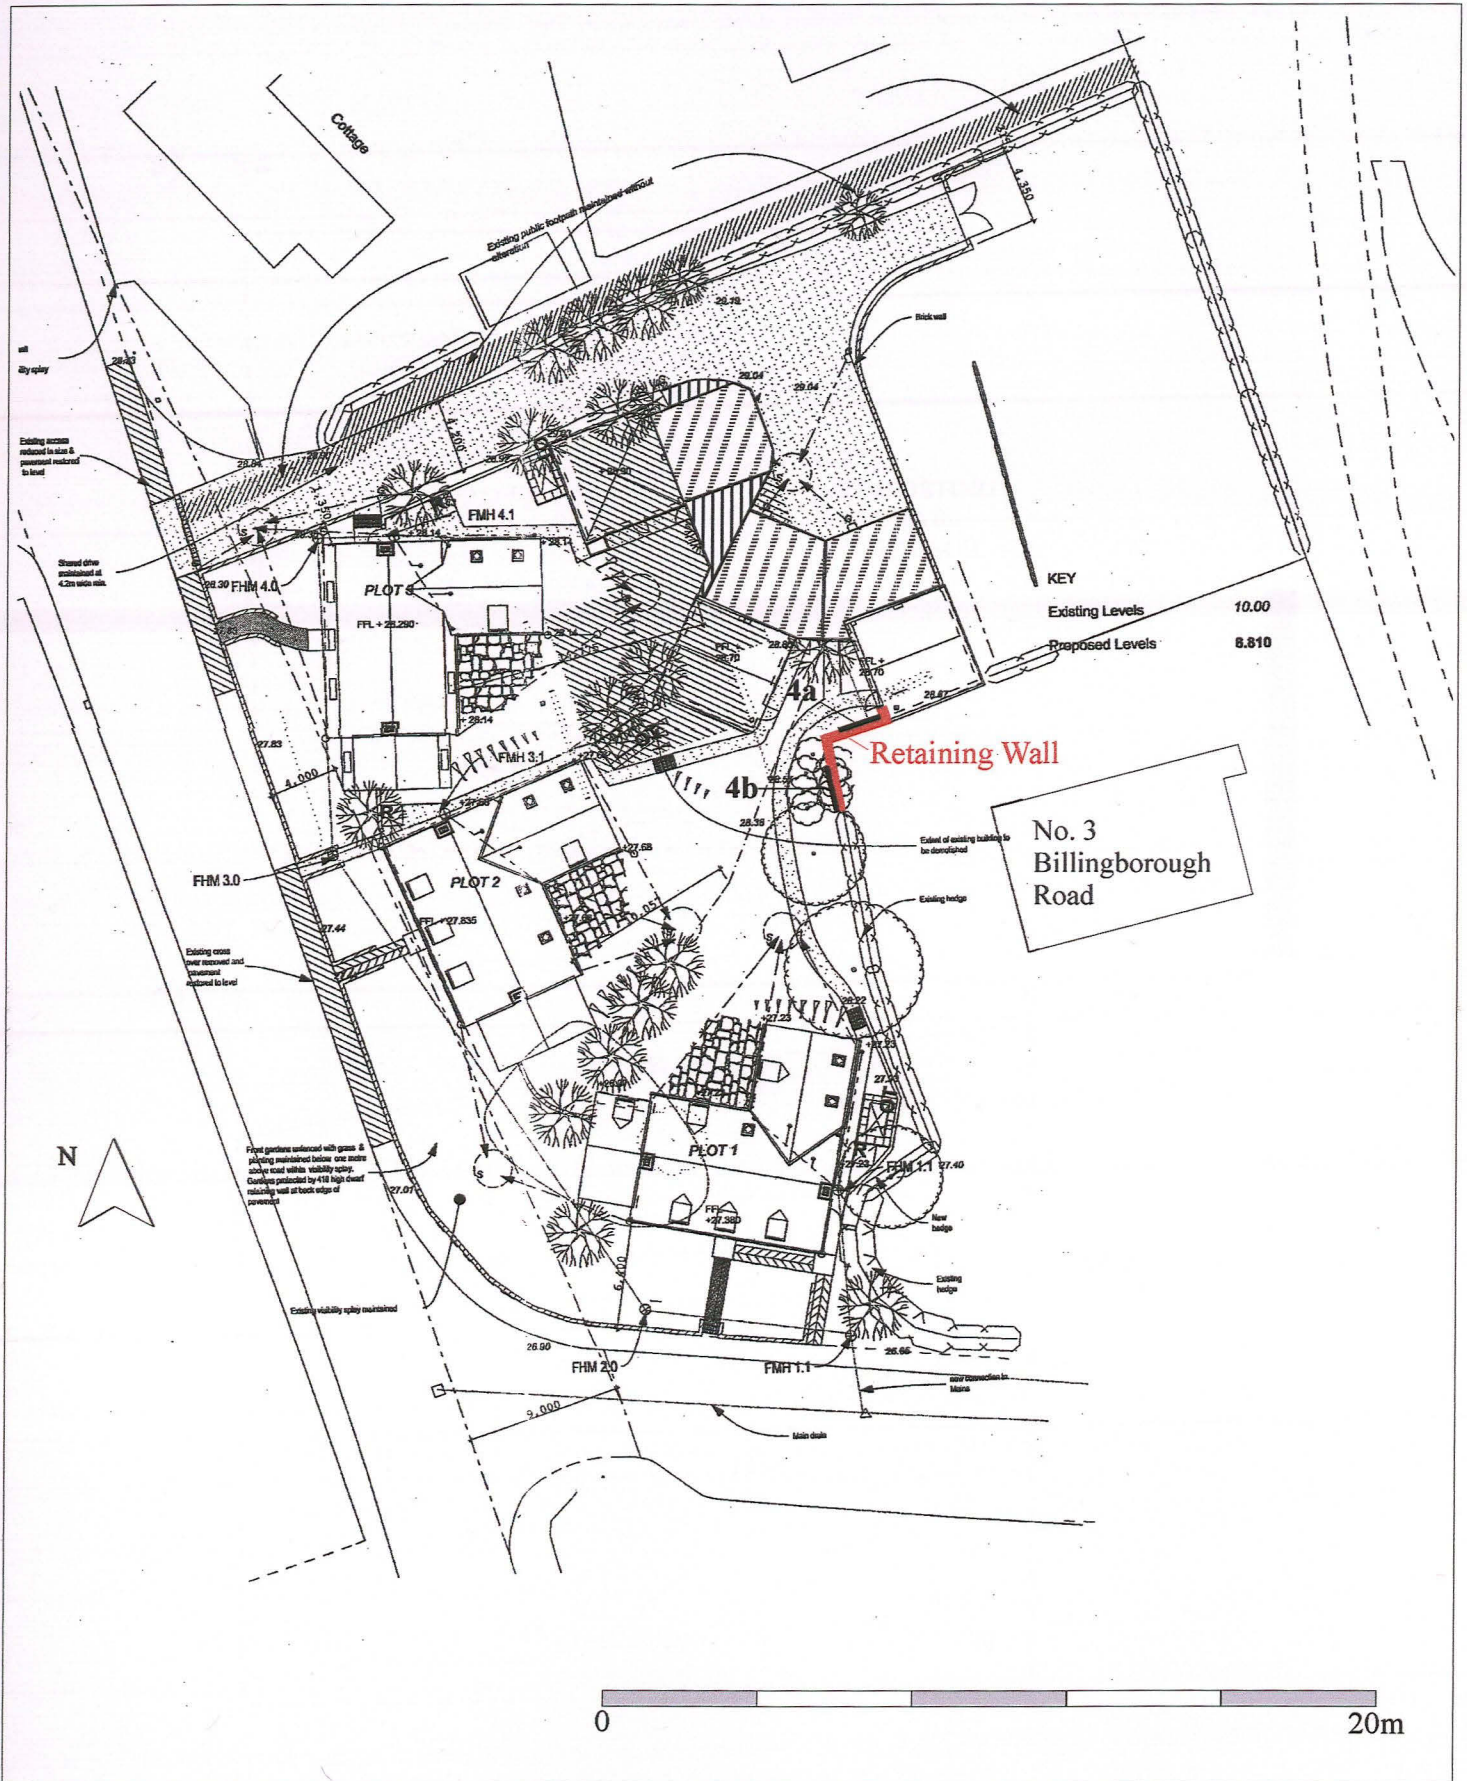
Fig. 3 Layout of the new development, showing the position of the monitored groundworks (based on Rochford Homes Ltd dwg. 030/S-WD01).

Planning permission was granted for the construction of a three dwellings with integral garages on the site, with access drive, and services (Fig. 3). An archaeological condition required that an archaeological watching brief should be kept during the groundworks phase of the development, except on areas affected by the petrol tanks.

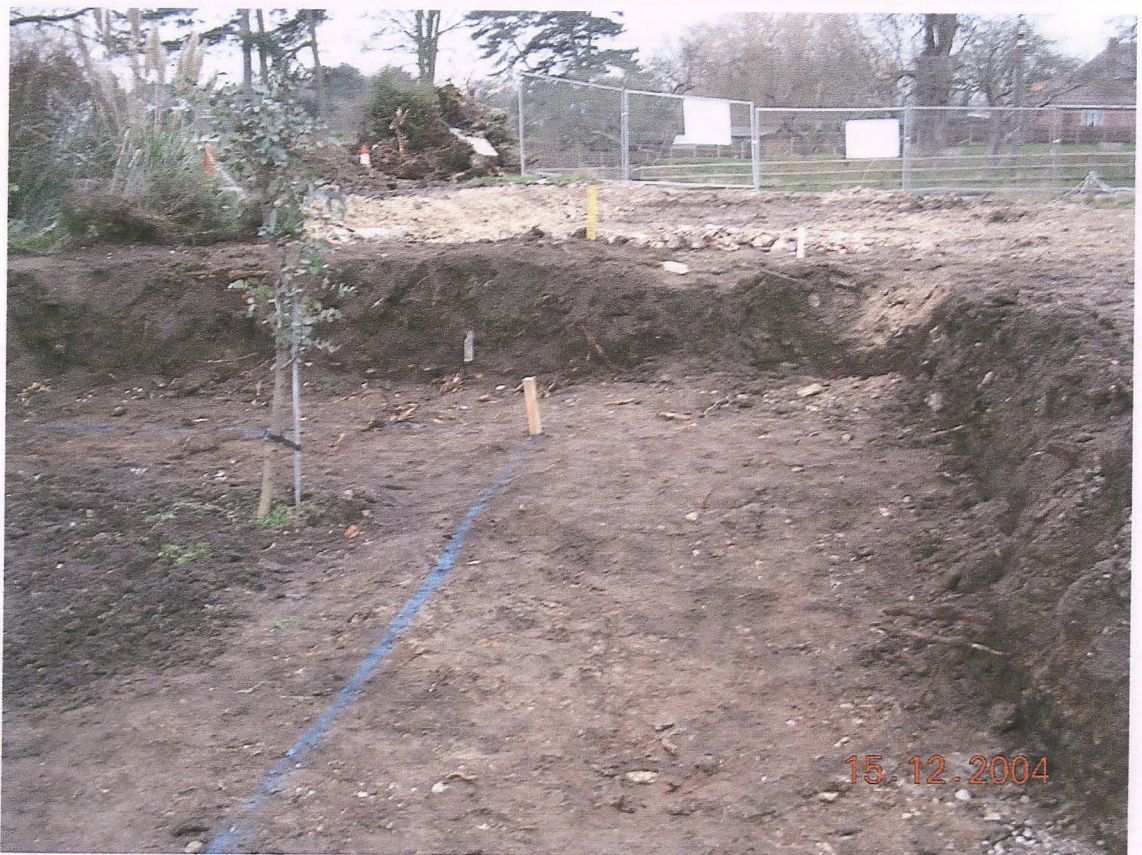
PI. 2 Area stripped of topsoil for the new retaining wall (looking west towards Bourne Road).

Soil **2** was removed from the slope between the new development and an existing bungalow, prior to excavation of a construction trench for a new retaining wall (Pls. 2-4). The stripped surface was at between about 0.7m and 0.95m below the 2004 ground level.

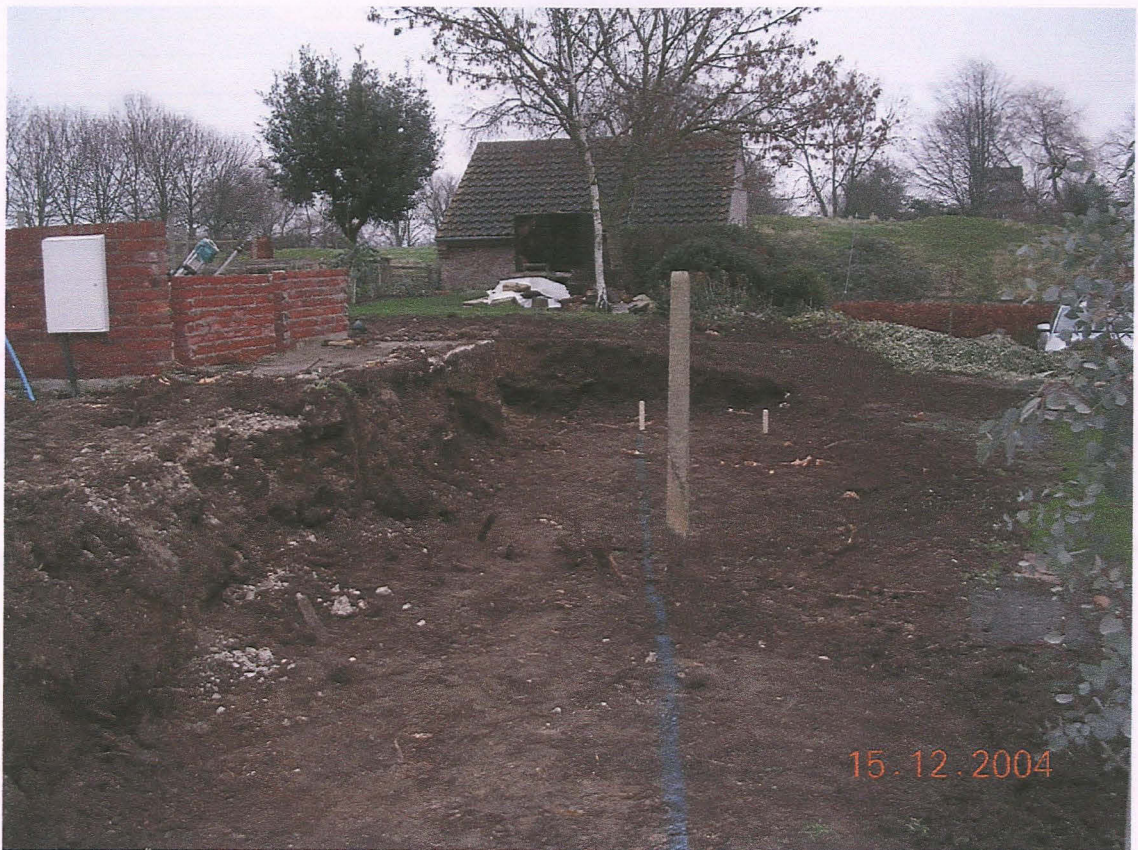
PI. 3 Area stripped for the retaining wall (looking east towards the castle site).

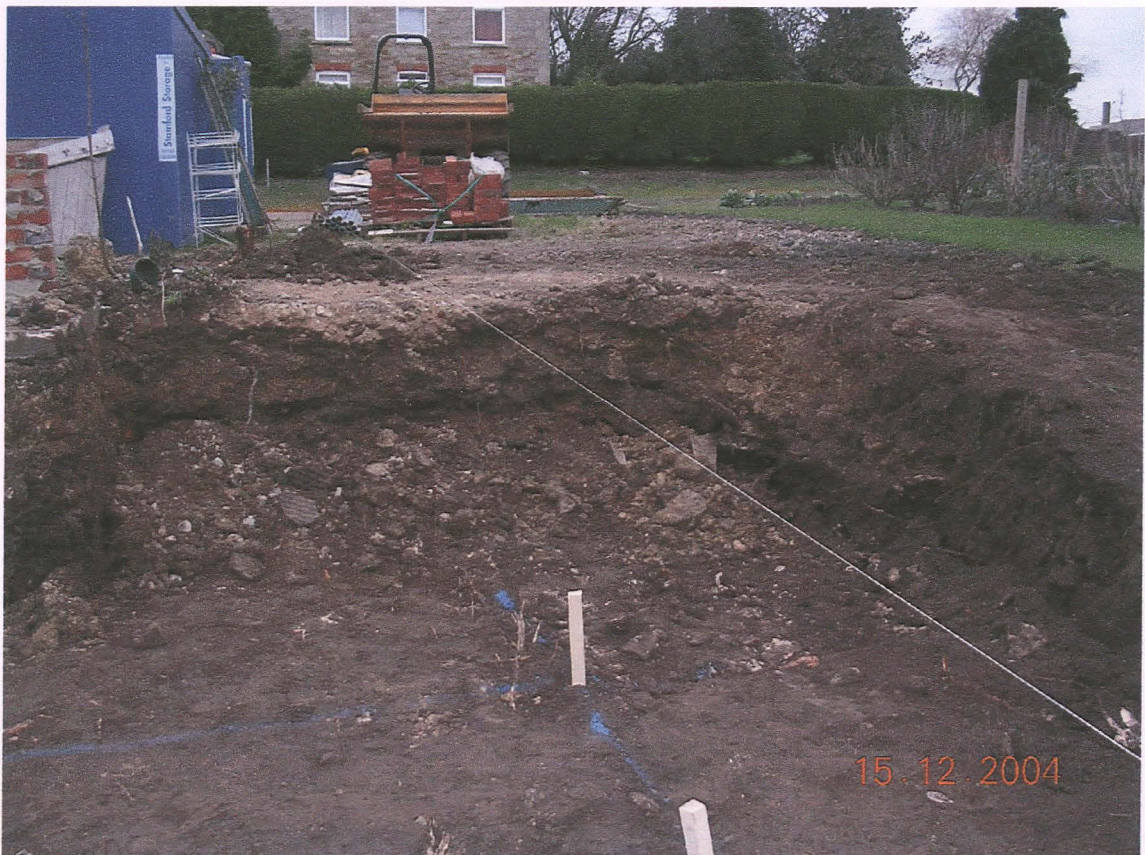
PI. 4 North-eastern corner of the area stripped for the retaining wall (looking north). Rubble from the soakaway 9 is visible. The sloping ground to the north appears to have been lowered when the garage was built.

The eastern side of the stripped area cut into the western edge of a west-east aligned earth bank, revealing an area of limestone rubble **8**. This was identified as the fill of an extensive feature **9**, over 0.95m deep, and extending at least 4m. The feature was interpreted as a twentieth century soakaway, probably associated with the petrol station.

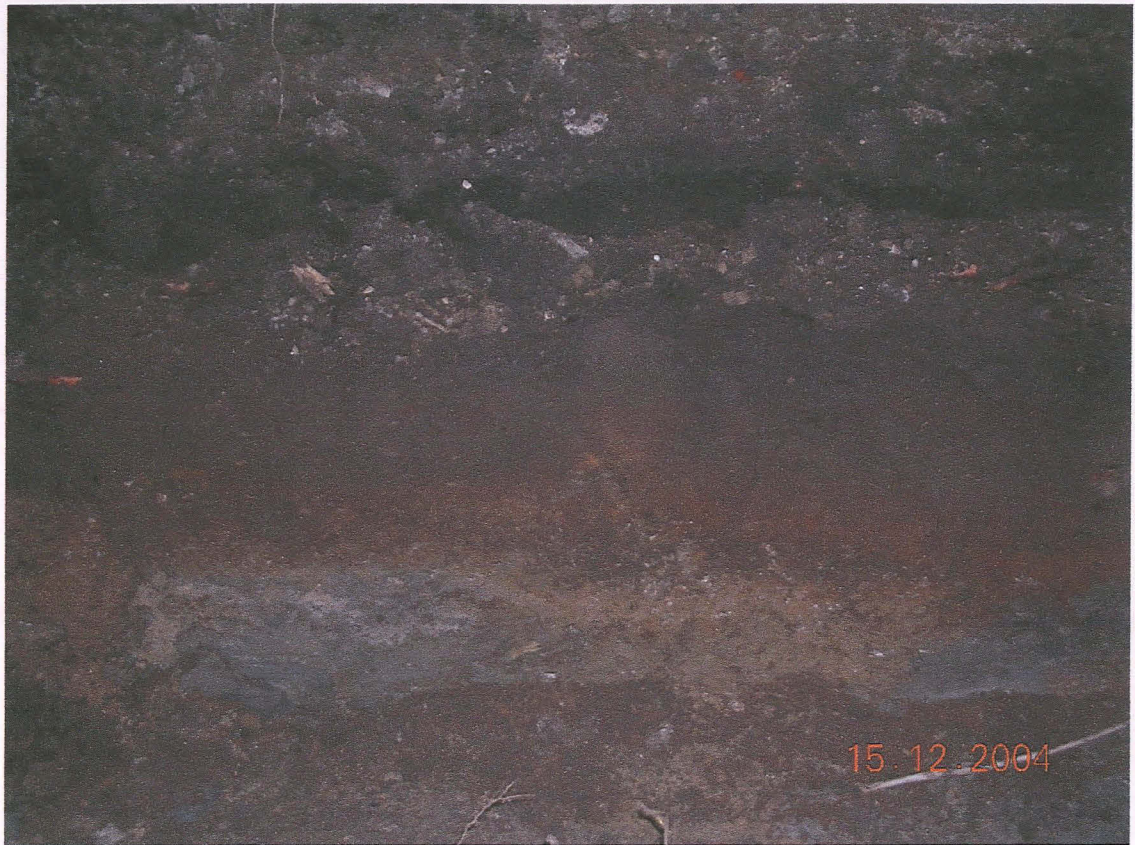
PI. 5 Trench face of the northern retaining wall (looking north).

The northern side of the retaining wall trench face was disturbed by a pipe trench at its eastern end. The topsoil **1** depth to the west of the pipe trench was about 1m from 2004 ground level, and this may have been the western limit of the soakaway pit **8**. Below the topsoil was a layer of orange clay loam **3** with an irregular base which sloped slightly down towards the east. Beneath it was a layer of chalky buff clay **4**, above grey clay **5** (Pl. 5). The grey clay appeared to be at the edges of a narrow channel **7**, which was assumed to be naturally formed.

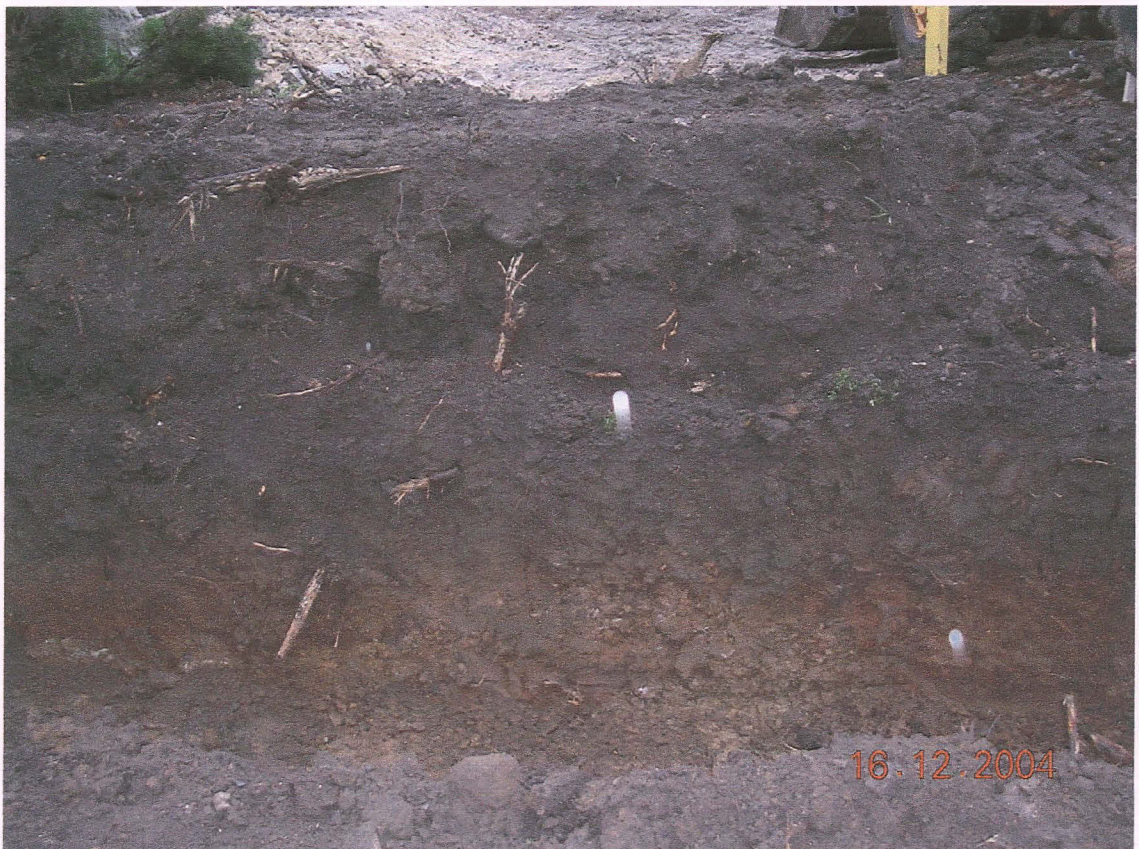
PI. 6 The trench face for the western retaining wall, showing the orange loam filling two features.

The western return of the retaining wall trench revealed a thick layer of redeposited topsoil **10** covering a previous topsoil layer **12** (Pl. 6). The extra material probably represents soil moved in 1980 when the fuel tank was excavated. The earlier topsoil layer, up to 0.45m thick, covered a thin band of stone fragments **13** which had probably formed as a result of cultivation of the layer above.

Below it was orange clay loam **3**, which was at least 0.2m thick, but seemed to be filling two separate features **14** and **15** cut into the yellow clay **16** below. A fragment of medieval roof tile was found in **3** where it filled **15**.
