OLD BOLINGBROKE
Onion Factory site Main Rd
(Accn no. 183.94)

Archaeological Evaluation

D. L. S. (Holdings) Ltd

February 1995

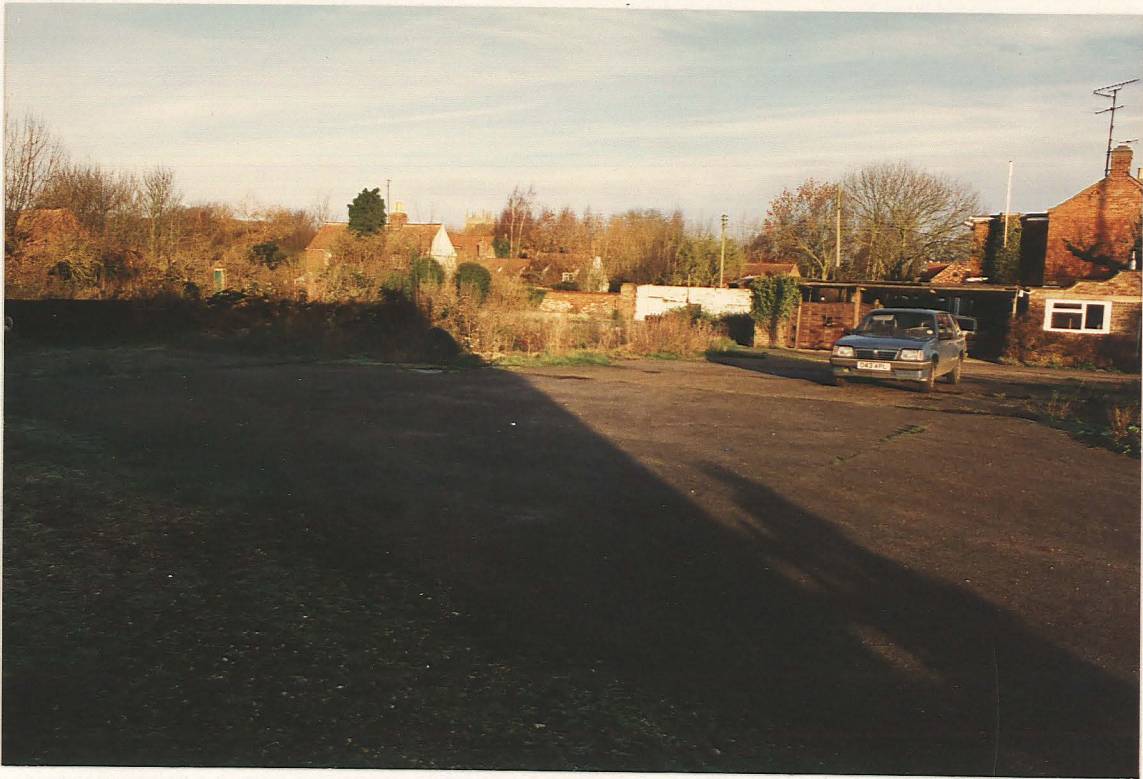
Trench 1 was located on the edge of the brewery block. which survives as a large slightly raised concrete platform surrounded by brick foundations. The purpose of the trench was to determine the depth of ground disturbance caused by its construction (Pl. 2).

Pl. 2 General view of site looking N

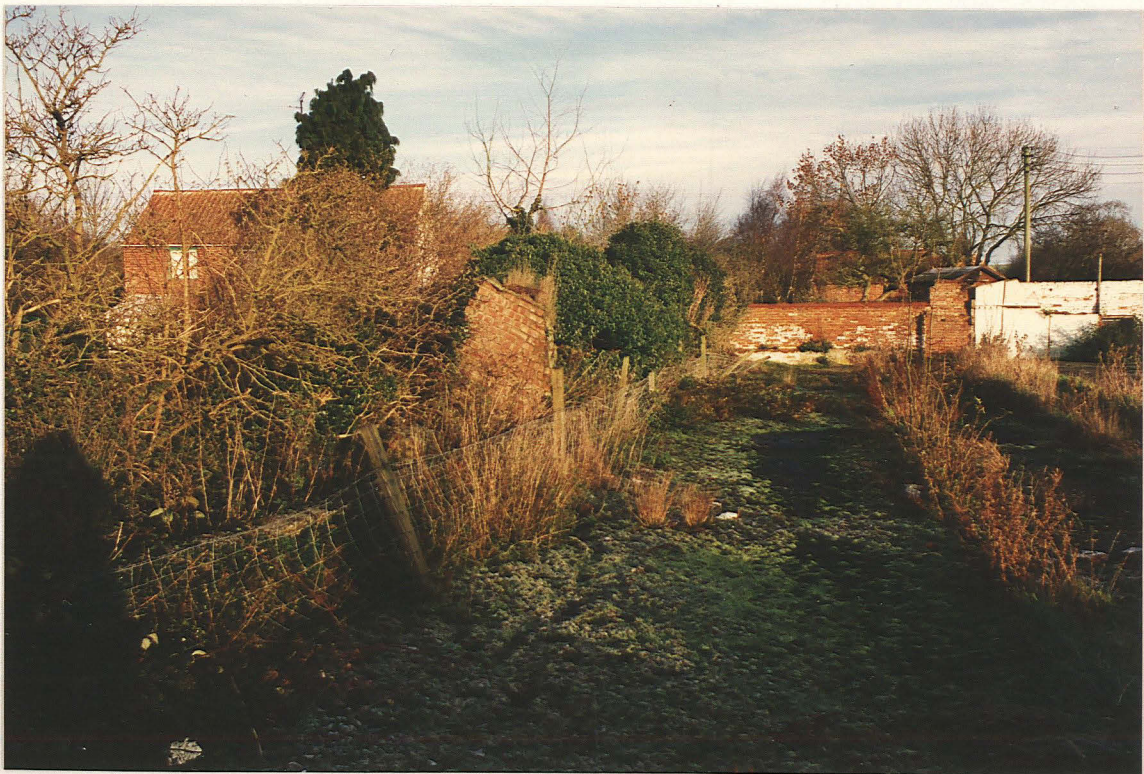
A zone of grey brown clay subsoil, c.0.20m thick, which contained brick rubble, was visible beneath the bedding and overlay the natural sandy clay (Pl. 3). It was thought that the natural deposits may be derived from the watercourse to the west of the site. Without clearance of a larger area it is difficult to tell whether all archaeological remains have been removed but it is considered that the area beneath the brewery has reduced potential because of previous soil clearance.

Pl. 3 View of NW corner of site looking N

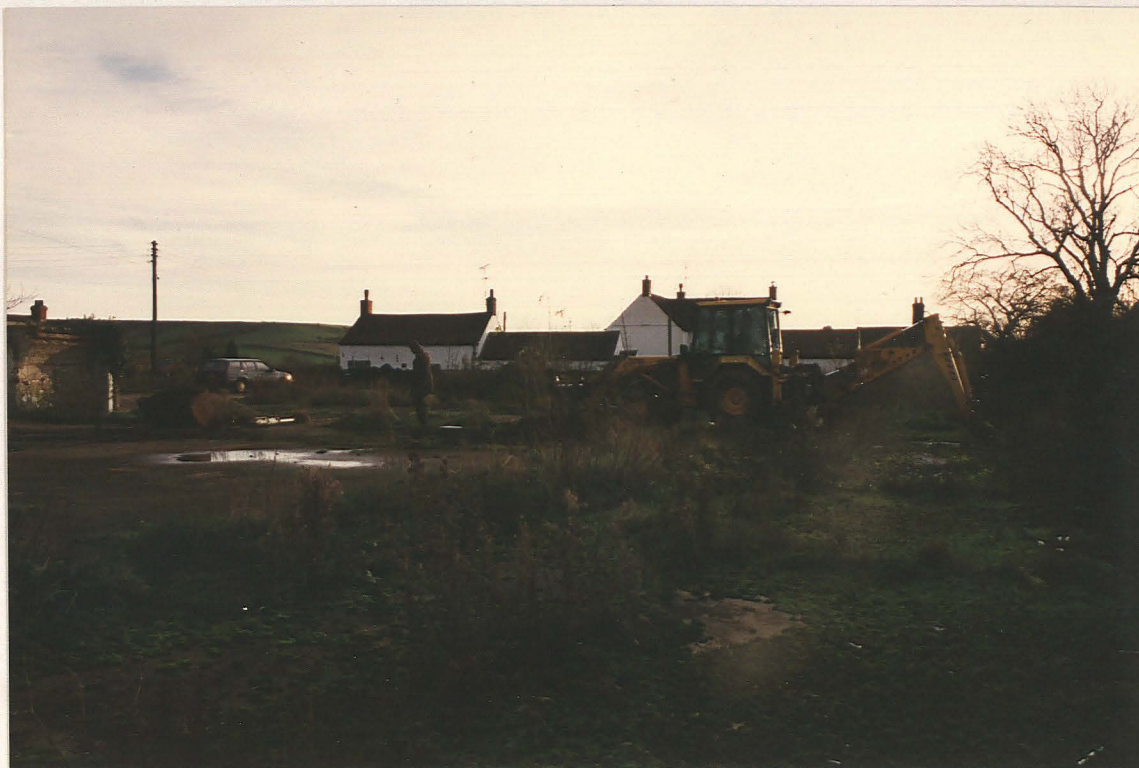
A shallow trench 4.30m long and 0.30m deep was dug to the south of Trench 1 which cut across the brick footings of the demolished maltings. The trench also crossed the line of a plastic pipe at its east end. The whole of the trench appeared to cross disturbed ground and was abandoned (Pl. 4).

Pl. 4 General view of site looking S, excavation of Trench 2

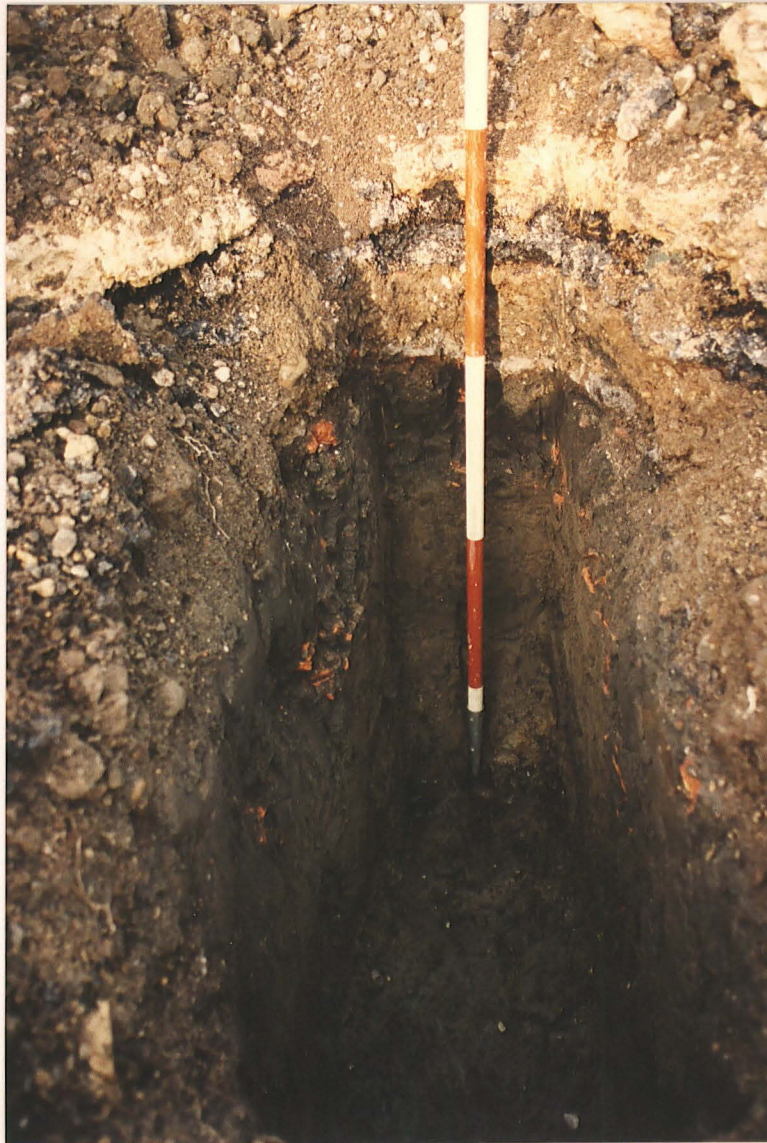
The trench cut through the brick footings of the south wall and extended across a small section of the concrete floor. Beneath the concrete was a layer of crushed limestone chips which formed a bedding for the concrete. the topsoil had been removed prior to laying of the floor.

Pl. 6 Trench 1, close up showing silty clay beneath make-up for concrete floor.

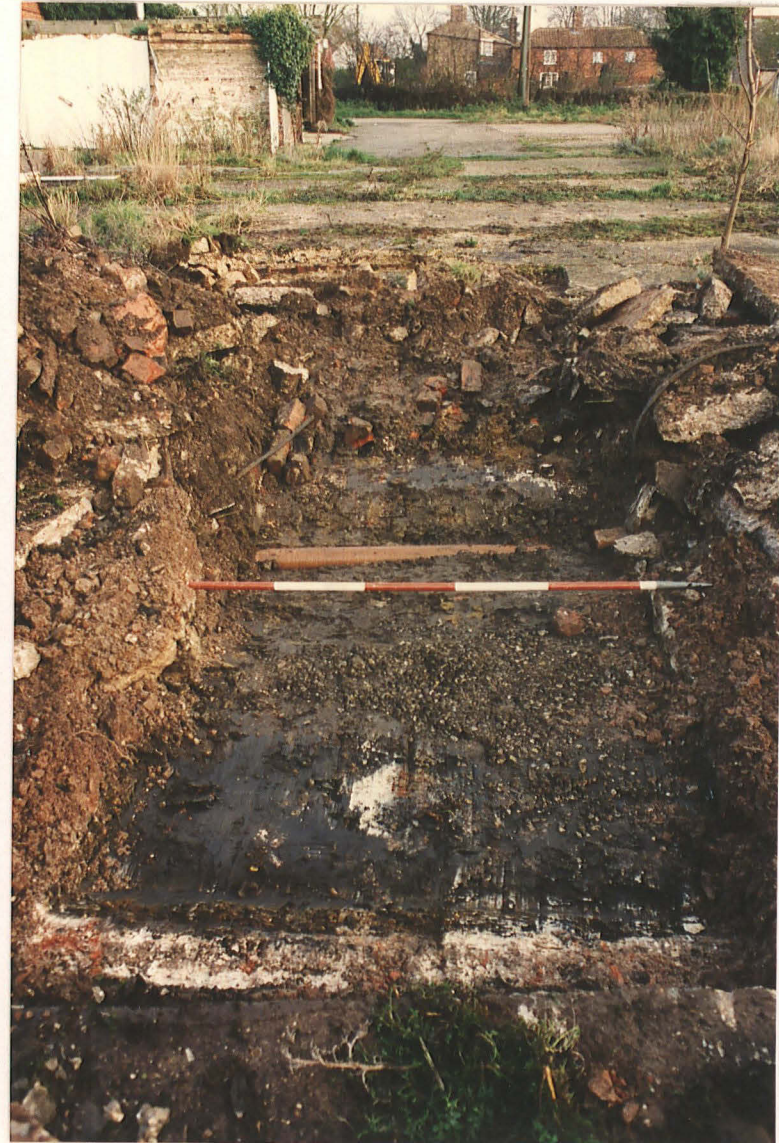
Pl. 7 Trench 2, view E. modern plastic pipe cutting through disturbed ground, site of former maltings block

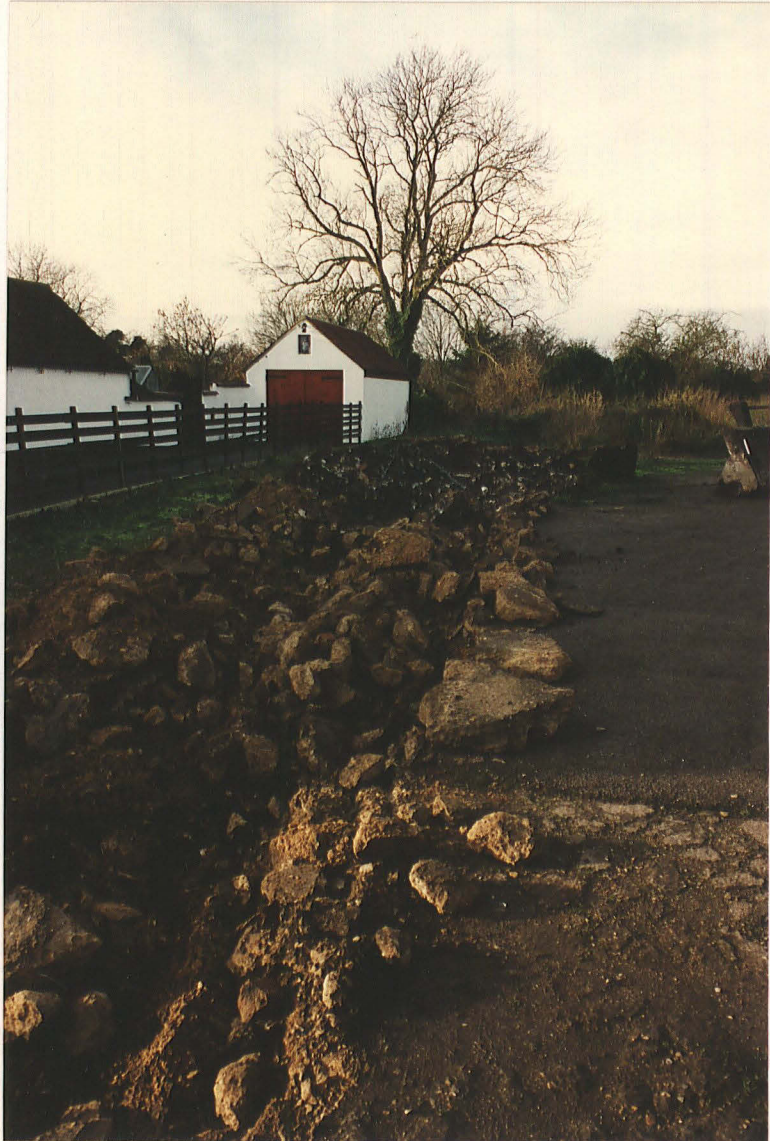
The ground surface over Trench 3 comprised a layer of concrete, c. 0.20m thick (Pl. 8). To the west, over Trench 4, the ground surface gave way to a mixed layer of brick and chalk rubble. (Pls. 8 and 9). The remains of an earlier yard surface were visible in the side of Trench 4 (Pl. 12). A layer of grey-brown subsoil containing brick rubble was observed in both trenches c. 0.30m deep. This was very similar to the layer observed in Trench 1. Beneath was a paler grey-brown clay.

Pl. 8 Trenches 3 and 4. Surface clearance, view W

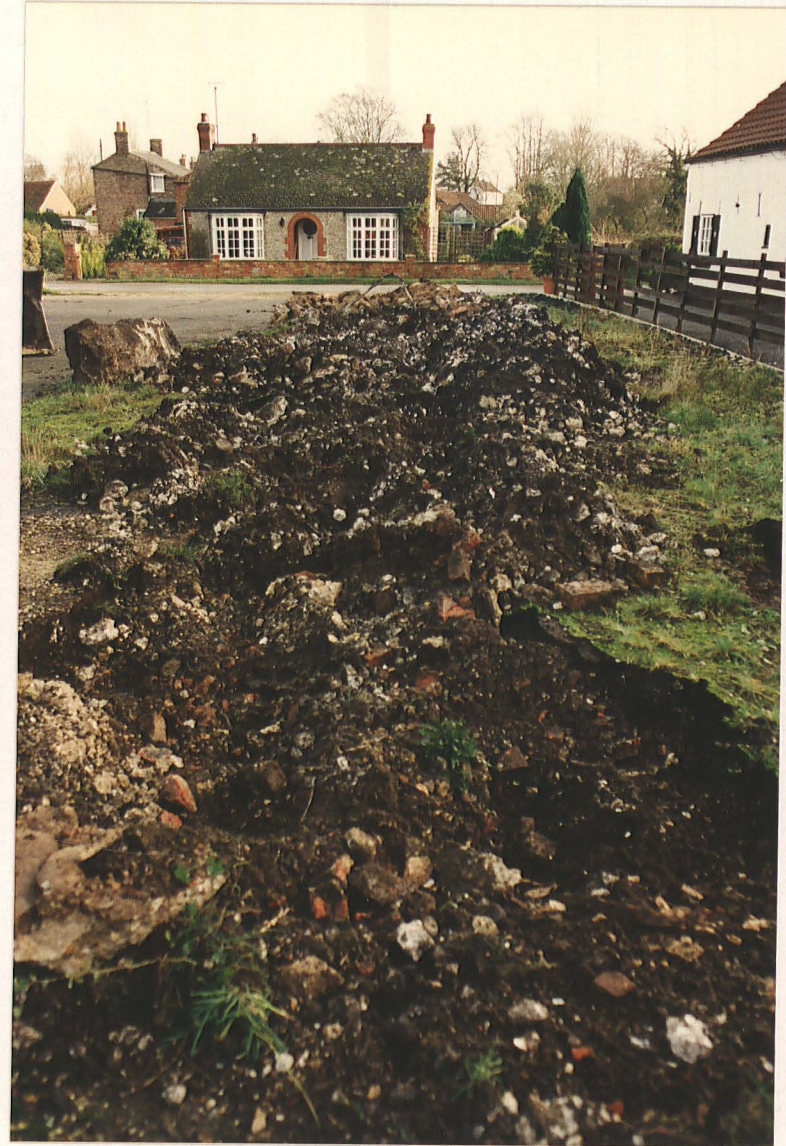
Pl. 9 Trenches 3 and 4. Surface clearance, view E

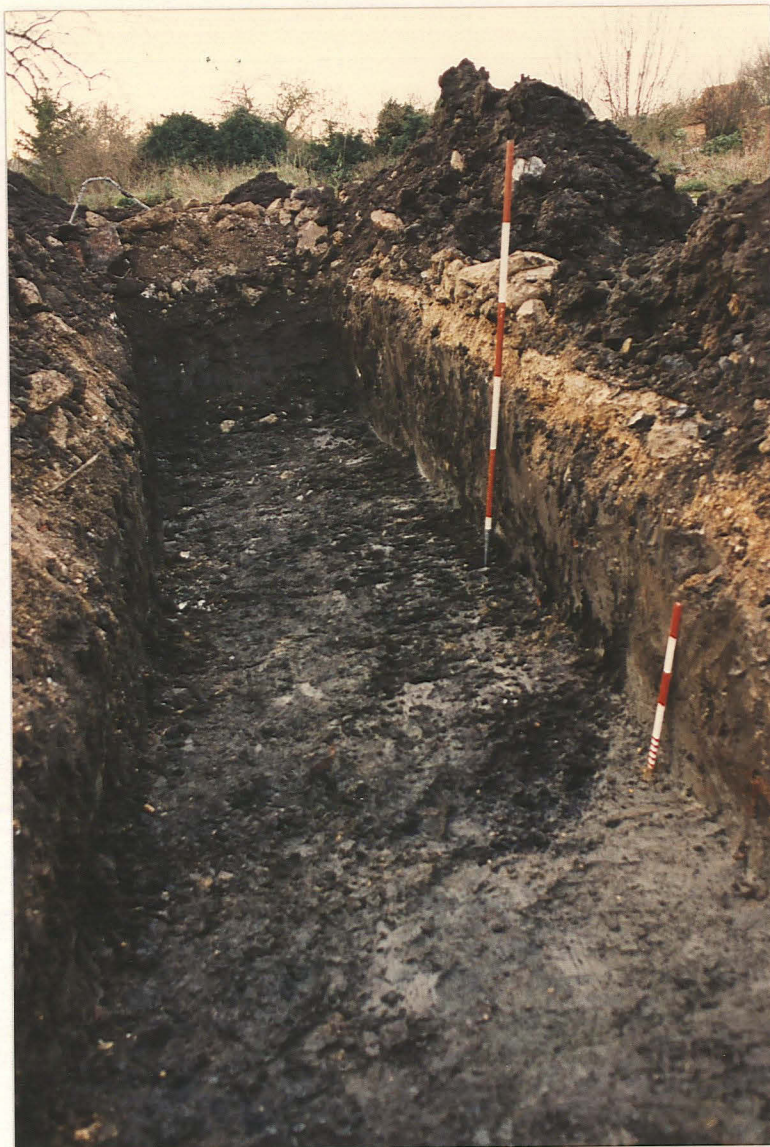
To the west of the pipe trench was a disturbed area where black patches were mixed with the grey clay (Pls. 10 and 11). It smelt as if it had a high organic content. This area produced 16 sherds of Bolingbroke type pottery dating to a period between the 16-18th centuries. The majority were large pieces which were not worn or abraded. The same feature was observed in Trench 4 (Pl. 12), although the soil was not so black, where a further 15 sherds of pottery were found including a piece which had been distorted during firing. The presence of a waster might mean that the feature was a waster pit, where products from a kiln firing had been dumped.

Pl. 10 Trench 3. Dark band of soil to west, possible feature/ditch running diagonally across trench.

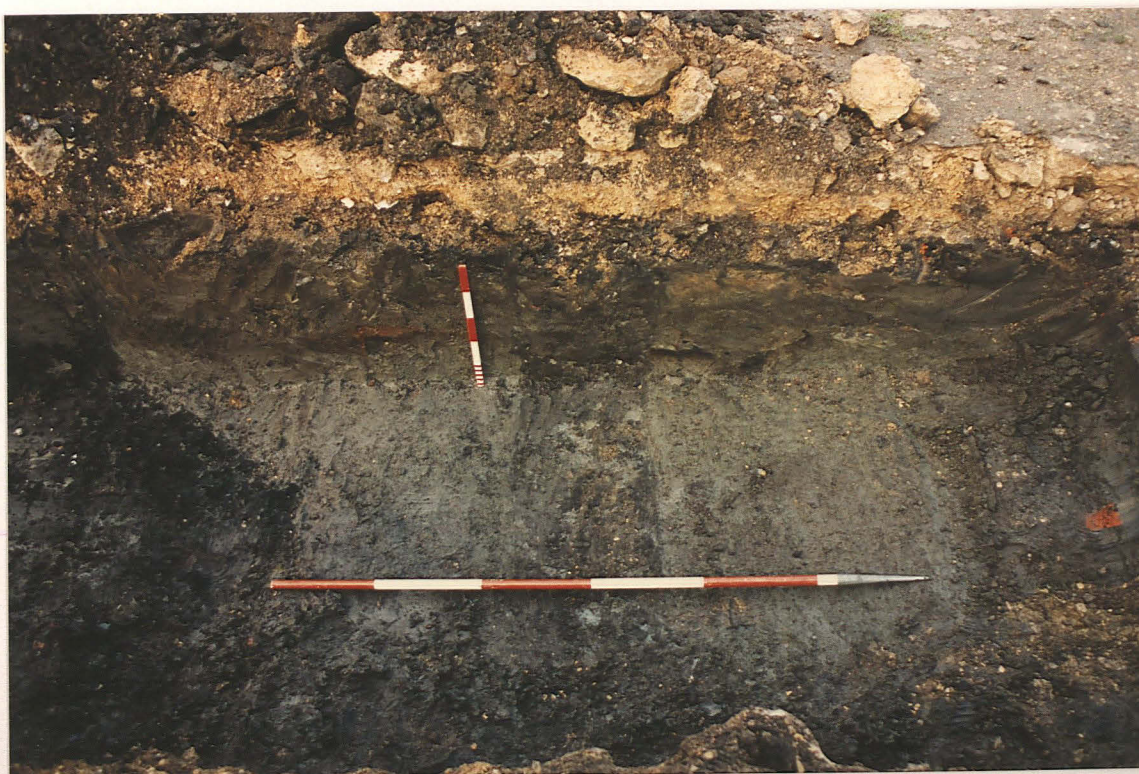
At the east end of Trench 3 was a modern, backfilled pipe-trench 0.30m wide which cut through the subsoil but was sealed by the concrete (Pl. 11).

Pl. 11 Trench 3. View N, showing backfilled modern pipe trench with dark soil to W

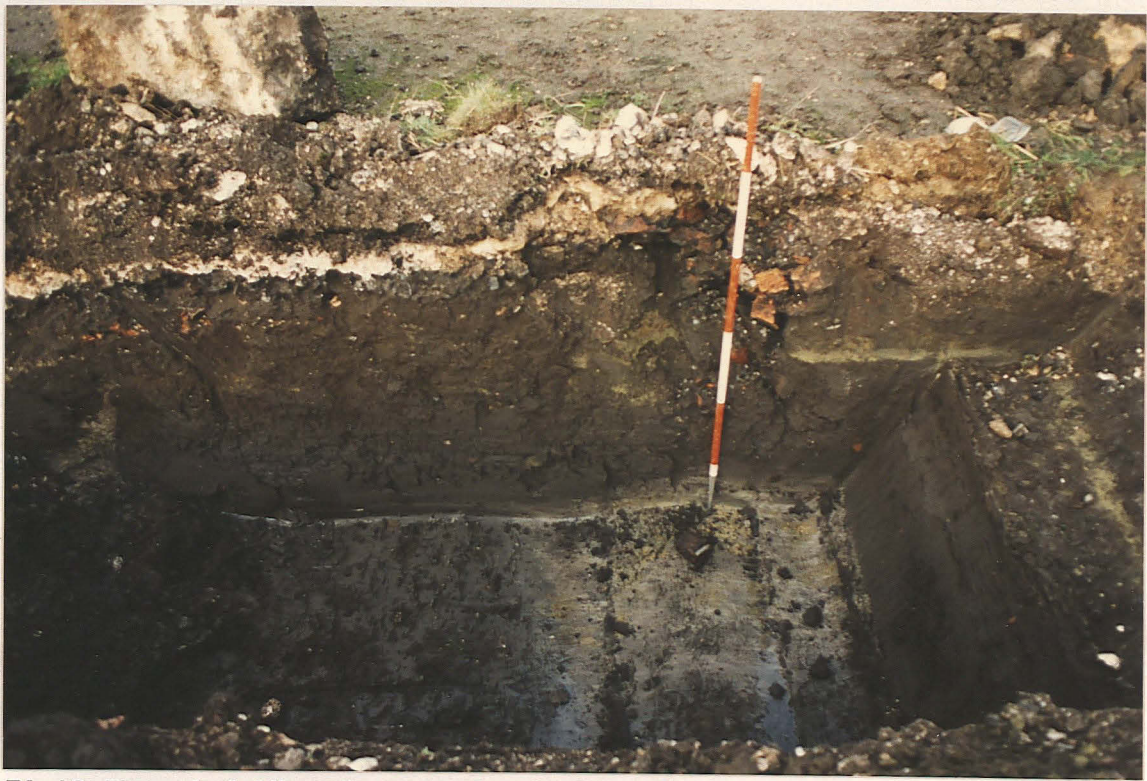
It is difficult to interpret the shape of the feature in such a narrow trench. It extended beyond the western limit of Trench 4 but was at its deepest at the junction between the 2 trenches. (Pl. 12 shows Trench 4 excavated down to the natural clay (1.20m below ground level) on the west (right) side of the trench. At the same depth on the east side the dark deposit was still present. It was not possible to investigate these trenches fully because of strong fumes which were thought to be from contamination by diesel. No section drawings could be made for reasons of safety.

Pl. 12 Trench 4. View S, area of contamination.

It is unfortunate that the only area which showed potential for archaeological remains (Trenches 3 and 4) could not be fully investigated because of diesel contamination in the soil. There was a major pottery industry at Bolingbroke in during the 15th-18th centuries and the presence of large pottery sherds, including a waster may be significant, especially in the absence of similar finds in the other three trenches.

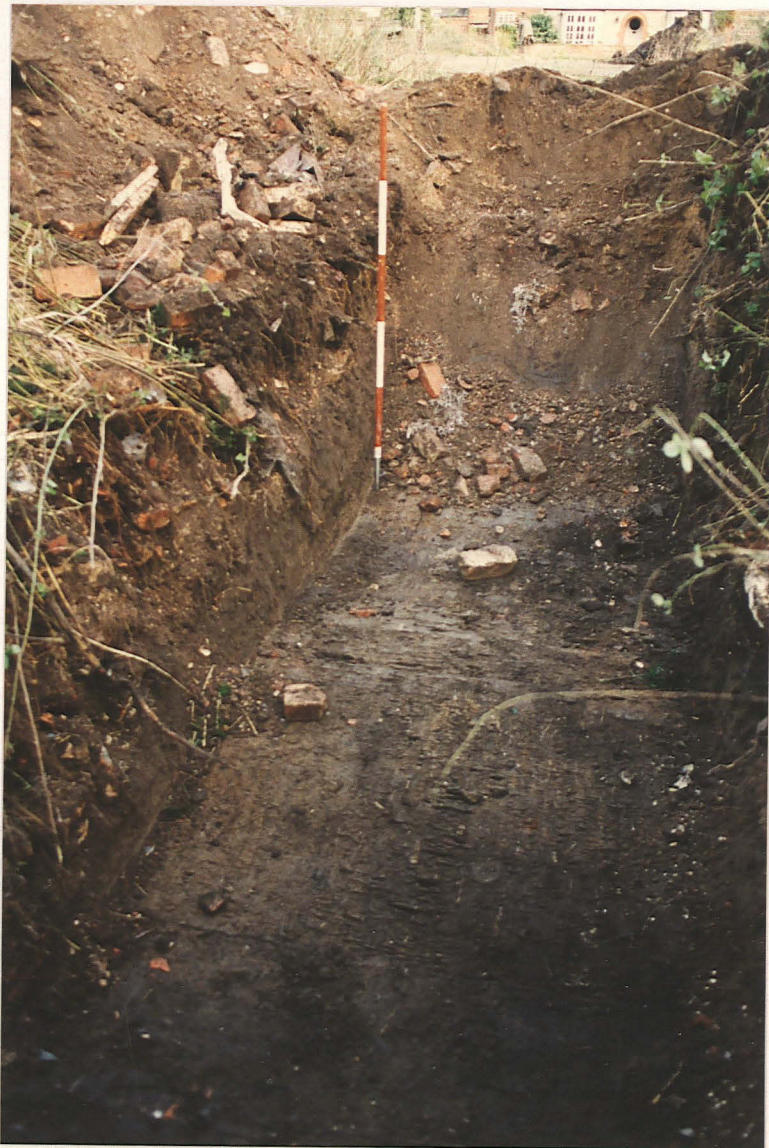
There was one area of the site which was marked as being without a concrete surface. A trench was dug across this area but it was apparent that the whole area was disturbed and contained brick rubble, plastic sheeting and domestic refuse (Pl. 13). Natural deposits of sandy silt were reached at a depth of 1.20m. It was again assumed that they were derived from the adjacent watercourse. The trench was abandoned.

Pl. 13 Trench 5. View E, disturbed ground containing brick rubble, plastic sheeting and domestic waste.
