Tonge's Farm, Norton Disney Quarry Phase 3

Norton Disney, Lincs.

Archaeological Watching Brief

LAS Report No. 853

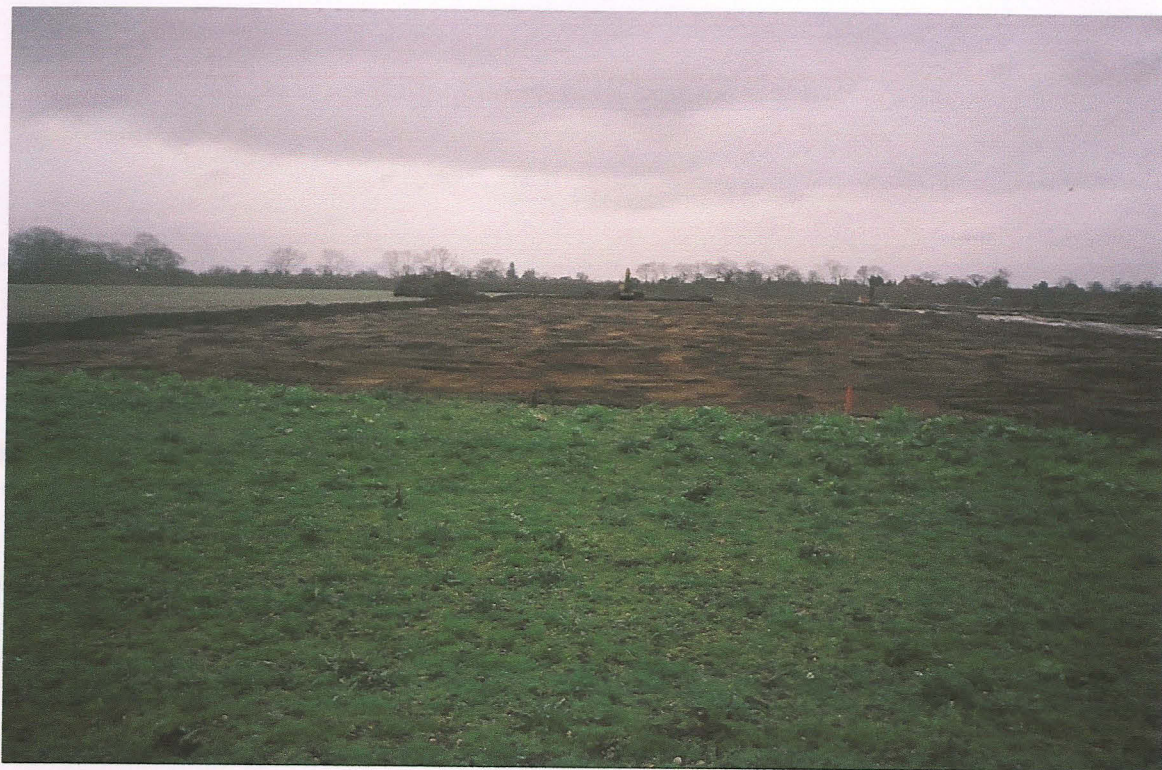
PL. 1 Phase 3 topsoil stripping in progress. Looking south.

Topsoil stripping was undertaken (using a 360° machine equipped with a 1.6m wide flat-bladed ditching bucket), excluding land below overhead cables at the northern end of the area (Pl. 1).

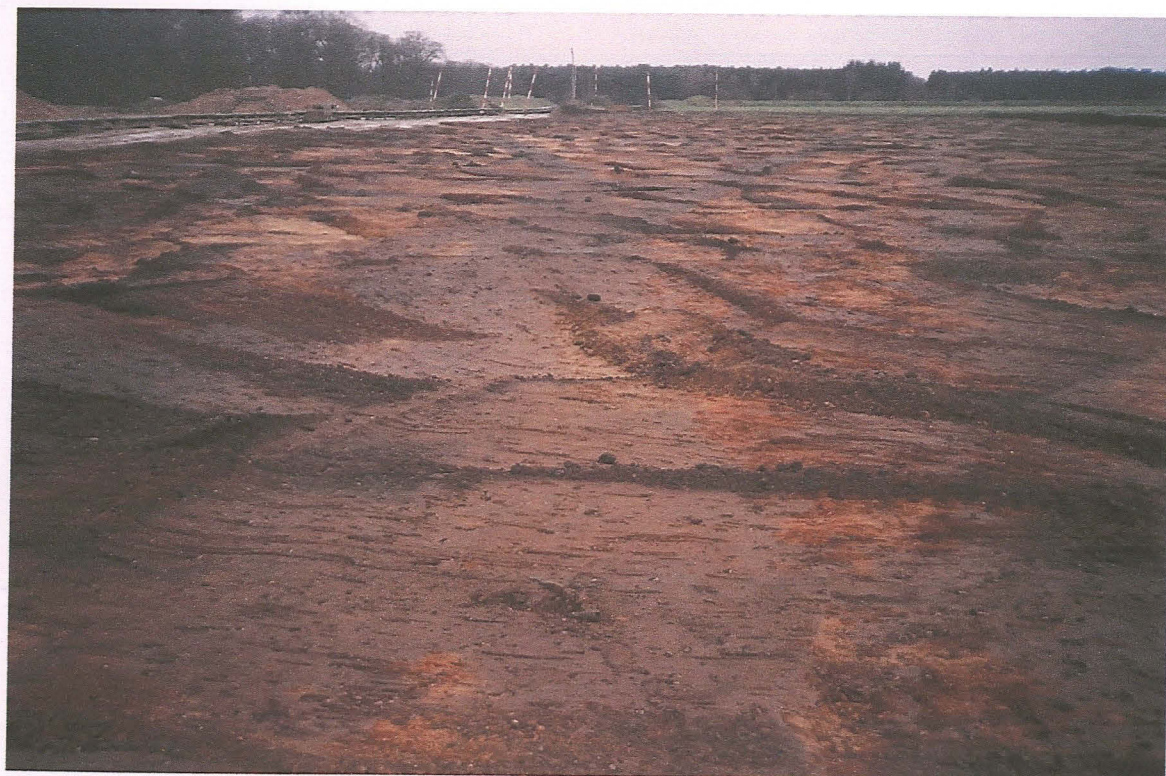
PL. 2 Phase 3, north end, stripped of topsoil. Looking north west. Note pipe in foreground ditch.

Unlike the adjoining Phase 2 area to the west, no identifiable trace of ridge and furrow was found. A long north-south aligned backfilled field ditch was seen close to the western edge of the stripped area, with a piece of steel pipe in the fill (Pl. 2). This ditch was about 10m east of the removed hedge boundary. Other short segments of linear (and slightly curvilinear) ditches appeared to cut that ditch, and a clay tobacco pipe stem fragment was found beside one of these. All ditches contained a grey/brown slightly silty sand, with frequent pebbles.

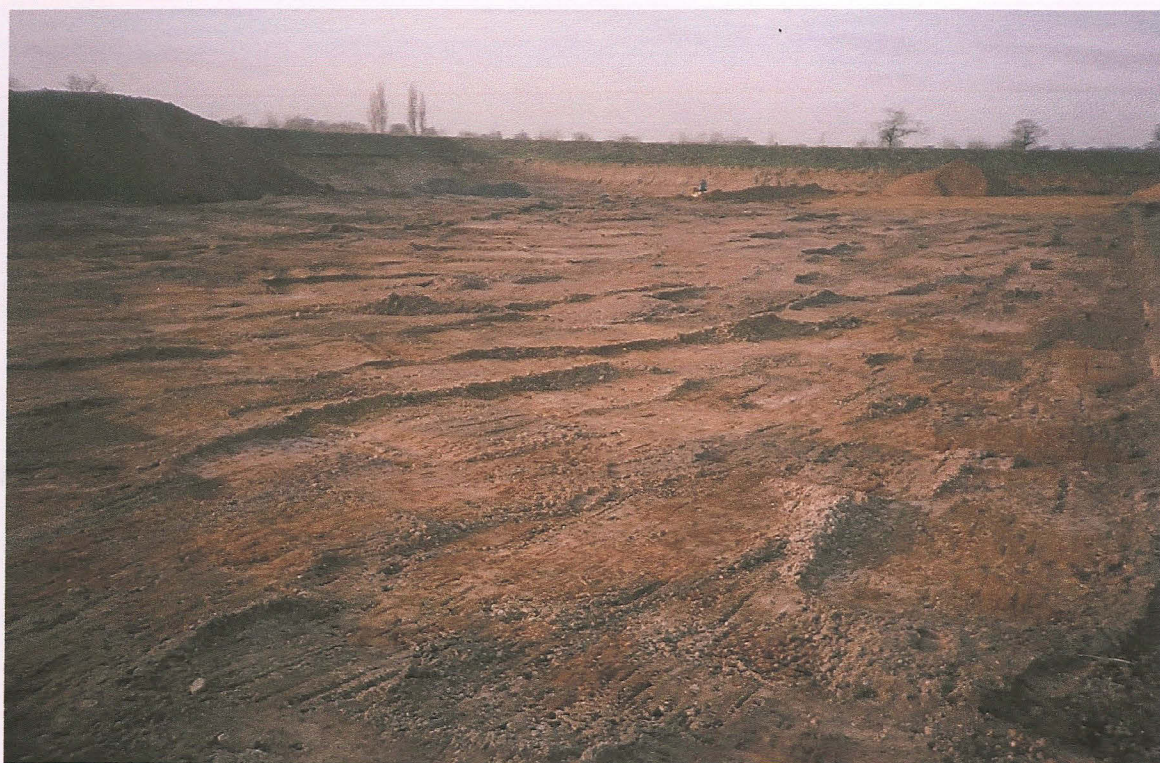
Pl. 3 Phase 3, north end, stripped of topsoil. Looking south-west.

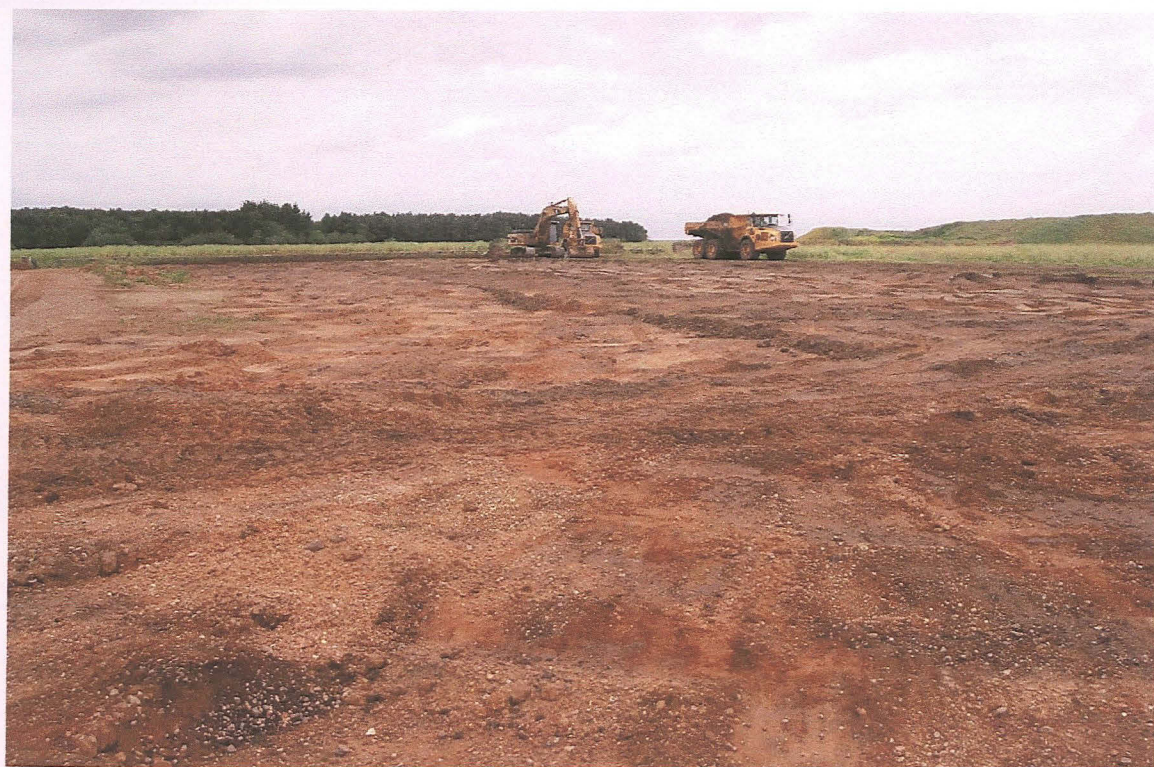
Pl. 4 Phase 3, south end, stripped of topsoil. Looking west.

No archaeological features were revealed during this phase of the watching brief. Occasional traces of plough scores running northwest/southeast were visible cutting the natural deposits, but there was no trace of the ridge and furrow cultivation remains seen elsewhere in the quarry. The compacted remains of a northwest/southeast orientated modern farm track was visible crossing through the centre of the area. Running parallel to the north of this track were two modern ditches. They measured 1m wide and 0.15m deep, with vertical sides, flat bases and contained a yellow grey silty sand fill which produced modern pottery. In the southern part of the area was a series of east/west orientated agricultural field drains and two shallow ditches on the same alignment. No finds were recovered. They are also likely to be remains of recent agricultural features and contained a brown grey sand fill.
