LONG BENNINGTON

NEW PARSONAGE HOUSE

**Archaeological Watching Brief
(Lincoln Museum Accession No. 112.94)**

Long Bennington Replacement Parsonage: Archaeological Watching Brief

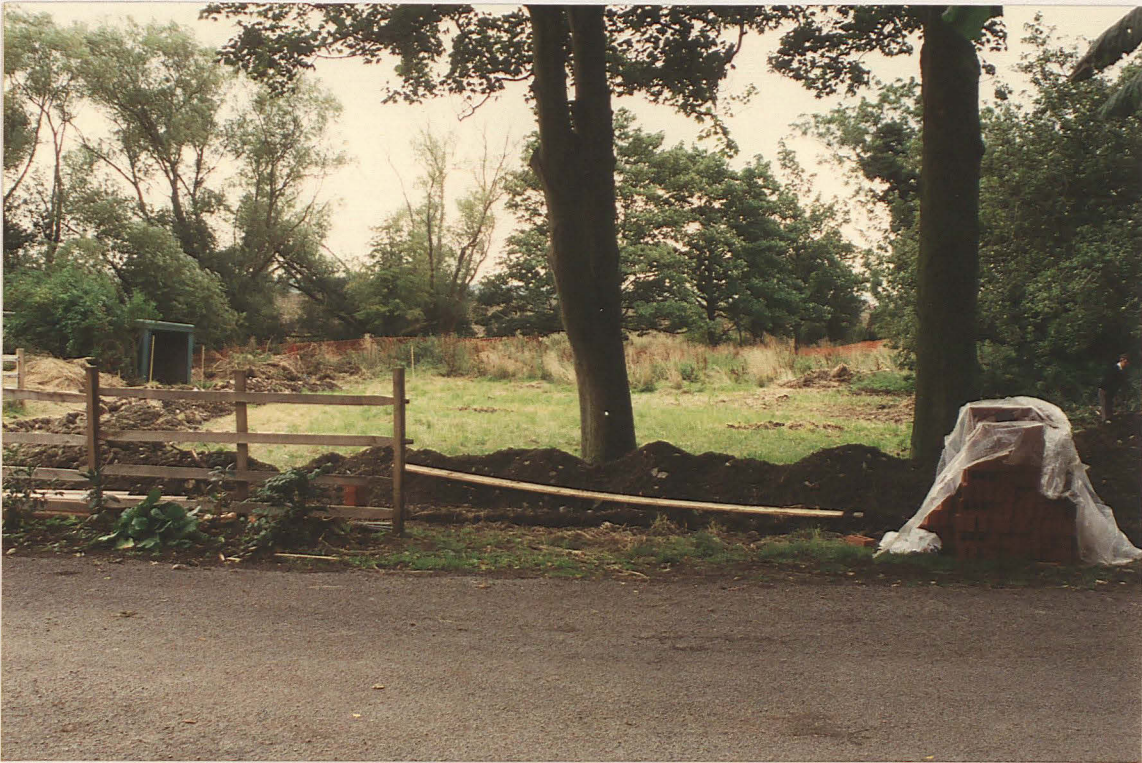
The purpose of the Watching Brief was to record any evidence which might be revealed in the foundation trenches for the medieval priory. Monitoring began on 5th September when the ground clearance and excavation of building foundations commenced. Drains along the north and east boundaries of the building plot had already been dug and manhole 1 (Fig. 2, M1) had been constructed (Pl. 1).

Pl. 1 View of the site looking south. Note dense vegetation (centre, rear) marking position of possible fishpond.

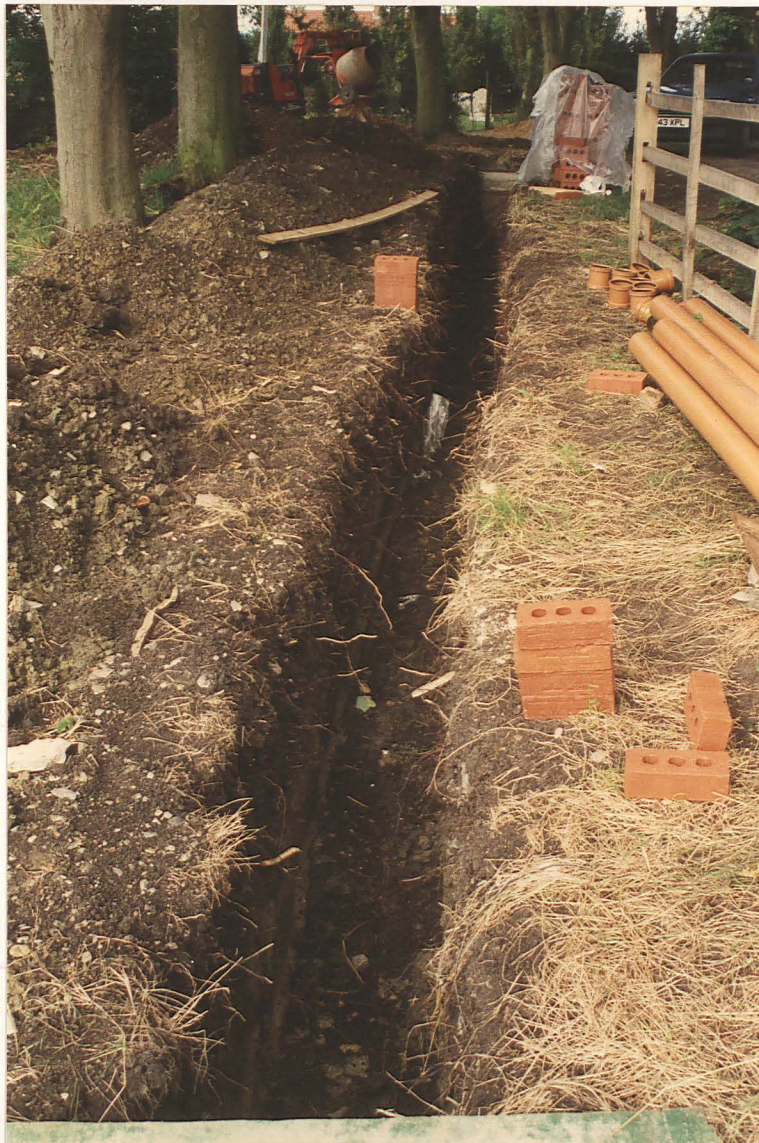
A few cattle bones were found in the soil removed from the northern trench but no pottery was seen. The trench had dried out since it was excavated and the soil had been disturbed by tree roots; no archaeological features were visible (Pl. 2).

Pl. 2 Sewage pipe trench along north boundary of site, looking west.

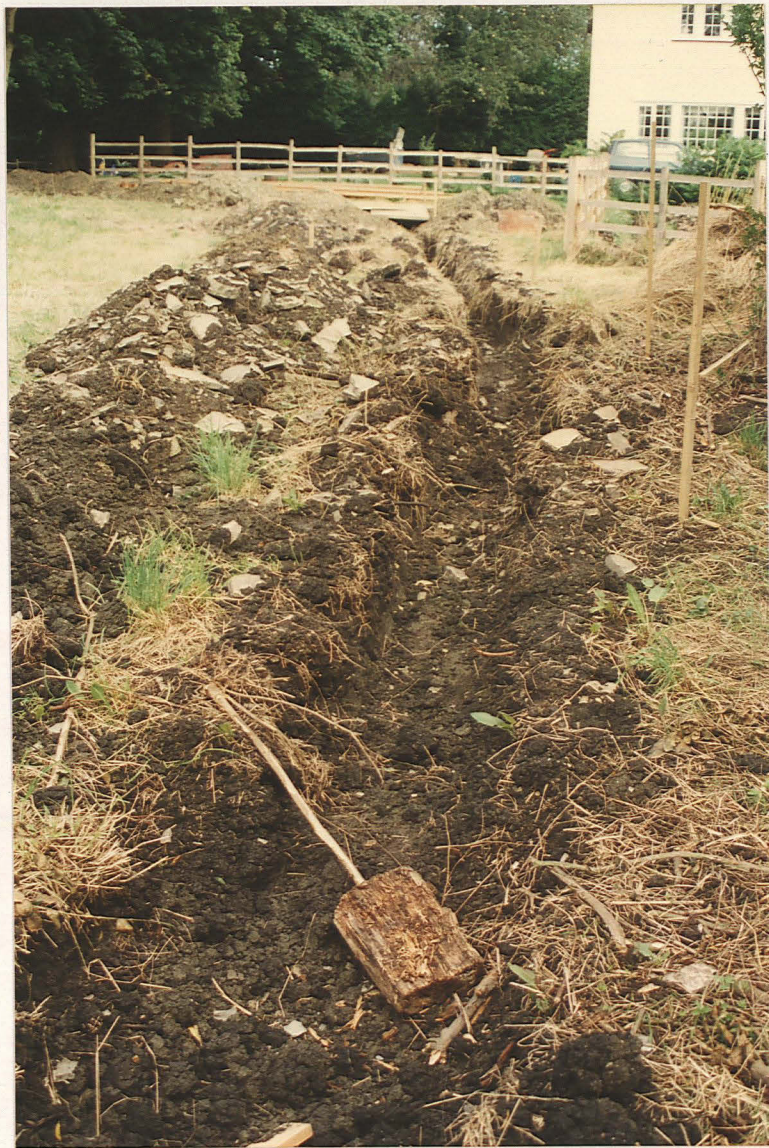
Pl. 3 Sewage pipe trench along east boundary of site, looking north.

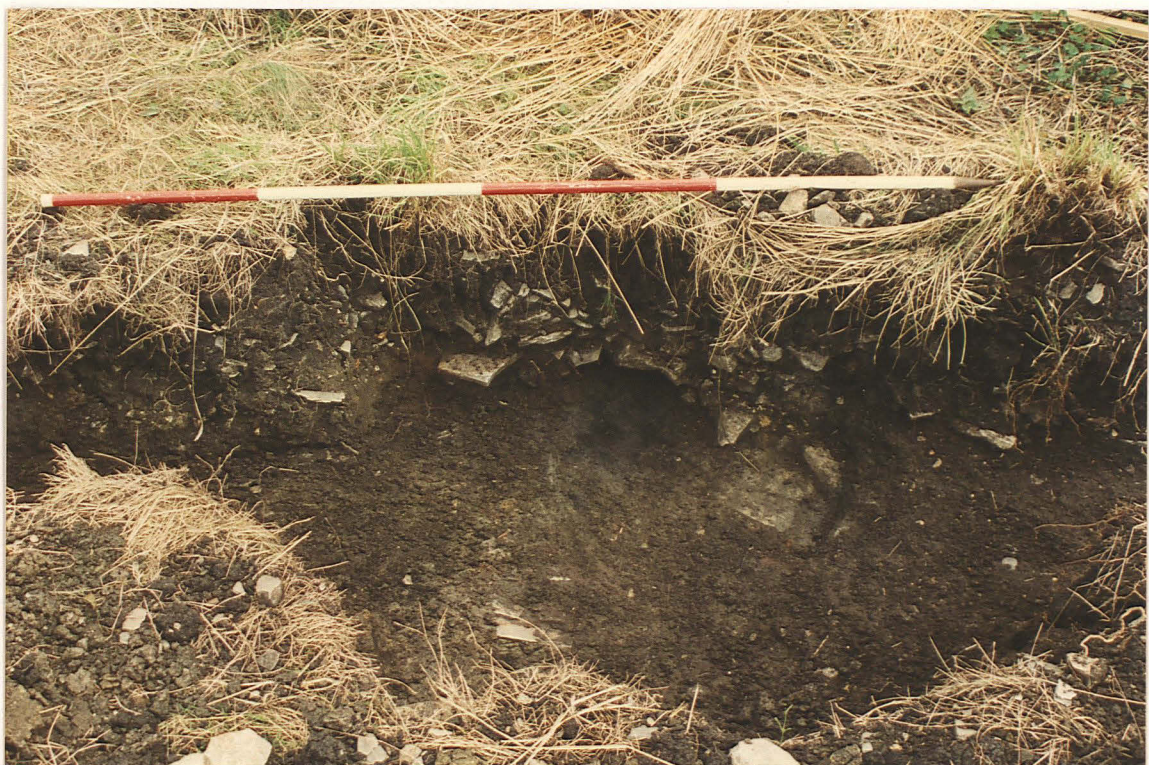
Excavation in the east drain trench for a manhole had disturbed quantities of flat mudstone which appeared to have been part of a drystone wall crossing the site from east to west (Fig. 2.2; Pls. 3-5). The small mudstone pieces were concentrated in a layer between the topsoil and the subsoil at a depth of c. 0.25-0.30m below the ground surface. The maximum surviving width of the wall was 1.30m, on the west side of the trench, and only one course was visible in the trench. Two fragments of medieval green-glazed pottery were found together with the base of a later, 18th century, stoneware vessel.

Pl. 4 Remains of stone wall at manhole 4, looking east.

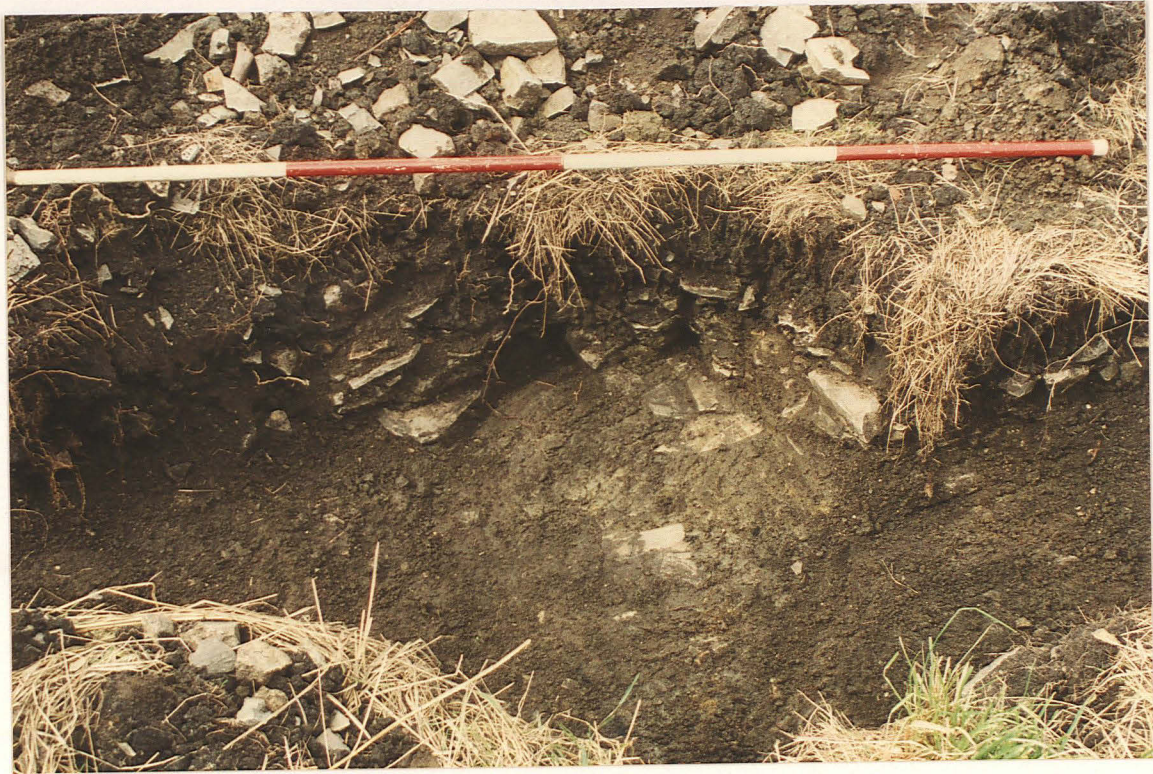
PI. 5 Remains of stone wall at manhole 4, looking west.

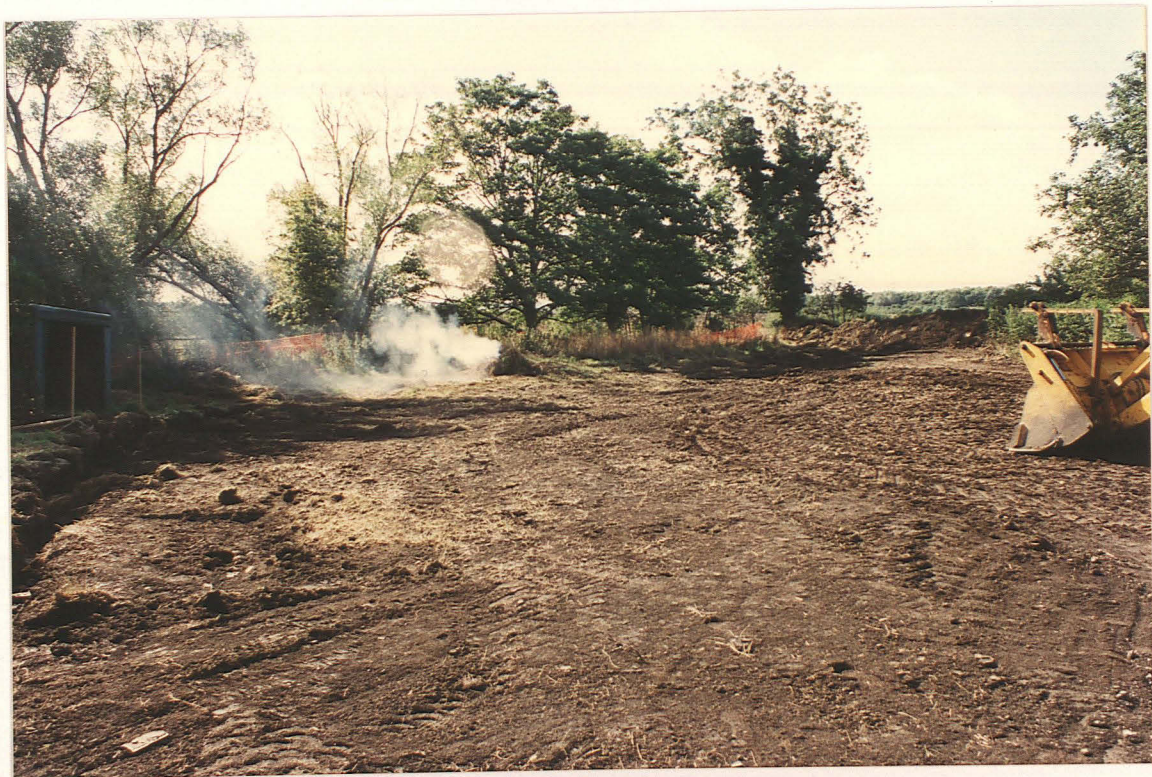
Ground clearance was carried out prior to excavation of the foundation trenches. This comprised removal of ground cover and levelling of the plot which sloped downhill from north to south. Vegetation clearance revealed an oblong depression aligned NNE-SSW (Pls. 6, 7), roughly parallel to the medieval fishpond close to the SE boundary (Pl. 8), which lies south of another fishpond in the old vicarage gardens (Pl. 9). This was tentatively identified as the remains of a third fishpond. The north end of the depression extended into the building plot, but machine levelling and infilling had altered the ground contours at the south end so its full extent was not recorded. Its maximum width was 7.50m and maximum recorded depth of the depression after topsoil removal was 0.52m. Surface levels on the architect's plan suggests that the depth may have been 0.60m.

PI. 6 View of site, looking south, after clearance of vegetation showing depression in ground to right of bonfire.

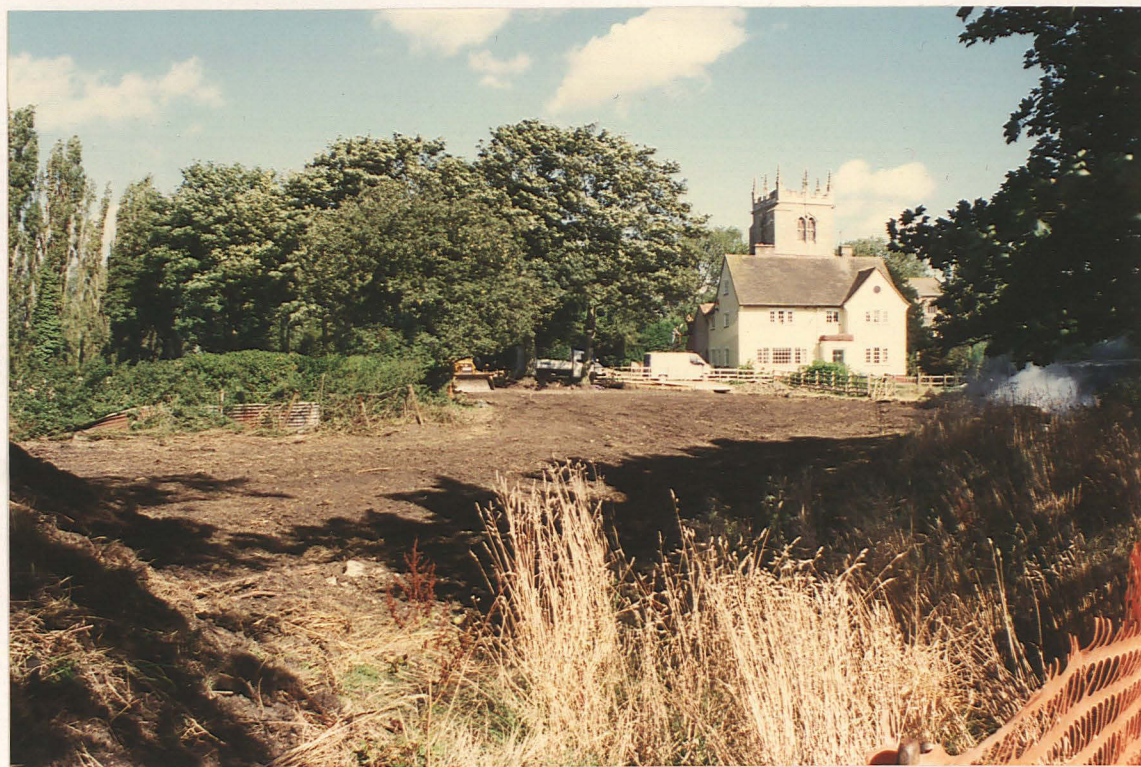
PI. 7 View of site, looking north, after clearance of vegetation showing depression in ground marking position of a third fishpond. Church and old vicarage (built 1930's) in background.

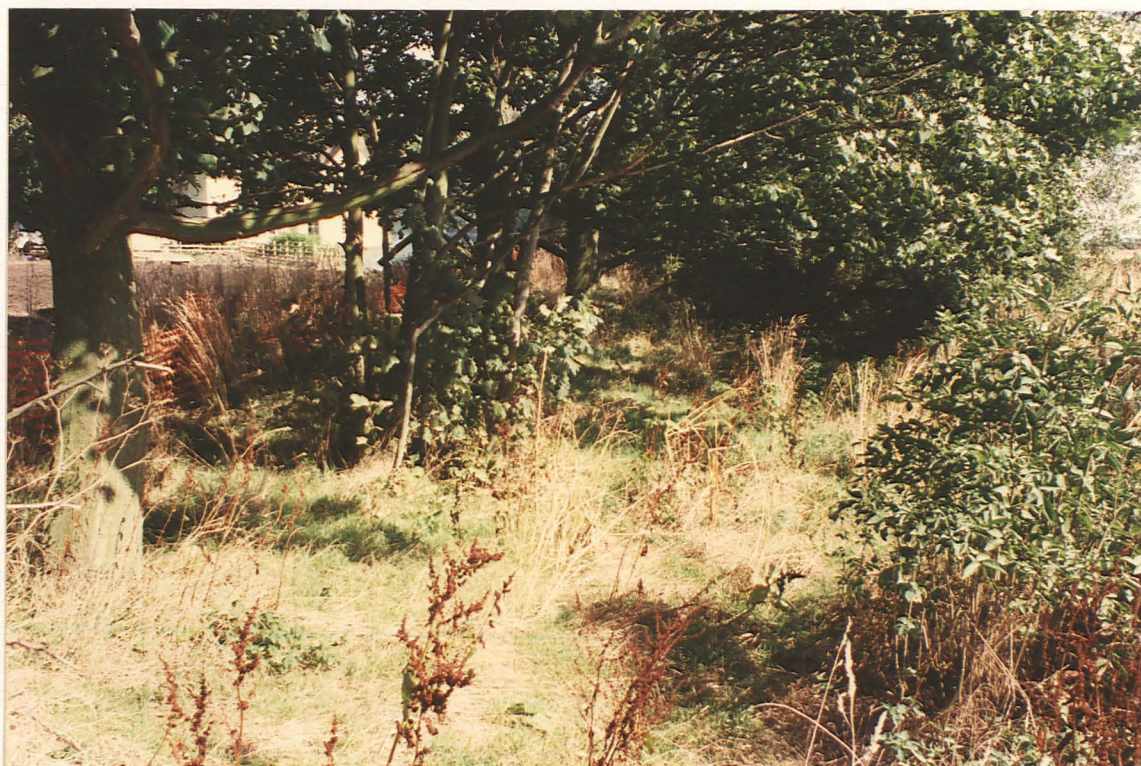
PI. 8 Fishpond east of site, looking north.

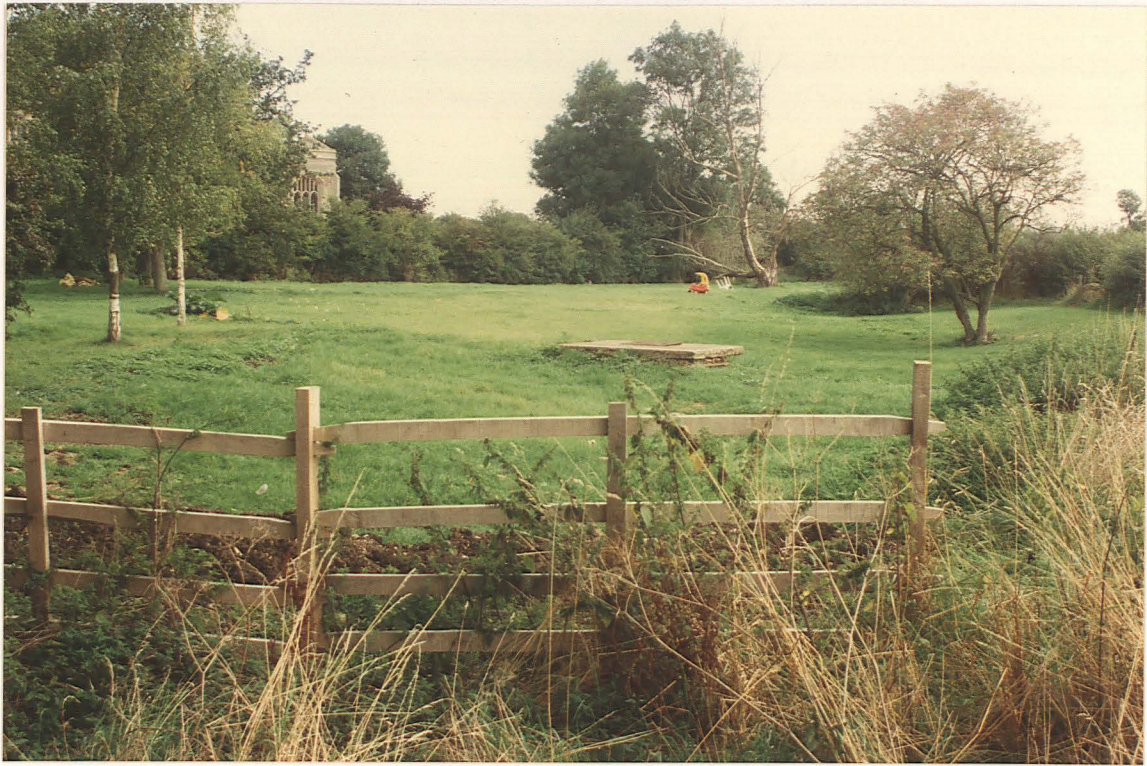
Pl. 9 Fishpond north-east of site in old vicarage garden.

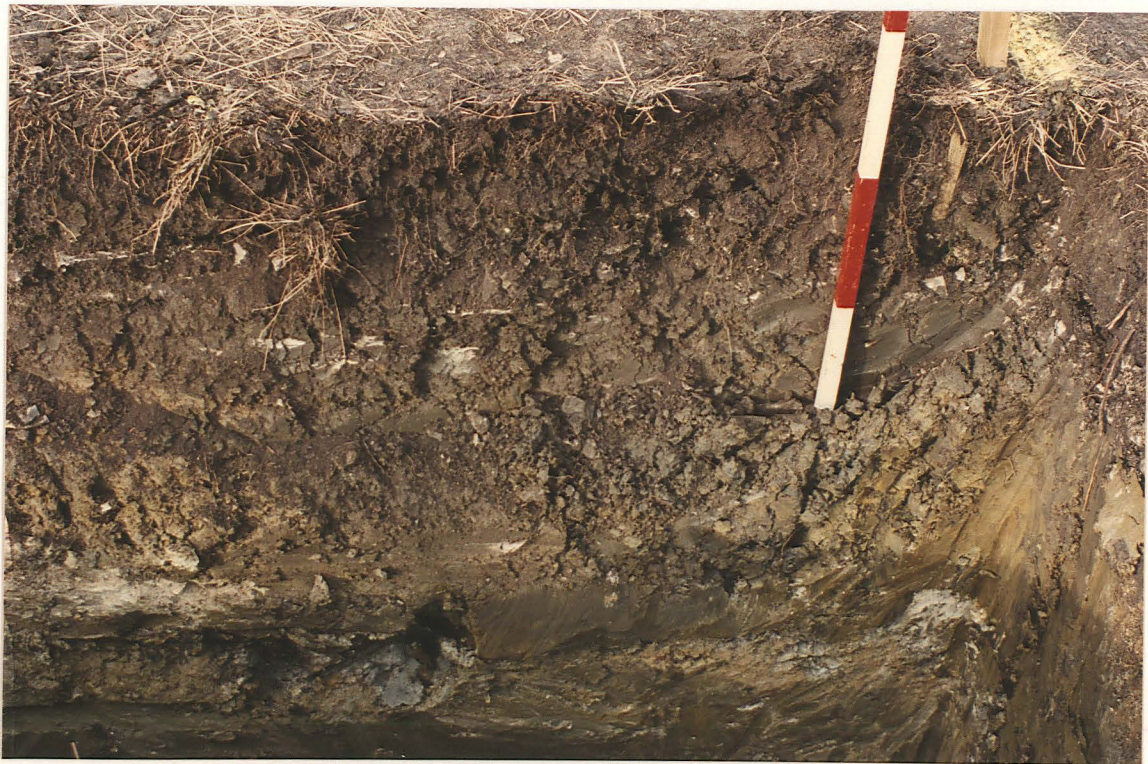
The same ditch that was seen in the sewer trench and the garage foundations was recorded at the NE corner of the house foundations which cut through the yellow clay to a depth of 0.80m below the ground surface (Fig. 2.4; Pl. 10). A small area of dense charcoal incorporating two medieval pottery sherds of late 13th-14th century date, was observed at its base; the remainder of the fill in the NE-SW aligned feature was a darker brown clay.

Pl. 10 Gully at north-east corner of house foundations (observation 4).

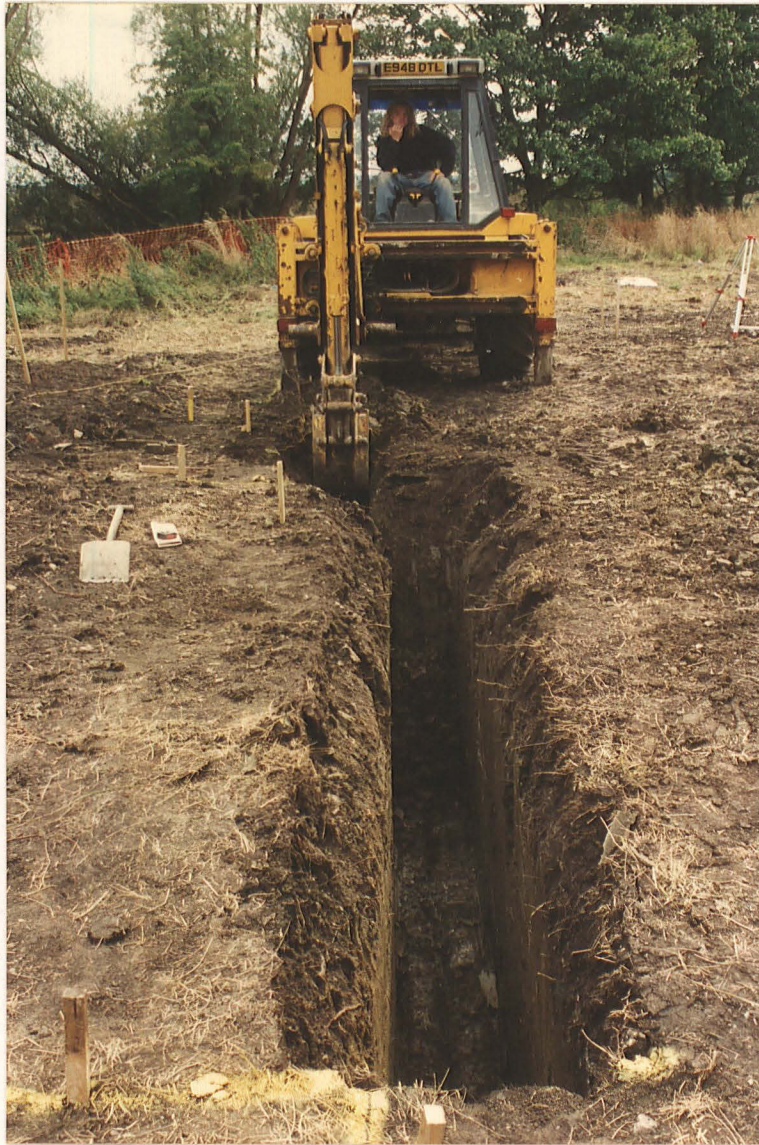
At the northern side of the bathroom footings, a concentration of thin limestone pieces was observed in the topsoil. Below this, further pieces were found in a 0.7m deep feature 1m wide and with a dark clay fill (Fig. 2.5; Pl. 11). This may have been a continuation of the wall observed at a higher level in the sewer trench (Fig. 2.2).

Pl. 11 Foundation trench along east side of house cutting through stony deposit (observation 5).

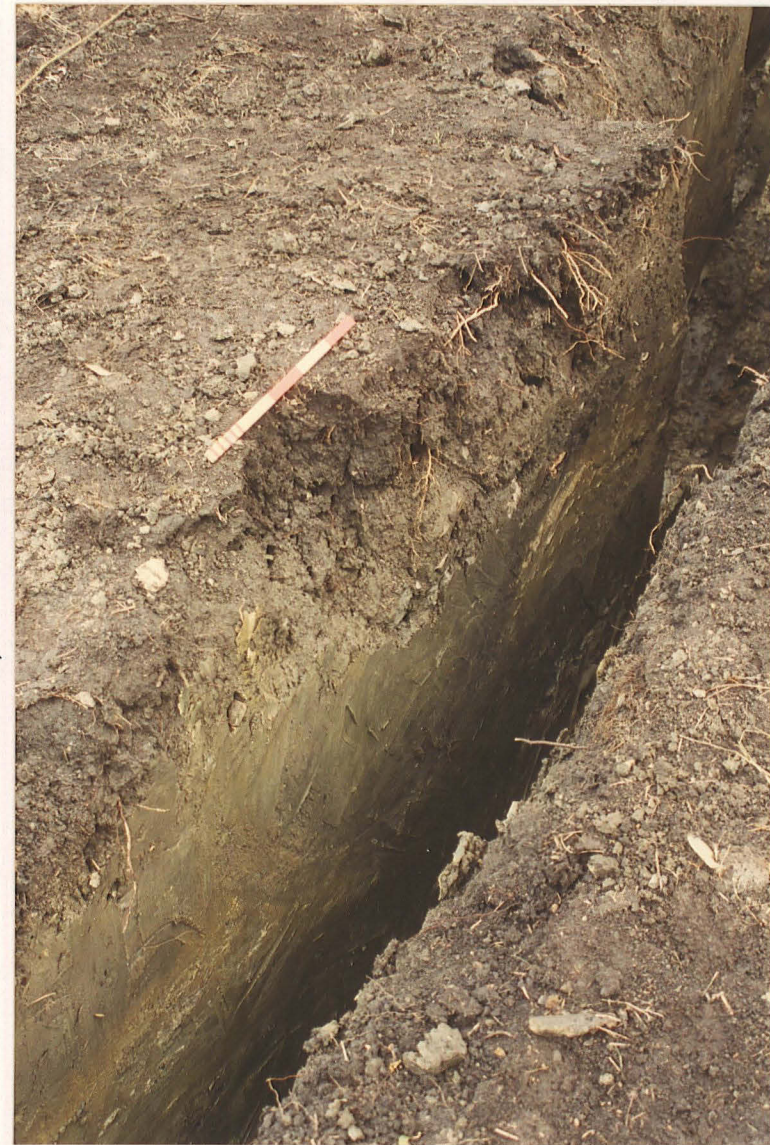
East of the stony area was a second shallow gully, aligned SW-NE, noted in both faces of the east trench (Fig. 2.8; Pl. 12). It was approximately 1.60m wide and 0.7m deep and its fill consisted of dark clay with thin mudstone pieces and charcoal fragments. The same gully was identified crossing two more foundation trenches (Pl. 13, marked by the scales). Its deepest point was at observation 9 where it was 1.25m deep and 1m wide (Fig. 2.9).

Pl. 12 Gully at observation 8.

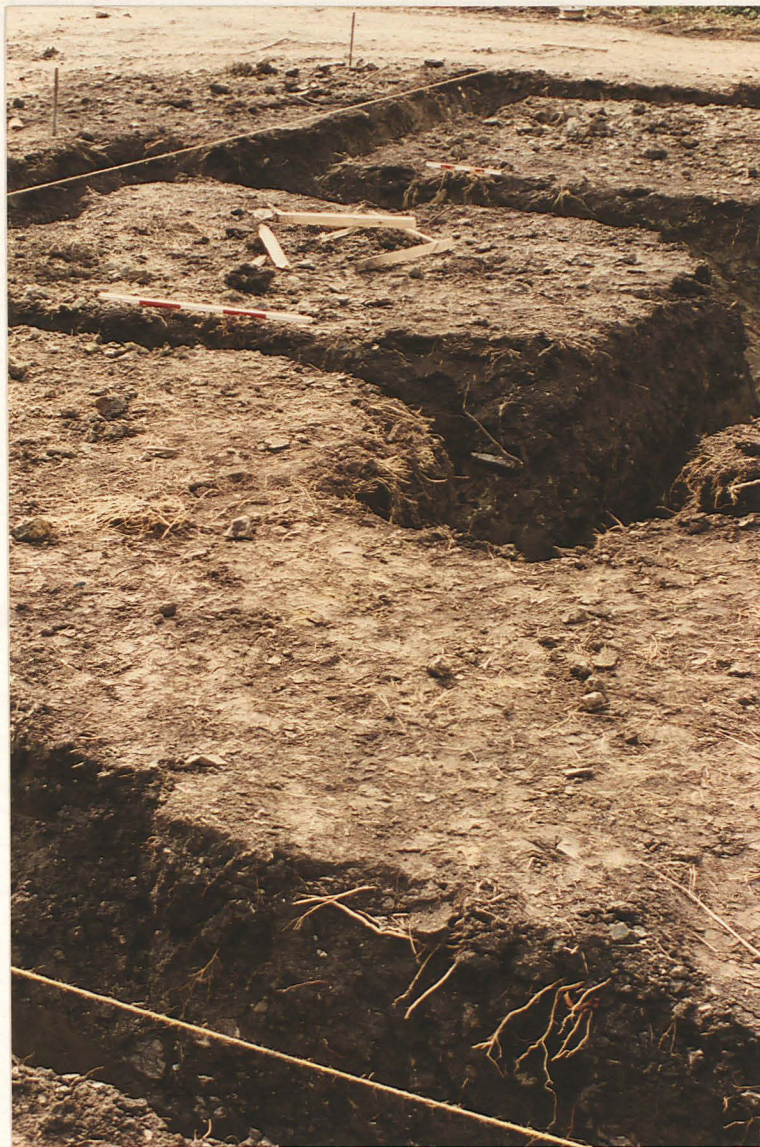
Pl. 13 Position of gully marked by scales cut by the house foundations (observation 9 centre, observation 8 rear, looking west).

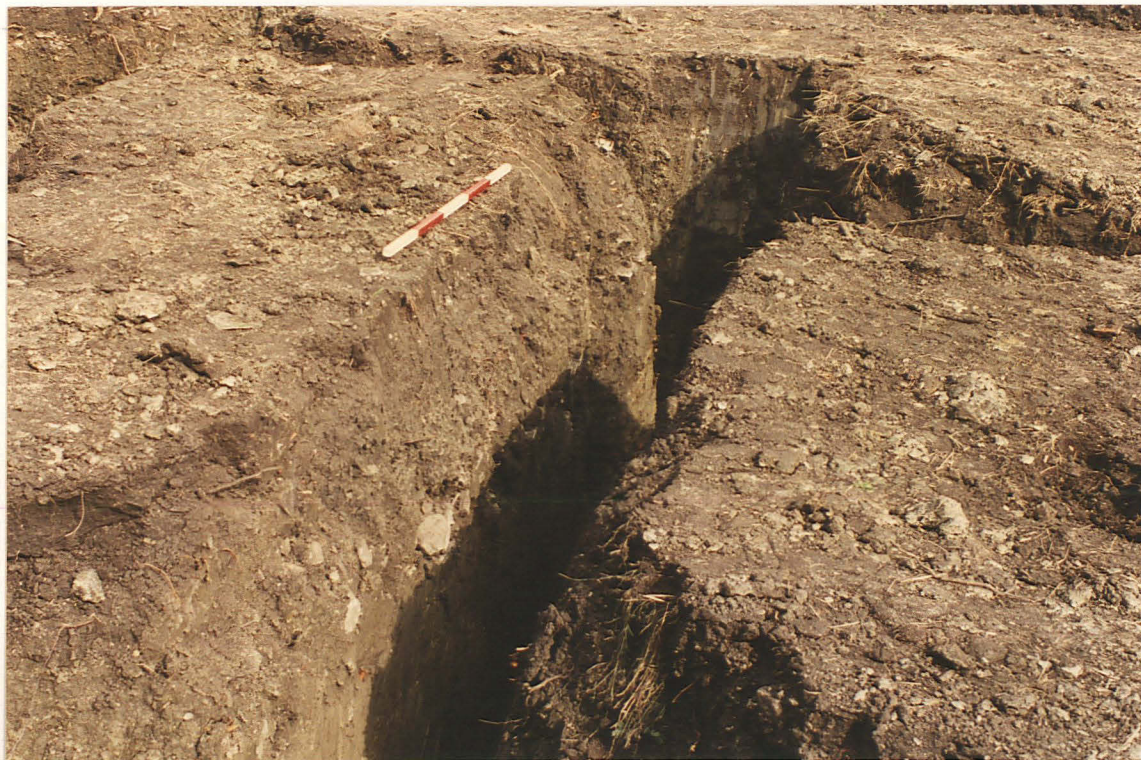
The gully was seen in the SE corner of the living room Fig. 2.10; Pls. 14,15). It was about 0.9m wide and apparently shallower at 0.90m deep, but the fill was identical to that seen in observation 9. The gully was identified in the north face of the external wall trench but not in its southern face, and is presumed to have terminated.

Pl. 14 Position of gully marked by 50cm scale at observation 8, looking south.

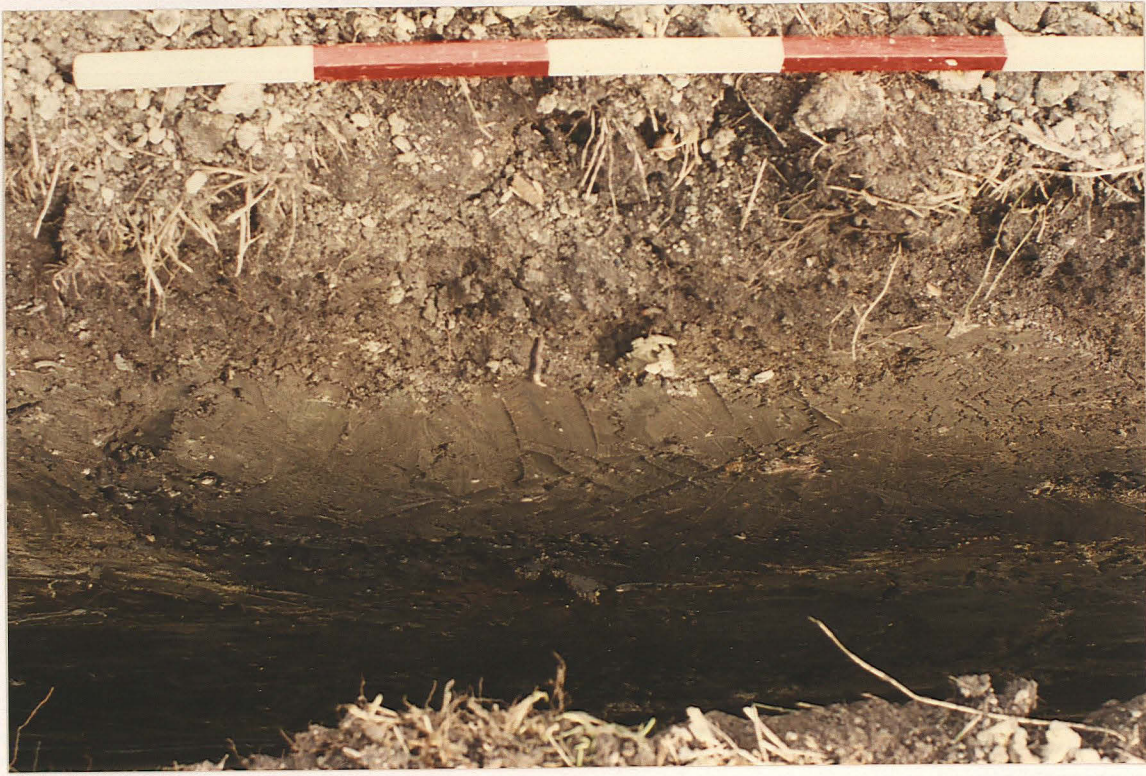
Pl. 15 Gully at observation 10, looking west.

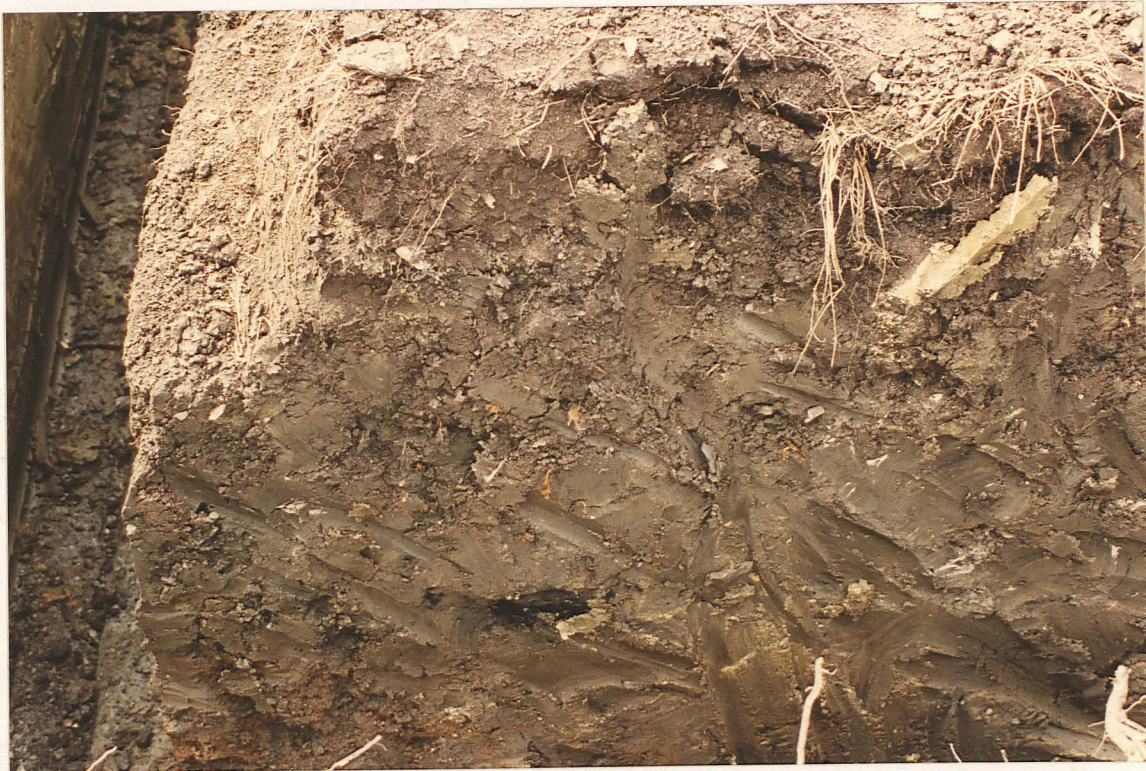
A spread of charcoal was seen 0.6m below the stripped surface in the northern face of the southern footing for the dining room (Fig. 2.11; Pl. 16).

Pl. 16 Charcoal flecks in fill of gully at observation 11.

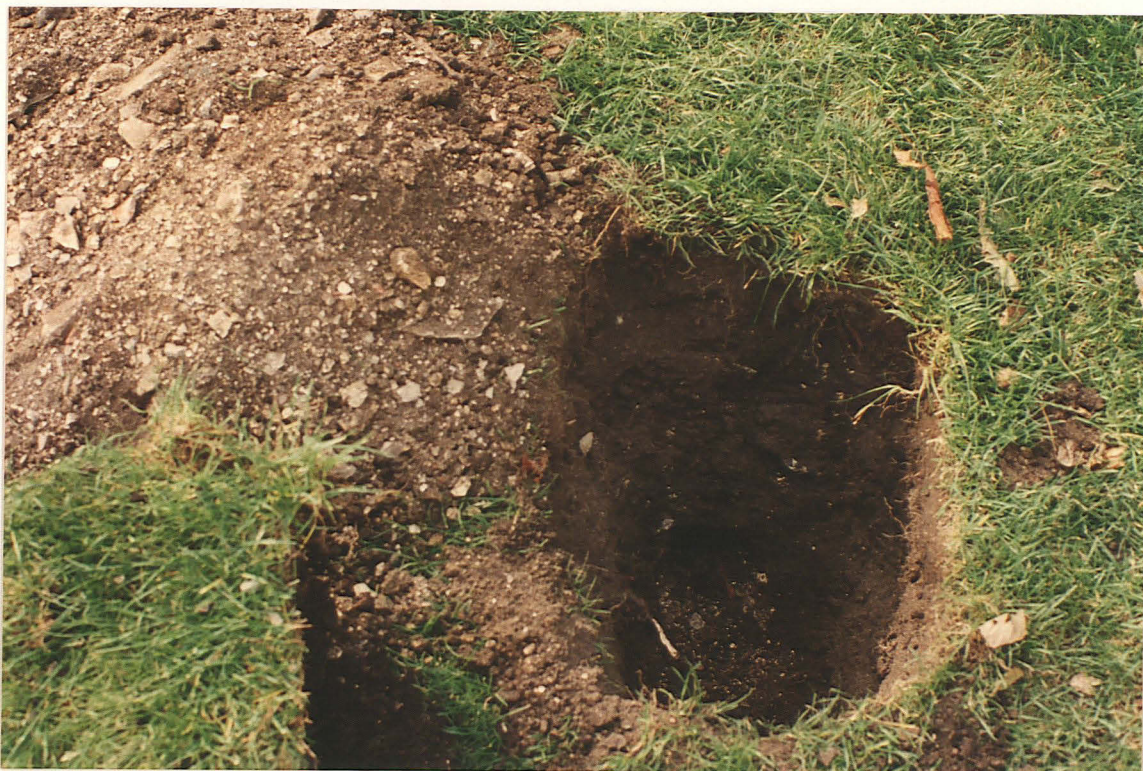
A replacement electricity supply was being installed into the existing old vicarage building while the groundworks for the new building were in progress, and the opportunity was taken to observe three small intermediate holes hand-dug in the front lawn to direct the moling device. One hole was dug through a deposit of medieval glazed roof-tile fragments and mortar (Fig. 2.13; Pls. 17,18). The tile fragments were from a single ridge tile, possibly manufactured in Bourne. A single sherd from a stoneware jar dating to the 17-19th centuries was also found, together with a plain bone knife handle, probably of similar date.

Pl. 18 Old vicarage garden, tile and mortar deposit at base of the hole dug for electricity cable.

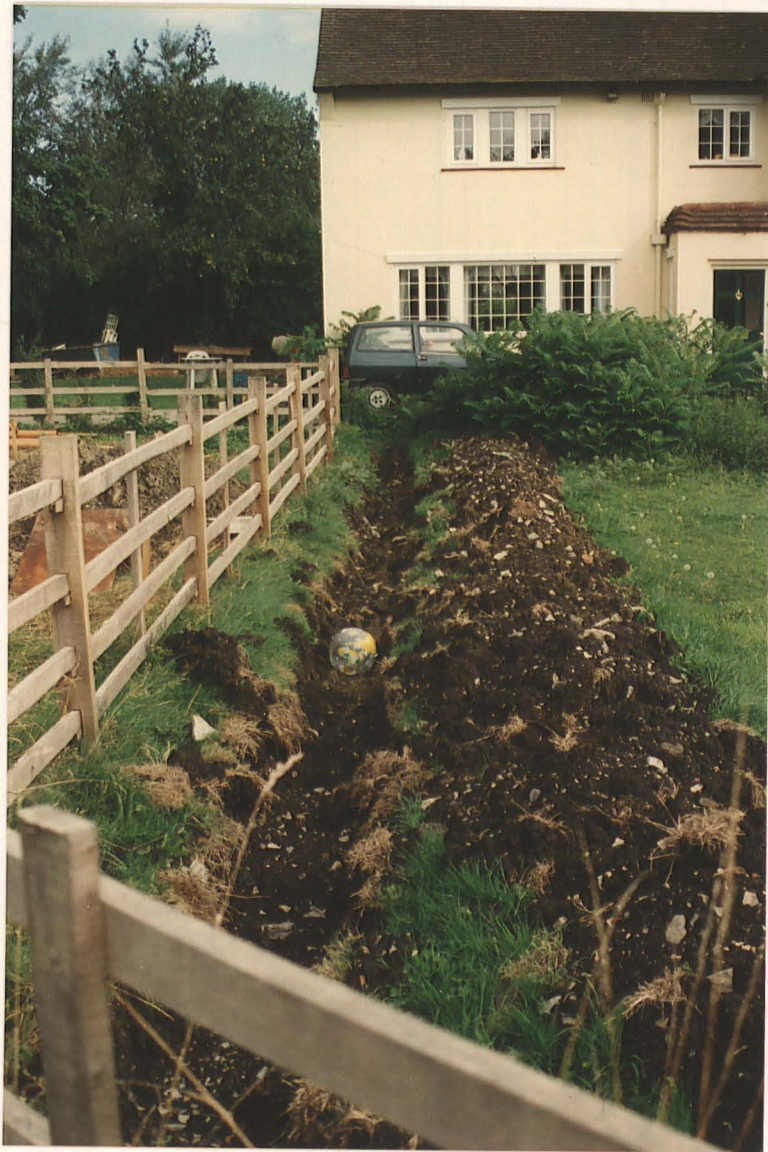
A shallow trench had been hand-dug along the common boundary east of the new parsonage house and south boundary of the garden in preparation for the planting of a new hedge (Fig. 2.14; Pls. 19, 20). Twenty-eight sherds of pottery were found in the adjacent spoil heap. One of the sherds was Roman and two were medieval, of local manufacture and 13-15th century in date. One small sherd was 15-16th century in date. The remaining twenty-four sherd were of 17-18th century date and included pottery from Staffordshire and Yorkshire. In addition there was a piece from a 13-14th century glazed roof tile and second glazed piece of medieval roof furniture, possibly part of a chimney pot.

Pl. 19 Hedge boundary east of parsonage house, looking north.

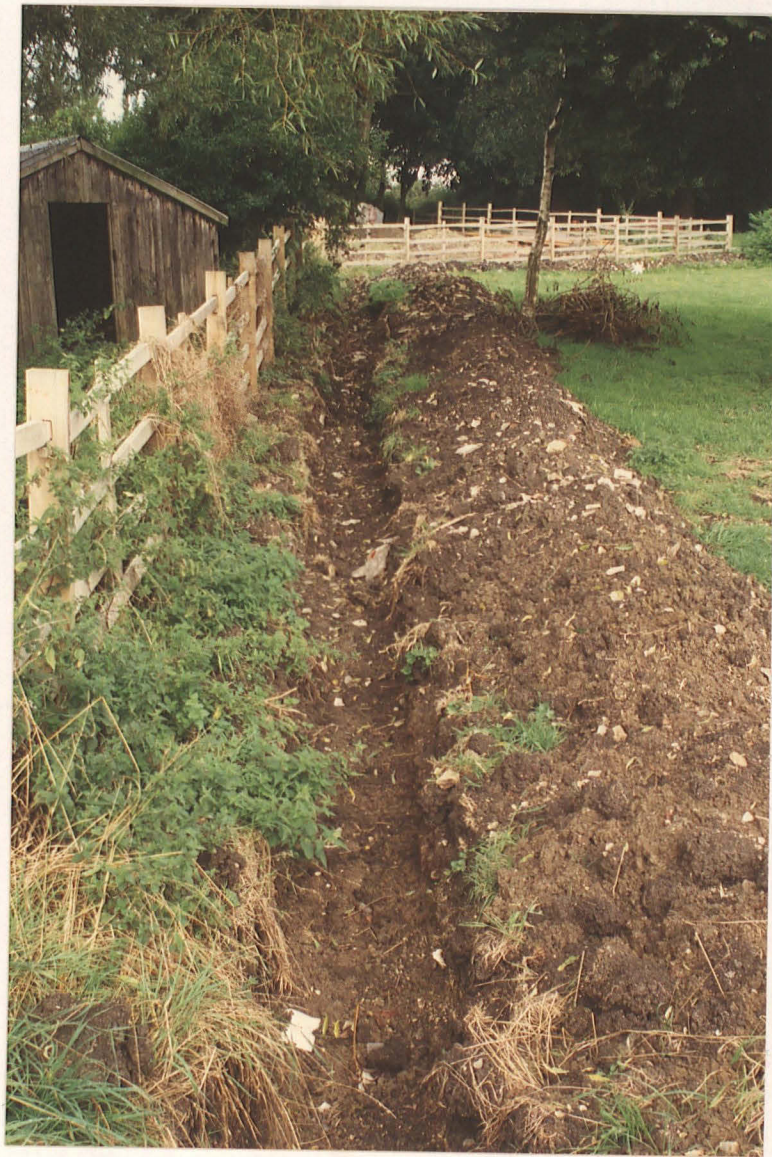
Pl. 20 Old vicarage garden south boundary, looking west towards site.
