**Horncastle, Banovallum Gardens Development:
Archaeological Watching Brief
on
Plots 49-53**

**Planning Application No. S/086/0647/93)
LCNCC Museum Accession No. 32.93**

February 1995

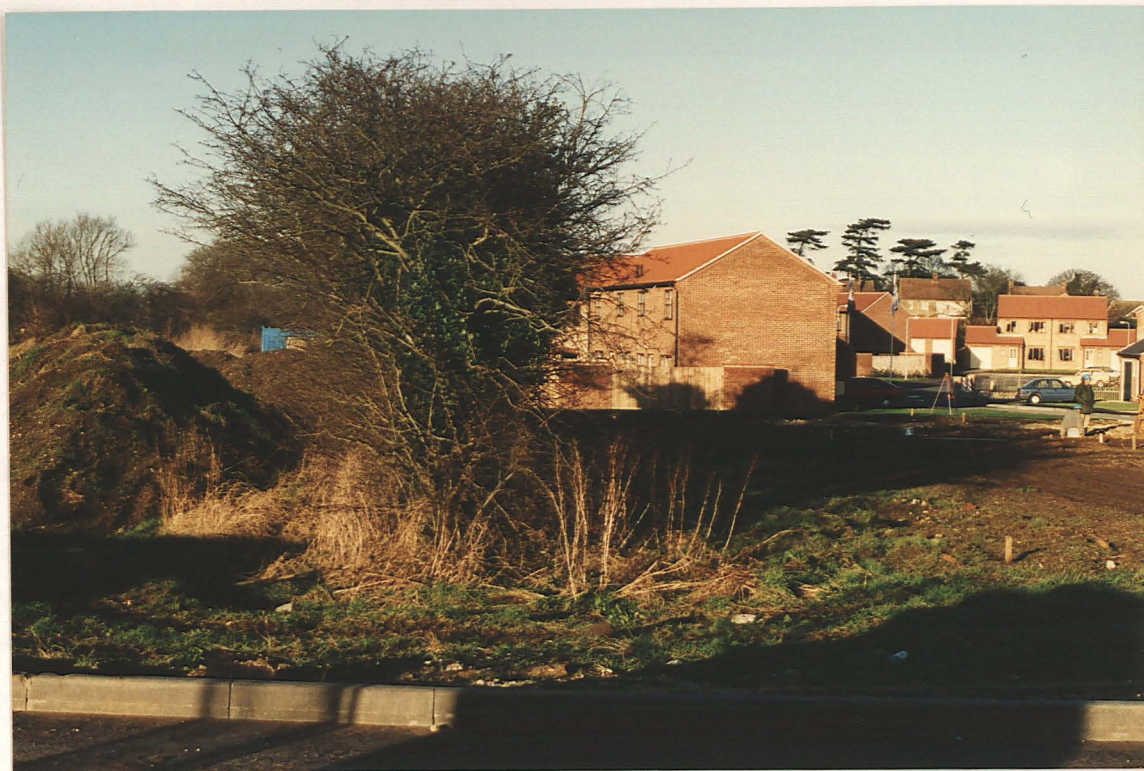
Pl. 1 Location of Plots 49-53, Horncastle Banovallum Gardens development. Trench 17 lay to the right of the hedge (looking NE).

An archaeological condition was placed on planning consent for new houses at Banovallum Gardens, Horncastle by East Lindsey District Council's Planning Committee in 1993 (Fig. 1). The developer, Stamford Homes, commissioned Lindsey Archaeological Services (LAS) to conduct the required archaeological evaluation in July 1993 when 18 machine excavated trenches were examined and recorded (Tann 1993). Two areas of the development site produced a small number of archaeological finds and further work was requested. A geophysical survey by Landscape Research Centre (Yorkshire) in March 1994 concluded that there was probably minimal archaeological activity in two of those areas and further excavation was unlikely to reveal significant remains (Lyll, in Field 1994). A final area, close to Trench 17 of the 1993 evaluation, was designated as of potential interest and a watching brief on the mechanical excavation of house foundation trenches was required. The present report describes the findings when 3 of those building plots were trenched for house footings (Fig. 2; Pl. 1). Further monitoring will take place when Plot 54 is to be built.

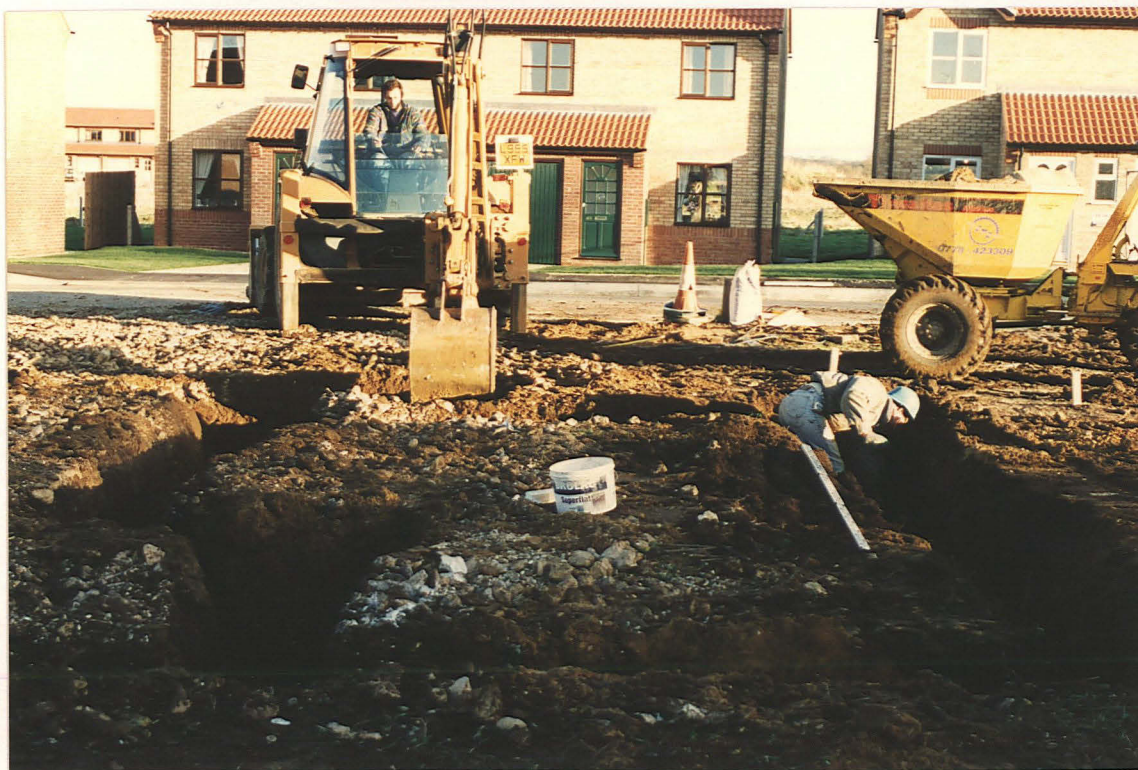
Pl. 2 Plots 49 and 50 after excavation, with introduced stone on ground surface. (looking east).

Stamford Homes excavated the house footings for semi-detached Plots 49 and 50 on 11th January 1995, using a JCB with two sizes of narrow toothed bucket. The trenches were dug to a base level of 32.95m OD. Observations were made while the soil was being removed and the trench faces and base were inspected after machining had been completed. Access into the trenches was not difficult (Pl. 2).

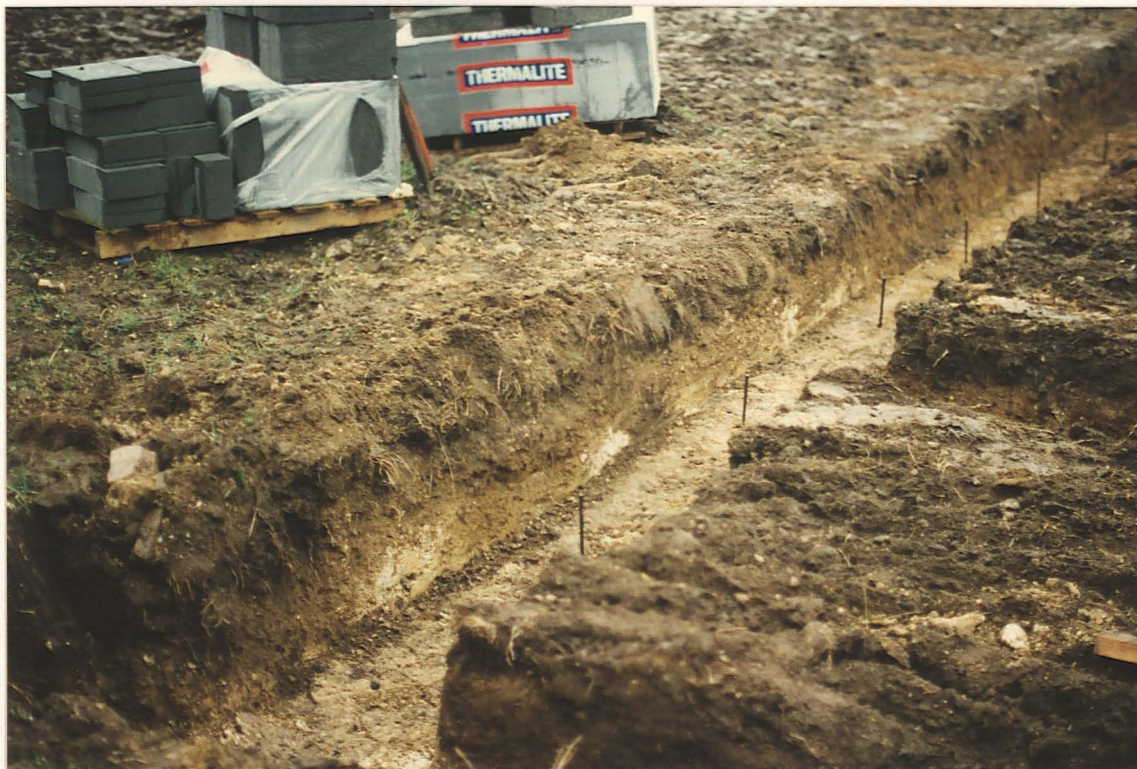
Pl. 4 The rear wall trench of Plots 52 and 53, showing four soil-filled furrows cutting the natural chalk in the foreground, and the abrupt change to brown sandy clay in the background. (Looking NE).

The trenches were excavated to a base at 35.40m OD in order to maintain a uniform ground level around the houses; as a result the excavation was less deep than at Plot 49. The footings revealed an abrupt division between chalk geology below Plot 53 and sand below Plot 52, probably reflecting the southern limit of precursor stream channels to Thunker Drain (Pl. 4).

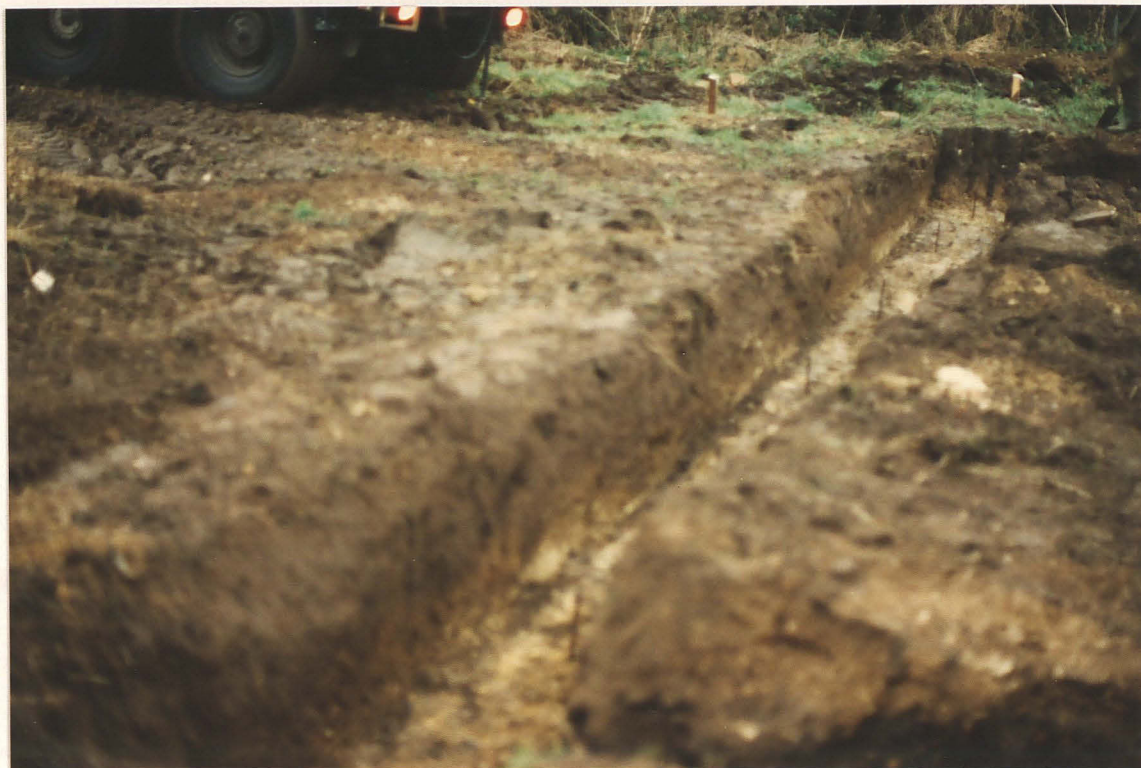
Pl. 5 The uneven interface between subsoil and natural chalk in the SW trench face of Plot 53, reflecting 4 medieval plough furrows. (Looking NW).

Four linear features filled with dark brown clay loam were noted cutting the end wall trench of 53 (Pl. 5). A similar number of parallel features were identified in the back wall trench and it has been assumed that they represent a continuation of the others (Fig. 3; Pl. 6). The most easterly cut was about 1.7m wide and 0.7m deep, extending to or just below the base of the trench. The adjacent cut was separated by a peak of soil 0.6m wide. The spacing between the cuts was much less on the back wall; this could be because of the angle at which they were truncated or produced by more than one phase of activity. The most likely interpretation of these features is ridge and furrow

marks from medieval ploughing (some of which were identified elsewhere on the site during the 1993 evaluation). Further furrows may have crossed Plot 52 but could not be distinguished in the disturbed sandier material.

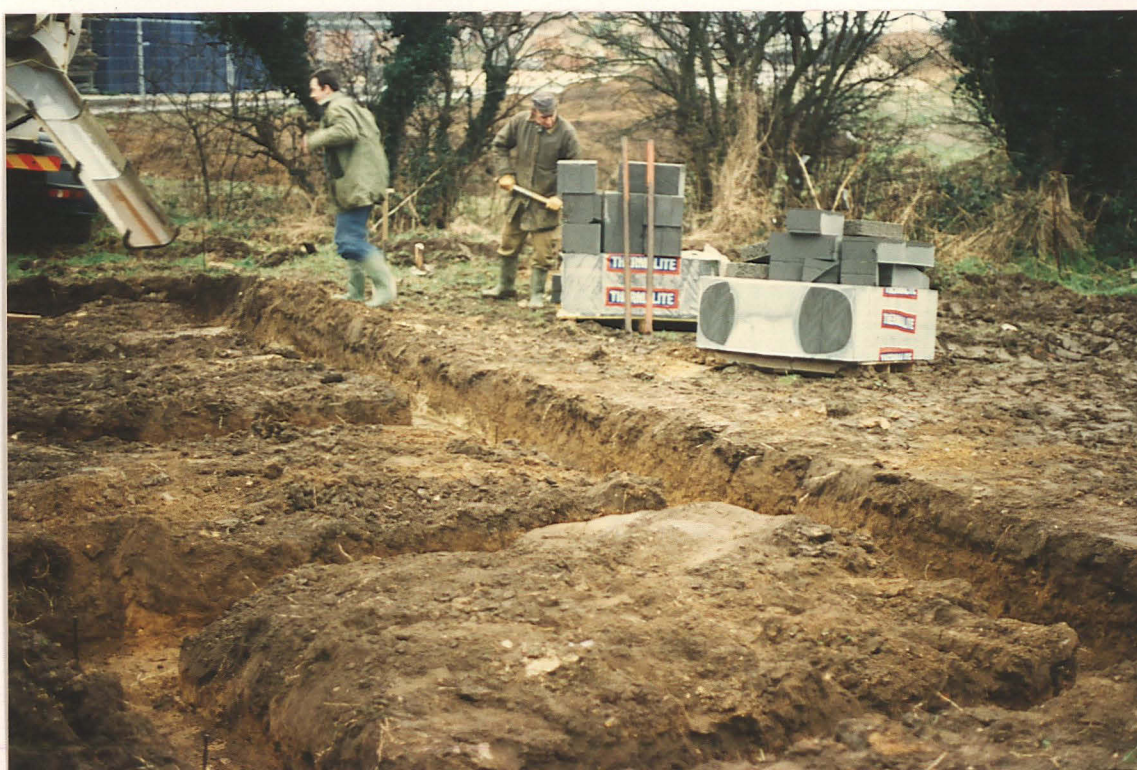
Pl. 6 Rear wall of Plots 52 and 53 in relation to the position of Trench 17, looking west.
