## Telephone Cable Ducting, Lincoln Archaeological Watching Brief

Site Code.: LTCS05 Accession No.: 2005.52

LAS Report No. 849 September 2005

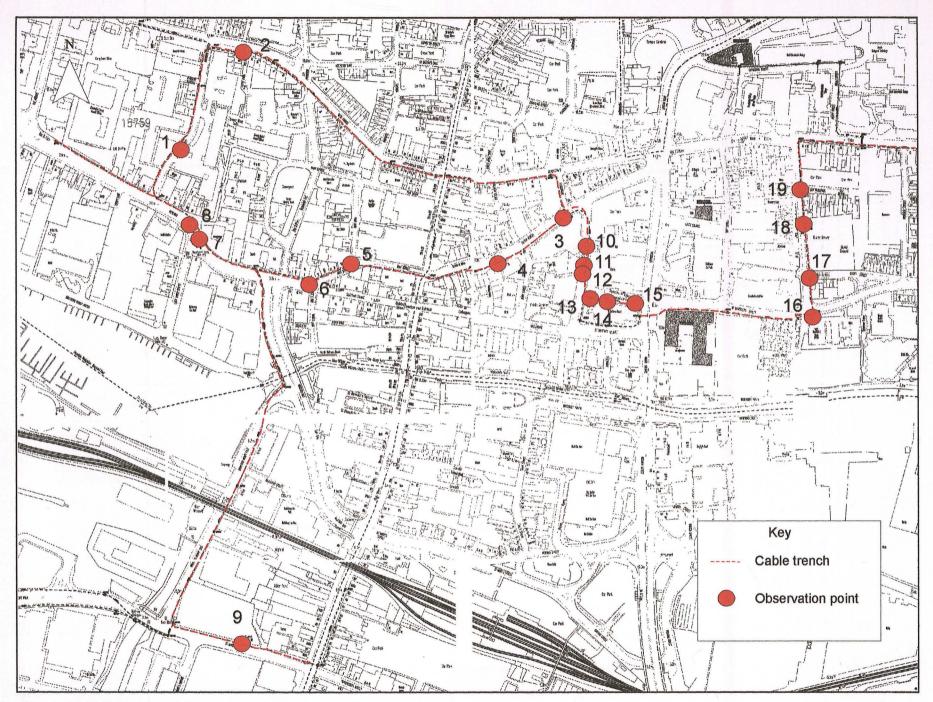
Fig. 2 Location of the cable trench and watching brief observation points.

A new telephone cable system has been installed in Lincoln Kingston Communications plc. The ducting was installed in various locations in the city, but primarily in the south-west, north-east and central areas, within pavement and carriageways (Fig. 2). Trenches were 250-300mm wide and 550-600mm deep. Jointing chambers were a little deeper.

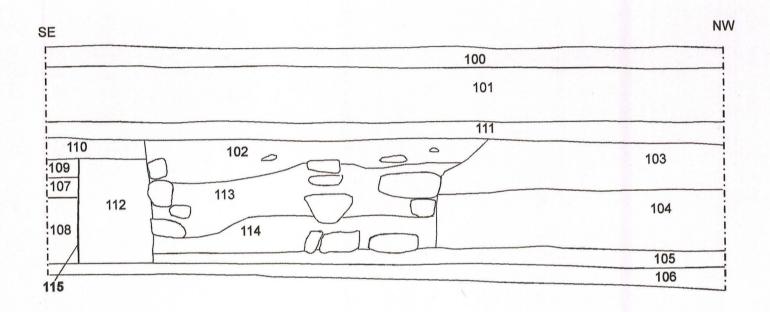
Fig. 3 Section through wall seen at Observation Point 7.

The trench was viewed opposite Lucy Tower Street, where a mid brown loose sand 101, was present beneath the road surface, 100. This overlay a 0.10m thick mid grey brown sand layer 111, with inclusons of limestone rubble. This overlay a 0.4m thick section of limestone wall, 102, 113 and 114, which was 1.5m wide and aligned north-north-west/south-south-east (Pl. 10). A foundation cut 115 was noted on the southern side of the wall filled with grey sandy silt, 112. The wall sat on a mortar base, 105 which covered a dark grey brown silt layer, 106. The wall may be part of the lower Roman city wall which ran south from the castle to the corner of Newland, a segment of which is preserved beneath the City Council buildings north of the trench. Grey brown silt 102 may represent a robbing of the wall.

trenches, it was impossible to accurately work out their orientation. Bones and a skull recovered on Orchard Street were also from a previously disturbed context. They were probably from the known cemetery of the parish church of St Stephen which closed some time in the 16<sup>th</sup> century (Jones, Stocker and Vince 2003, 310). The architectural fragment found near the library confirms the remains of the Greyfriars. The most substantial and significant feature identified was the remains of a north-northwest/south-southeast orientated limestone wall seen in the trench as it ran through Newland. It is likely to represent a portion of the Roman city wall from the castle to the corner of Guildhall Street. The wall is depicted on the Stukeley map of 1722, and on Marrat's map of 1817 where it is described as a Roman wall. It crosses Newland at the point seen in the trench (Fig. 3). The wall and an arch over Newland are depicted on Marrat's 1848 map.

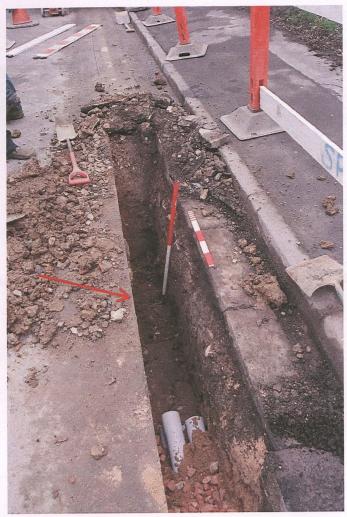
The cable trench along the edge of the pavement revealed earlier kerb stones 5cm below the tarmac, overlying crushed limestone hardcore. The trench was 38cm wide and 98cm deep. On the east side of the trench the ground had already been disturbed because of the insertion of a gas pipe. Parts of a human skull and some animal bones, were found in the trench opposite the lower entrance to City Hall and just north of the Orchard House sign. Although the machine had caused lots of fragmentation it was still evident that the bones had been previously disturbed. The bones were in a matrix of brown clay with brick and limestone inclusions. Bone was present both in the bottom of the trench and ran

into the west side at a depth of ca.90cm below the existing tarmac. The human bones were reburied in the pipe trench.

Pl. 1 The trench on Orchard Street, outside Orchard House, scales 0.50m and 1m. Location of human skull and bones, looking south.

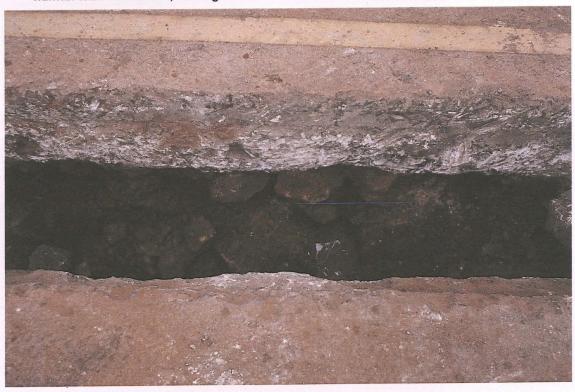
Pl. 2 The trench opposite Lucy Tower Street, showing Observation Point 7.

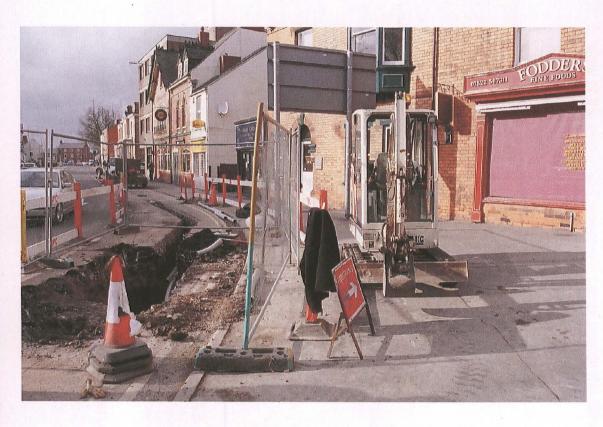
Pl. 3 The trench outside No. 29 Newland, looking west.

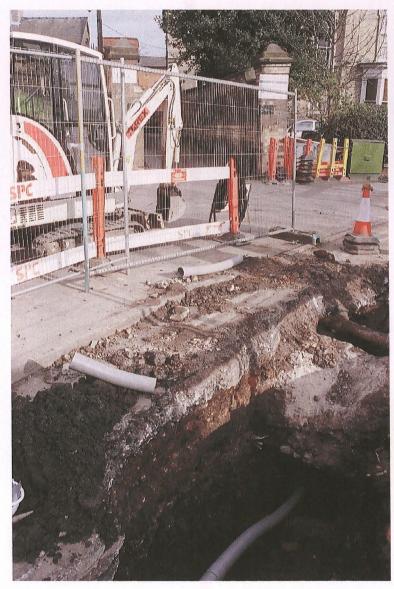
Outside No. 29 Newland, 0.20m of modern road surface, overlay a 1.06m deep cut for a concrete pipe. This cut through several layers of grey silt deposits measuring 0.52m thick (Pls. 8 and 9). The lowest, 110, overlay a yellow grey sandy silt, 109, with occasional limestone inclusions. This overlay a 0.38m thick layer of grey silt with angular limestone pebbles, 103/107, which overlay a dark grey clay silt layer with inclusions of limestone cobbles, 104/108, which in turn overlay a dark grey clay silt, 106. The number of silt deposits may represent the proximity to the Brayford Pool to the south which would have been much larger at one point with layers of flood silt at its edges.

Pl. 4 Observation Point 8 deposits at Newland outside No. 29.

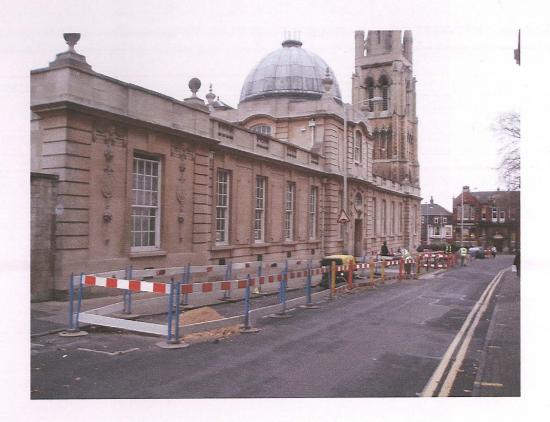
Four trenches were dug along Freeschool Lane along length of the library building (Pl. 5).

Pl. 5 View of the trench in Freeschool Lane ouside the library, looking south.

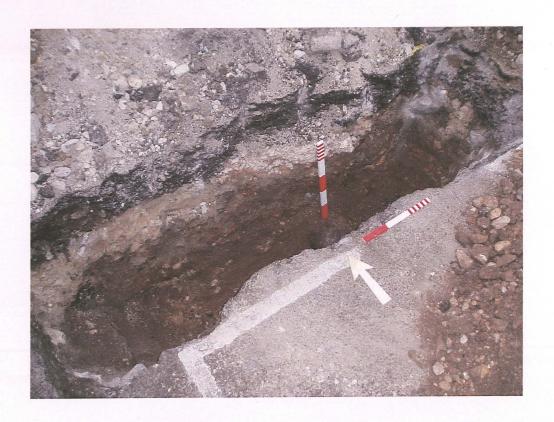
South of the library entrance, the trench showed the same profile as Trench 2 with more pipes present. Limestone blocks were present beneath the tarmac along the edge of the trench which measured 0.3m in length.

Pl. 6 Observation Point 12 outside the Lincoln Library, Freeschool Lane

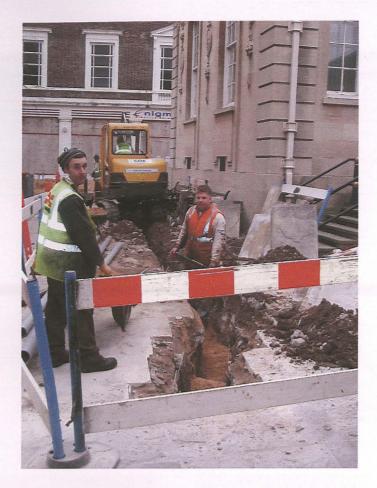
The trench excavated in the passageway between the library/Greyfriars and St Swithin's church (Pl. 7) was an alteration to the original planned route which was to go round the south side of St Swithin's

church. A dark grey sand silt, **4**, was noted beneath the York paving slabs and levelling material, **1** - **3**. A single limestone architectural fragment was retrieved. It was fragment of window tracery comprising a centre mullion head junction dated  $12^{th}$ – $13^{th}$  century, with a centre mark on the base (Pl. 8), was found with five rectangular blocks of limestone, which were recorded and photographed but not kept (Pl. 9). A layer of limestone fragments, **5**, *c*.1.9 m wide, crossed the trench and were possibly the remains of a north/south aligned wall.

PI. 7 Observation Point 14 west wnd of passage between lincoln library and Greyfriars.

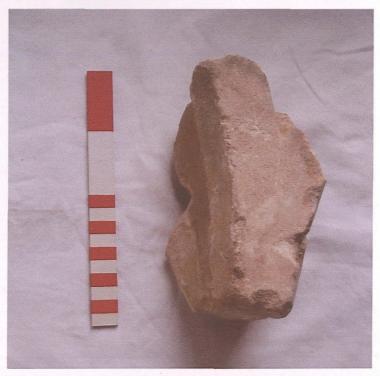
Pl. 8 Architectural fragment from medieval window found at west end of Greyfriar's Passage. Scale 0.30m

As predicted the cable trenches cut through areas already heavily disturbed by previous modern service trenches. The narrowness of the cable trench meant that little by way of recording was possible. However, confirmation of the precise position of the Roman lower city wall and the recovery of the medieval window tracery from the Greyfriars have been useful additions to the archaeological database for Lincoln.

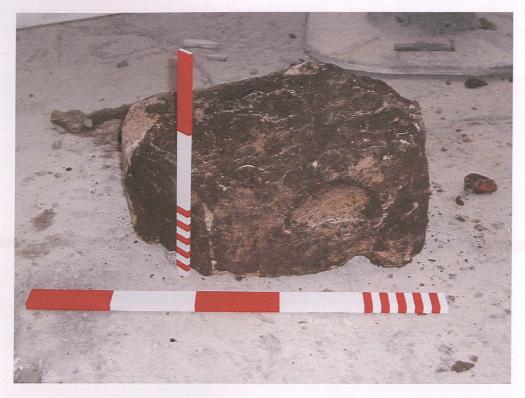
Pl. 9 Limestone block from west end of trench in Greyfriar's Passage. Scales 0.30m and 0.50m

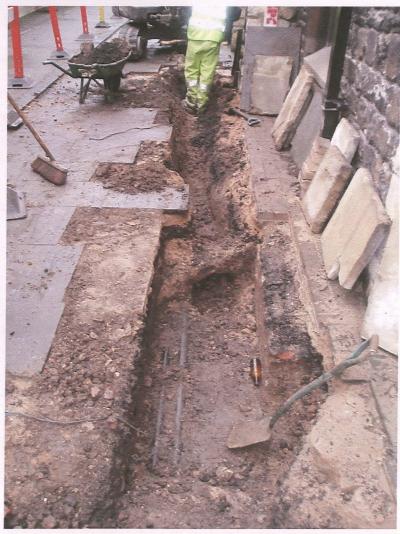
At the east end of the trench previous services had disurbed the ground (Pl. 10).

Pl. 10 Observation Point 15 showing existing pipes at base of trench.

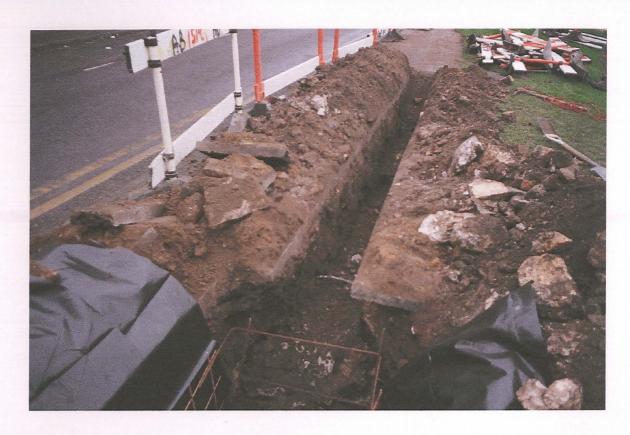
At the junction with Saint Rumbolds Street, outside the YMCA 0.20m of tarmac overlay a 0.3m thick layer of brown loam with inclusions of limestone lumps (Pl. 11).

Pl. 11 Rosemary Lane, Observation Point 16 to south-west of graveyard.

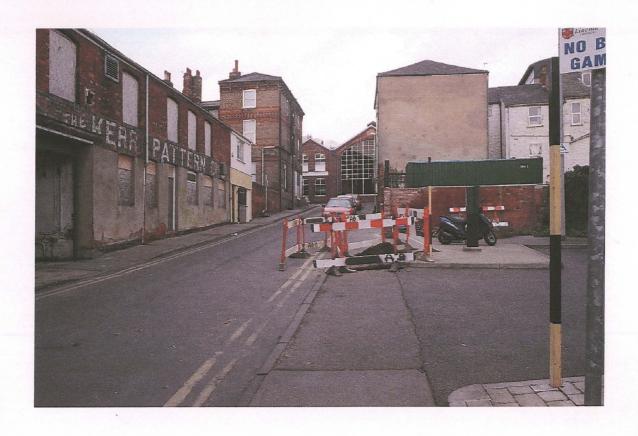
The north side of the junction with Croft Street revealed a red brick wall foundation beneath the tamac which was present to a depth of 0.65m beneath ground level. The wall curved round the corner of Rosemary Lane/Croft St (Pl. 12).

Pl. 12 Rosemary Lane, Observation Point 17, looking north towards Monks Road.
