ARCHAEOLOGICAL EVALAUTION **EVALUATION**
ON LAND AT
TEMPLE FARM
TEMPLE BRUER
LINCOLNSHIRE
(TBT05)

A.P.S. Report No. 142/05

Temple Farm
Temple Bruer
Lincolnshire
(TBT05)

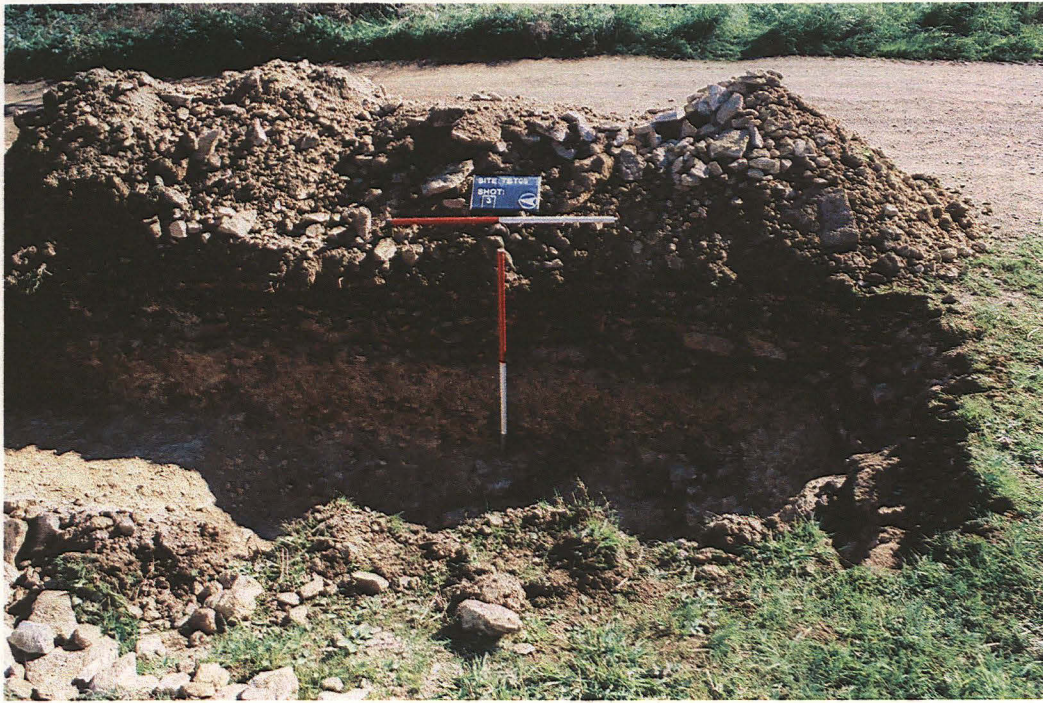
Plate 3
Trench 1,
Representative
Section

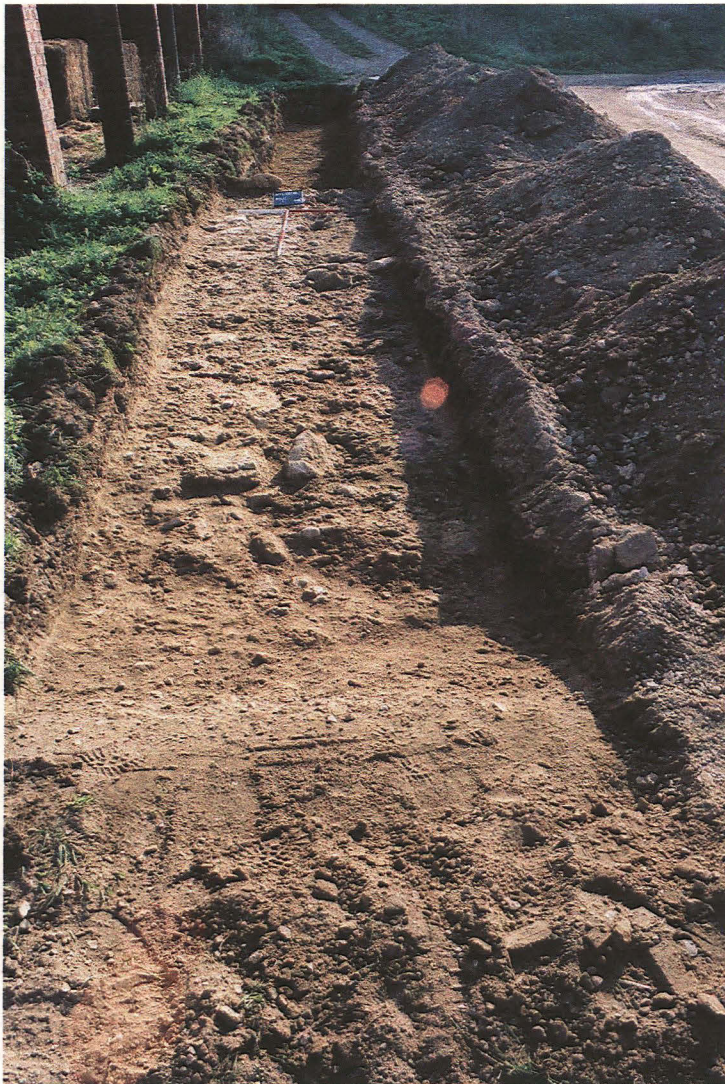
Plate 4 Trench 2, Plan view
showing post-medieval
surface in foreground

Post-medieval occupation activity was also recorded in Trench 2, where a limestone and mortar surface was identified, at only 0.30m beneath the present ground surface. The surface was constructed onto a sequence of levelling deposits from which a fragment of post-medieval handmade brick was recovered.

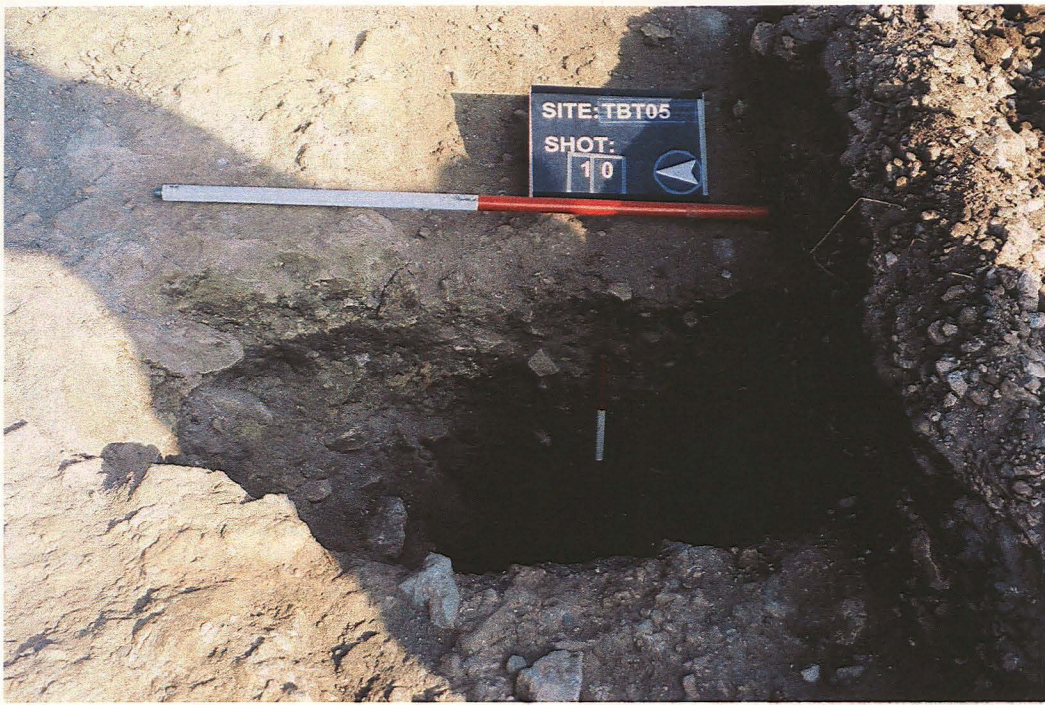
Overlying the levelling deposits was a 0.25m thick pale yellow mortar and limestone surface (203)=(215), at 49.58m OD (0.30m beneath the present ground surface). Truncating the surface along the southern edge of the trench was [212], an east-west aligned possible robber trench.

Contained within the trench were fills comprising mid-brown silt (210) and mid-brown sandy silt (209). Both fills contained post-medieval and modern brick fragments, with 2 sherds of 17th century pottery retrieved from (209).

Plate 5 Trench 2, Section 4 - through possible Robber Trench [212], looking east

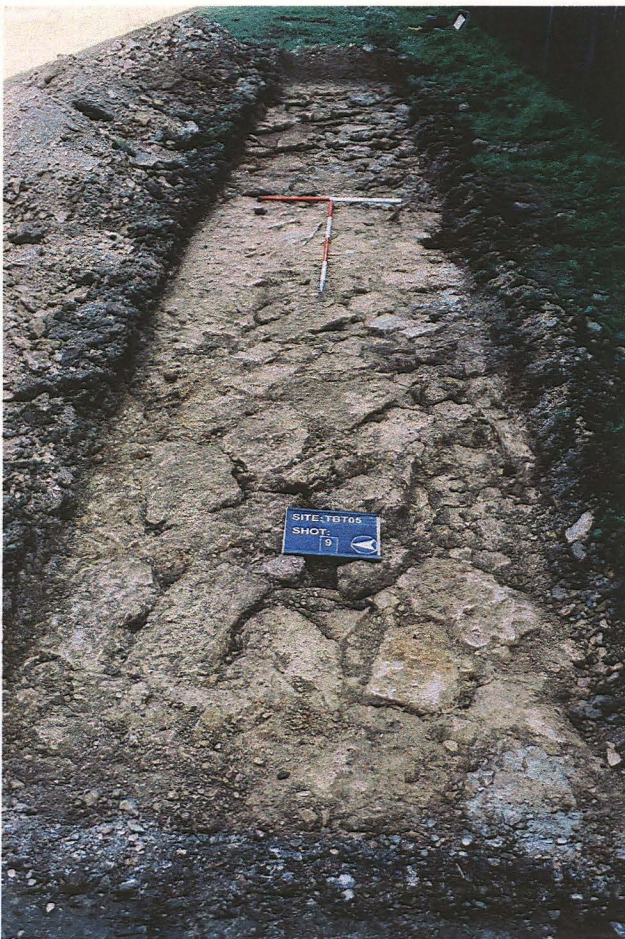
Extending across the trench, only 0.20-0.30m below the present ground surface was (300), a rough surface constructed of laid assorted limestone fragments. A 0.15m thick layer of mortar (301) sealed the limestone fragments to provide a reasonably level surface. Evidence of use

Plate 6 Trench 3, Modern limestone surface (300), looking east

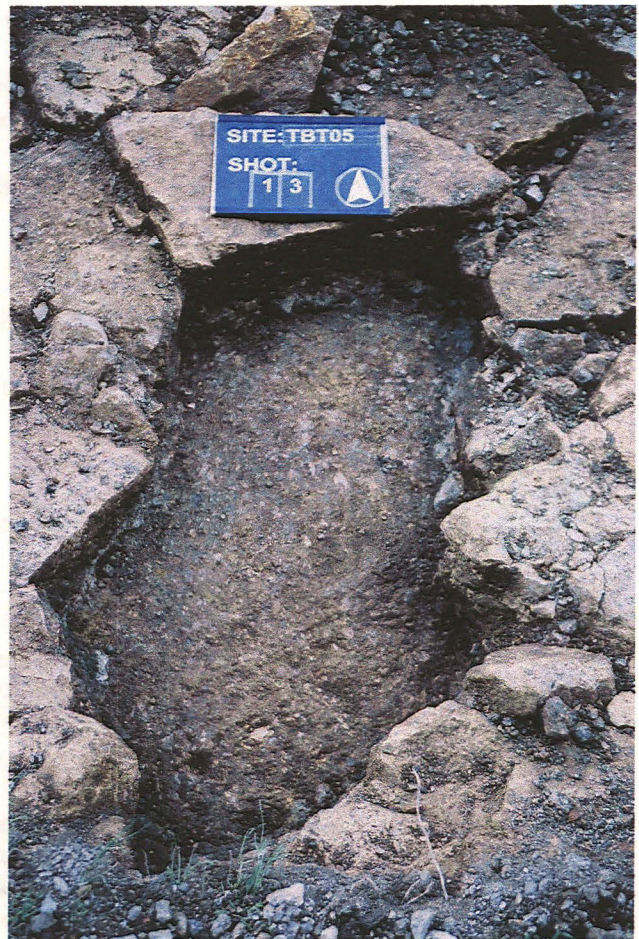
Within Trench 3 several former surfaces were identified. The earliest of these (306), comprised a 0.05m thick layer of crushed and compacted limestone located at 0.49m beneath the present ground surface (49.19m OD). Two small fragments of medieval tile were found in association with the floor (Appendix 3).

Later medieval activity was recorded in Trench 3, where a fragment of medieval tile core was found in association with the earliest crushed limestone floor surface (306) (49.19m OD). Where exposed, within a small sondage, this floor surface was well compacted and very clean in nature, perhaps suggesting a building which was well maintained or was purposefully kept clean, such as a dairy, perhaps associated with the Preceptory. Overlying the floor were two further surfaces, which are discussed in Phase 3 and 4 below.

Plate 7 Trench 3, Medieval surface (306), looking north
