# Blackthorns, Five Mile Lane, Heighington, Lincs Archaeological Evaluation

NGR: TF 049 704 Site code: HWB 05

LAS Report No: 873
October 2005

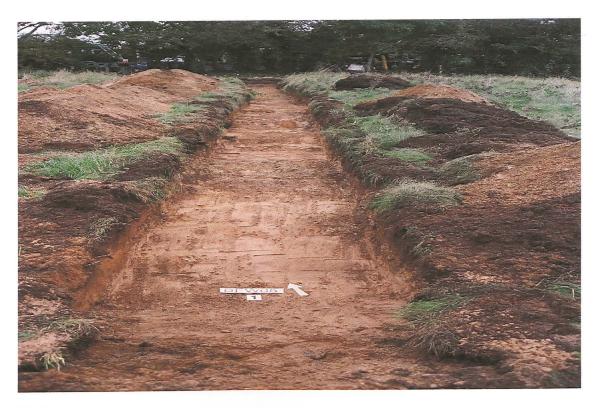
PI 2 Trench 1 looking east.

Trench 1, was located to the north of the site and pond. The trench was machine excavated in spits in expectation of archaeology. However it quickly became apparent that the natural sand, **103**, the presence of which was established by the geo-technical pits, was present at a depth of 40cm, its most shallow point, and 80cm at its deepest. Within the sand were bands of small gravel and stones. No archaeology was present in this trench but a number of pieces of very modern brick were found in the subsoil just above the sand.

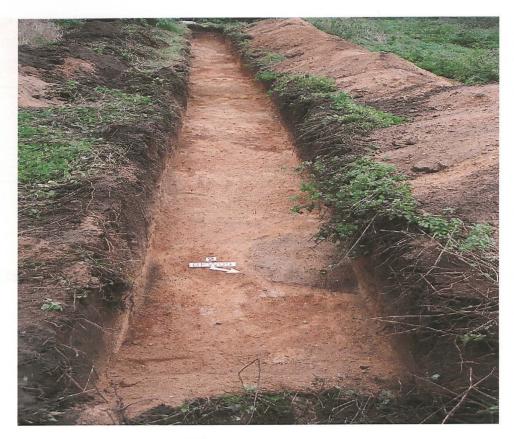
PI 3 Trench 2 looking west with context 203 to the right

Trench 2, was located to the south of the site. Whilst every effort was made to avoid the pond, the excavation demonstrated that it had occupied a larger area than had previously been suspected. The south perimeter of the pond was detected in the north side of Trench 2 and its fill was visible in the section as a soft black silty deposit.

The natural sand, **202**, was reached at a depth of 70cm with some undulation along the trench surface. Once again the sand was mixed with small patches of gravel and stones. One cut feature, **203**, (Pls. 3 and 4) was clearly visible in the sand. This was a clearly defined oval pit with sloping sides and a flat base. Hand excavation of the pit revealed very dry, grey, well compacted, powdery sand, **204**. However, securely within the fill was a single large piece of pantile, thereby confirming a post medieval date for this part of the trench.

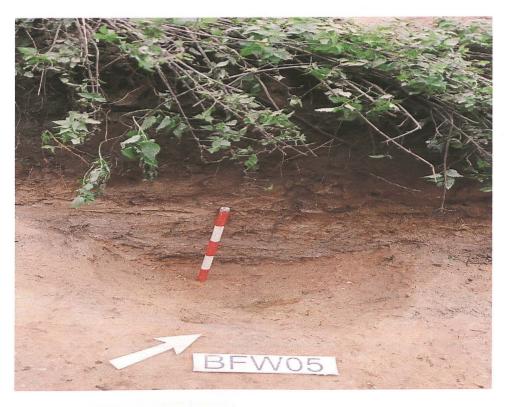
PI 4 Context 203 after excavation

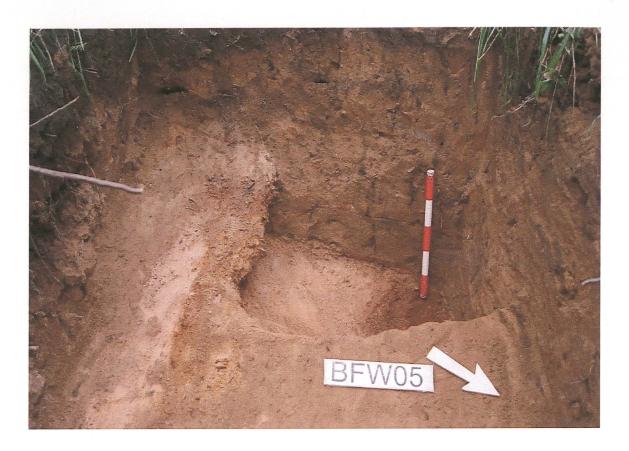
PI 5 Excavated ditch 206 in Trench 2

In the south west corner of Trench 2 was part of a possible ditch, 206, (Pl. 5). It had a vertical side and a curved base and contained three different types of sand, 207, 208, 209 all variations on the natural sand found on the site. The cut of the feature, 206, was either contemporary with the pond or perhaps pre-dated it. No dating evidence was found within it.

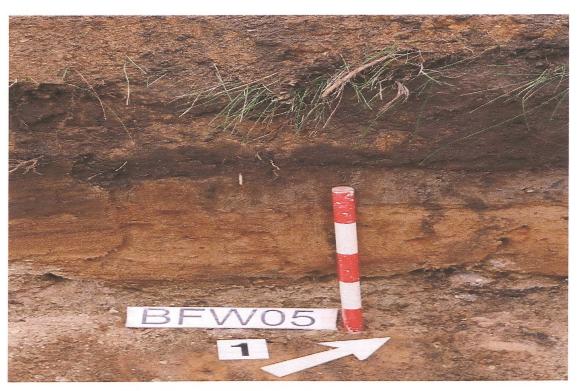
PI 6 The sequence of deposits in both trenches.
