**AN ARCHAEOLOGICAL WATCHING BRIEF REPORT:  
15-17 UPGATE LOUTH, LINCOLNSHIRE**

Site Code: UPLO 05  
NGR: SK3271 8634  
Planning ref.: N/105/00553/05  
Acc No. 2005.234

Report prepared for HJW Developments Ltd.

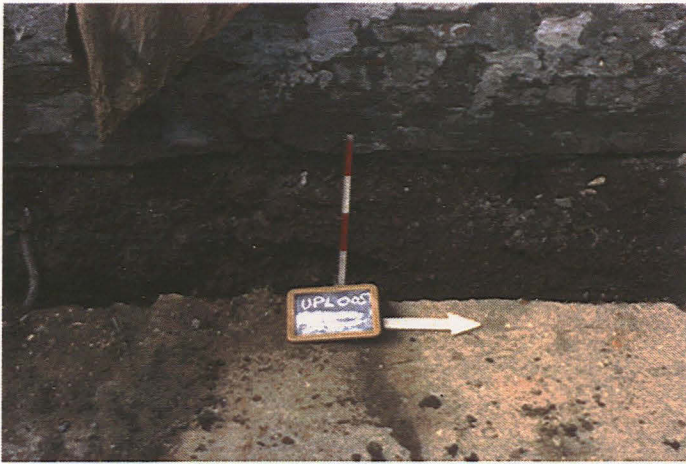
Plate 1: East Section showing sealed York stone yard surface

Context (1001) was a leveling layer of demolition rubble overlain by a yard surface (1011) of York stone flags (Plate 1:). This yard surface was sealed by modern concrete (1010). This formed the uppermost layer of the site.

A final phase of ground raising occurred evidenced by a layer of demolition rubble. This formed the base for a yard surface constructed from York stone flags. A layer of modern concrete sealed the stone yard surface.

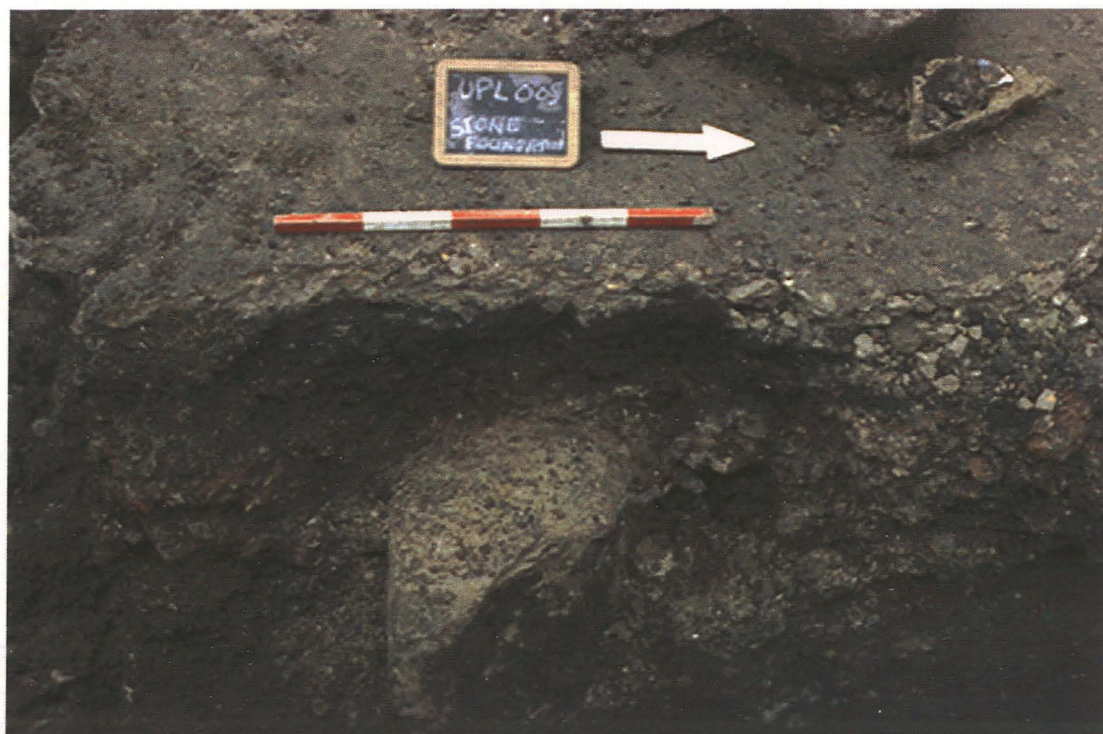
**Plate 6:** Stone foundation (1013) visible in west section

Sealing (1006) was a leveling layer of re-deposited natural (1003). This comprised light brown silty clay with moderate chalk flecks. Cut into (1003) was building foundation (1013). The cut [1014] for this feature is not immediately obvious in section (Plate 6:) although it was discernable in plan.

The building foundation was orientated east-west (Fig 4:) and consisted of re-used blocks of worked limestone (Plate 2:) sitting on a lime mortar bed (1015). The blocks were multi-faceted with an average measurement of 0.40m x 0.30m x 0.17m thick, with one exception measuring 0.75m x 0.40m x 0.17m thick. This had a semi-circular cut on one edge (Plate 6:).

The worked stones that formed foundation (1013) are possibly re-used from a building of some status but their original function is not immediately apparent. The construction cut [1014] was not discernable, except by the footprint of mortar -bedding layer (1015). Orientated east-west, the foundation extended beyond the limits of excavation.
