**12-14 SILVER STREET,
GAINSBOROUGH, LINCOLNSHIRE**

**ARCHAEOLOGICAL
WATCHING BRIEF REPORT**

Site code:	SSGA 05
NGR:	SK 8140 8981
LCCM Acc No:	2005.232
Planning refs.:	M05/P/0394
PCA job no.:	170

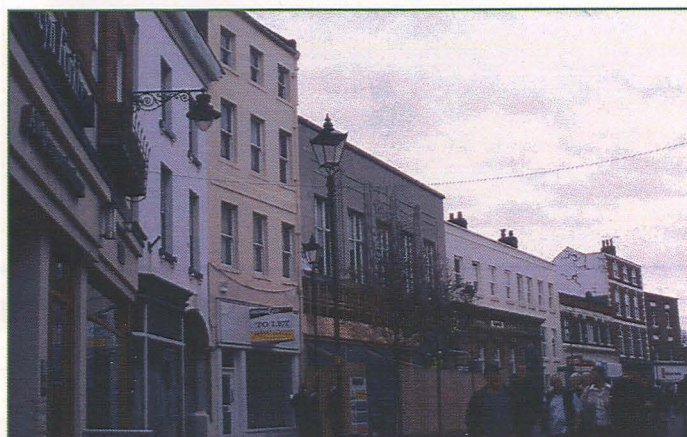
Plate 1 (right): General shot of the north-west side of Silver Street, looking north-east from the junction with Bridge Street. The building being redeveloped, behind which the watching brief took place, is in the centre of the picture, behind the lamppost.

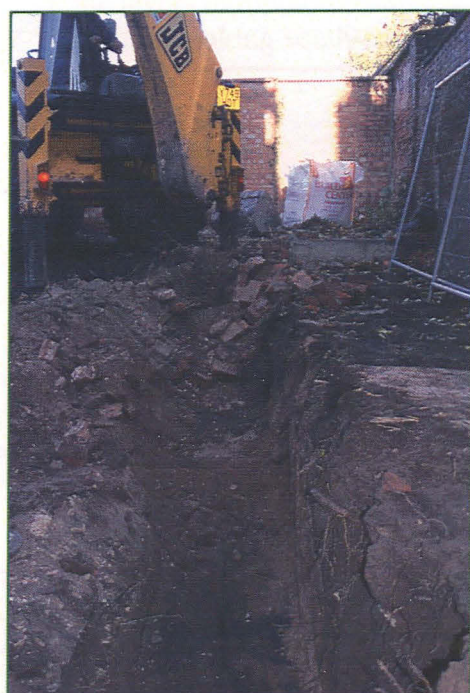
Plate 3 (above): General shot of the site during the initial strip, looking west from the north corner of the present building.

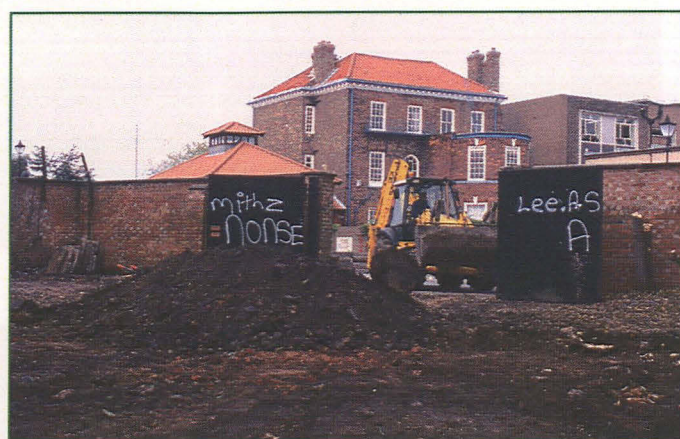
Plate 4 (left): Working shot: excavation of the foundation trench in the area of section C-D, looking north-west.

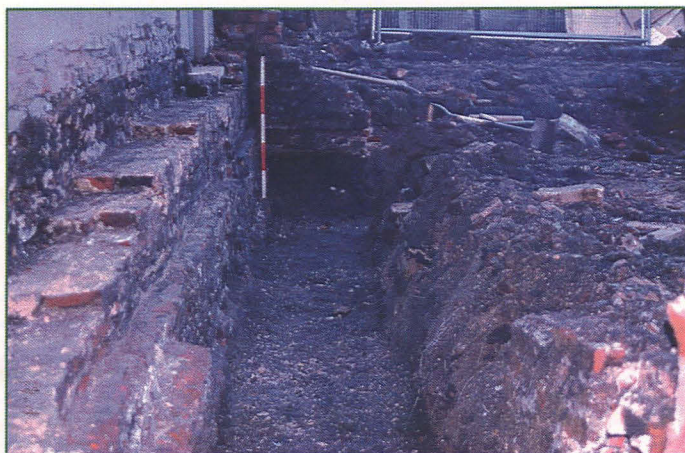
Plate 5 (right): View looking north-west along the eastern foundation trench. The exposed foundations of the Eight Jolly Brewers are on the left of the trench; in the foreground are the remnants of structure [005], and at the end of the trench is structure [006], with the broken edge of the demolished building visible directly above the photographic scale.

The foundations of another brick building, [005], were observed during the excavation of the foundation trench: it had not been exposed by the initial strip. It was unclear whether [005] had been a free-standing structure or had shared walls with the structures to north-west and south-west of it, as the foundation trench truncated the walls at both corners; however, the exposed foundation of building [006] to the north-west had no break or disturbance in it, suggesting that [005] and [006] had been separate buildings, while the foundations of the Eight Jolly Brewers did show a patch of disturbed brickwork opposite the south-west end of [005], as though this wall had been built against it (plate 5). Structure [005] varied from 6 to 11 surviving courses of thin, irregular mid-red bricks with distinctive light yellow inclusions, measuring approximately 240mm x 115mm x 55mm. It had a brick floor, although this was only seen in the trench sections, which was laid on a bed of sand and covered with a concrete skim.

of the demolished walls were of modern bricks, but the rear wall, which stood back-to-back with the rear wall of the Eight Jolly Brewers and had previously contained a connecting doorway (recently blocked), and the foundations exposed during trenching (structure [006]) were of much older bricks, a mid reddish-brown colour and approximately 230mm x 140mm x 50mm, similar to those used in the Eight Jolly Brewers itself. Ten courses of these older foundations survived below current ground level. Structure [006] had a brick floor, which had been partially destroyed during demolition and subsequent groundworks: the bricks were similar to those used in the foundations, and had been laid on-bed without any recognisable bedding layer.

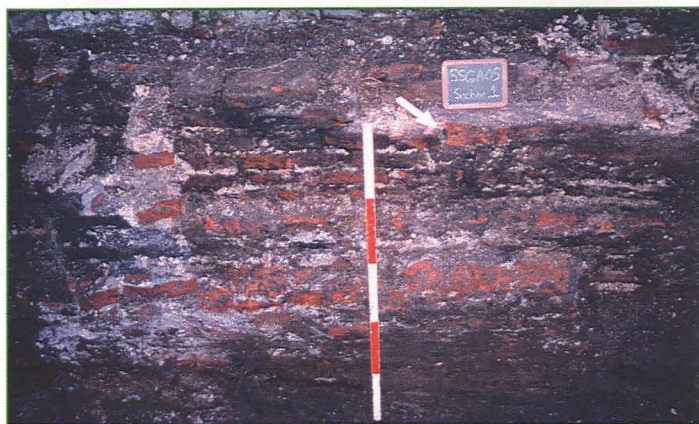
Plate 6 (left): The exposed foundations of the Eight Jolly Brewers. The disturbed area visible on the left of the picture indicates that structure [005] abutted these foundations.

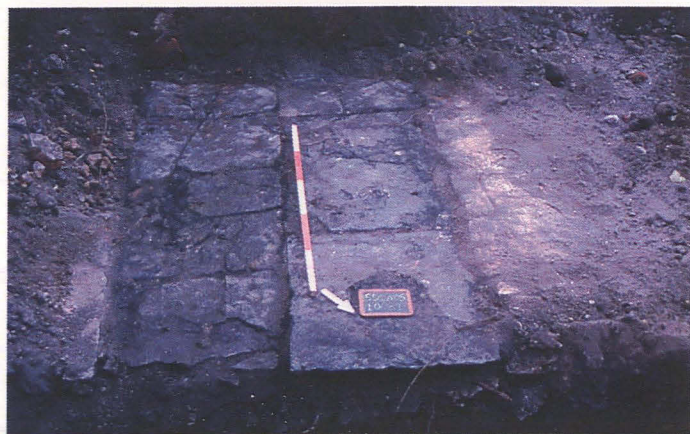
Plate 8 (left): Stone floor [008] partially exposed in the lower area of the strip, looking south-west; the brick foundation of structure [004] is visible to the left.

On the eastern side of the site, the strip exposed the foundations of a brick building, structure [004], with a partial concrete floor. The foundations were five courses deep, on a concrete footing 0.18m thick, and were of mid red, sharp-edged bricks approximately 230mm x 110mm x 75mm (similar to those in the existing building). The concrete floor was lifted during the initial strip, showing the south-eastern 'room' of the structure to be filled with a mixture of lime mortar fragments, crushed mortar, sand and small fragments of brick. This deposit, 007, sealed a stone-flagged floor (plate 8), which was only seen in the deeper strip in the corner of the site: floor [008] was only 1.25m wide NW-SE (its full extent NE-SW was not exposed), bordered by a double row of bricks which did not appear to correspond to any part of structure [004], and may have represented a remnant of a previous building. Lead water pipes and earthenware drainpipes were particularly frequent within the area of this building.
