**5 Lindum Road, Lincoln
Archaeological Watching Brief**

**Report for
Page Nelson Solicitors**

**LAS Report No. 888
December 2005**

Telephone Cable Ducting, Lincoln: Archaeological Watching Brief

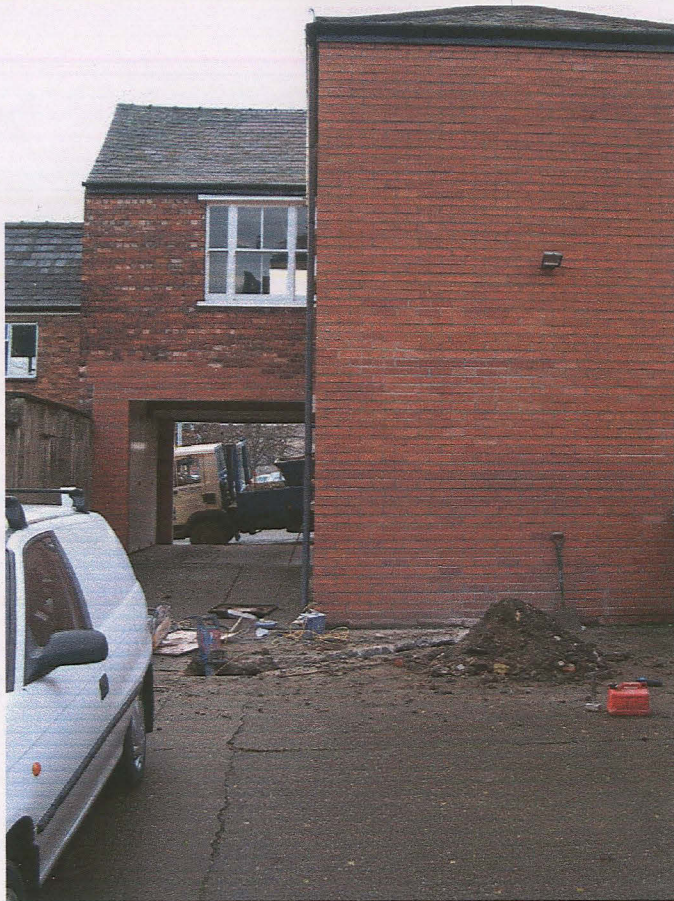
Pl. 1 The location of the trench on at 5, Lindum Road, Lincoln, looking west.

No. 5 Lindum Road is located on the west side of Lindum Road, north of the Clasketgate junction. The groundworks were at the rear of the plot, east of Danesgate (Fig. 2, Pl. 1). The site lay within Conservation Area 1 (Cathedral and City Centre), and the building is Grade II Listed. The works monitored also included any connections outside the property boundary.
