**Land at Fonaby, Caistor  
Archaeological Watching Brief**

**Site Code.: HAFC 05**

**William Green & Sons Ltd**

**LAS Report No. 890  
December 2005**

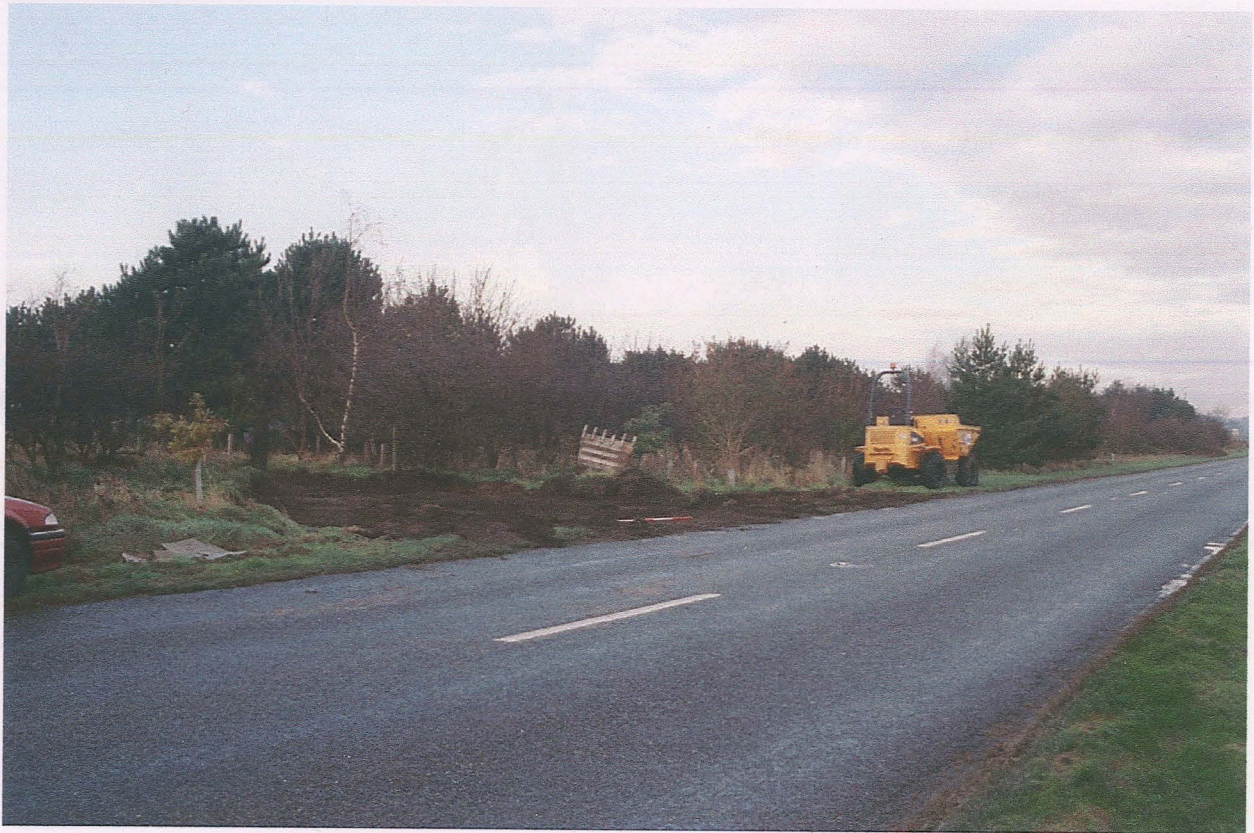
Pl. 1 The location of the access road, looking north-west.

The rectangular development plot is located on the west side of the main road, through the village, on the former site of Castle Farm and associated outbuildings (Fig. 2, Pl. 1).

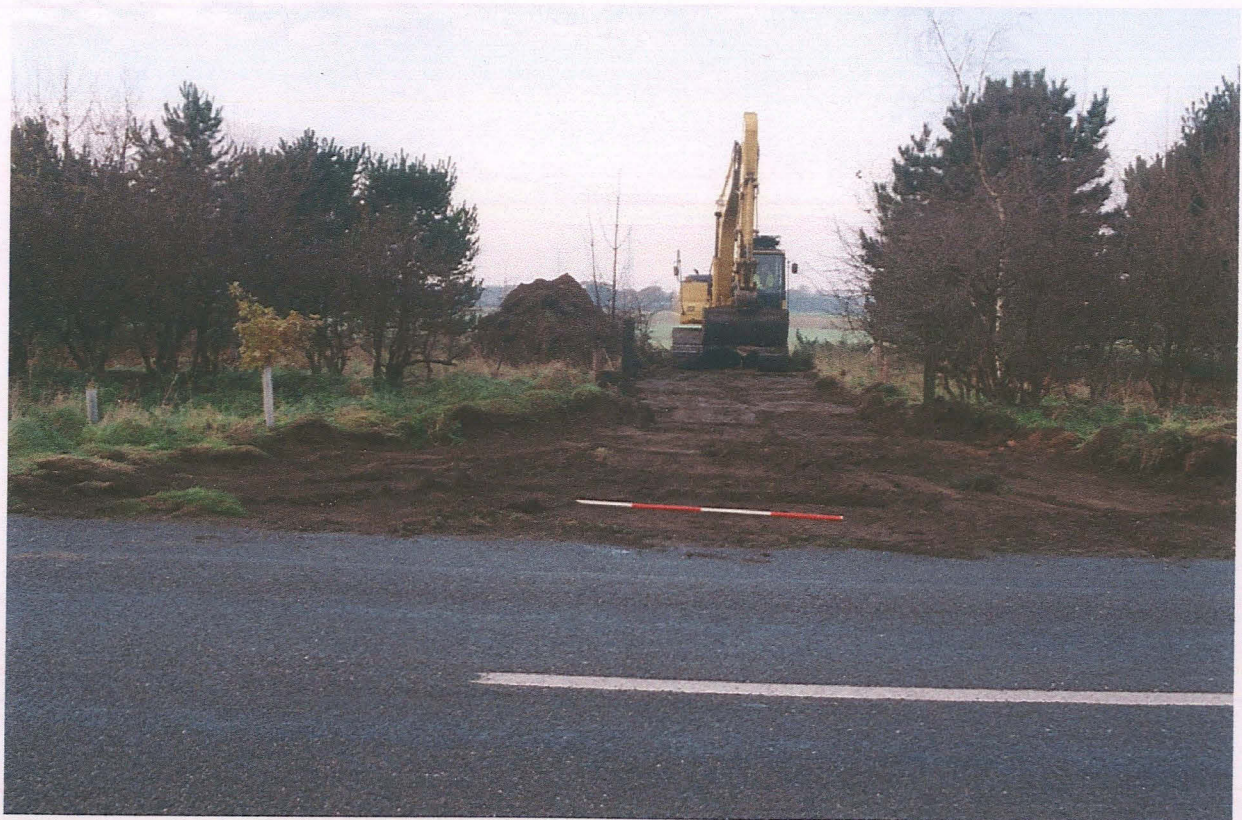
Pl. 2 General view of the access road after stripping, looking west.

The access road was 30m long x 40m wide, at its widest point, and 0.50m deep. The depth of the access road reflected the depth of topsoil, **1**. Excavation of the access road exposed only deposits associated with service trenches, **2**, for c.5m, from the eastern end of the access point. A manhole within the service disturbance was investigated, exposing a chamber c.2m deep which contained fibre-optic cables. To the west of the service trenches was yellow brown natural sand, **3**, which showed signs of animal disturbance at the south-west. The ground was noted to be c.6m higher, at the highest point on the access road, to the area of back filled quarry to the west (Pl. 3).

The access road revealed no archaeological features partly due to the presence of service trenches and animal disturbance.

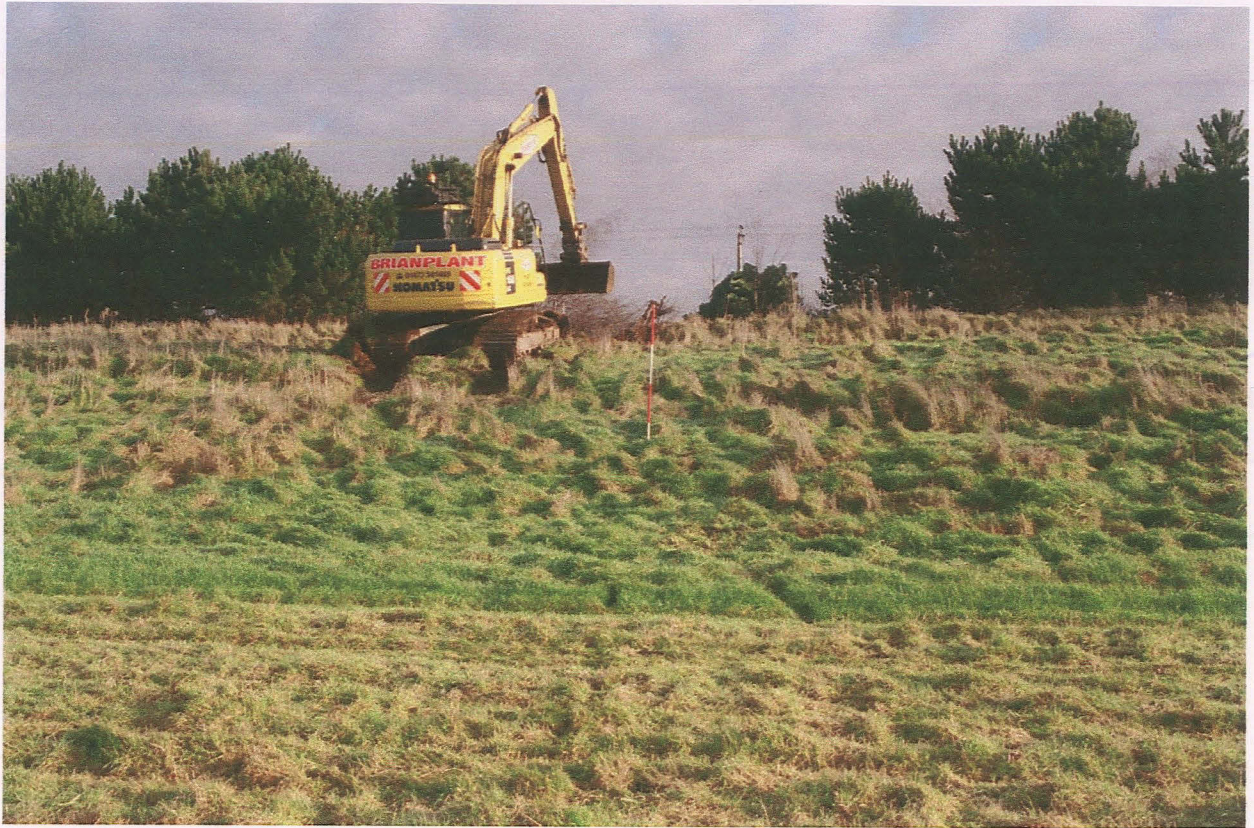
Pl. 3 Height difference between the quarried land and the monitored area.
