## **BILSBY VILLAGE WATERMAIN RELAY** Archaeological Watching Brief

(NGR: TF 4640 7677 - 4710 7663)  
LCNCC Museum Accession No 33.95

**ANGLIAN WATER SERVICES LTD**

March 1995

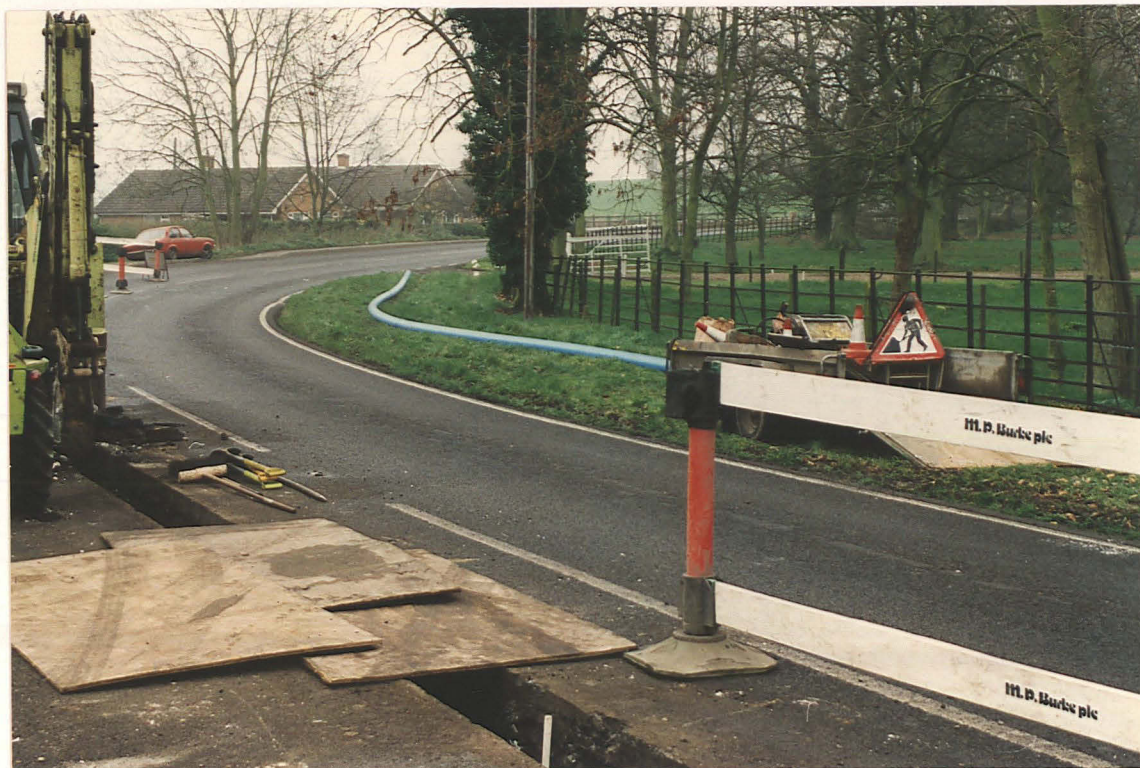
**Pl. 1 The grounds of Bilsby House with the raised Alford - Sutton on Sea road**

**Observation 1** The first visit was made when trenching from East Street, Alford had reached the bend by Bilsby House (Pl. 1). Outside 'Newhaven' the combined thickness of tarmac surfaces and asphalt was 0.41m, above 0.2m of chalk mixed with a light brown loam and an underlying 0.03m of gravel with chalk (Pl. 2). A dark brown clay below this, 0.4m thick, seemed to represent post-glacial soils, above red boulder-clay which was present at the trench base.

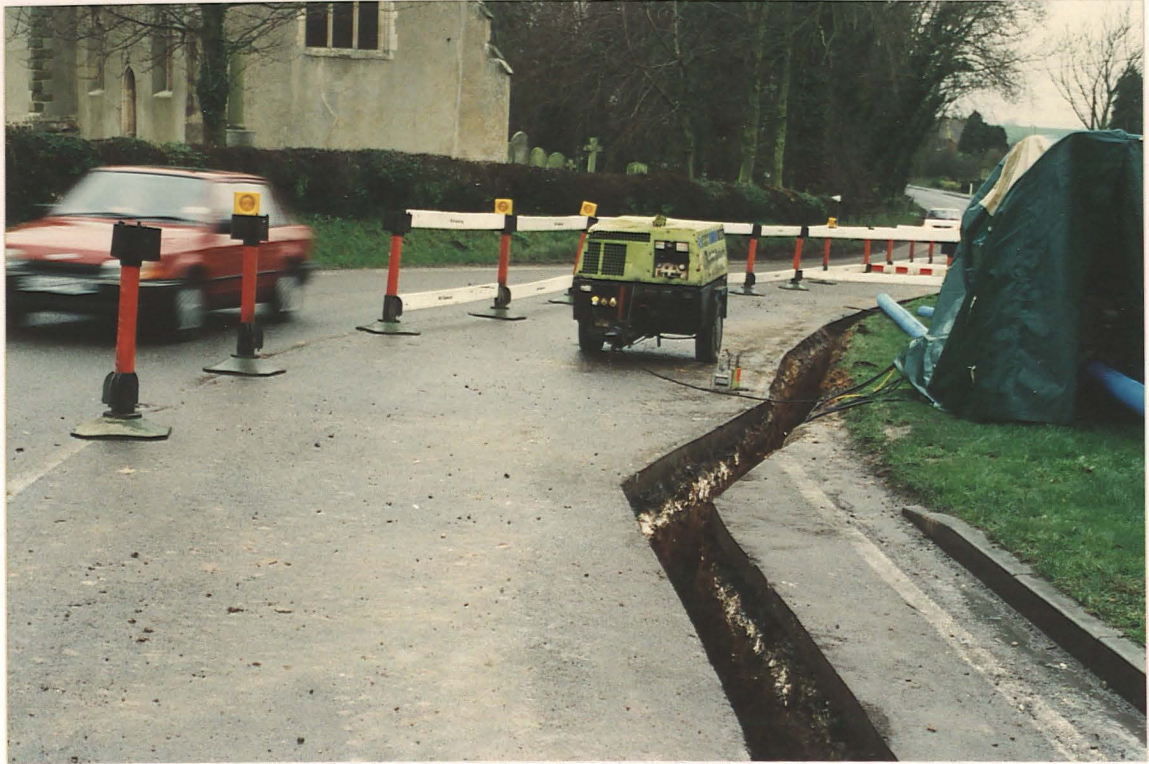
**Pl. 3 Chalk rubble above sandy clay to the east of Holy Trinity Church, looking NW**

**Observation 2** A very different stratigraphic sequence beside the church may have been affected by another service trench along the road edge. The 0.15m thick tarmac road surface overlay 0.18m of loam and chalk rubble, above 0.2m of large chalk lumps (Pls. 3 and 4). The soil below this make-up was a brown loam. This part of the road had apparently been widened onto adjacent open ground after the construction of the tramway.

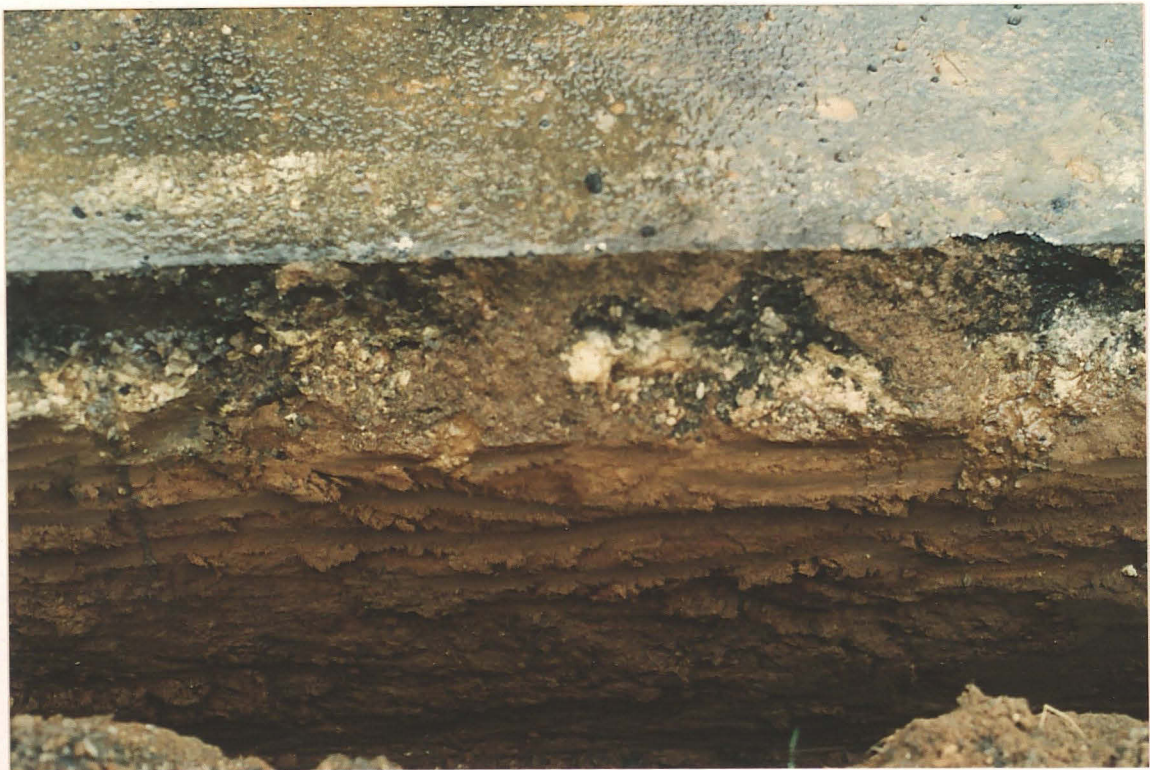
**Pl. 4 Trench face close to Bilsby Church showing tarmac and chalk rubble above sandy clay subsoil**
