**LAND OFF CHURCH STREET,
SOUTH WITHAM, LINCOLNSHIRE**

**ARCHAEOLOGICAL
WATCHING BRIEF REPORT**

Site code: SOW 05
 NGR: SK 92663 19368
 LCCM Acc No: 2005.248
 Planning refs.: S05/1131/68
 PCA job no.: 211

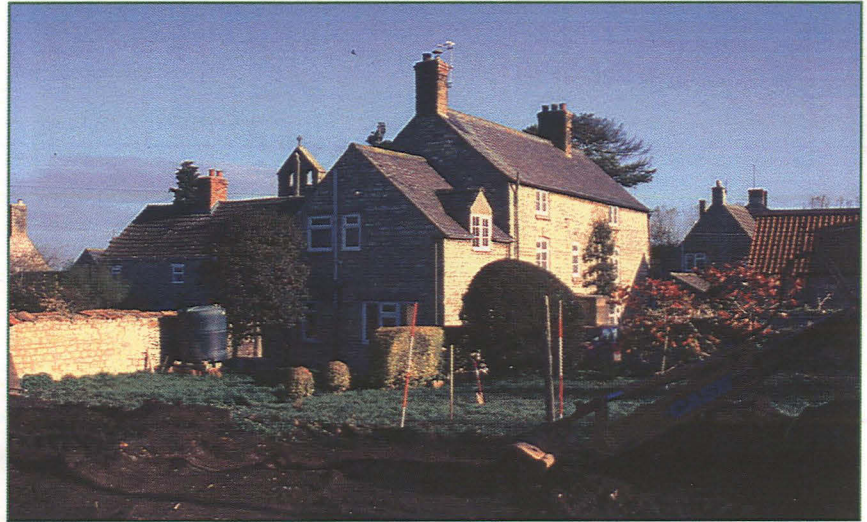
Plate 1 (right): Working shot taken during the initial topsoil strip, looking north-east across the development site towards the neighbouring farm buildings. The bell-cote of St. John the Baptist's Church can be seen in the background.

Groundworks began on 15th November 2005. Topsoil was removed using a 180° excavator with a smooth-bladed ditching bucket (plate 1). The house footprint was topsoil stripped to a depth of approximately 0.25m, which exposed the subsoil in some areas but left remnant topsoil over much of the site; the rest of the development site was stripped more shallowly, removing the vegetation only. Spoil was initially stockpiled on the north side of the site, and subsequently removed by lorry.

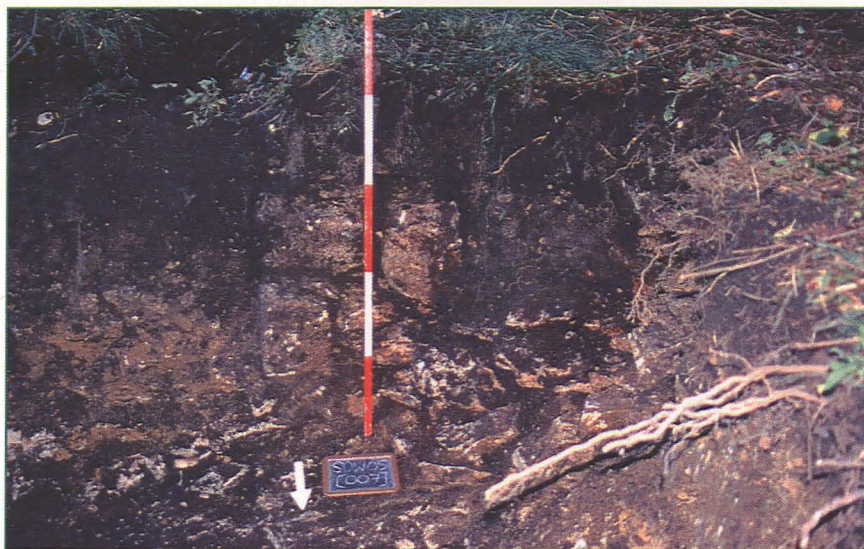
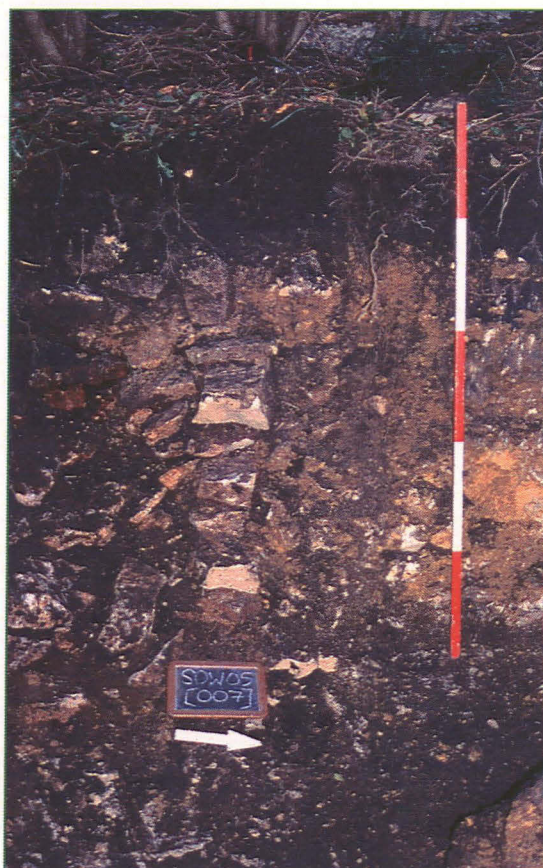
Plates 5 (above) and 6 (right): Wall 007 in the sections of the south-west corner of the house foundations. Plate 5, looking south, clearly shows the larger facing stones on the eastern side of the wall, with rubble fill 008 at its base. In Plate 6, looking west, the facing stones are not so distinct, but rubble fill 008 can be seen on the southern side of the wall. The base of wall 007 rests on the natural limestone 003, visible in both photographs in the base of the trench.

The south-western corner of the house foundation trench cut through a stone structure, wall 007. This structure was built of limestone blocks, roughly squared on their outer faces but otherwise unworked, with traces of lime mortar (plates 5 and 6). It cut through the loose surface layer of natural 003 to rest on the bedded limestone below; it was not clear whether the structure also cut subsoil 002, or whether this had formed after the demolition of the building, although the latter seems more probable. 007 appeared to be the north-east corner of a building occupying the adjacent plot: its external face could be identified, as it consisted of larger, more evenly set stones. Within the wall was a loose rubble fill, 008, consisting of limestone blocks similar to those forming 007, in a matrix of ashy, fine-sandy clay with patches of lime mortar; fragments of blue and white glazed earthenware and modern bottle glass were observed in this fill, but not retrieved.
