Ball Court, Monks Abbey, Lincoln Archaeological Watching Brief

NGR: SK 98878 71324
Planning Application: 2005/0168/F
Site Code: LIMR05
LCNCC Accn No. 2005.249

Report for
Groundwork Lincolnshire

LAS Report No. 899

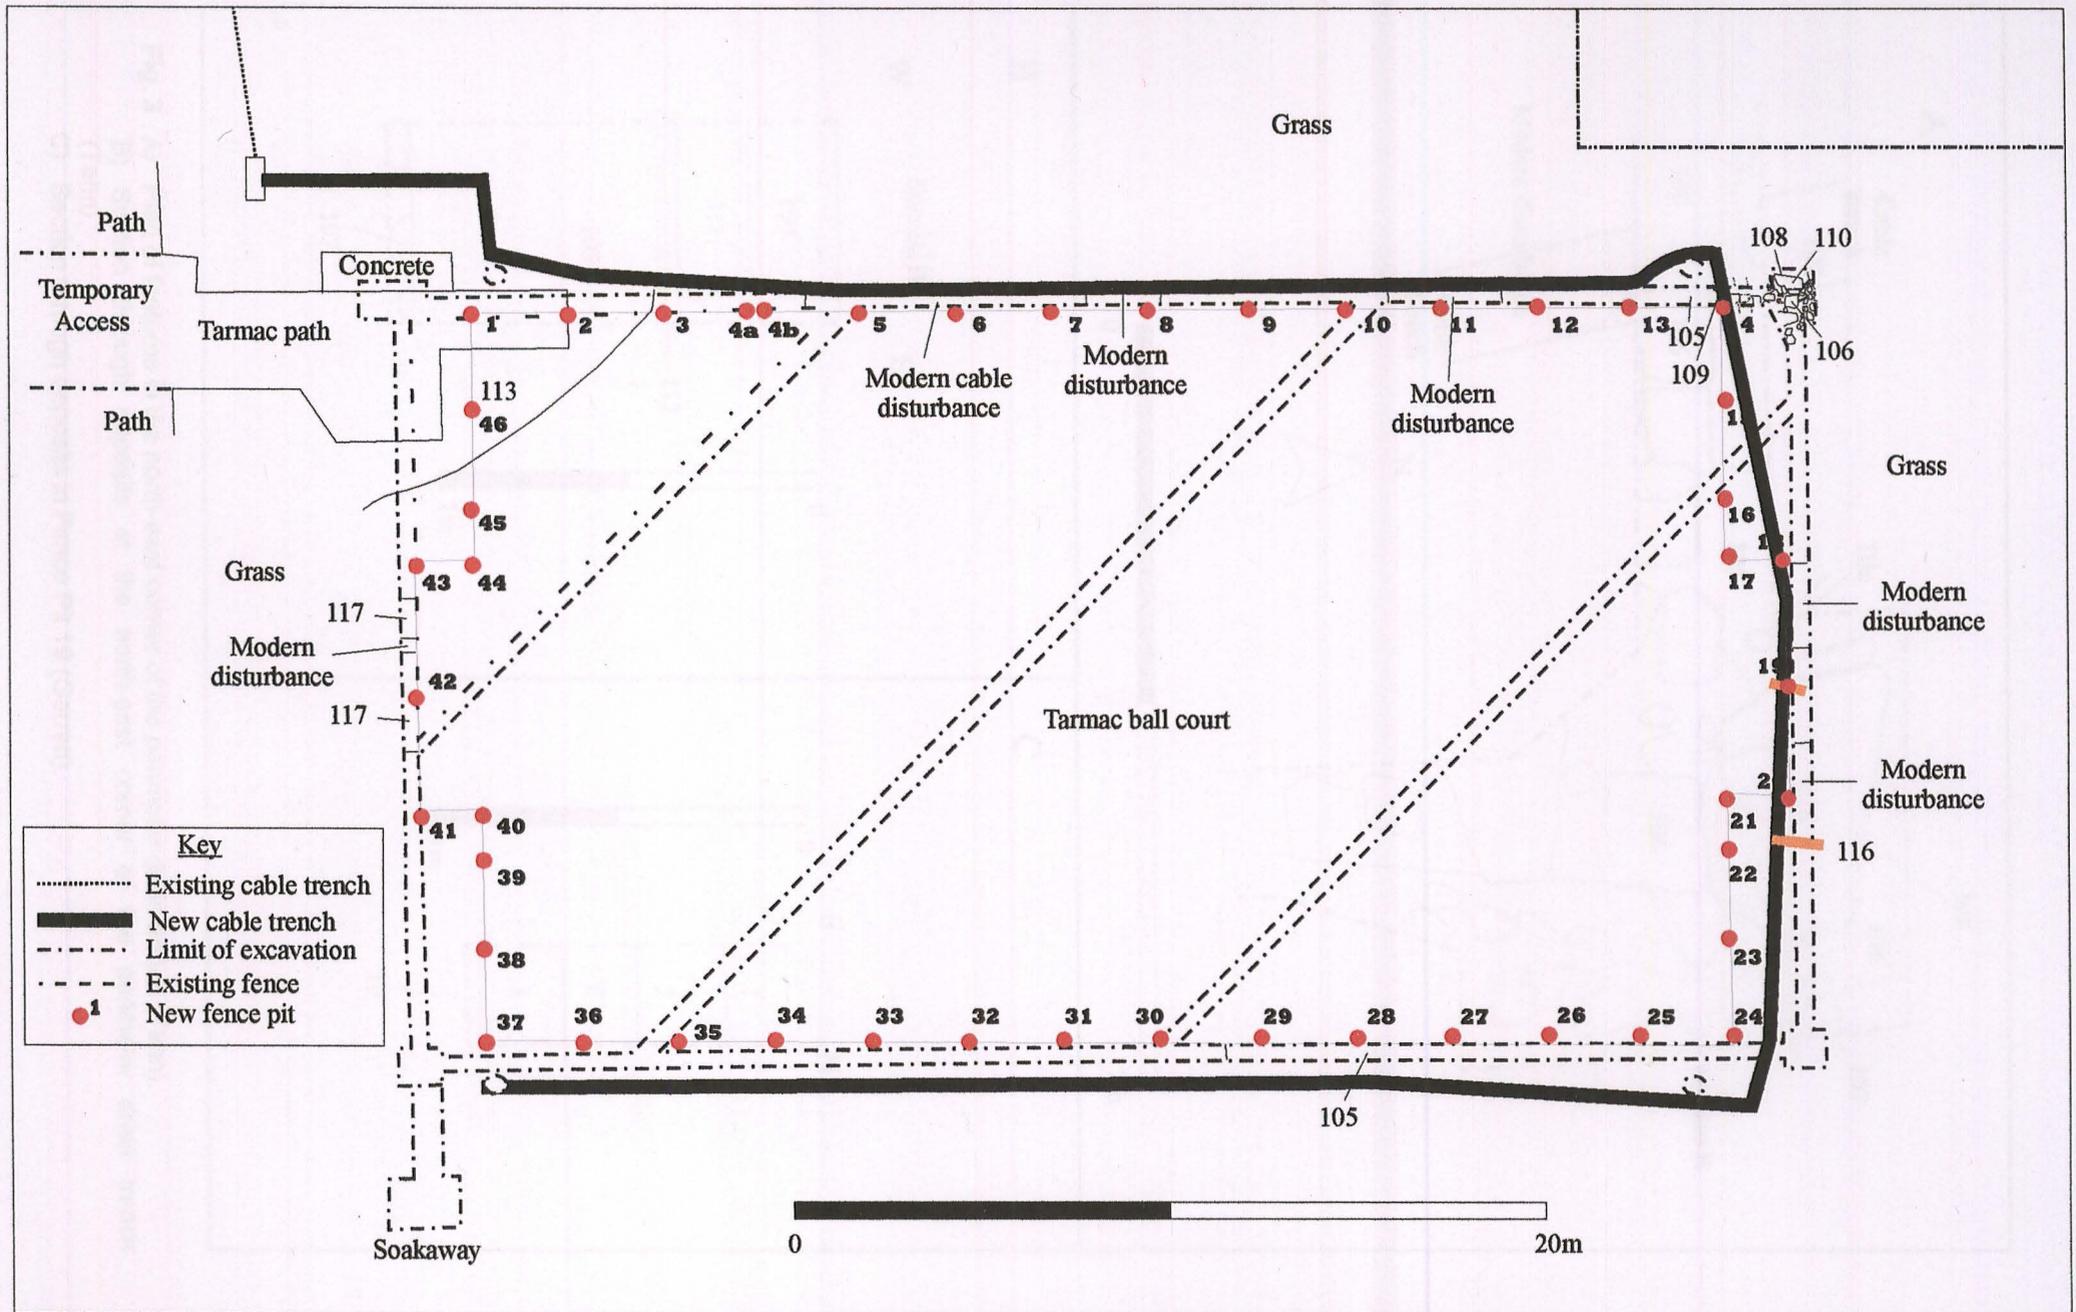
Fig. 2 Plan of the new ball court, showing the position of archaeological features (based on a plan supplied by the client, Smith Sports and Civils dwg. 3441/GA/01B).

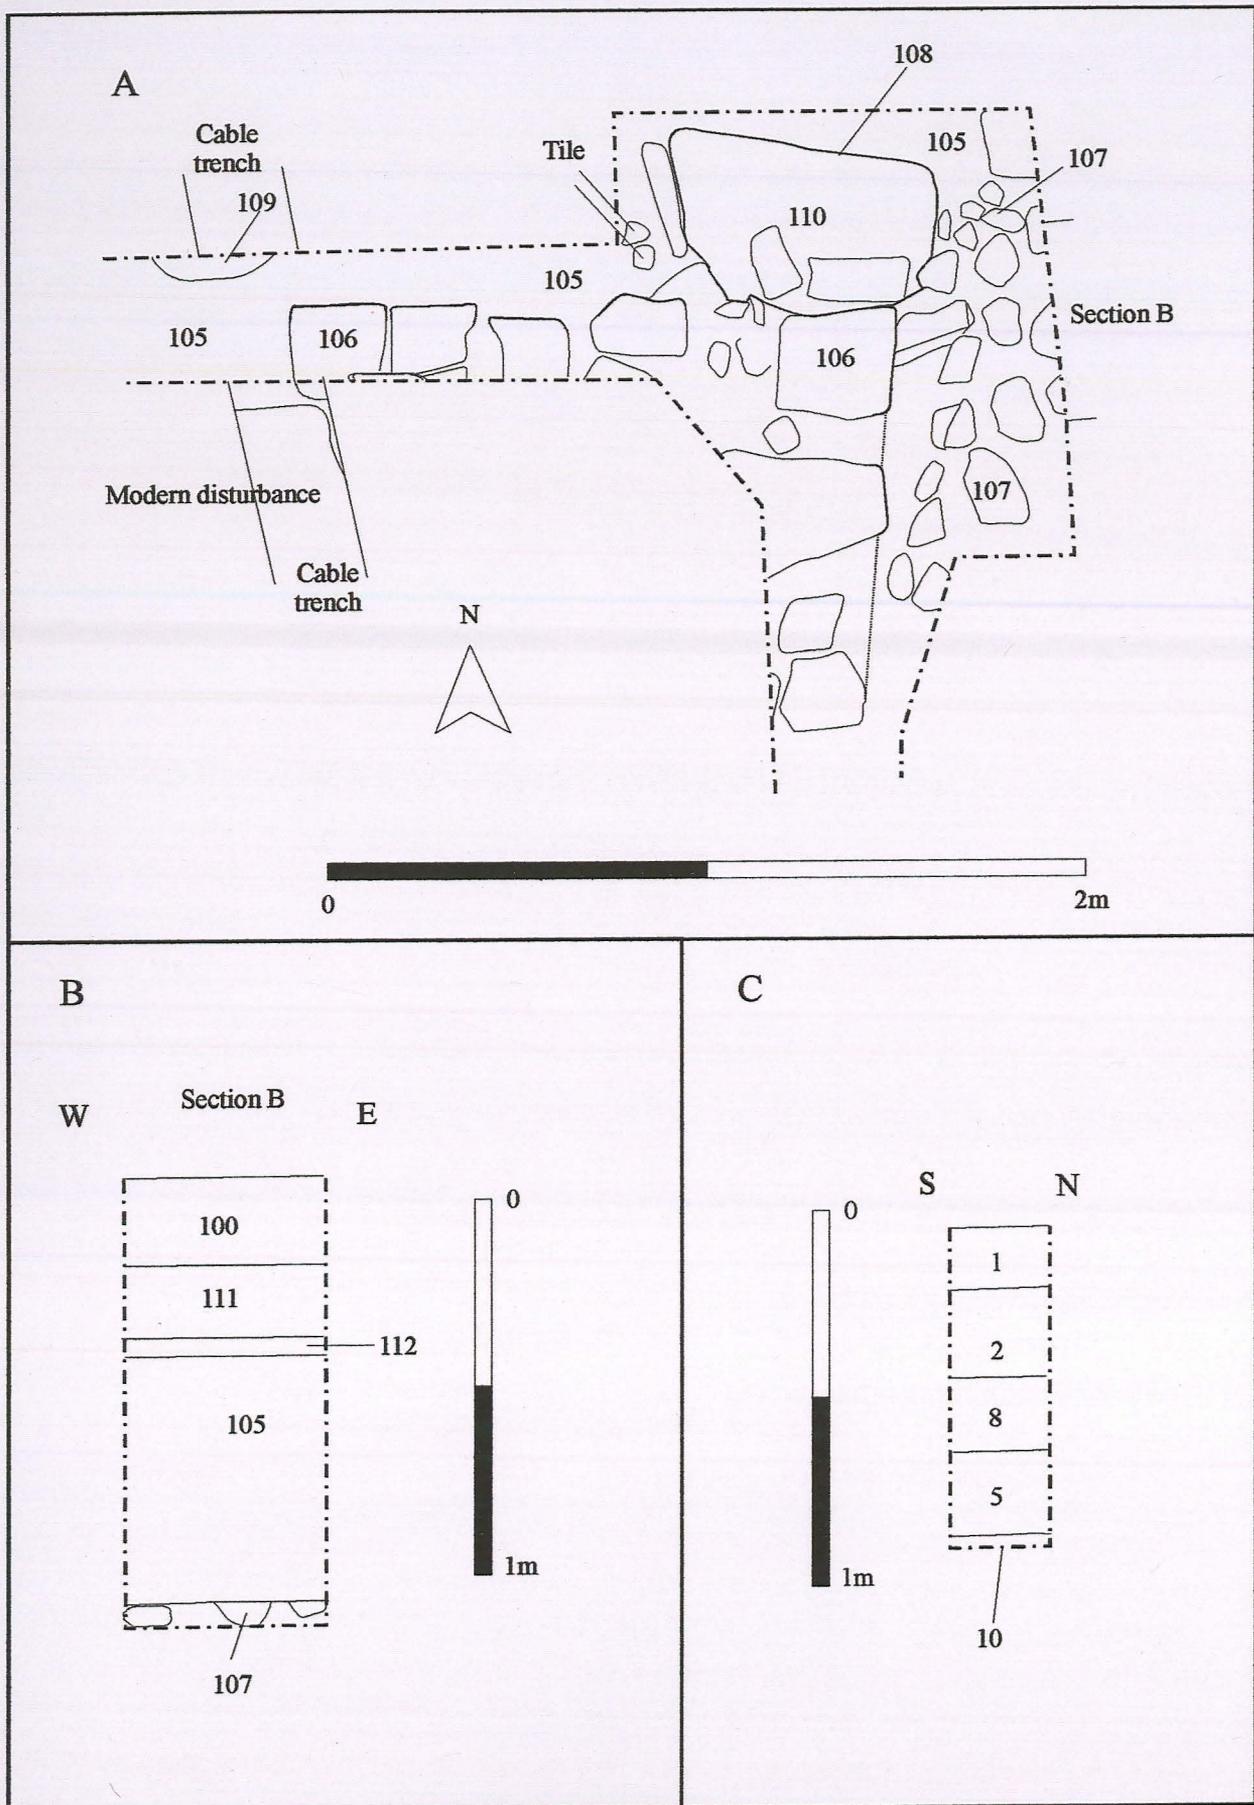
Fig. 3 A) Plan of features in the north-east corner of the perimeter drain trench (Tann).
 B) Section through deposits at the north-east corner of the perimeter drain trench (Tann).
 C) Section through deposits in Fence Pit 19 (Garrett).

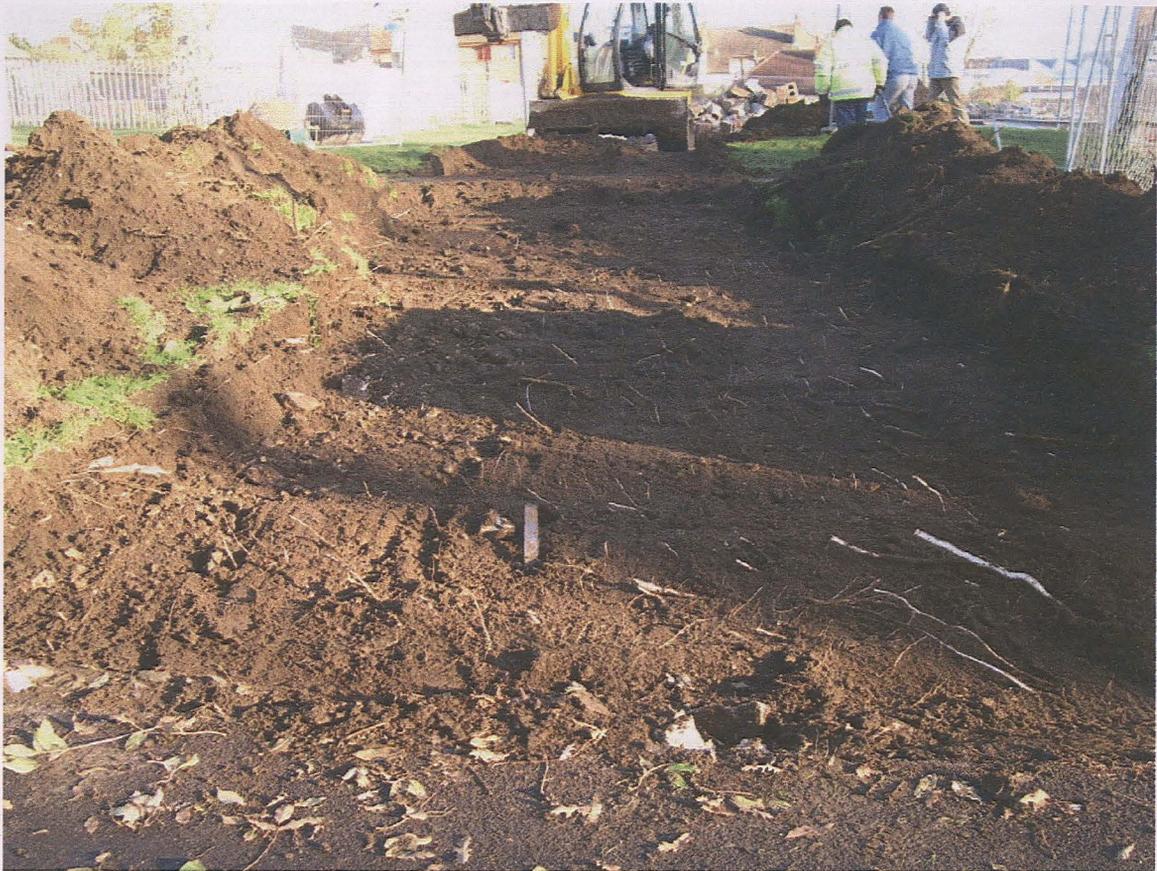
A new temporary vehicular access to the ball court site was created by the contractors at the start of the project. Turf and some topsoil was removed to a depth of up to about 0.35m from a 3.3m wide strip between the north-west corner of the ball court and opposite Nos. 8 and 9 Tempest Street. The modern topsoil layer across the development area was a dark brown sandy loam **100**, usually about 0.25m – 0.3m thick (except near the south-west corner of the ball court where it was up to 0.5m thick). In places, the topsoil had probably been used to level depressions. Elsewhere, patches of fine limestone brash **114** were exposed (Pl. 1). This material appeared to have no archaeological significance and incorporated fragments of bottle glass and modern rubbish. Where the stripped access was deepest, close to the ball court, a yellow/brown loam deposit with roof tile fragments **115** lay below the turf. This was interpreted as spread material derived from demolition and stone robbing from the adjacent priory ruins.

PI. 1 Temporary site access, during topsoil stripping (looking east).

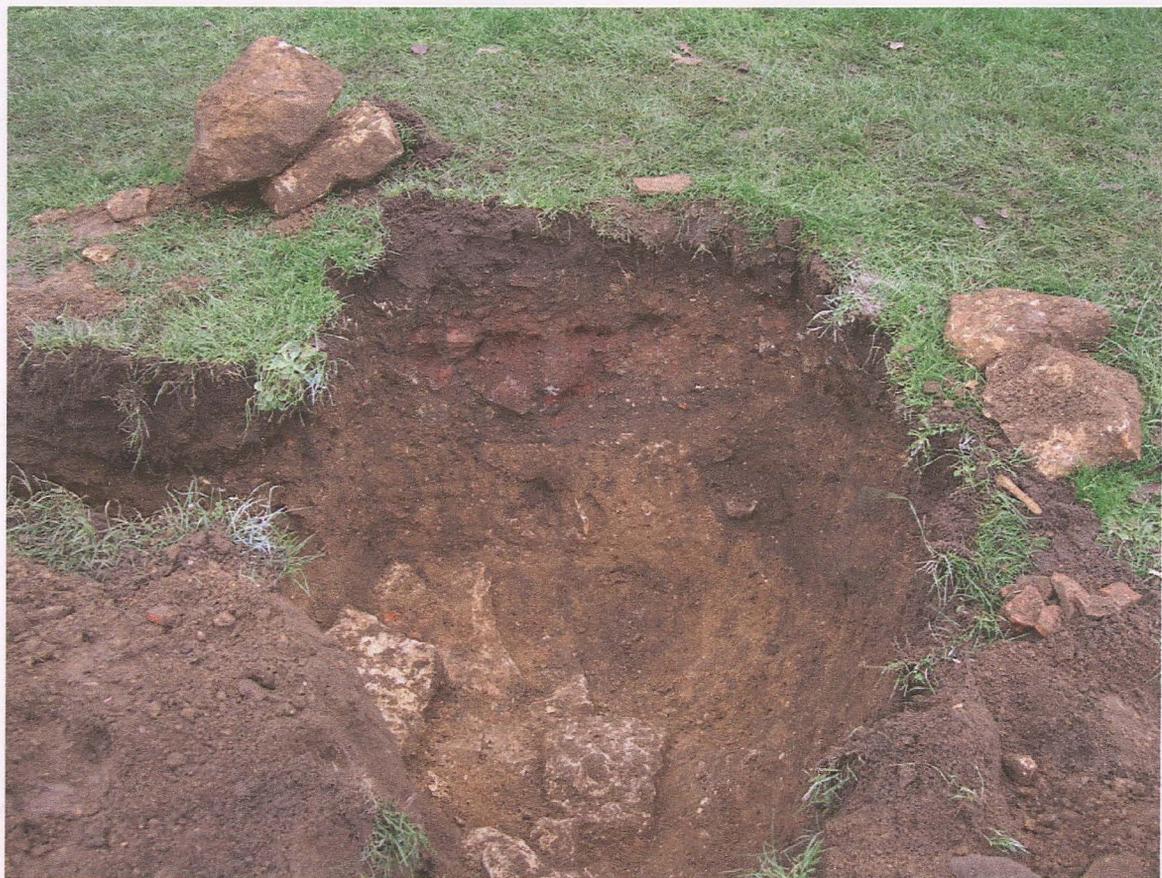
At the north-east corner it covered a layer of brick rubble **111**, with a thin band of redeposited topsoil **112** beneath it; this appeared to be a dump of material possibly used for levelling but with no obvious derivation. This dump did not extend across the drain trench, and was probably fill of a small pit **108** containing a mixed dirty fill with redeposited limestone lumps **110** below the redeposited topsoil (Pl. 2). The pit was probably late-twentieth century in date, but had disturbed earlier remains.

PI. 2 Limestone rubble at the NE corner of the drain trench, disturbed by modern pit 110 (looking north; scale 0.5m).

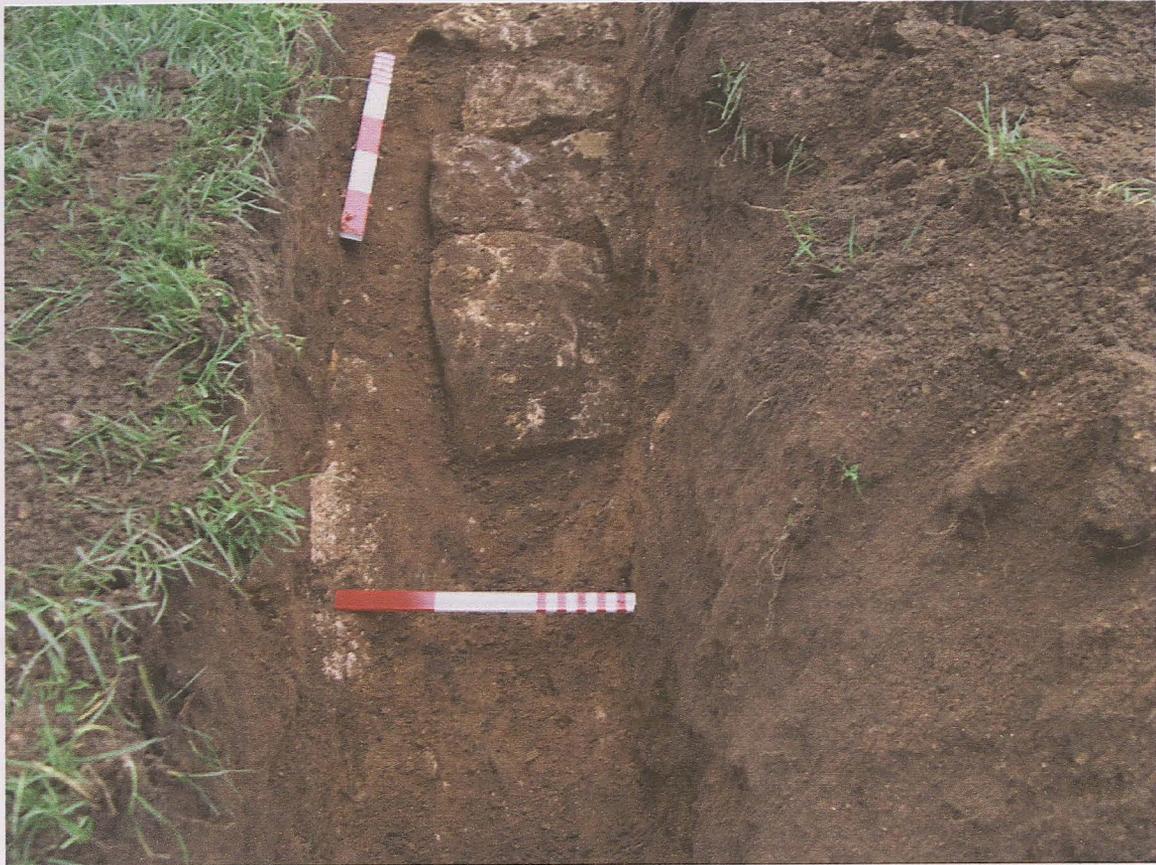
The most significant archaeological remains recorded during the watching brief were found immediately below the demolition spread **105**. An apparent west-east alignment of five pieces of limestone **106** was exposed in the west-east trench to the south of the choir ruins, beside the larger

hole for the drain inspection chamber (Pl. 3). The stones were not dressed and had no visible adhering mortar, but the northern edges of four were uniform and at a similar level about 0.55m below the ground surface (at 9.61m OD). Further similar stones were seen to the east and south-east in the return drain trench but these had either been disturbed or were not part of the feature. The foundation did not appear to have extended further east, but may have been robbed to the west. Theoretically it may have continued north and south of the trench, but an extension in these directions did not locate any further remains. The shallower trenches either side of the corner and across the pitch were not deep enough to demonstrate whether any more of the foundation was present. It seemed probable that it was the remains of the foundation of a small column or a buttress from a wall lying between the drain trenches and the ball court. However, a small evaluation trench had been excavated close to that position in 1983, and no archaeological remains had been found within about 0.5m of the then ground surface (Stocker 1984, 104-5).

PI. 3 Stone wall foundation 106 and mortar deposit 109 (looking east; scales 0.5m and 0.3m).

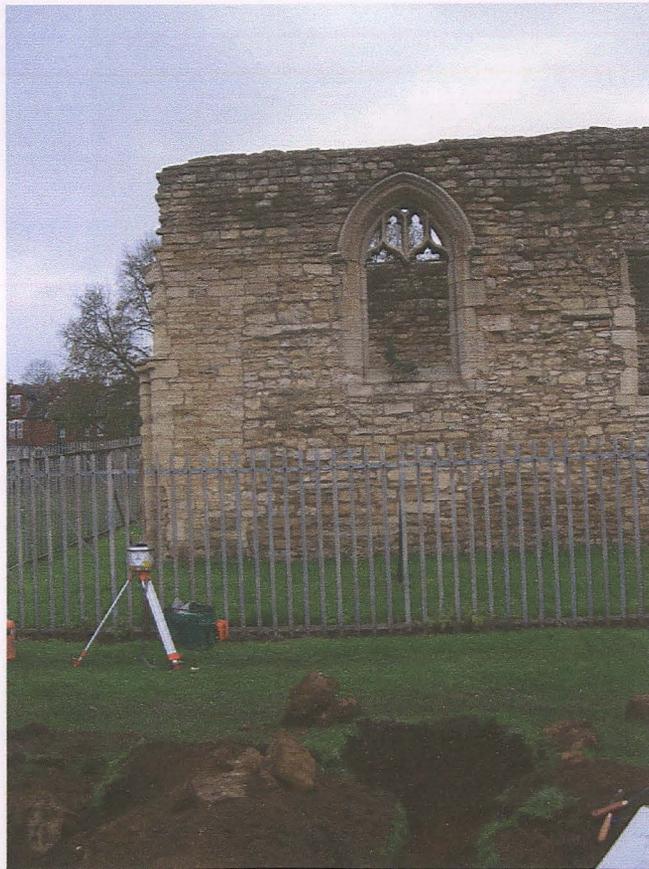
The contractors needed to lower the drain trench corner for an inspection chamber, and asked for some of the visible stones to be removed. LAS contacted the English Heritage Inspector, Dr Glyn Coppack, who agreed that this could be done after recording of the remains within the trench. After rapid planning and photography of the remains, the yellow material **105** to the east of the stones was removed to a depth of 0.75m below ground level. Below the soil was a dense layer of thin stones and roof tile fragments **107** which extended across all the deepened part of the trench. Although there was only a small area visible, the layer appeared to extend up to the stone foundation **106**, and to continue below it. It was interpreted as a deliberately created surface, probably an external yard area but possibly a coarse internal surface (Pl. 4). Roof tile fragments within the layer showed that the surface was thirteenth century or later in date.

PI. 4 Location of the NE corner of the drain trench (looking north to the abbey choir).

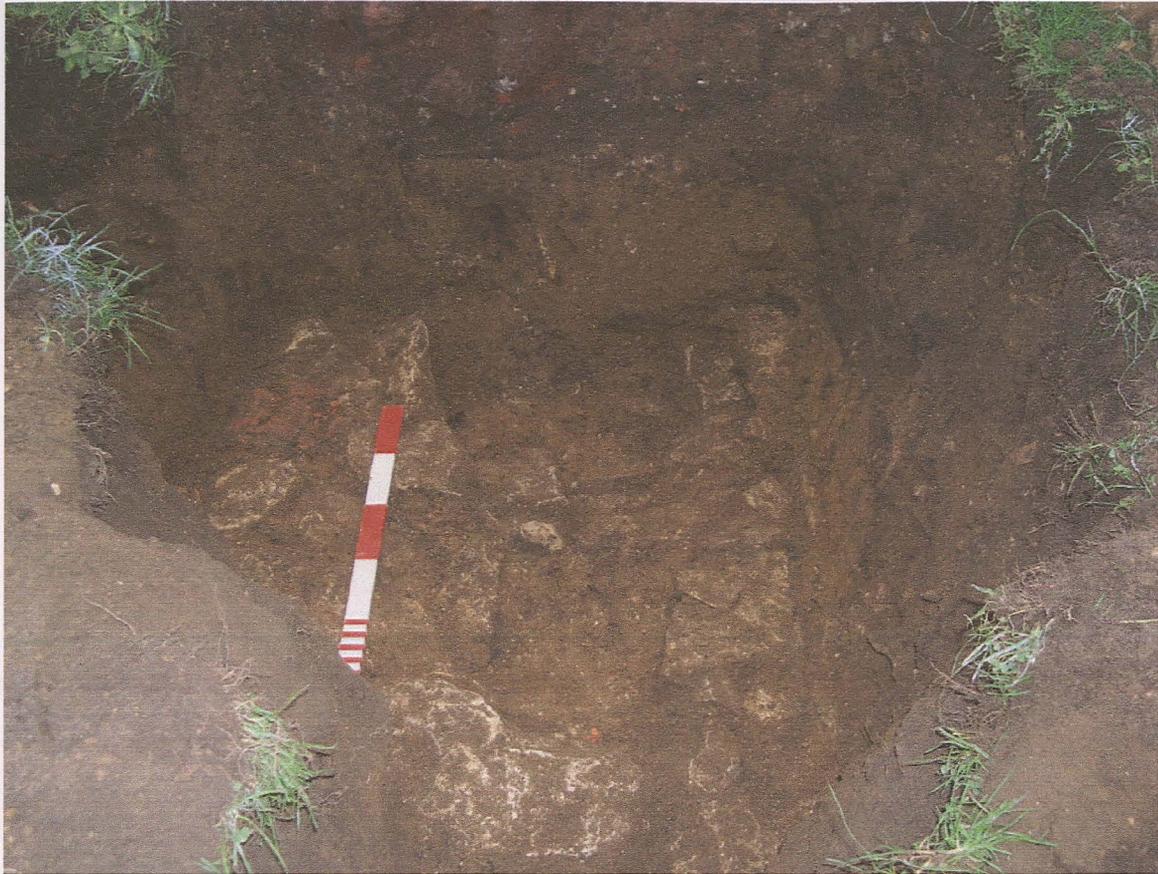
It is possible that the findings at the north-eastern corner of the new drain trench form a tantalising glimpse associated with the 'interior space to the south' of the medieval choir which David Stocker predicted after his analysis of the upstanding fabric (Pl. 5; Stocker 1984). It is unfortunate that so little more could be recorded, and that the interpretations remain so vague.

Pl. 5 Surface 107 with roof tile fragments, to north and east of foundation 106 (looking north; scale 0.5m).

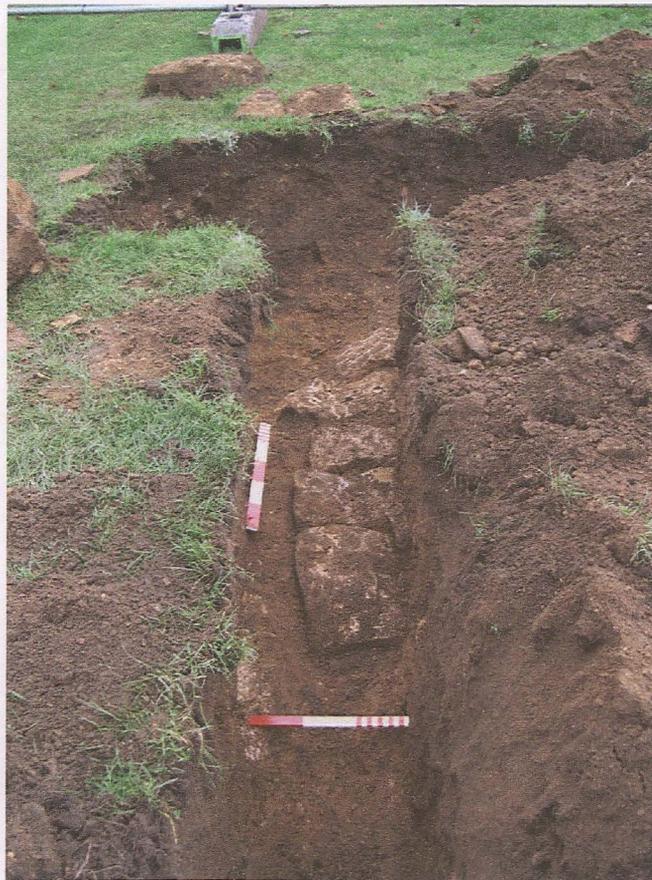
To the immediate north of the foundation **106**, and at the western limit of its exposed extent, a small deposit of white lime mortar **109** was seen at the edge of the drain trench below **105**, and at about 9.66m OD (Pl. 6). As no other mortar was observed, this could have been either a construction spill or the waste from cleaning robbed stonework.

Pl. 6 Stone wall foundation 106 and mortar deposit 109 (looking east; scales 0.5m and 0.3m).

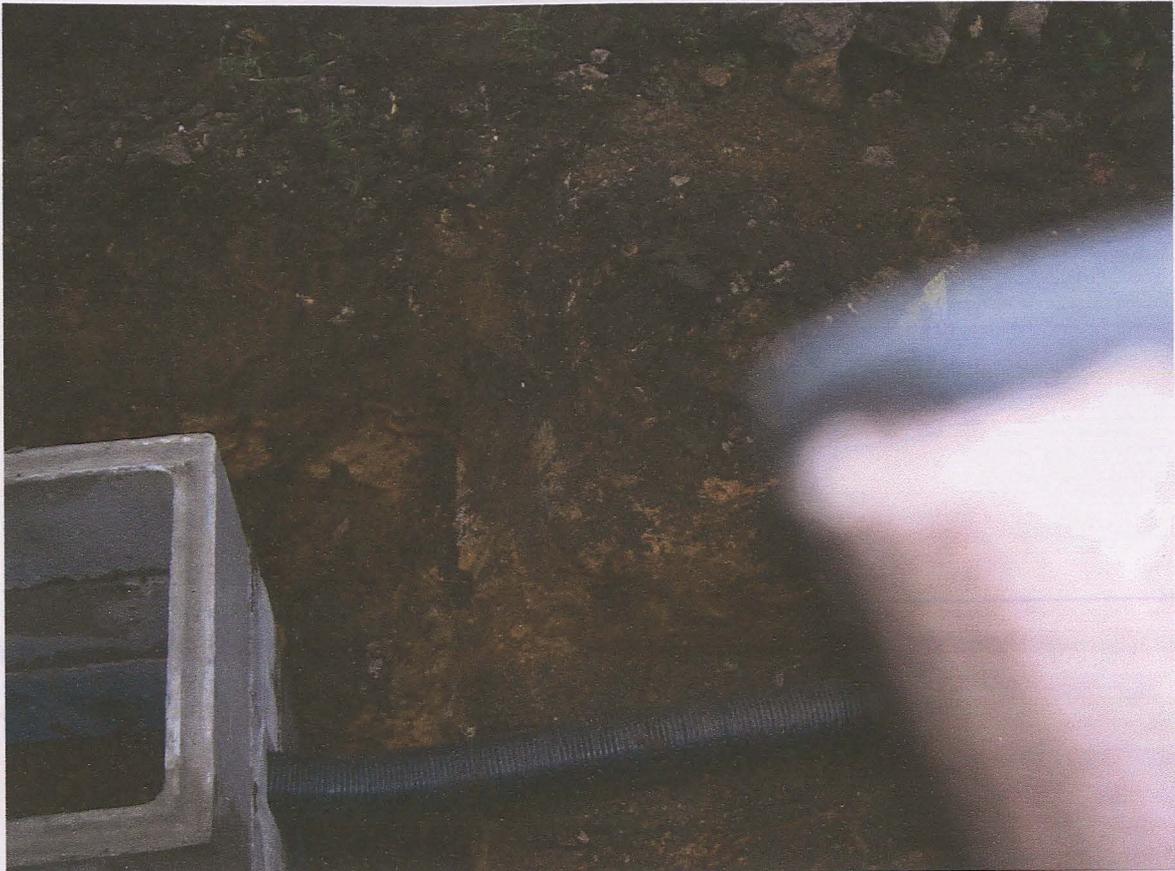
At the north-west corner of the ball court the trench cut into a limestone concretion **113** with a high iron component evident (Pl. 7). Samples of this were examined by Dr Alan Vince and identified as tufa, a natural product of iron-rich water percolation through limestone. Chalybeate (iron-rich) springs were recorded along the spring line beside Monks Road in the nineteenth century and these conditions would have produced the entirely natural concretion. More of this material was found at greater depth in the soakaway pit to the south.

Pl. 7 Limestone 'tufa' concretion in inspection pit at the NW corner of the ball court.

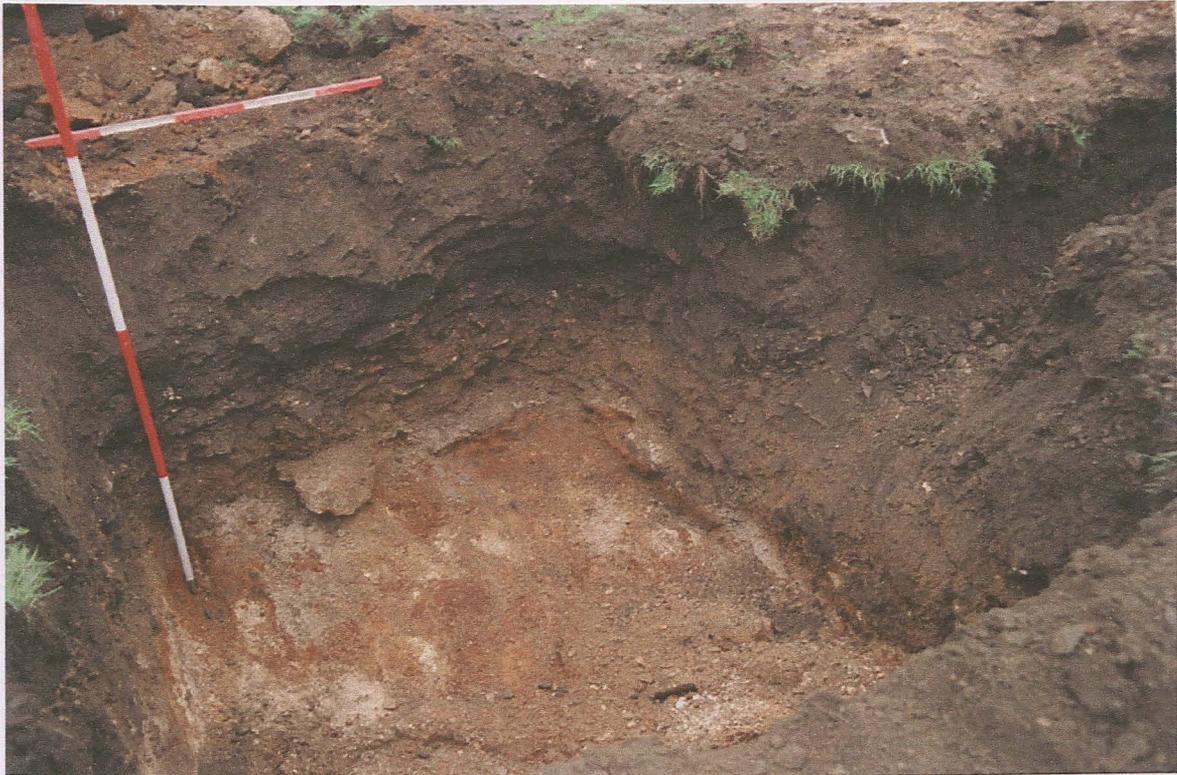
The 1.6m deep and 2m x 1.5m soakaway was excavated by machine about 5m to the south of the south-east corner of the ball court, and connected to the perimeter drain trench (Pl. 8). The topsoil covered a 0.55m thick layer of dark grey soil **101** which contained limestone fragments and medieval roof tile. This material sealed a 0.65m thick lighter brown, very loose deposit **102** which also produced numerous twelfth to sixteenth century roof tile fragments. Both layers were interpreted as a demolition spread or levelling deposit, probably derived from destruction of the abbey buildings, but this may have been reworked at a later date.

Below these layers was a 0.2m thick band of the natural limestone concretion, recorded here as **104** but similar to **113**. An underlying natural layer of orange/brown sand **103** was only seen in this pit, where it was at least 0.7m thick; no limestone bedrock was seen.

Pl. 8 West and north sides of new soakaway trench (looking NW; scales 2m and 1m).

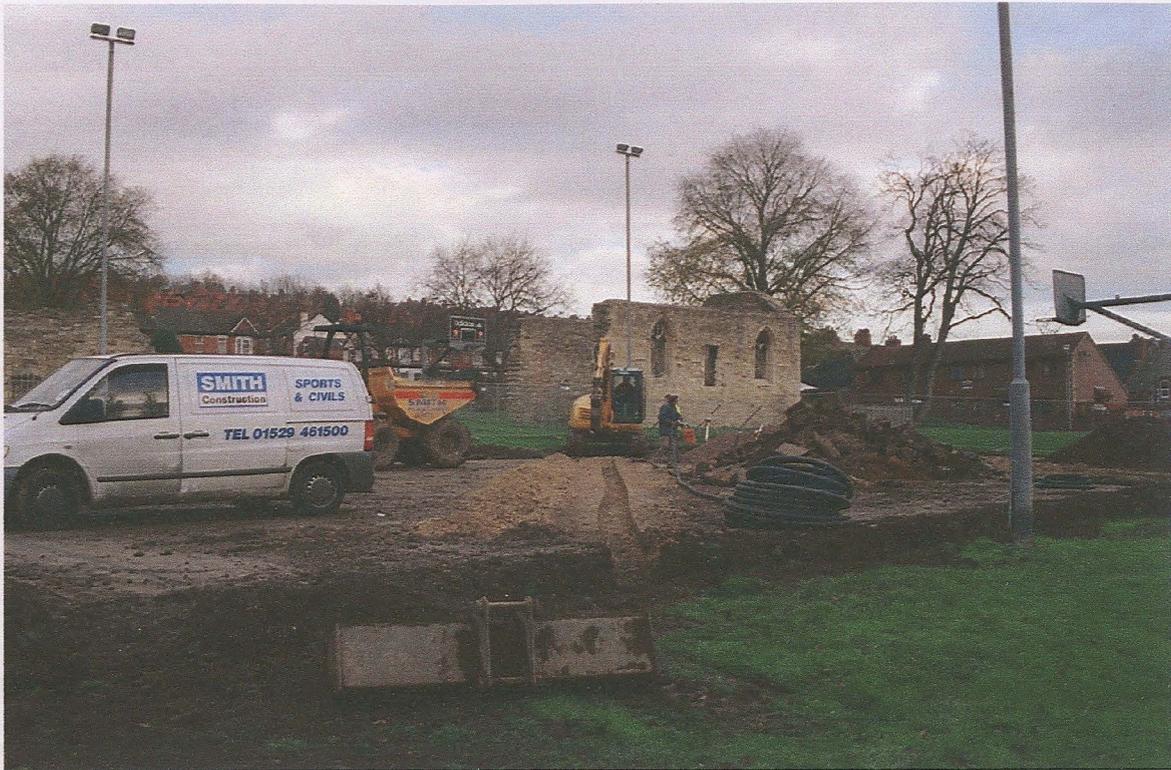
Three c.0.4m deep trenches were excavated across the existing ball court for drainage, connecting with the new drains (Pl. 9). These remained within the foundation material for the court and encountered no archaeological remains.

PI. 9 Location of the drainage trench across the existing ball court (looking NE).

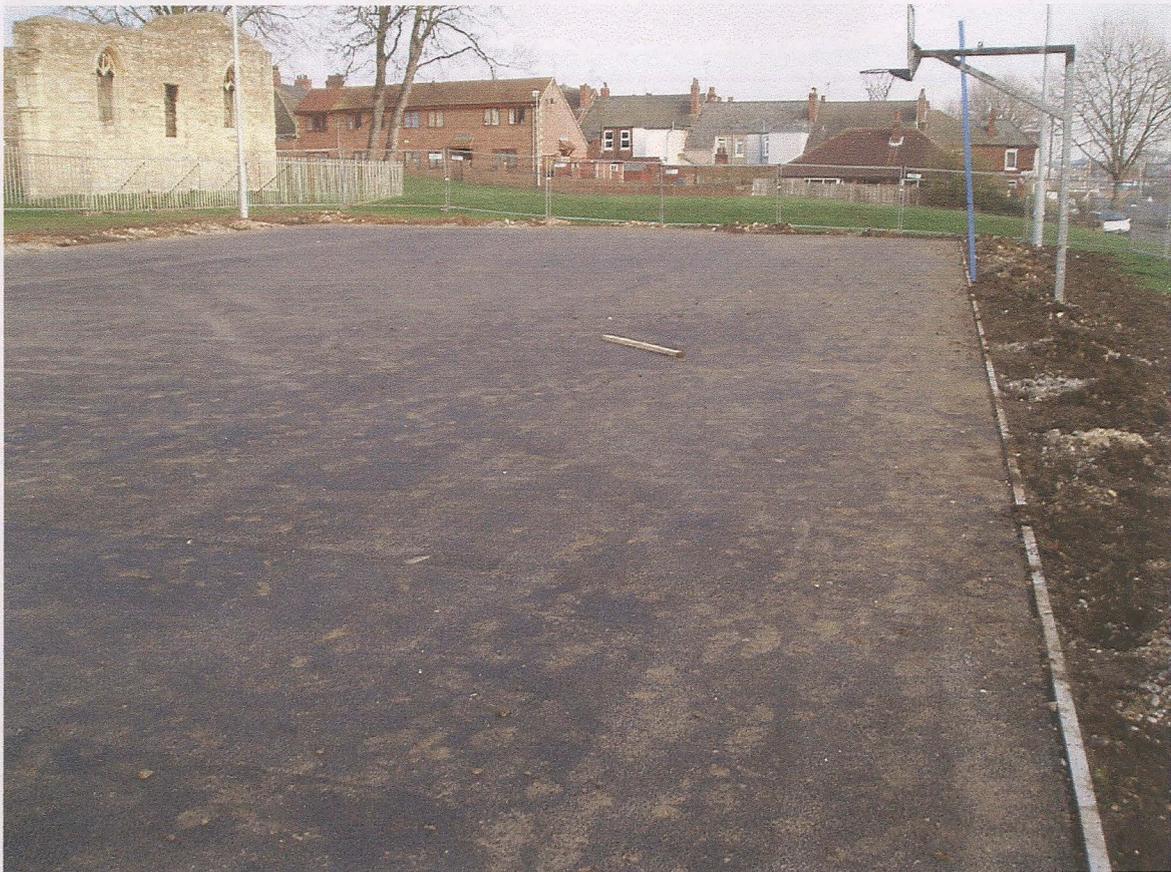
Forty-six fence post-holes, 0.28m diameter, 0.86m deep, were excavated for a new fence to surround the ball court (Pl. 10). These holes cut through the deposits already recorded, and only one, post-hole 19, may have encountered any structural remains. A limestone block, **10**, 0.86m below ground level at the base of this post-hole (9.3m OD), could be part of a wall foundation the hole was too small to confirm that it was not a redeposited piece of rubble (Pl. 11). This lay c.5m north of wall **116**.

PI. 10 Blue fence post marking the new fenceline around the ball court (looking west).

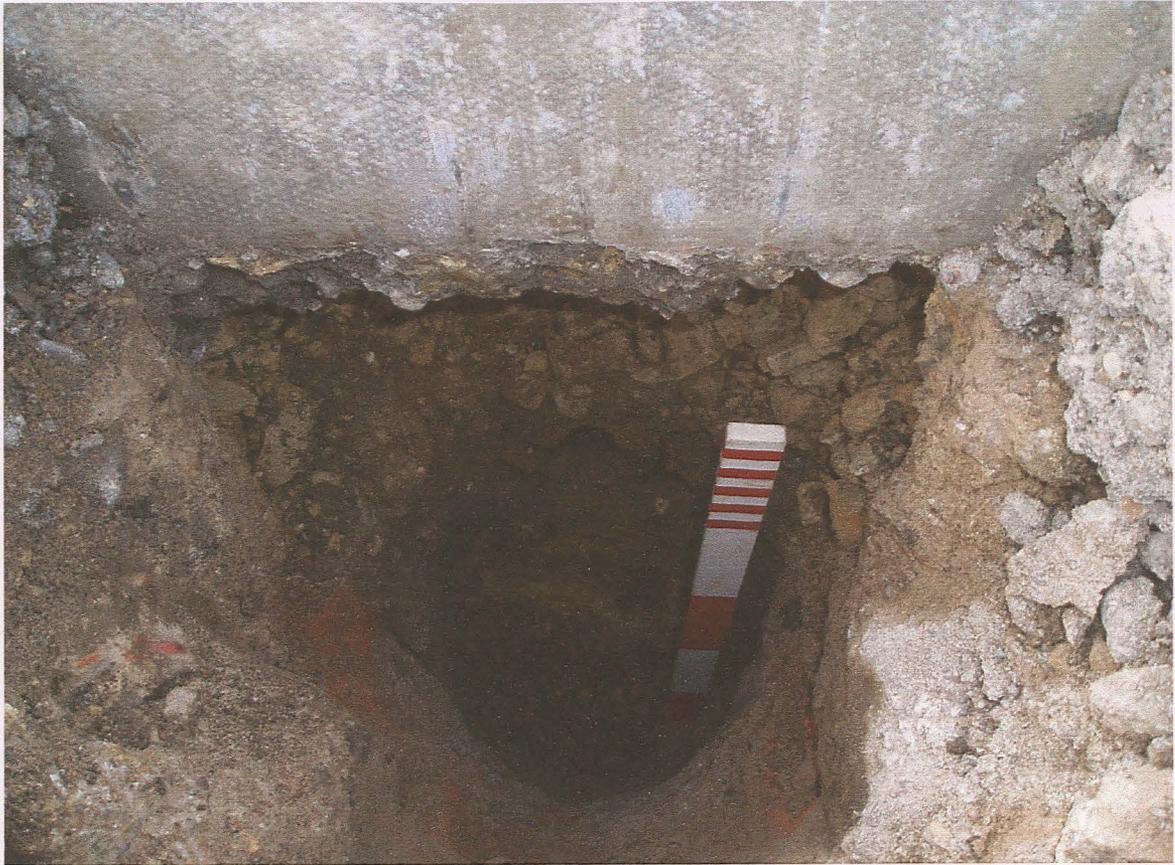
Pl. 11 Limestone block 10 at base of new post-hole 19.
