**Installation of Signage in the Cathedral Quarter,
Lincoln**

Archaeological Watching Brief

Site Code: LCQ05

LAS Report No. 903

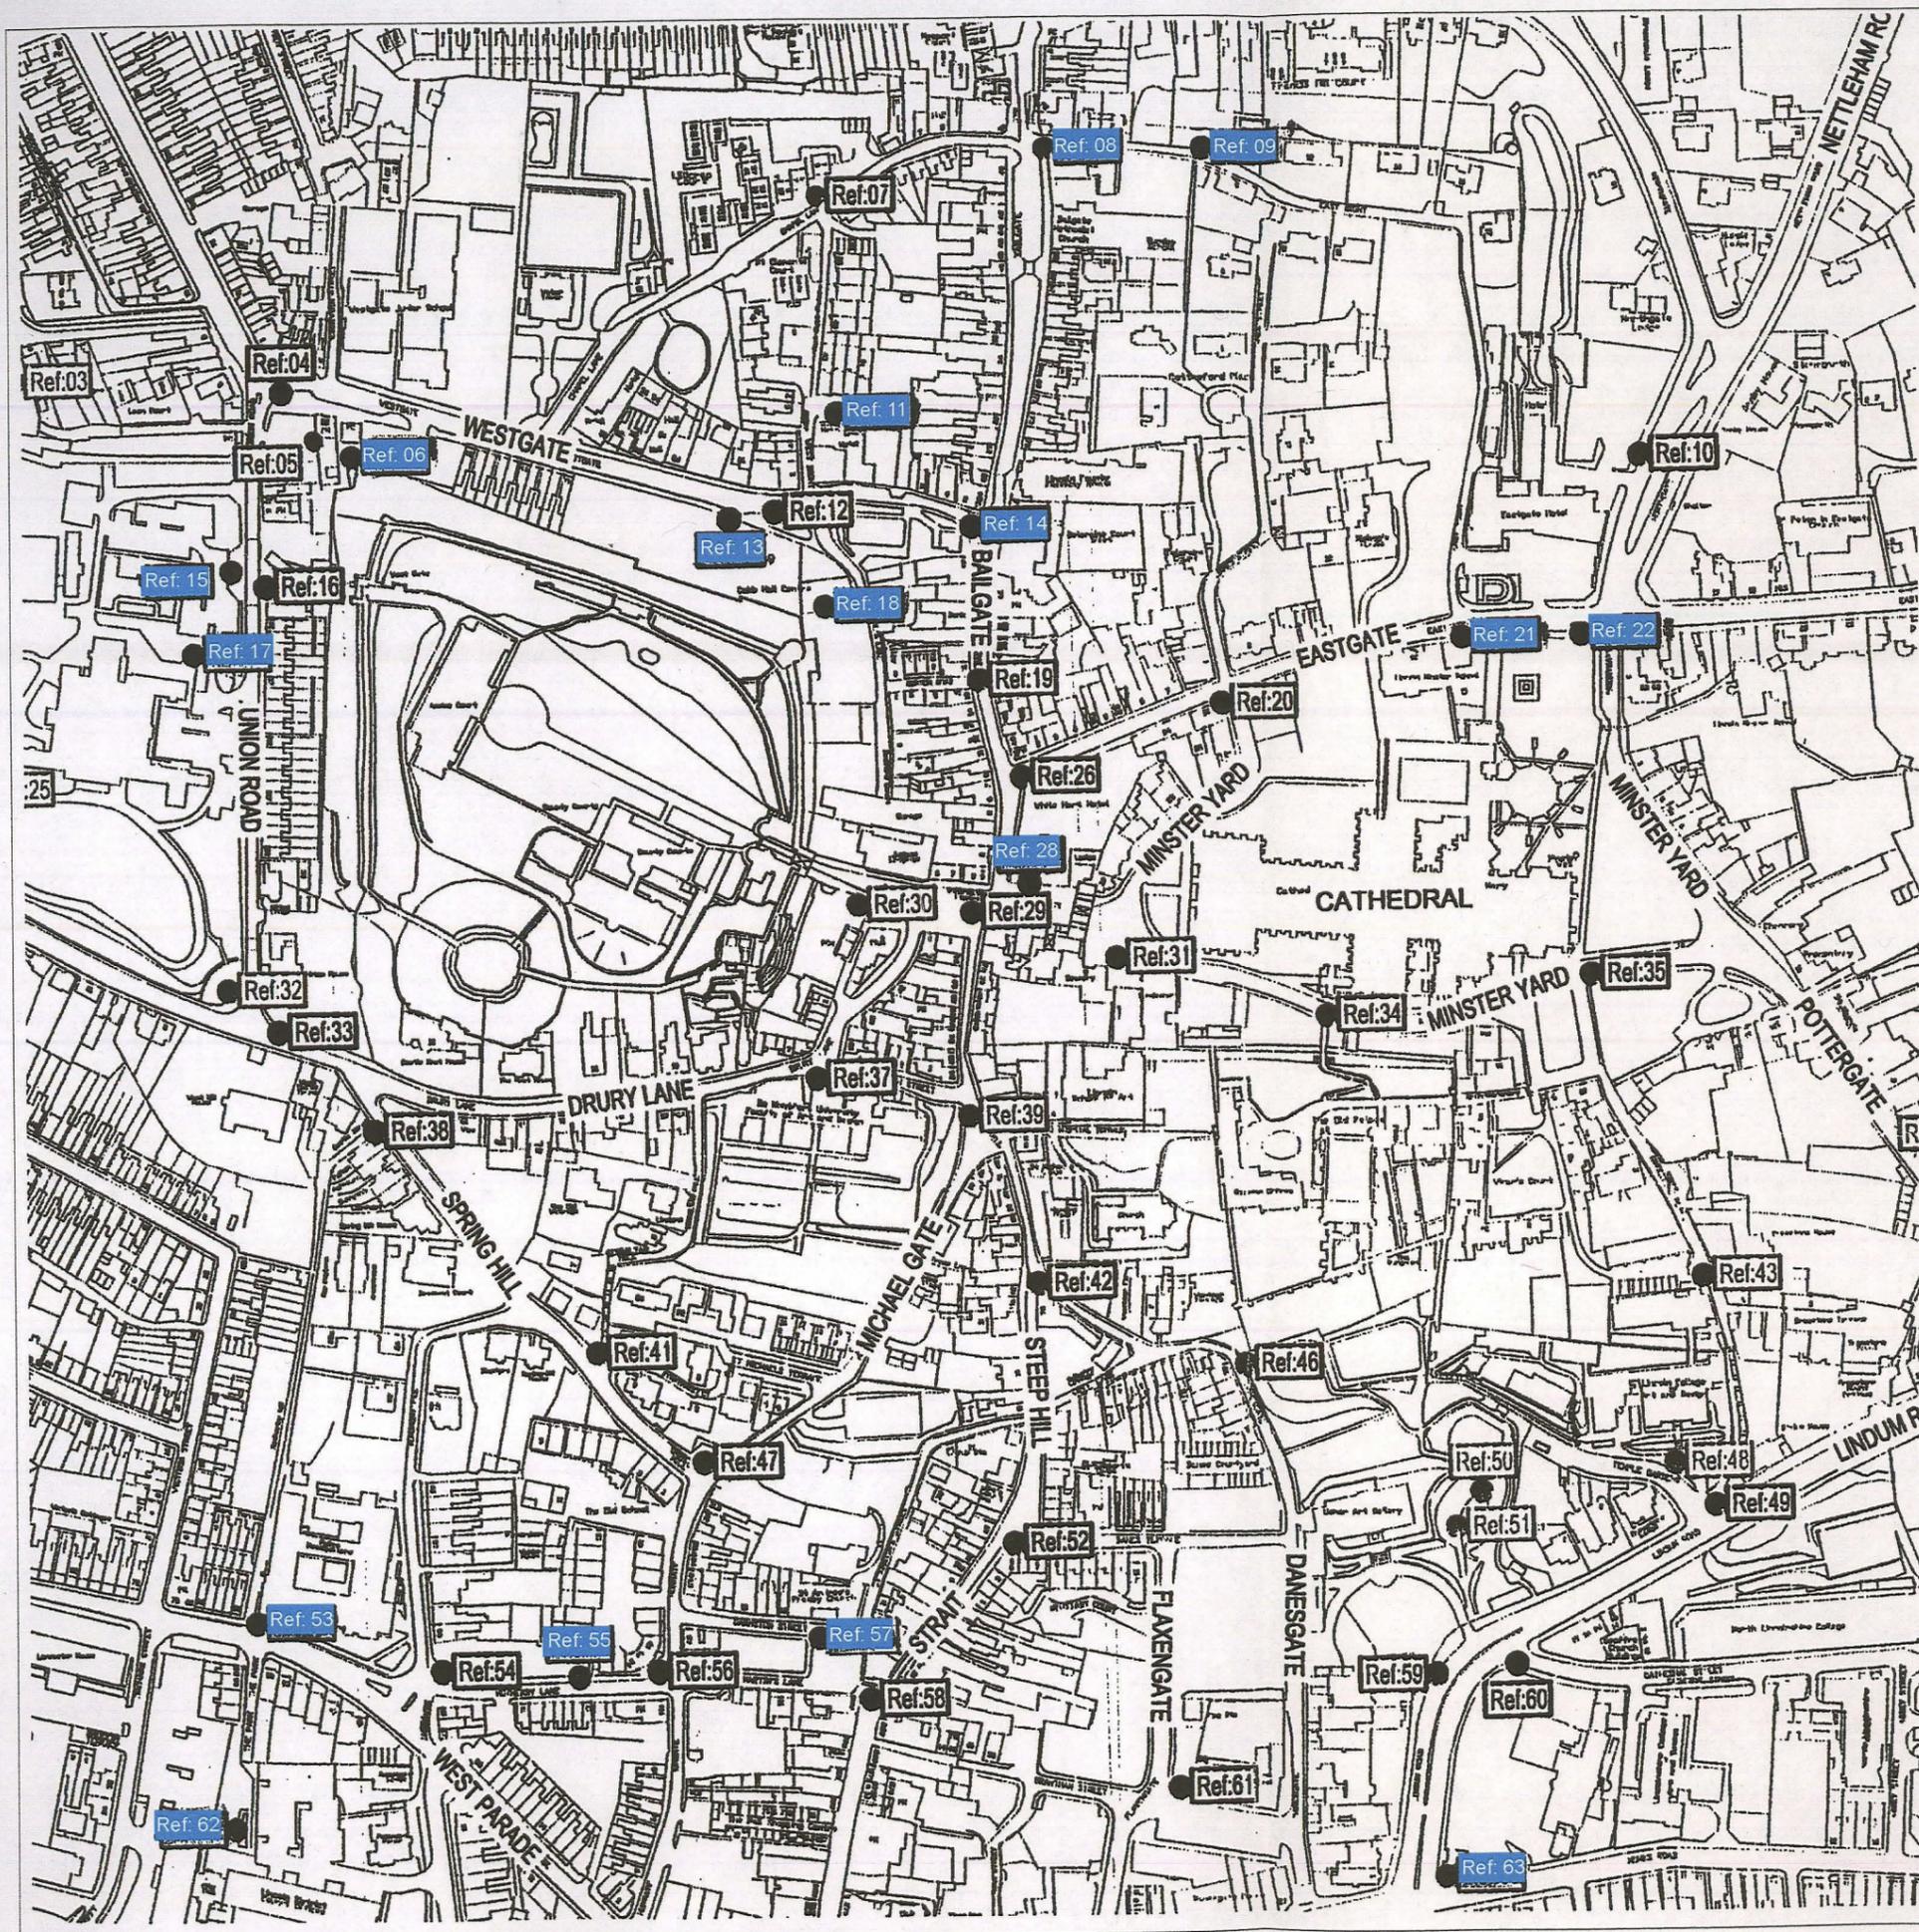
Fig. 2 Location of monitored signs, after City of Lincoln Project Management Team Location plan (1448/01).

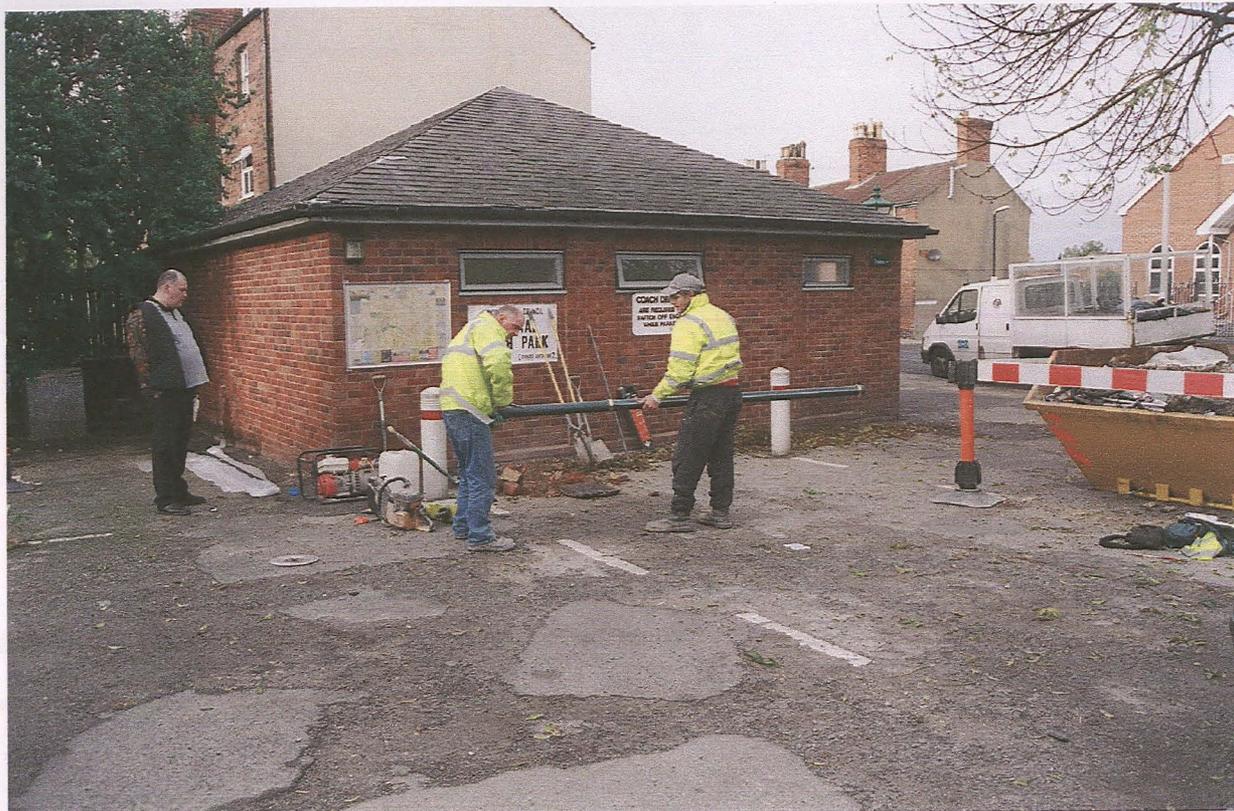
Sign 6 was located next to the public convenience in the Westgate Car Park. Two post holes were excavated through the car park surface and bedding (length 0.4m; width 0.37m; depth 0.51m). The deposit profile in both holes was 0.04m of asphalt, 0.13m of concrete and 0.34m of sand and brick (Pl. 1 & 2). No archaeological finds or features were observed.

Pl. 1 Sign 6 during excavations, looking west towards Westgate public convenience.

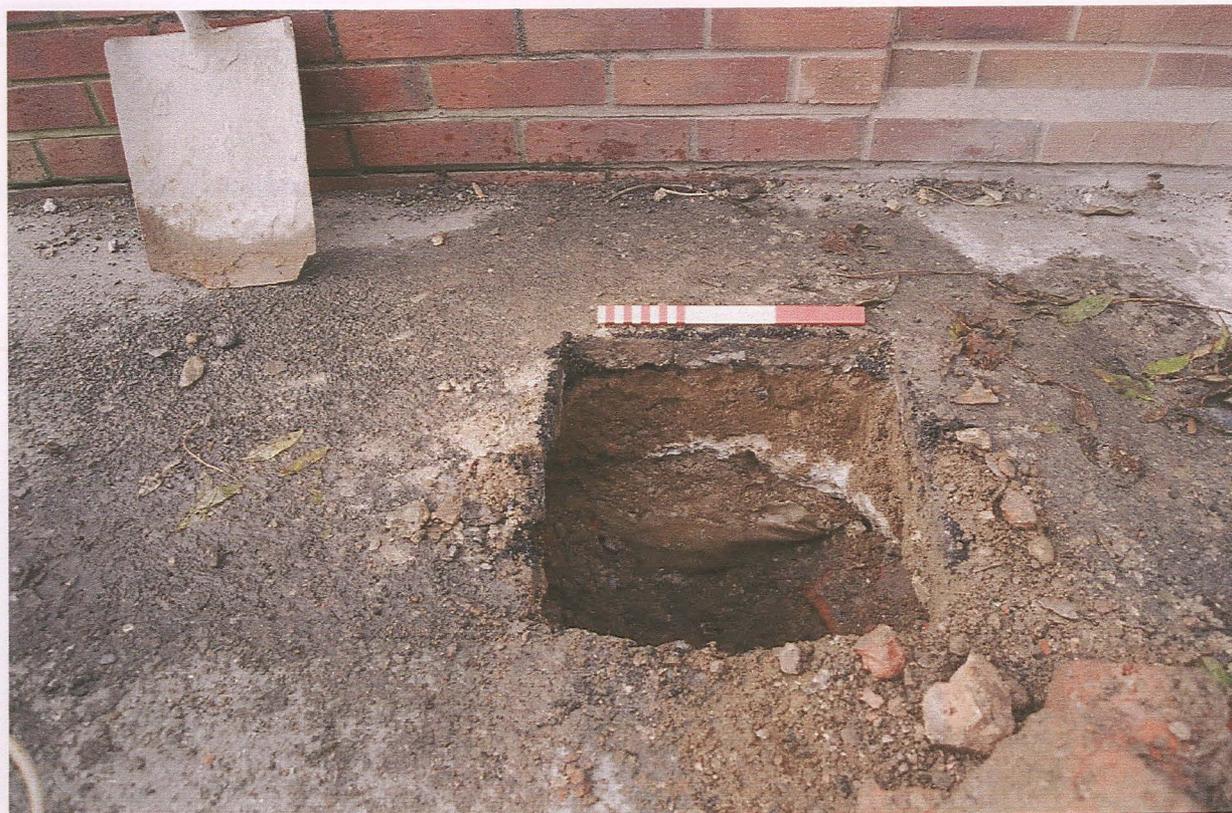
Pl. 2 Sign 6 posthole, looking west. Scale 0.3m.

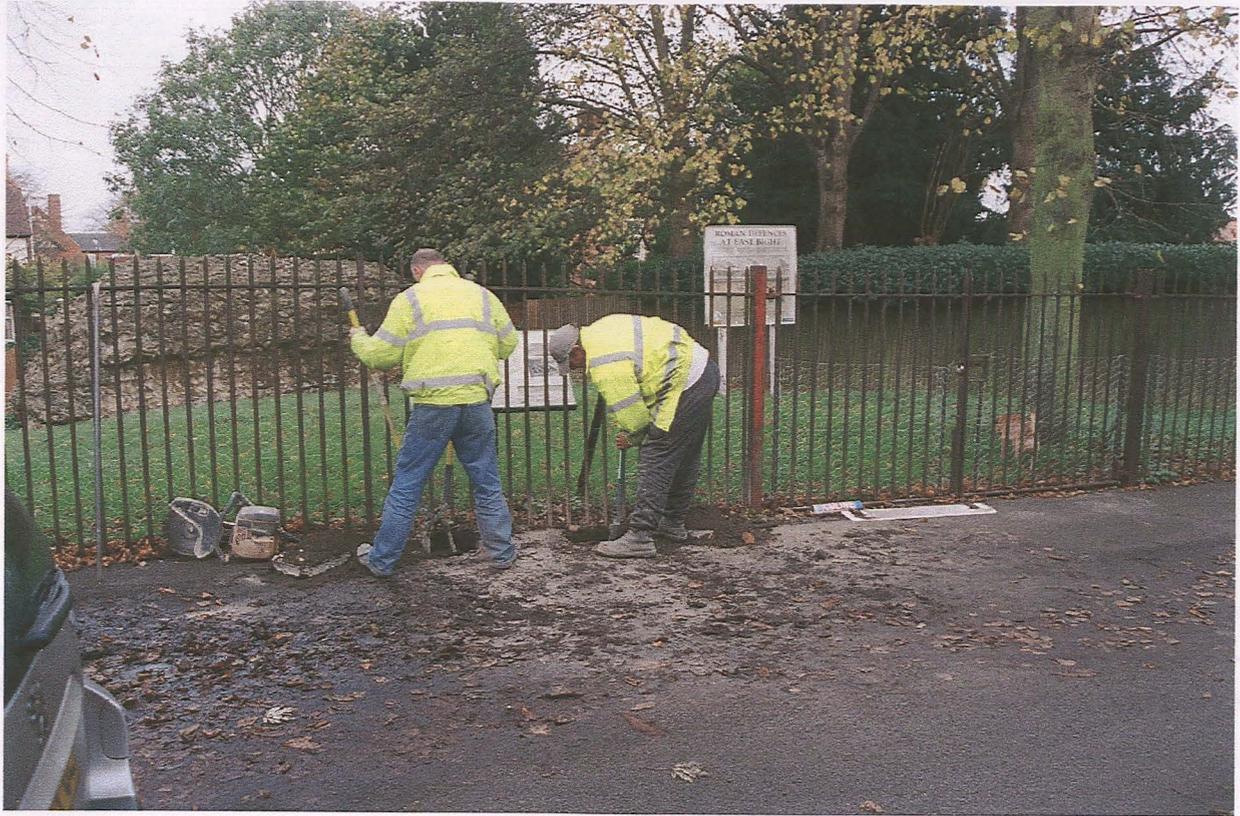
Sign 9 was located on East Bight, close to the extant section of Roman wall to the south of the railings (Pl. 3 & 4). Two postholes were excavated through the asphalt into the ground beneath (L 0.30; W 0.30m; D 0.43m). The deposits encountered were the same in both holes: 0.05m of asphalt above a dark brown soil (0.38m exposed). Exposed in the northern section of both of the post holes was the south face of a wall constructed of roughly hewn limestone blocks which had a similar alignment to the existing fence.

Pl. 3 Sign 9 East Bight during excavations, looking north.

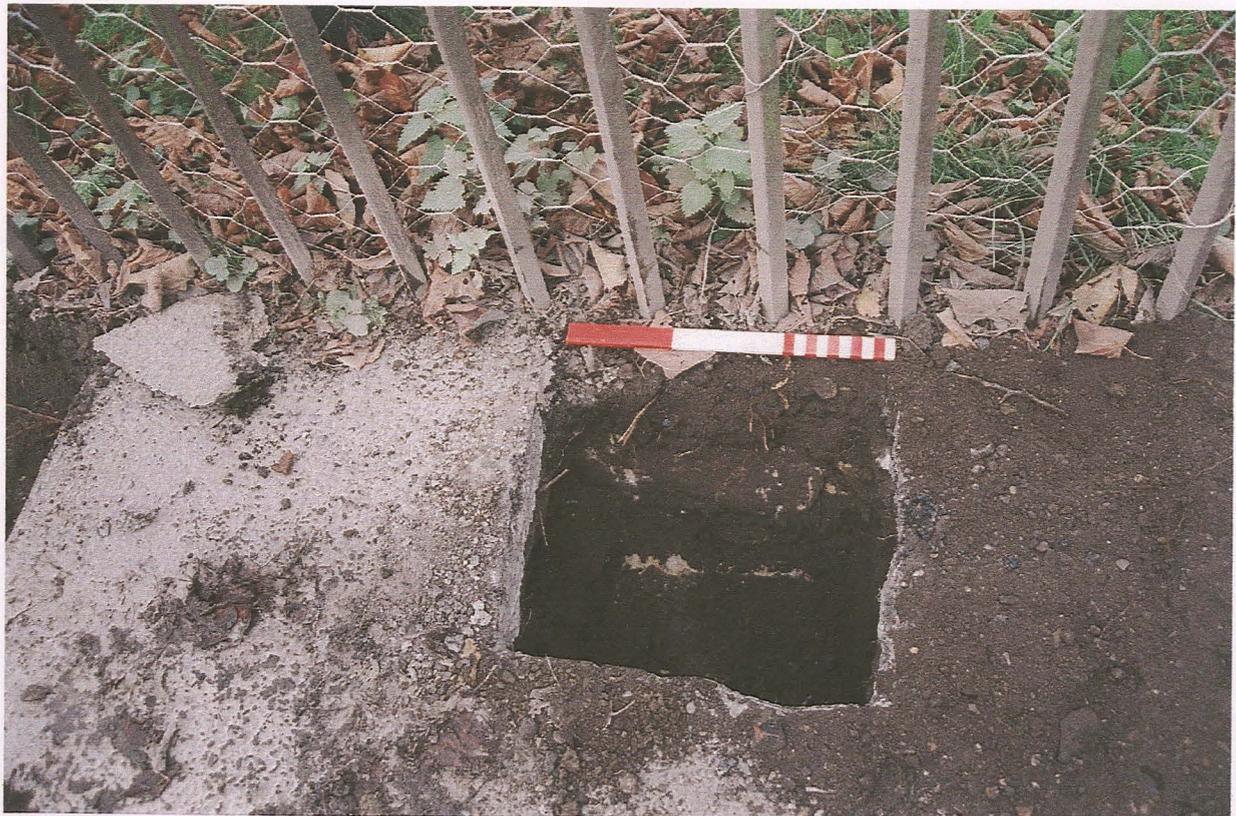
The age of the limestone walls encountered during the excavations cannot be dated on the basis of the shallow holes excavated and may be the surviving archaeological remnants of earlier walls (Rowlandson and Young 2004, 3). It is possible that as the walls exposed in the foundations for signs next to stretches of standing Roman walls (East Bight and The Mint Wall) may of interest but as insufficient depth, area and finds were exposed by the investigation it is not possible to date the features. The limestone wall exposed by the postholes for Sign 9 represents the limestone precursor to the iron railing fence but could not be dated. It appears likely that the wall and possible surface exposed by the groundworks for sign 11 may relate to a precursor of the existing footpath. The limestone wall may have been similar to the opposite boundary of the footpath The limited extent and depth of excavations will have caused minimal damage to these features.

Pl. 4 Sign 9 East Bight posthole showing the limestone wall, looking north. Scale 0.3m.

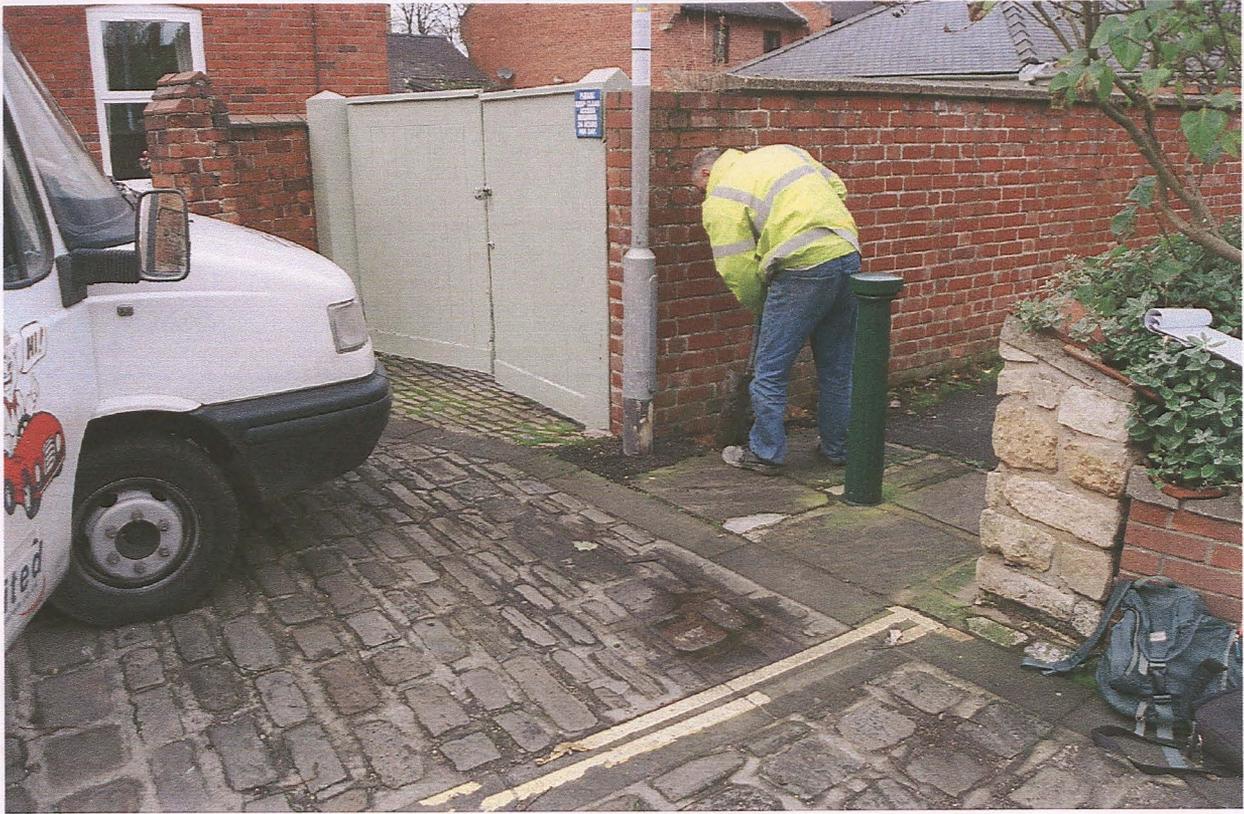
Sign 11 was located to the north west of the 'Mint Wall' at the entrance to a passageway between two properties (Pl. 5 & 6). Two postholes were excavated through the tarmac and into the ground beneath (L 0.35m; W 0.35m; D 0.4m). The deposits encountered were the same in both holes: 0.04m of asphalt, 0.04m of cobbles, 0.2m a mixed layer of brick, gravel and limestone in a dark soil matrix and 0.12m of concrete. Possible remnants of a limestone were evident in the north face of the hole beneath the existing brick wall.

Pl. 5 Sign 11 Mint Wall posthole during excavations, looking north.

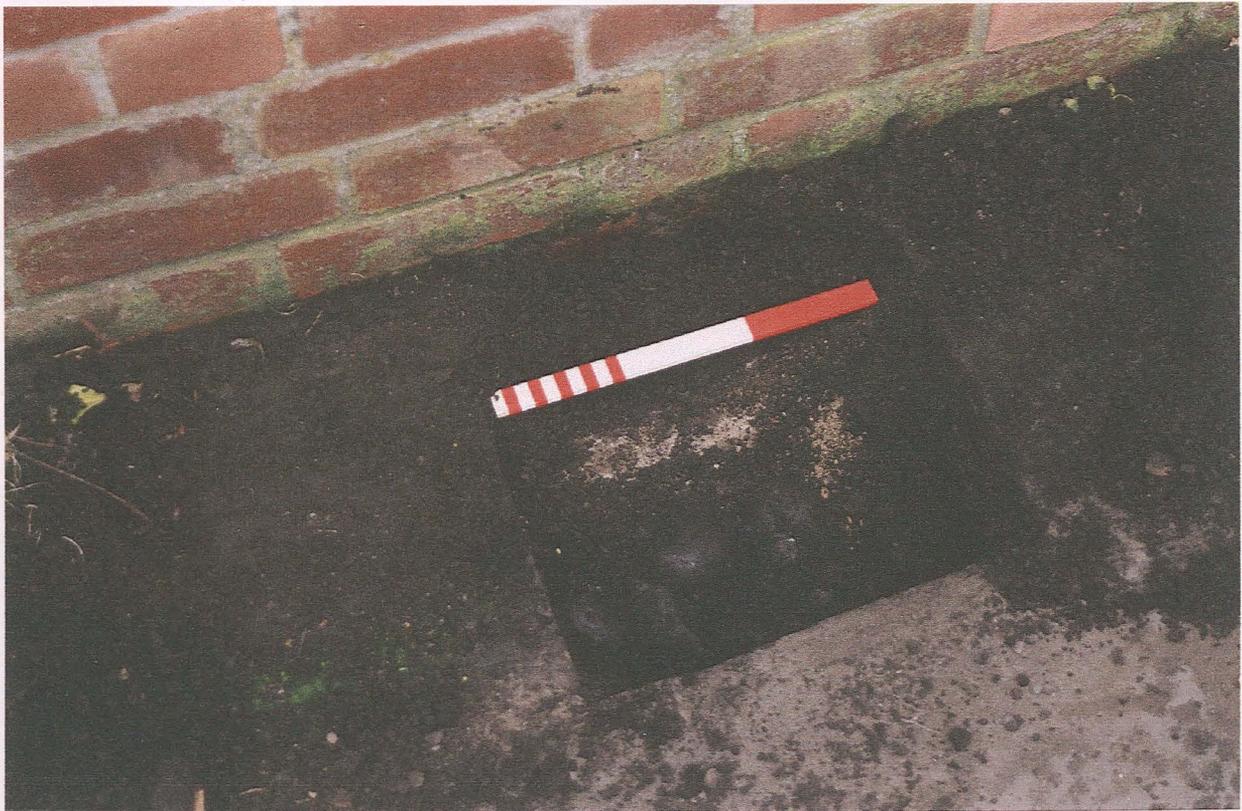
Pl. 6 Sign 11 Mint Wall posthole showing limestone walls and cobbles, looking north. Scale 0.3m.
