**Proposed Flood Water Storage Tank,  
Central Park, Boston, Lincolnshire**

**Report**

**LAS Report No. 908  
March 2006**

## **Proposed Storage Tank, Central Park, Boston, Lincolnshire Archaeological Evaluation**

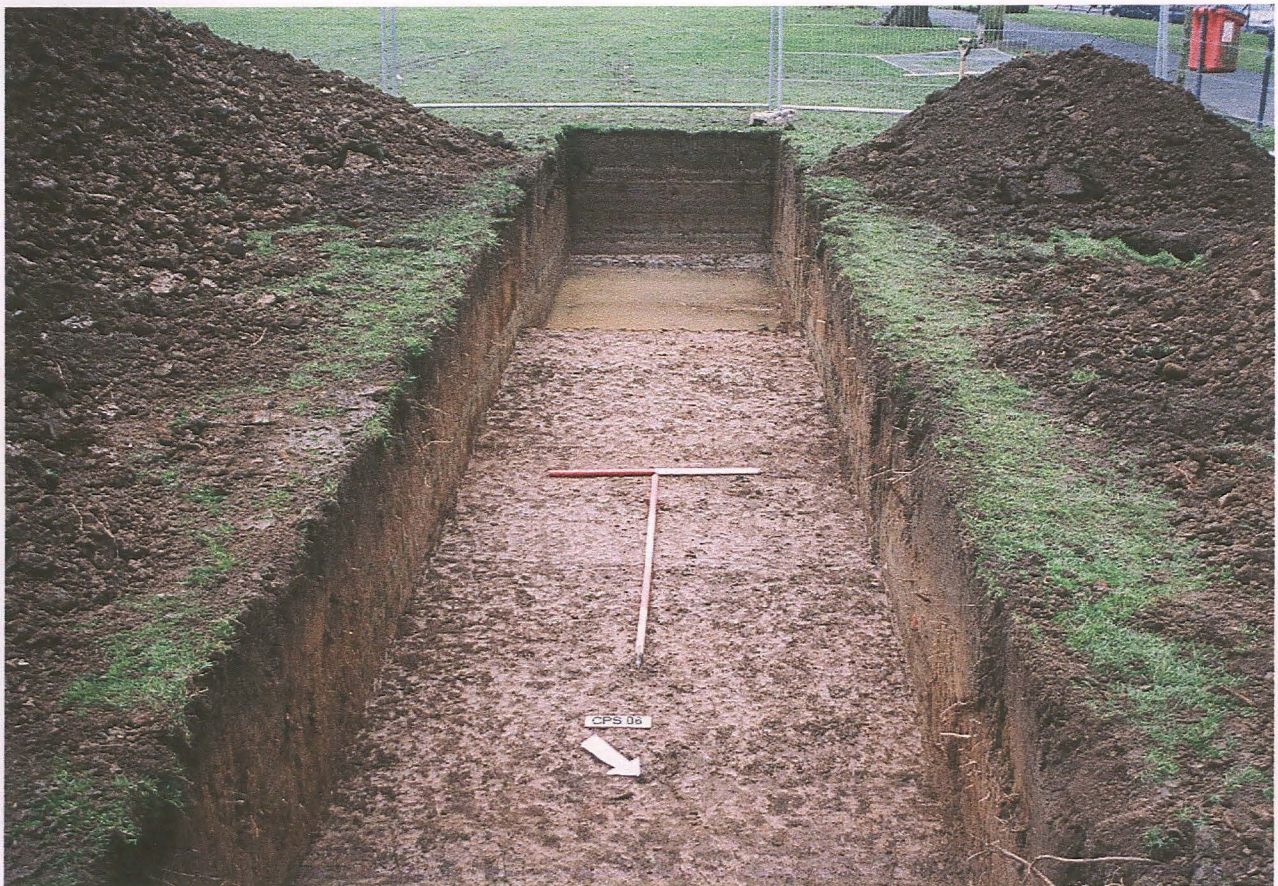
Pl. 2 Looking south-west at the evaluation trench after excavation and hand cleaning (1m and 2m scales)

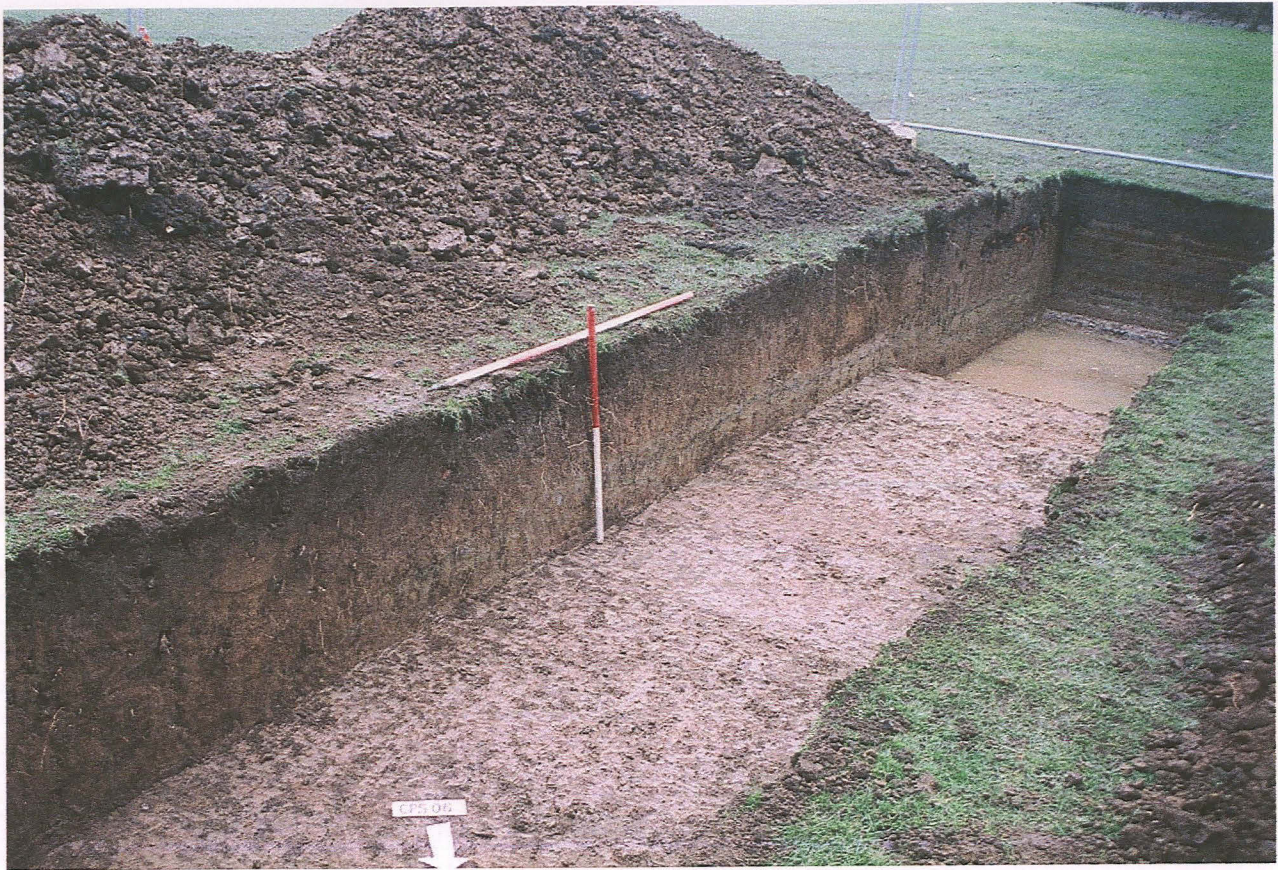
Pl. 3 Looking south at the section of the evaluation trench (1m and 2m scales)

In common with much of the Boston area, the northern end of Central Park has been subjected to seasonal flooding with a steady build-up of natural clays and silts clearly seen in the trench sections. The final and by far the most substantial layer encountered was **105**. This layer was characterised as being the natural geology of the trench, past excavations in the Boston area have shown similar clay and silt deposits continuing to a depth of several metres.

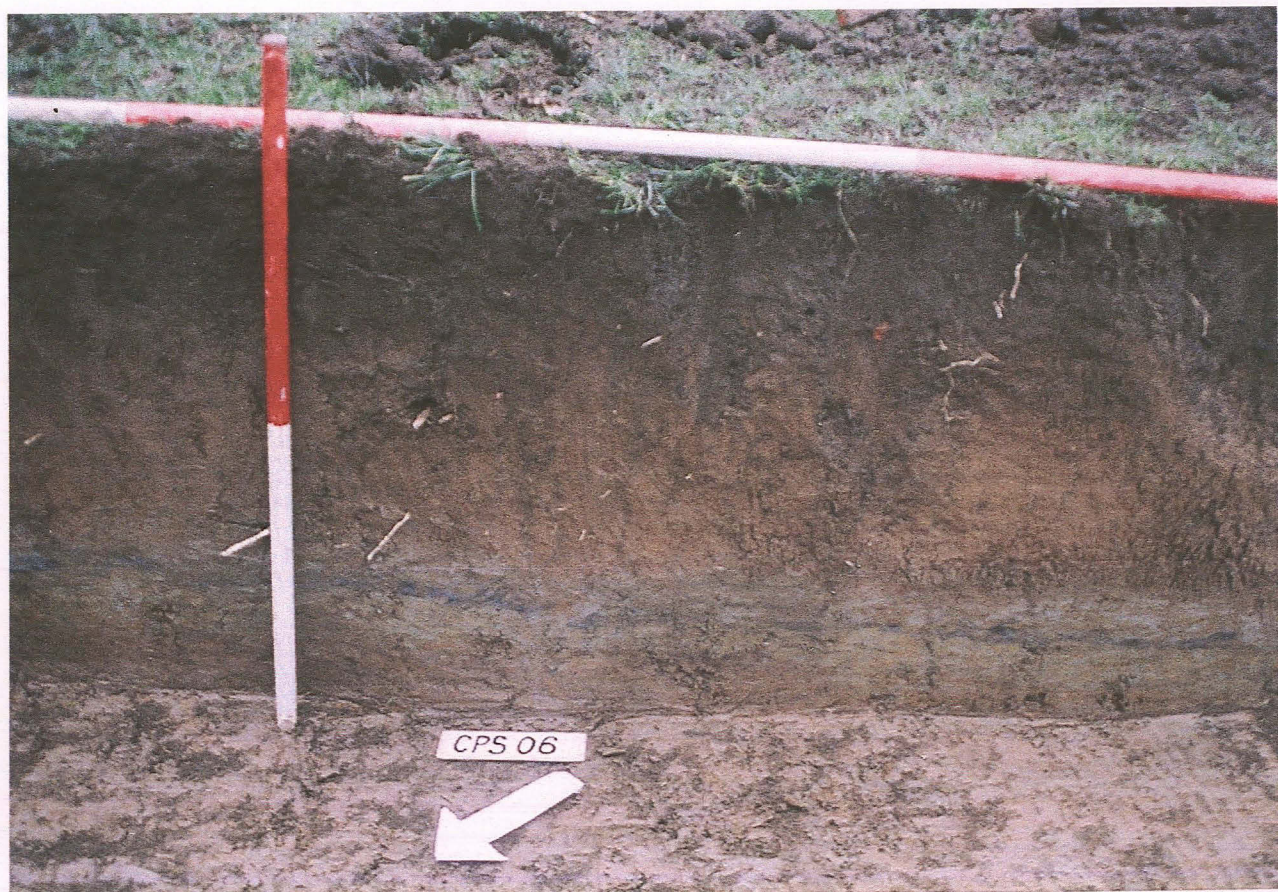
Pl. 3 Detail photograph looking south-east at the section of the evaluation trench (1m and 2m scales)
