**SWINDERBY AIRFIELD
SWINDERBY AND THURLBY
LINCOLNSHIRE**

**ARCHAEOLOGICAL DESK-BASED
ASSESSMENT**

CEMEX

CA REPORT: 05101

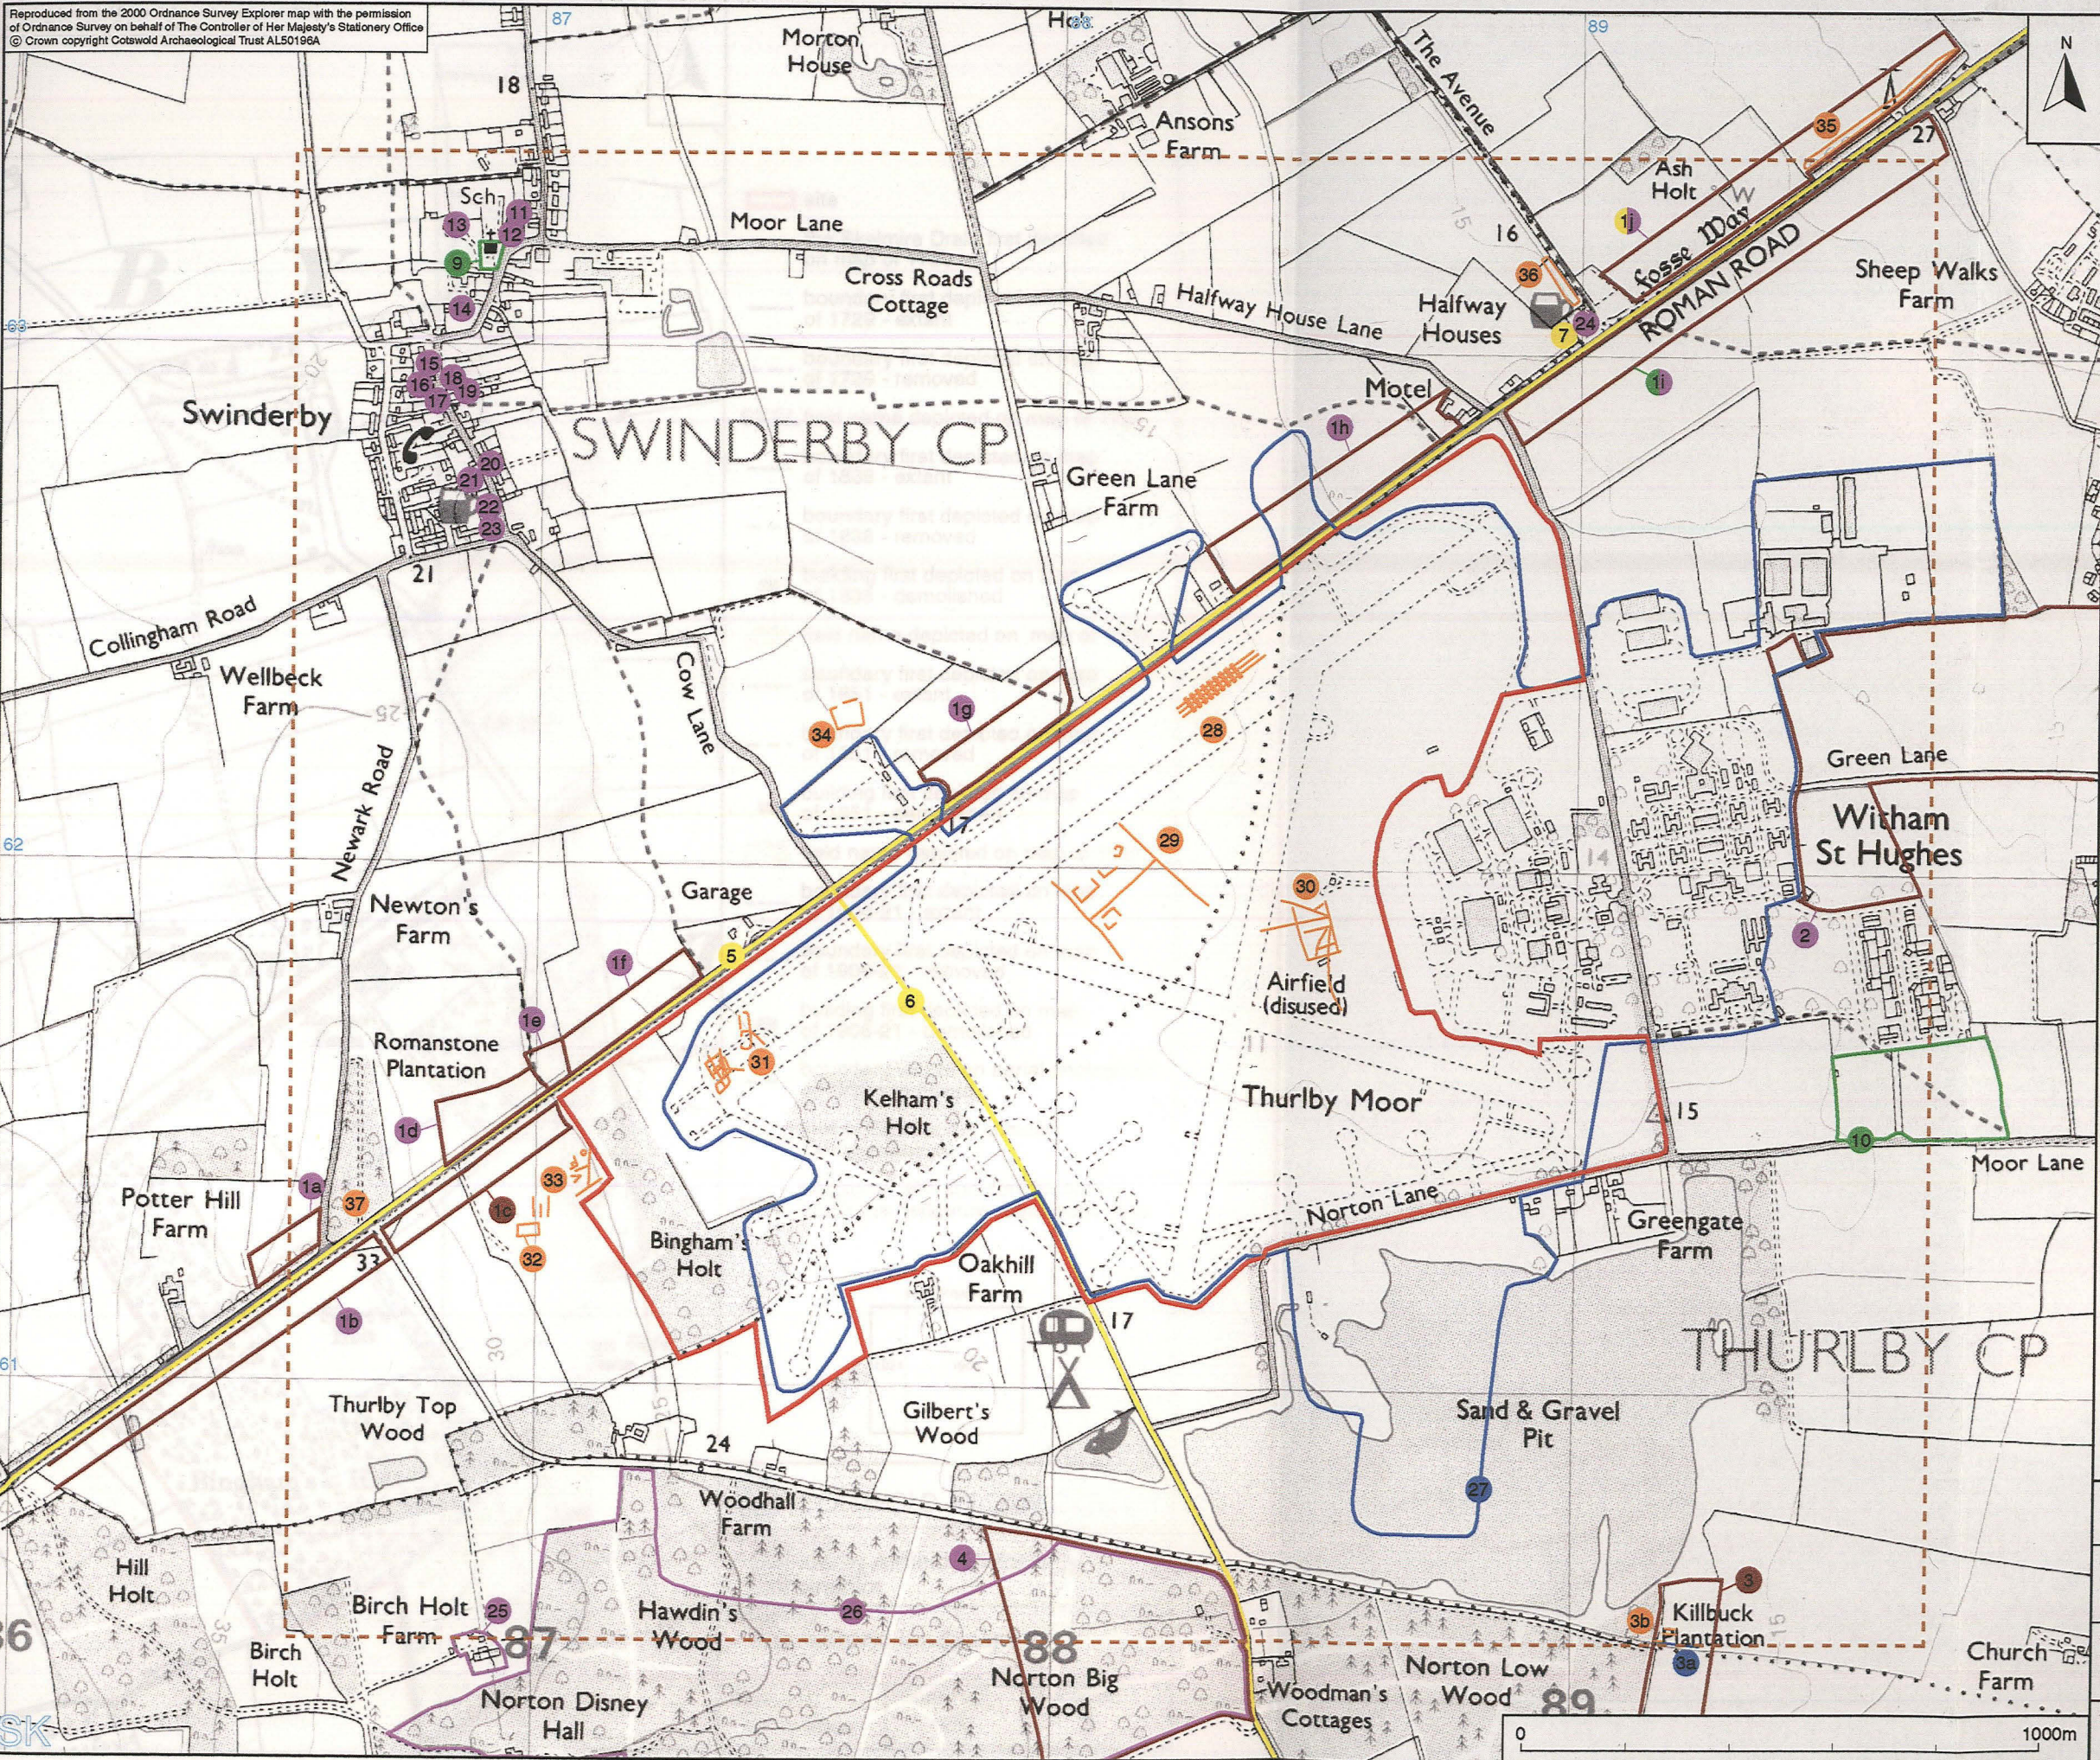
SCALE 1:12,500@A3	PROJECT NO. 1960	FIGURE NO. 2
----------------------	---------------------	-----------------

FIGURE TITLE
Known cultural heritage

- 2.3 All points of cultural heritage interest found in the baseline survey are located on Fig. 2. The gazetteer (Appendix A) correlates points of interest with their reference number on the Sites and Monuments Record (SMR), as well as any other relevant statutory designation or status. Points of interest are marked in bold in the body of the text thus, **00**.

- 4.1 The undated cropmarks present within the site (Fig. 2, 29-31) may indicate the presence of archaeological deposits, most likely of prehistoric or Roman date. Areas of gravel are common locations for such sites. However, some of the cropmarks, such as 28, are of probable modern origin and other linear marks, such as some of those at 29, are likely to show the location of now-removed post-medieval field boundaries. A fifth area of cropmarks is present immediately to the south-west of the site (Fig. 2, 33) and, if this indicates the presence of archaeological features, they may encroach into the site.

- 4.2 The route of a putative Roman road crosses the south-western side of the site, running north-west to south-east (Fig. 2, 6). The presence of this route has not been proven by archaeological excavation and it is not in Margary's survey of Roman Roads in Britain (Margary 1973). The route of the major Roman route, the Fosse Way, runs immediately to the north-west of the site. It is conceivable that Roman activity associated with the route, such as road-side settlement, was present within the site, although there is currently no evidence for this.

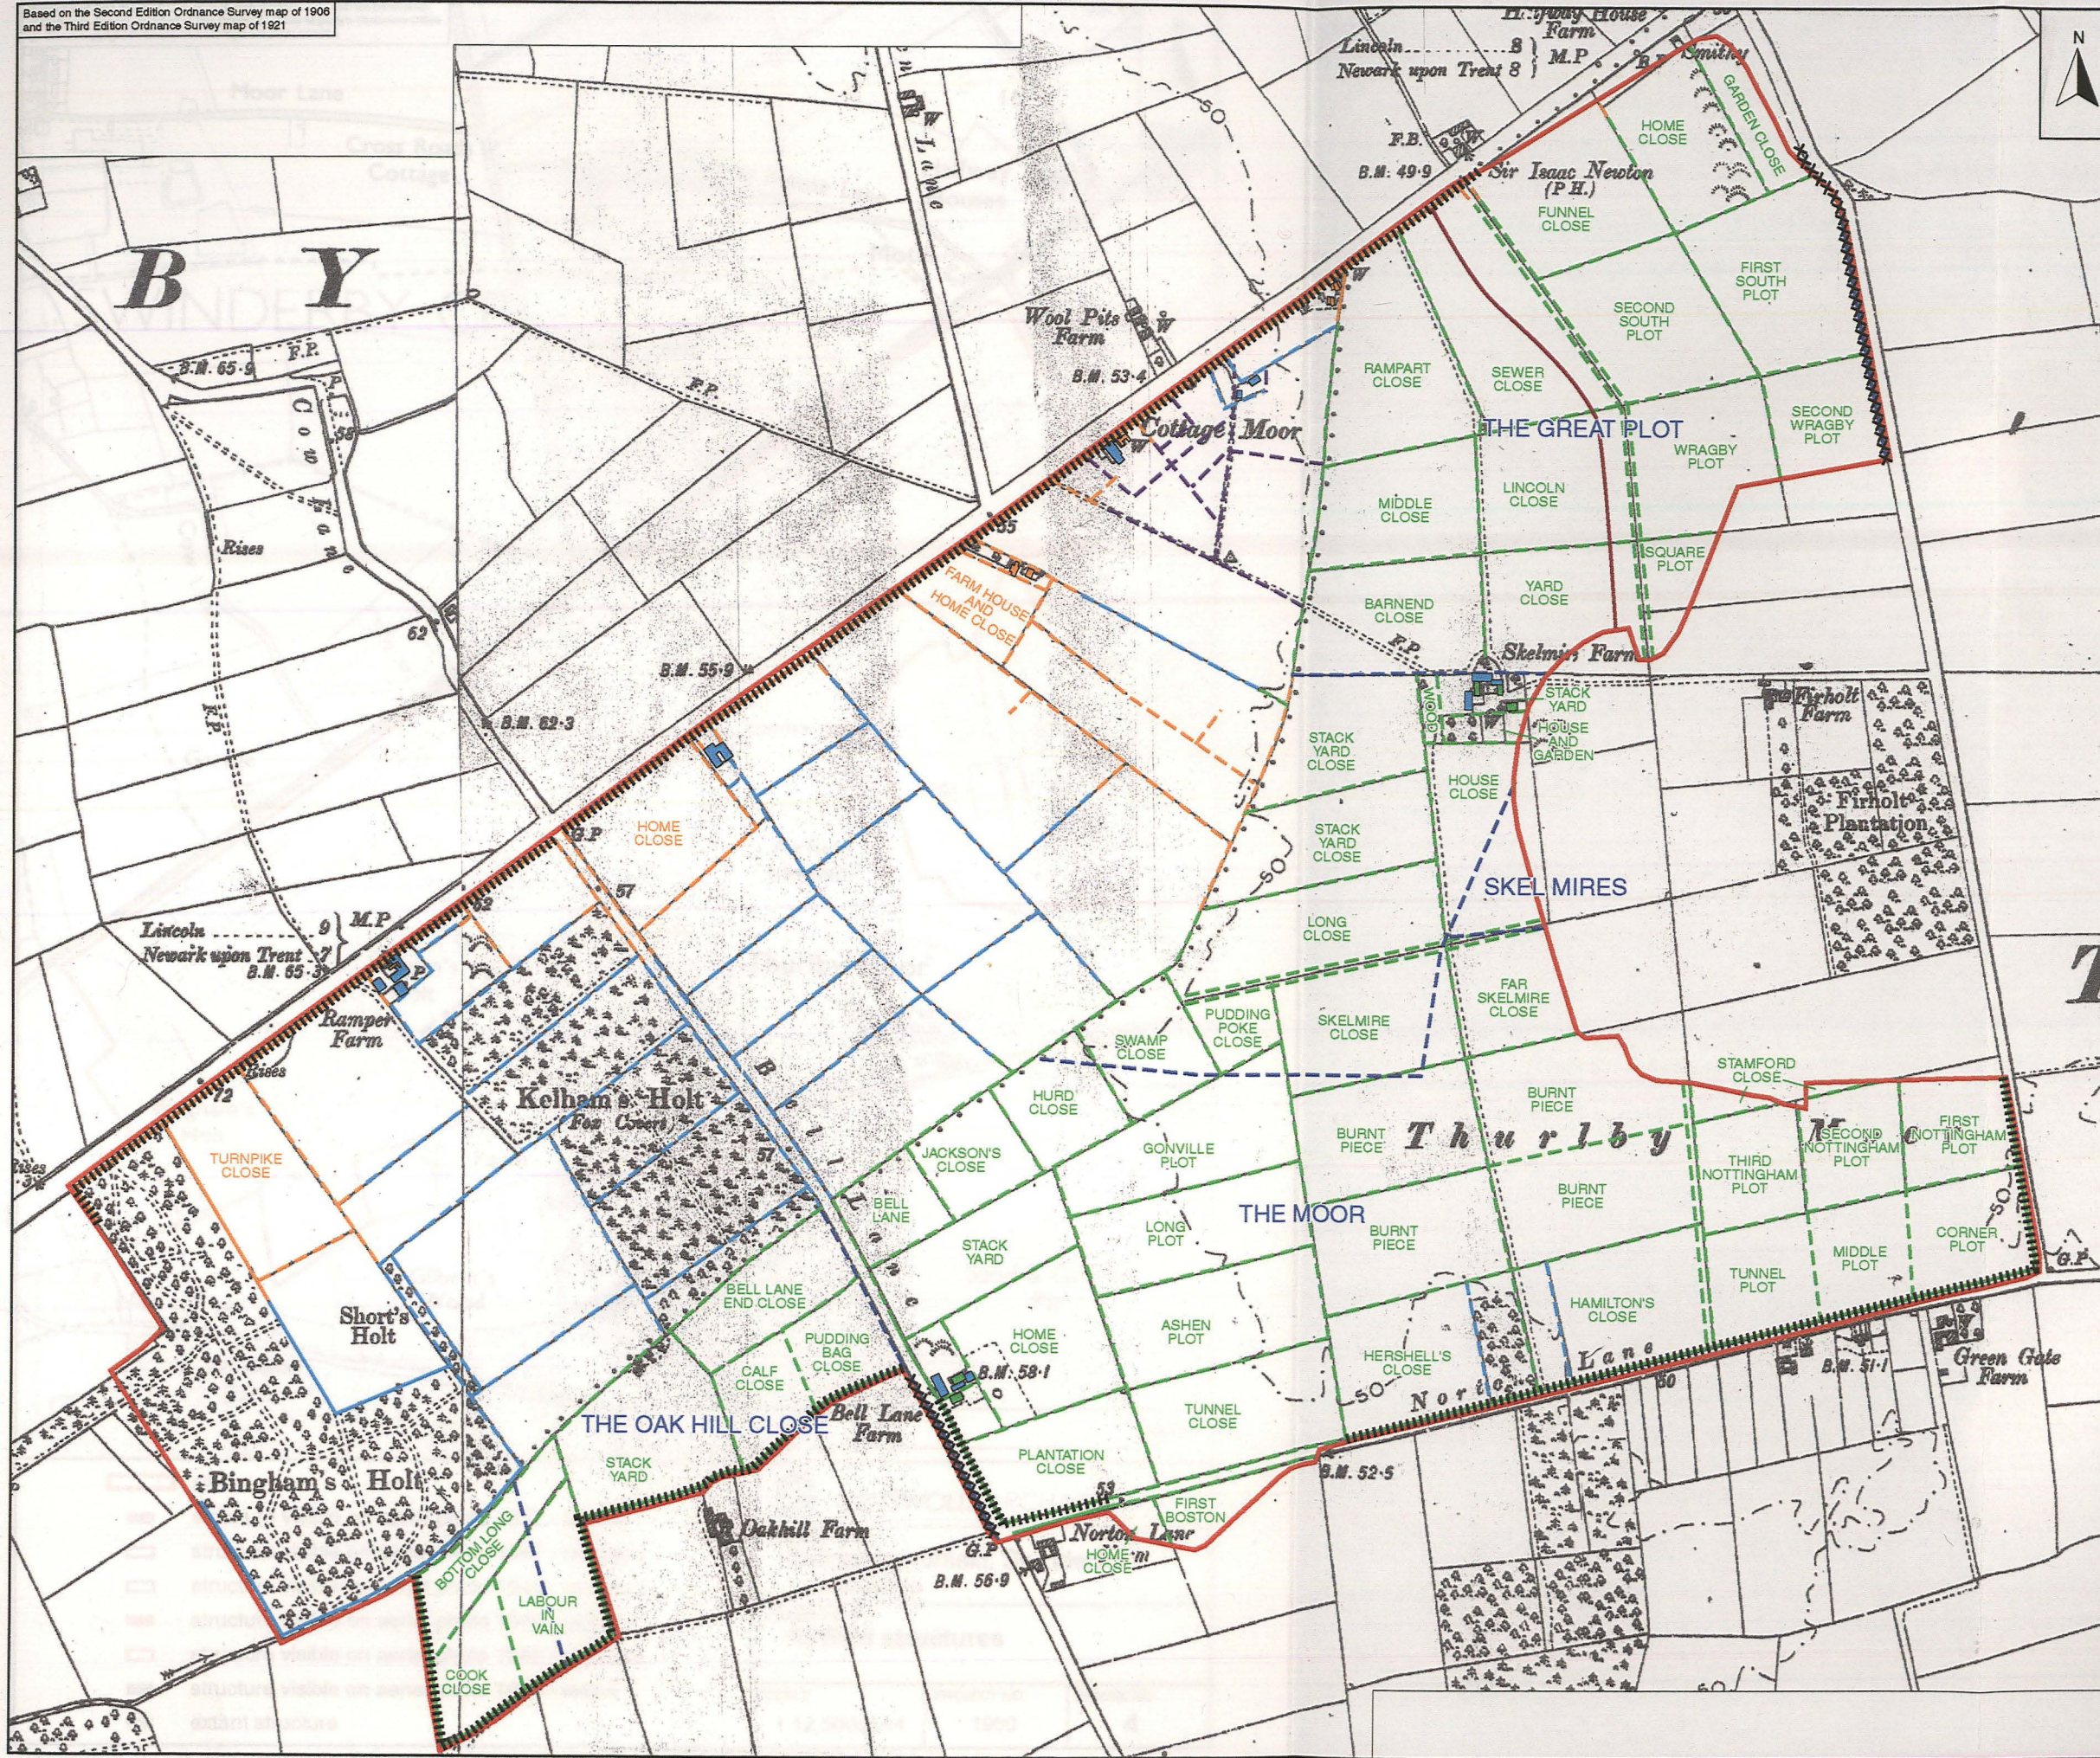
SCALE not to scale	PROJECT NO. 1960	FIGURE NO. 3
-----------------------	---------------------	------------------------

FIGURE TITLE
The historic landscape

- 3.21 The first cartographic source to depict an area of the site is a map of the parish of Thurlby of 1729, the boundaries of which have been transposed onto Fig. 3. This shows that the area of the site within Thurlby Parish was divided between four large plots prior to enclosure; The Great Plot, Skelmires, The Moor and The Oak Hill Close. A drainage channel, the Skelmire Drain, is depicted running through the north-eastern area of the site (Fig. 3). Where hedgerows are present along the boundaries of these plots, they have statutory protection under the Hedgerow Regulations 1997, as they are part of a pre-enclosure landscape. The hedgerow along the side of the Fosse Way is likewise protected (The relevant portion of the hedgerow regulations has been reproduced in Appendix B).

- 3.22 The Thurlby Tithe Map of 1838 shows the layout of the fields following enclosure, and their fieldnames (Fig. 3). None of these names are suggestive of previously unknown archaeological sites. The name *Rampart Close* is likely to refer to the proximity of the Roman road. This source depicts two farms within the site area, Skelmire Farm and Bell Lane Farm, which have now been demolished. Where hedgerows survive along the boundaries depicted on this source, they may be considered of some cultural heritage interest by the local authority (Fig. 3), as they are depicted on a source predating 1845.

- 3.24 Ordnance survey maps of 1906 and 1921 provide the first accurate coverage of the site (Fig. 3). These show that more buildings had been added to most of the groups depicted on the Tithe Maps and another group of buildings had been constructed to the east of Bell Lane, again adjacent to the Fosse Way. Some additional field boundaries had been laid out at the south-east of the site (Fig. 3).

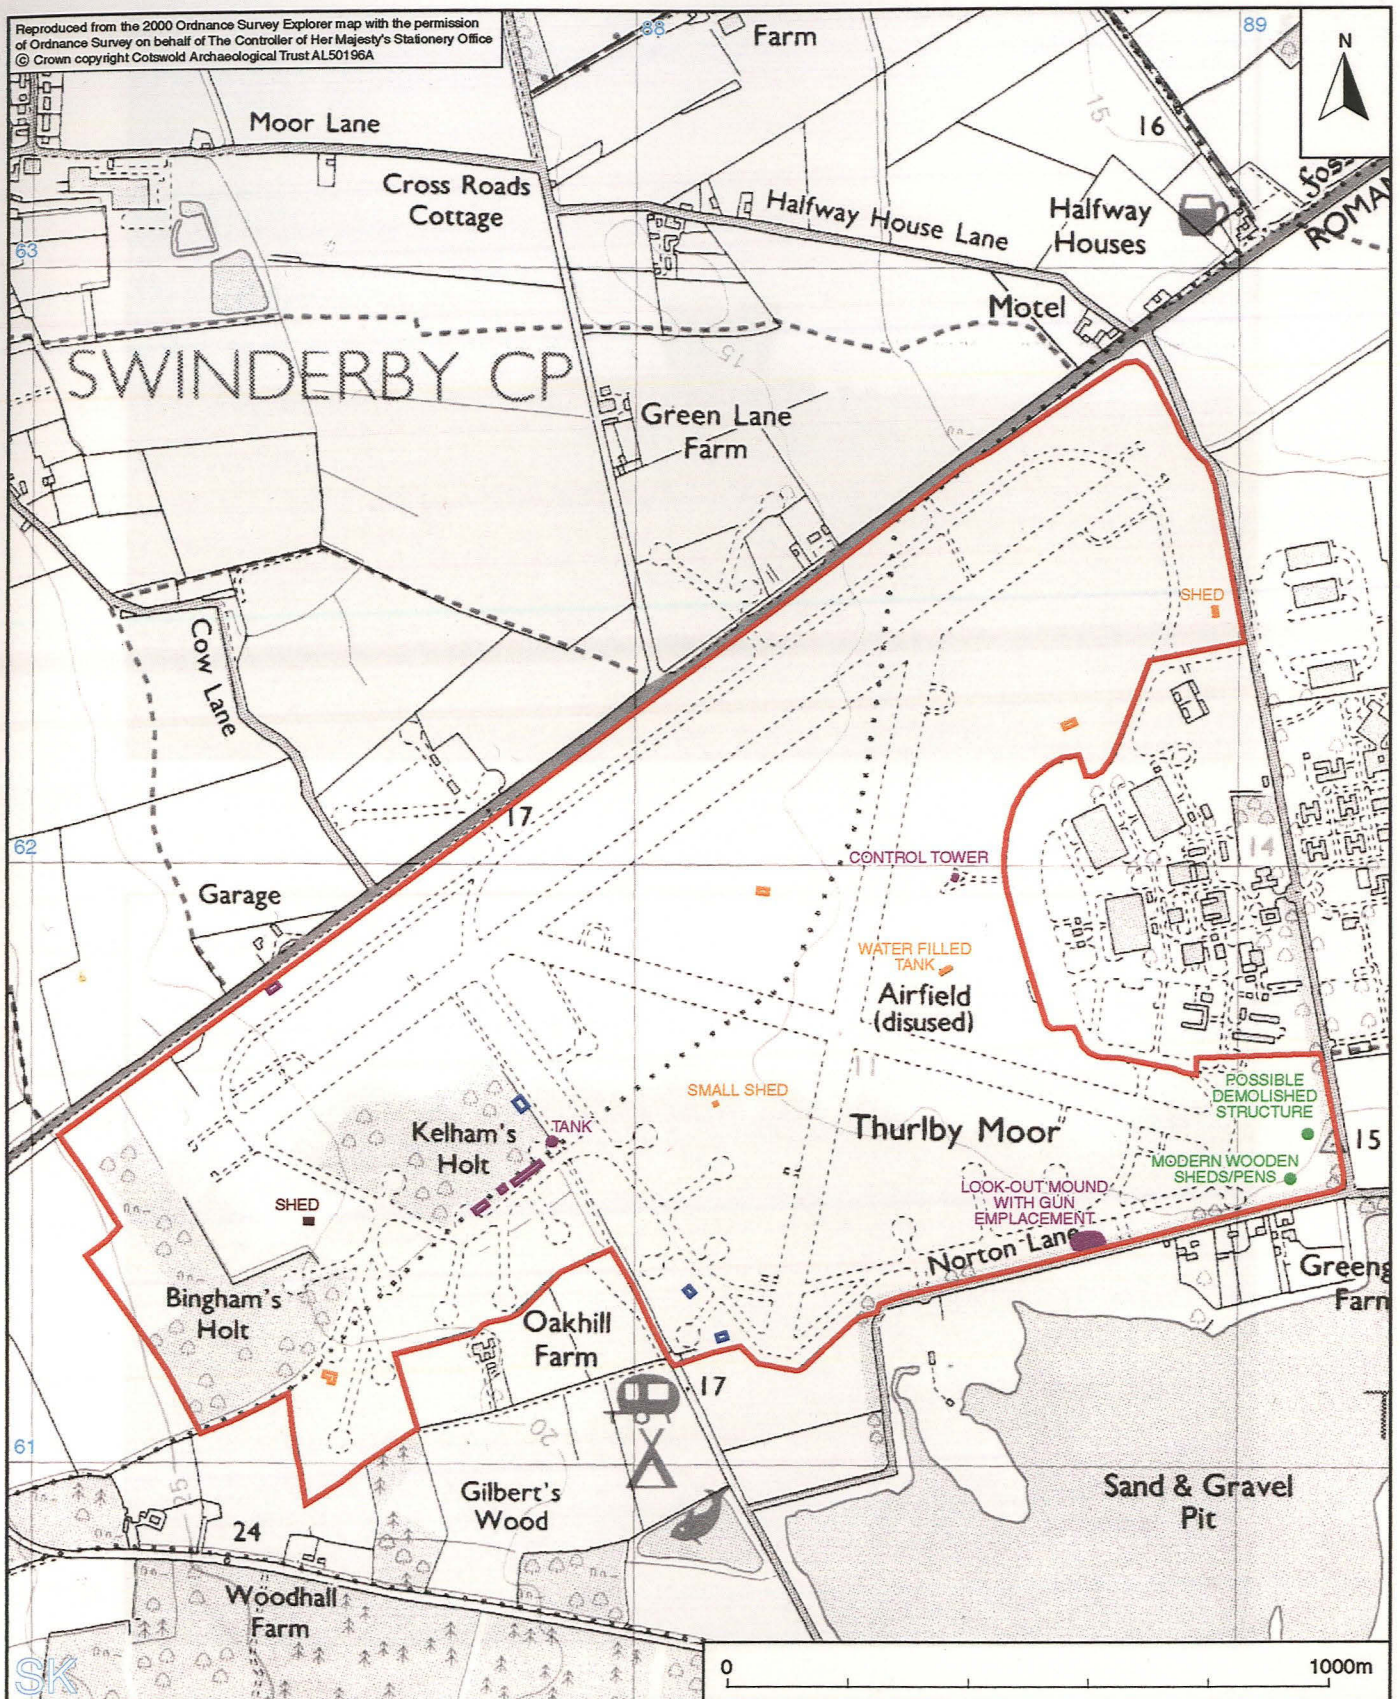
4

- site
- structure visible on aerial photo 1947 - extant
- structure visible on aerial photo 1947 - removed
- structure visible on aerial photo 1948 - removed
- structure visible on aerial photo 1949 - extant
- structure visible on aerial photo 1949 - removed
- structure visible on aerial photo 1973 - extant
- extant structure

- 3.25 Aerial photographs of 1941 show the airfield, which had been constructed in 1940. The control tower did not appear to have been constructed by this date, nor the look-out mound. The concrete run-ways also appeared to be absent, and may have been a later addition to the airfield. These features are all visible on an aerial photograph of 1947 and are all extant (Figs 4-6). Additional small buildings which have now been removed can be seen on aerial photographs of 1948 (Fig. 4). More small structures had been constructed by 1959, some of which are still extant including two sheds and a water-filled tank (Fig. 4). An additional building is visible on an aerial photograph of 1973 (Fig. 4).

- 3.26 A couple of additional structures were observed during the site visit. An area of rubble at the south-eastern corner of the site may have been a demolished structure and a group of recently constructed sheds were present to the south-west of the rubble (Fig. 4).

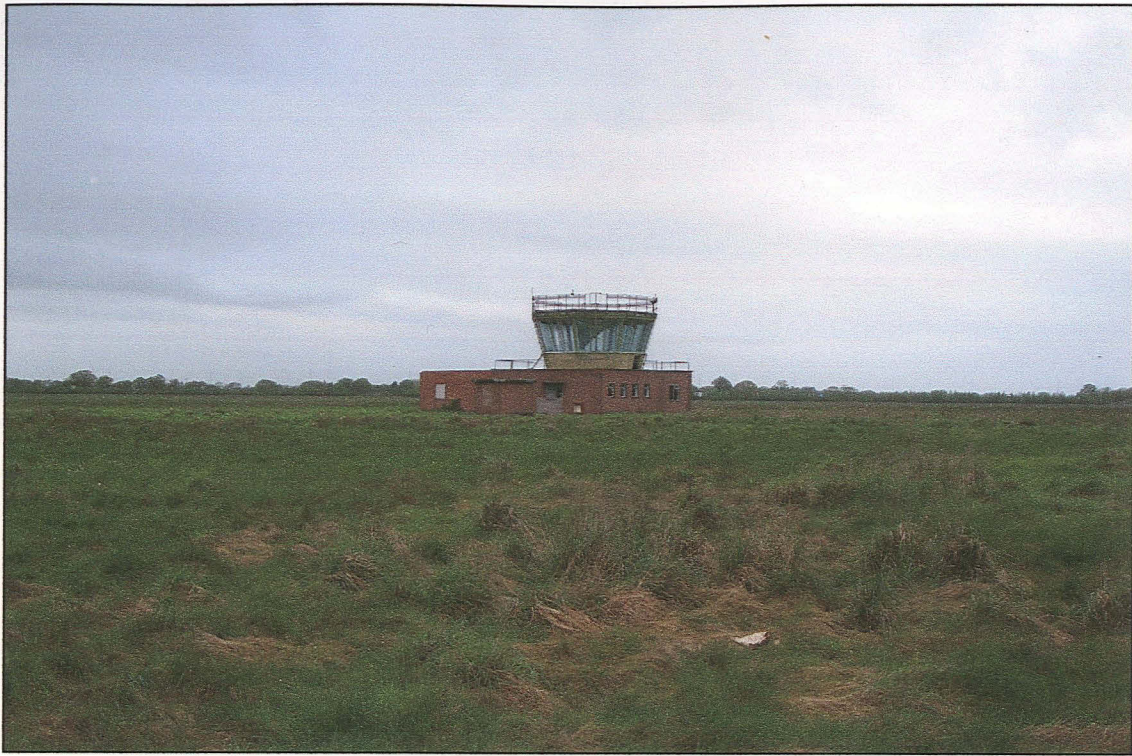
5 The control tower, looking north
